IN THE MATTER of an application by
TRUSTPOWER LTD
to the **BAY OF**
PLENTY REGIONAL
COUNCIL for water
permits associated
with the operation of
the Matahina
Hydroelectric Power
Scheme

STATEMENT OF SUPPLEMENTARY EVIDENCE OF BRUCE KELVIN CRABBE

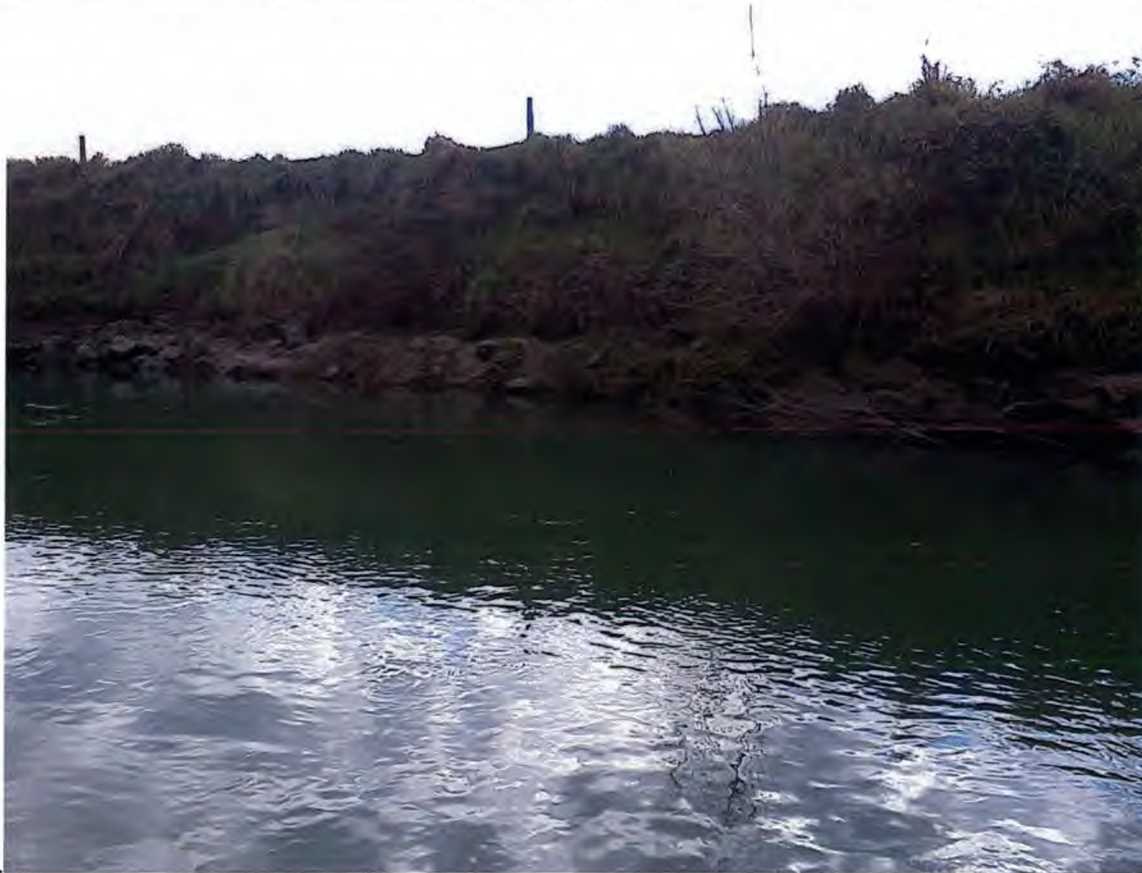
IMG488 (10 August 2011), 28.7km, Reach 3, Right bank: Rock protection works bare of vegetation and eroding through hydro dam fluctuation

zone.

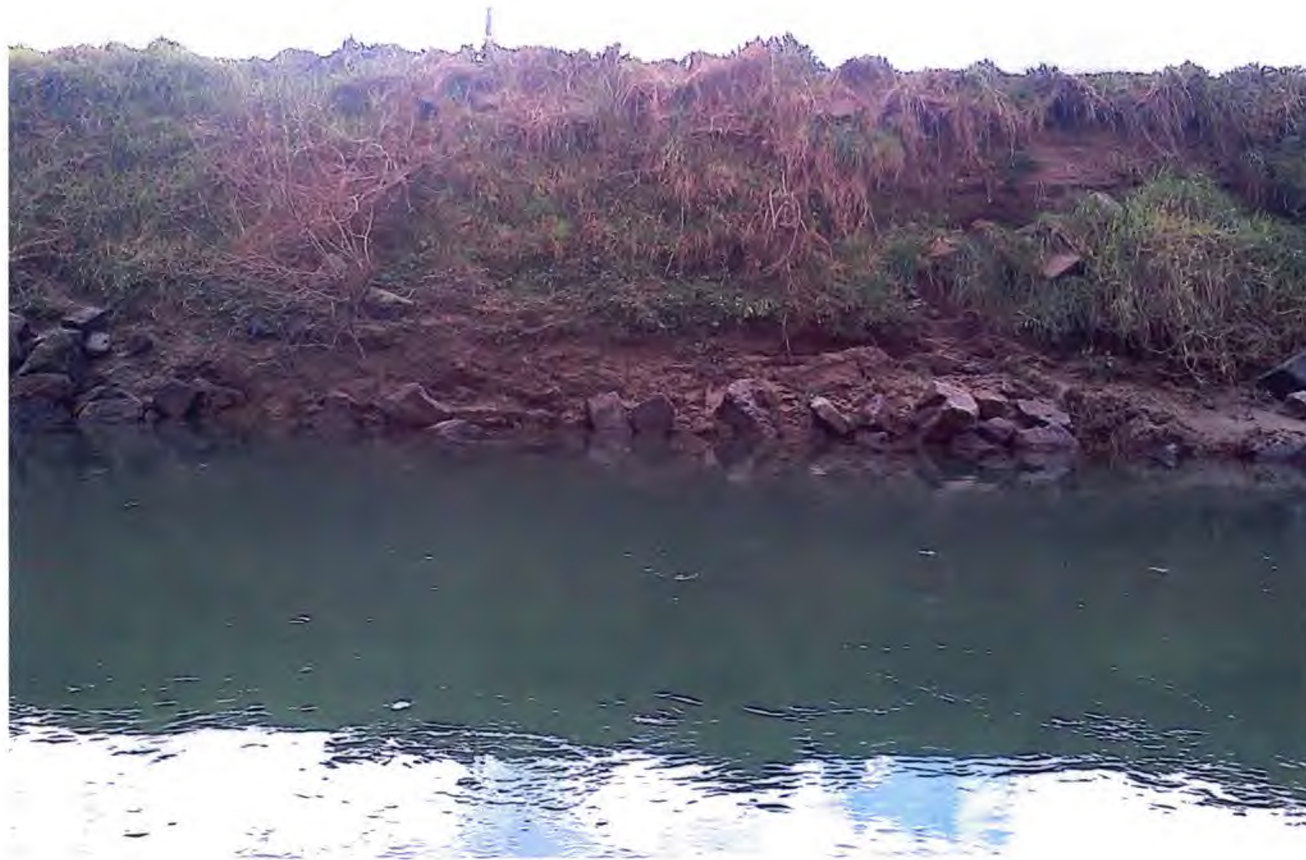
IMG 489 (10 August 2011), 28.68km, Reach 3, Right bank: Rock protection works bare of vegetaion and eroding through hydro dam fluctuation zone.

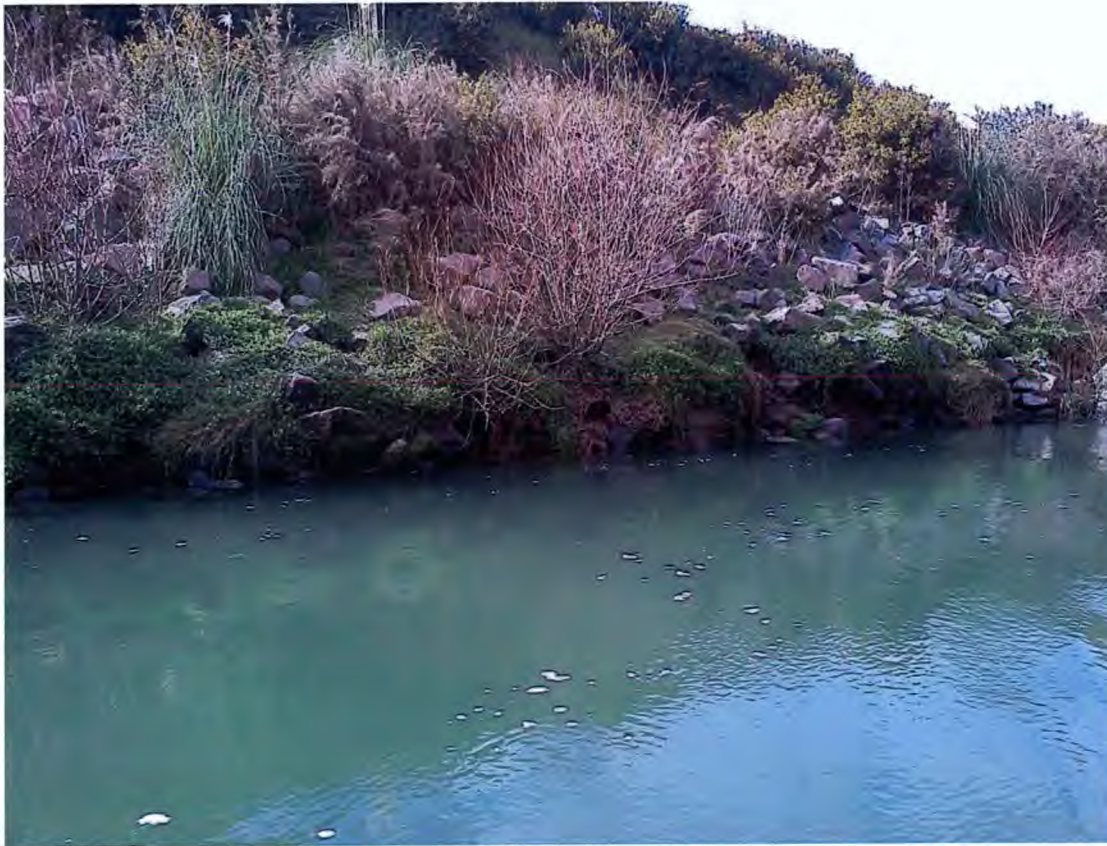
IMG511(10 August 2011), 26.9km, Reach 3, Right bank: Erosion of rock works at fluctuation zone. Rock works in good condition and reinforced with vegetation above the fluctuation zone despite being subjected to several large flood events. This site (Carter/McCauley) is a 2004 Flood Repair work completed in 2006.

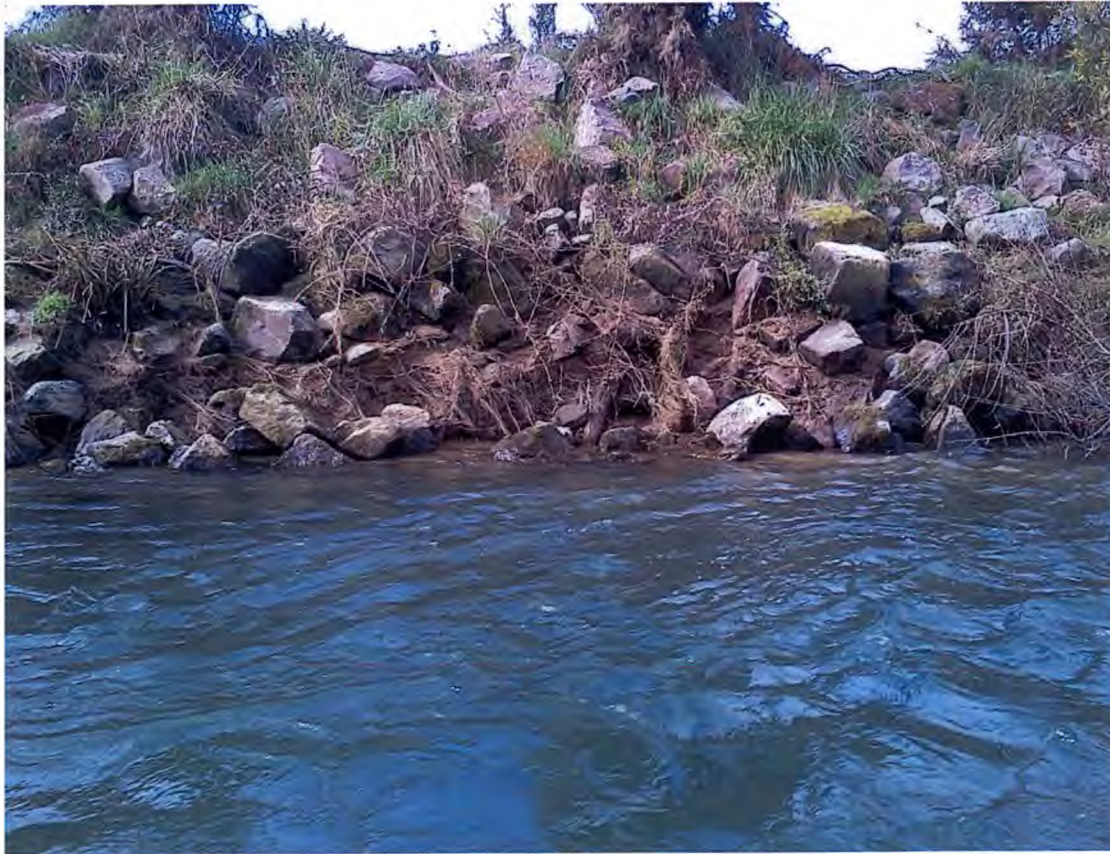
IMG522 (10 August 2011), 26.2km, Reach 3, Right bank: Erosion of rock works at fluctuation zone. Rock works in good condition above the fluctuation zone despite being subjected to several large flood events. This site (Demetroff) is a 2004 Flood Repair work completed in 2006.

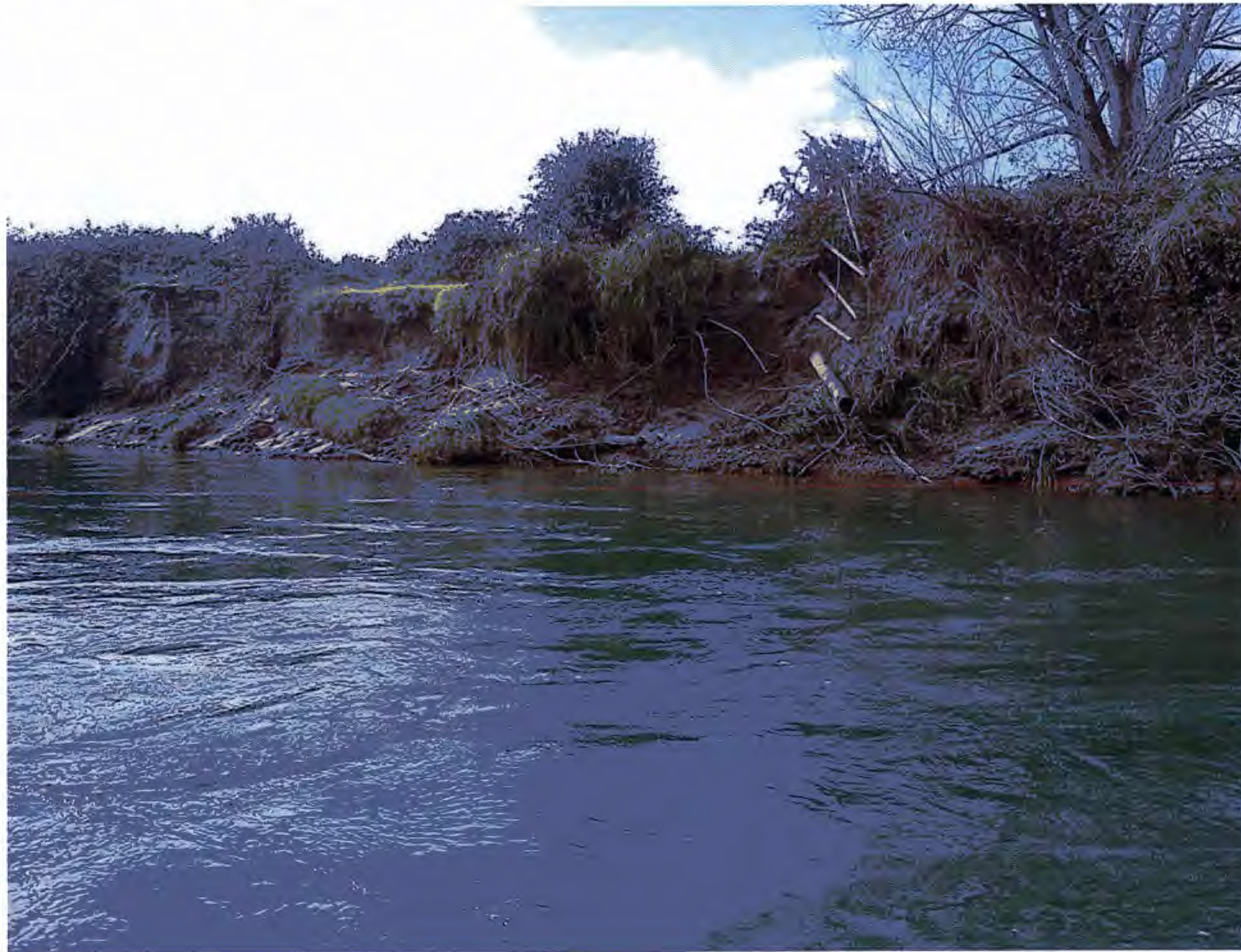
IMG524 (10 August 2011), 26.14km, Reach 3, Right bank:Raw river bank continuously eroding at the fluctuation zone. Note rate of erosion by collapsed length of fenceline.

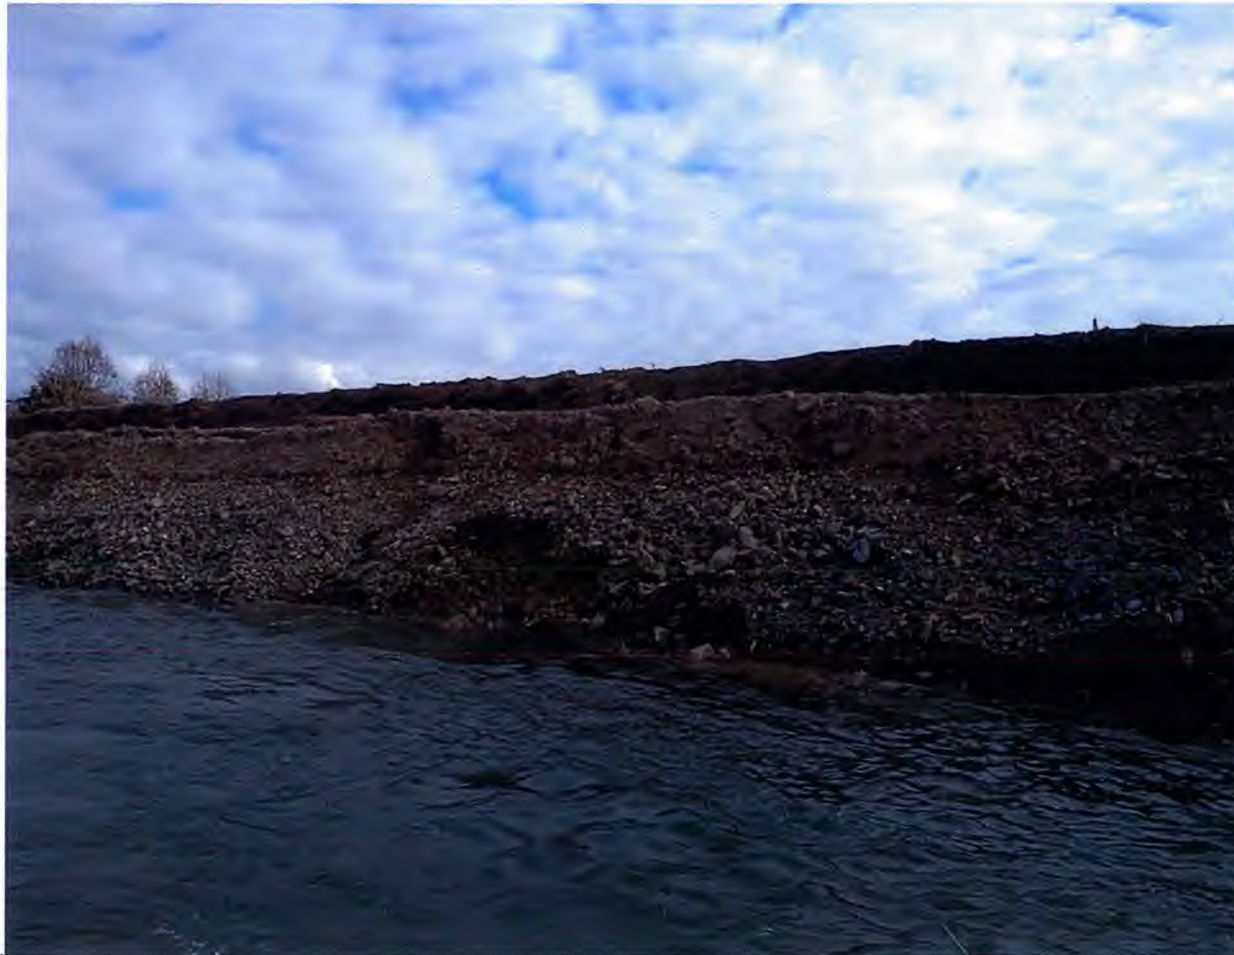
IMG538 (10 August 2011), 24.9km, Reach 3, Left bank:Section of eroded river bank with protection works in progress. First stage to place a filter layer of weathered rock for foundation of the larger rock material is being eroded by the regular fluctuations before the covering layer of rock can be placed. Note height of regular

fluctuations.

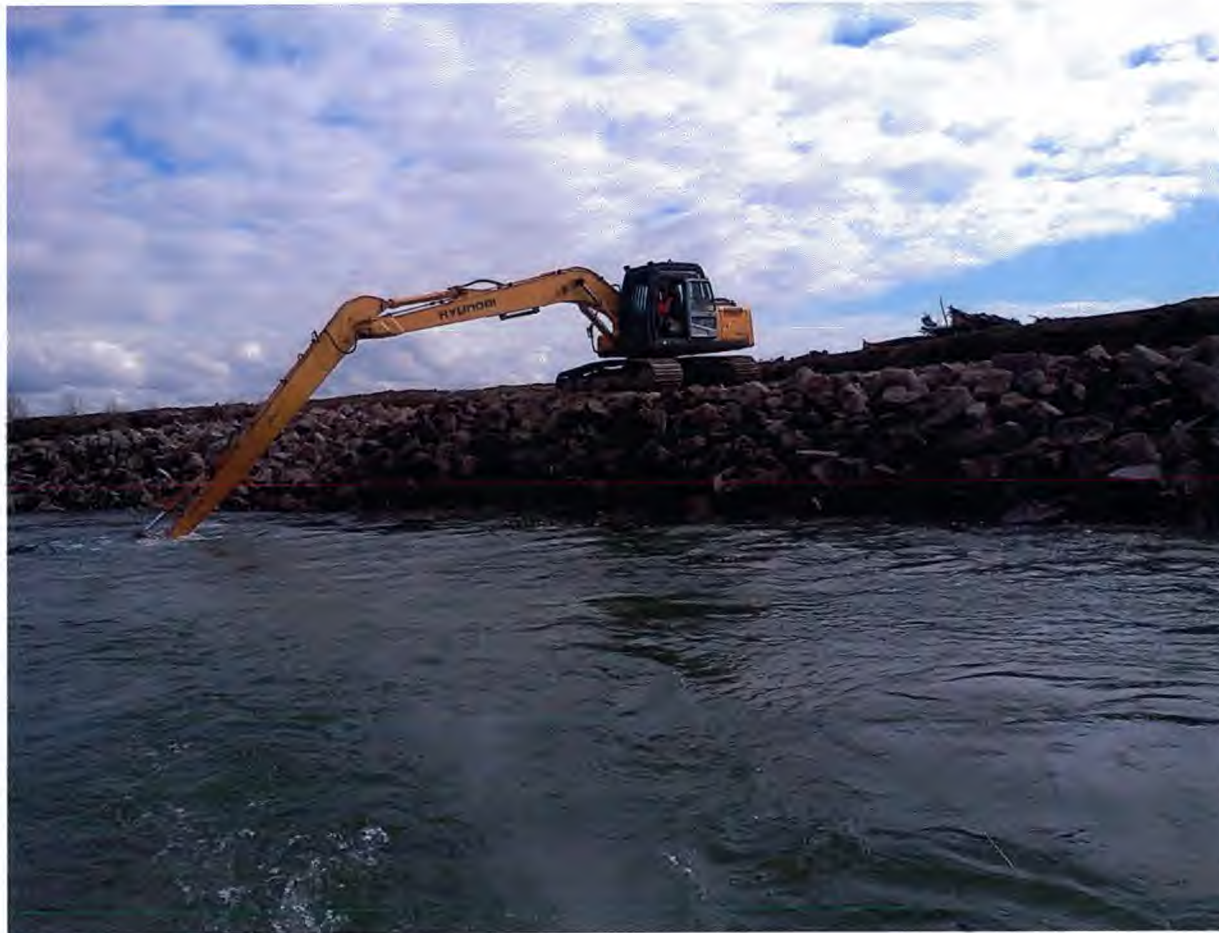
IMG540 (10 August 2011), 24.85, Reach 3, Left bank: Close to previous photograph. Rock protection works being placed over the foundation layer of weathered rock material.

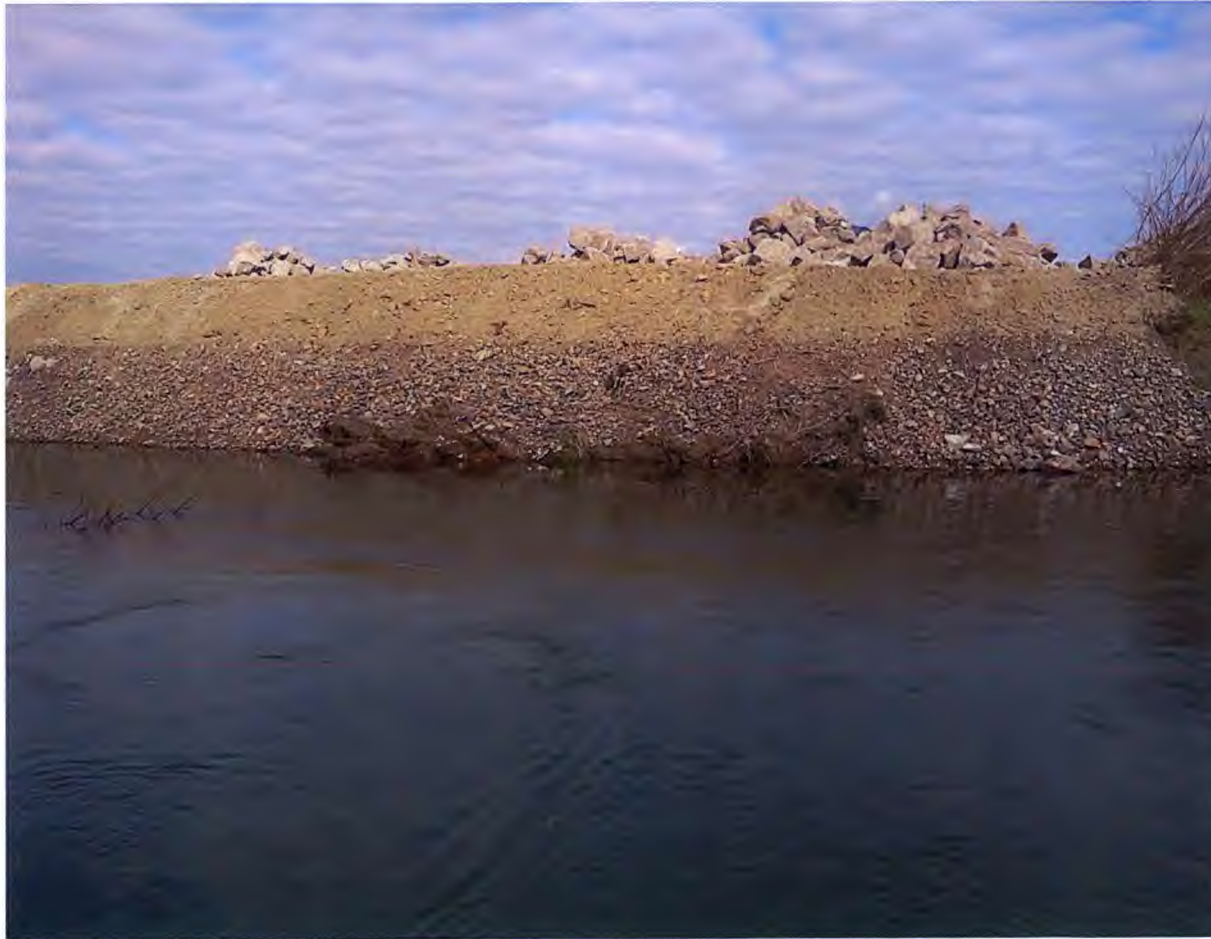
IMG553(10 August 2011), 24.5km, Reach 3, Left bank:Section of eroded river bank with protection works in progress. First stage to place a filter layer of weathered rock for foundation of the larger rock material (see rock stockpiles in background). Note height of regular fluctuations.

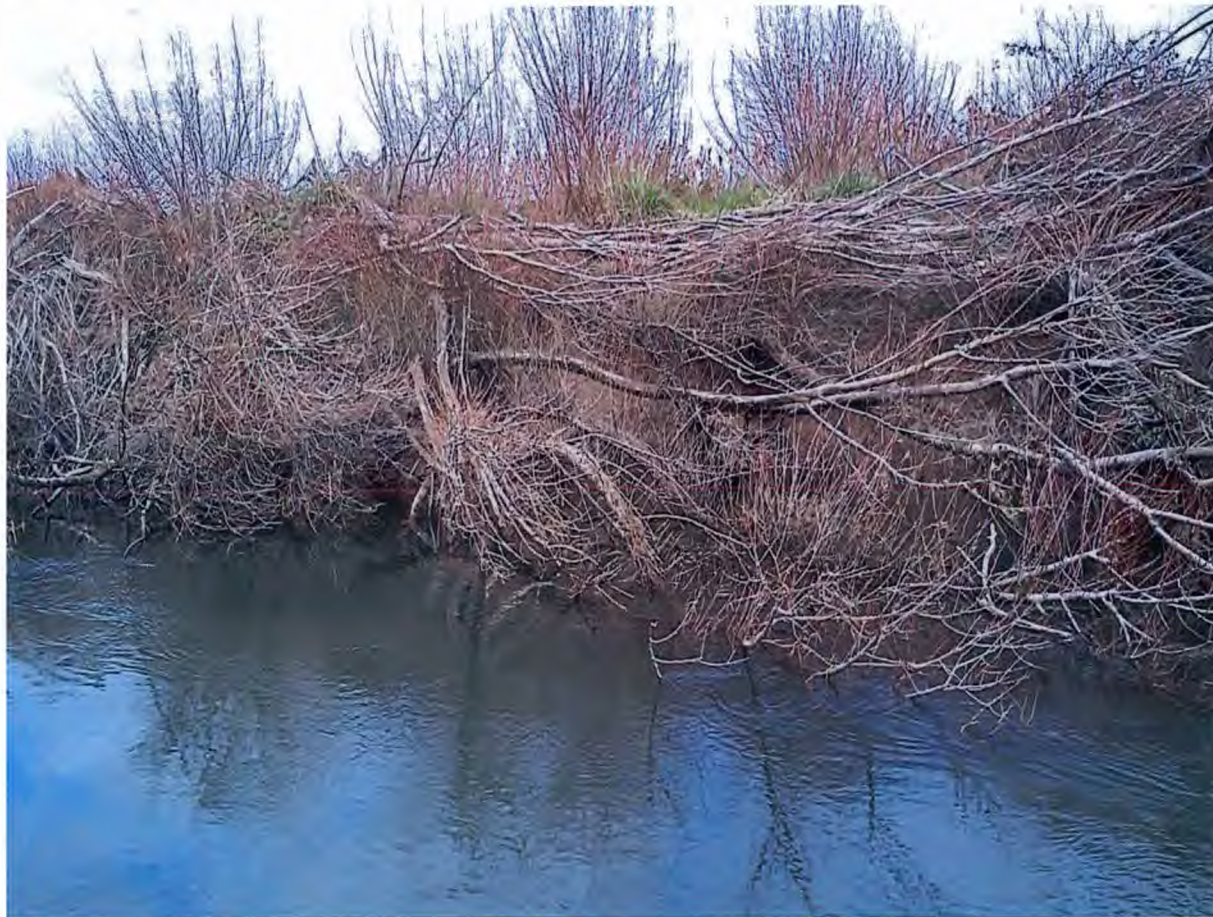
IMG555 (10 August 2011), 24.45km, Reach 2, Left bank: Layered willow edge protection works. Tree material in fluctuation zone dying off and bare eroding river bank behind.

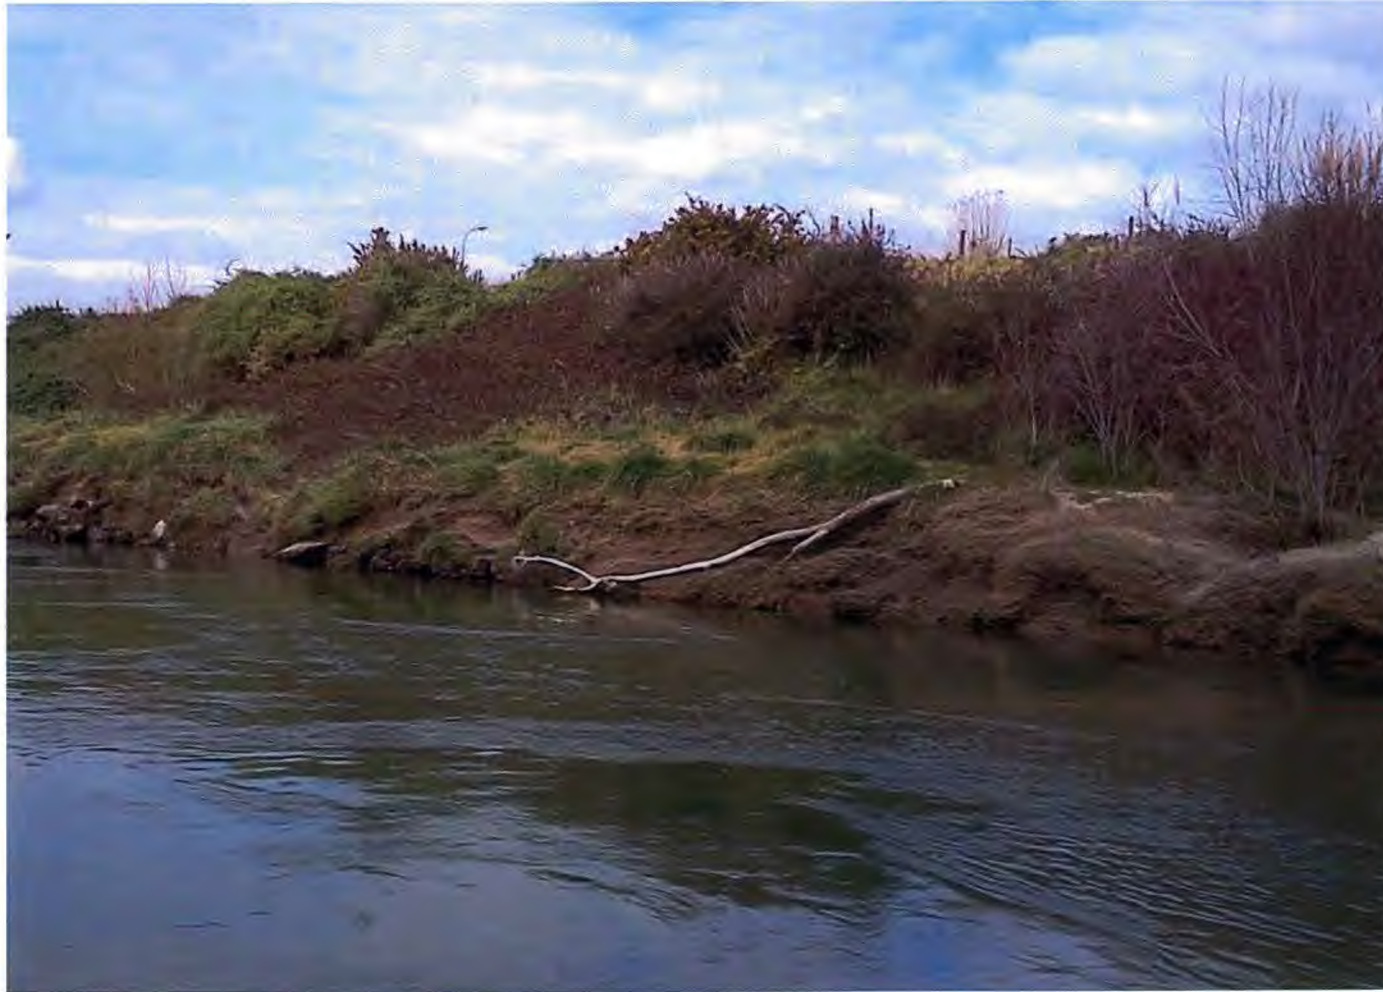
IMG569 (10 August 2011), 22.9km, Reach 2, Right bank: Bare river bank at fluctuation zone and slumping rock works at left.

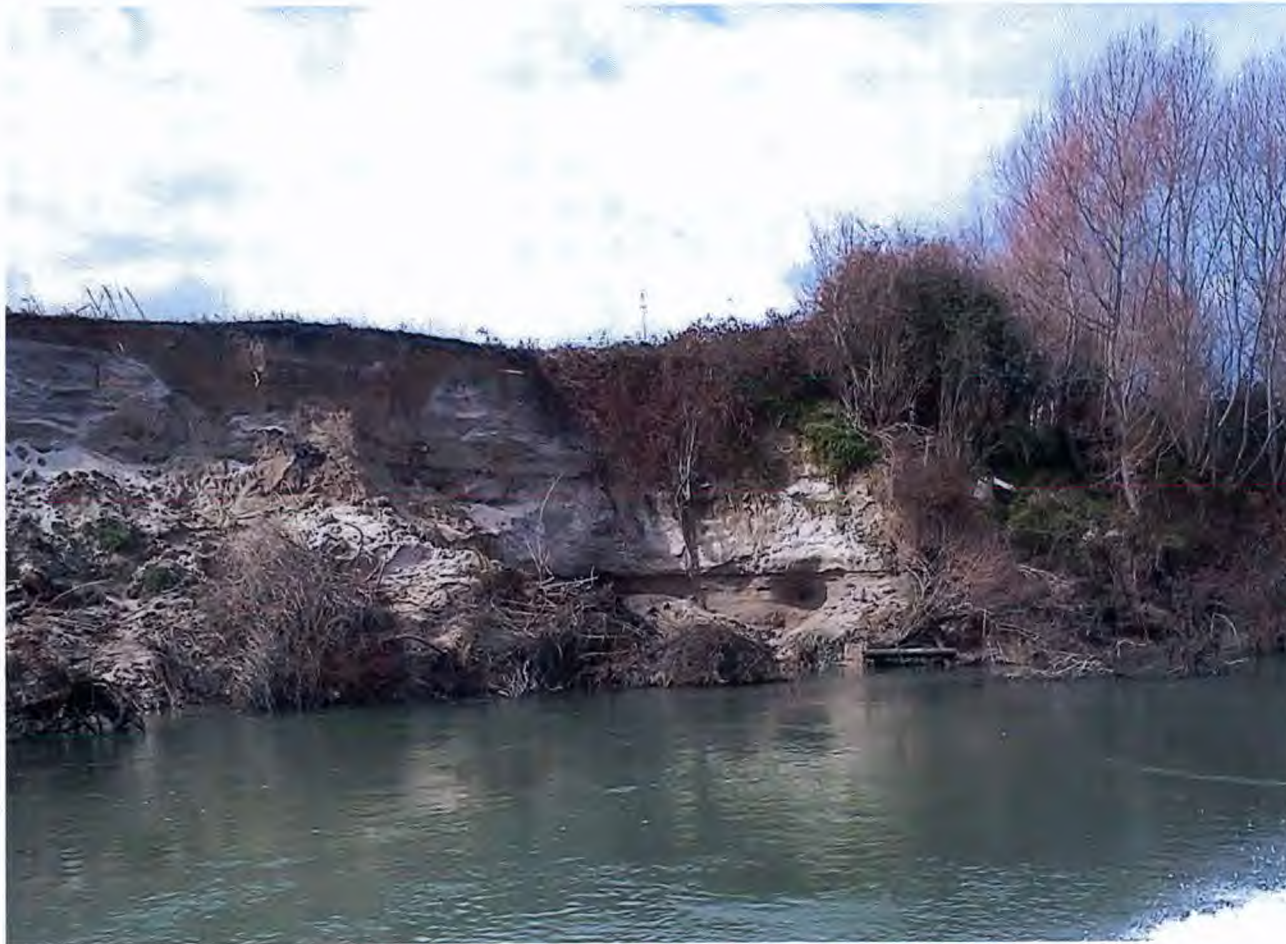
IMG573 (10 August 2011), 22.2km, Reach 2, Right bank:Raw river bank continuouslyeroding at the fluctuation zone. Note height of regular fluctuations on bank in centre of photo that is undercutting the vulnerable soils.

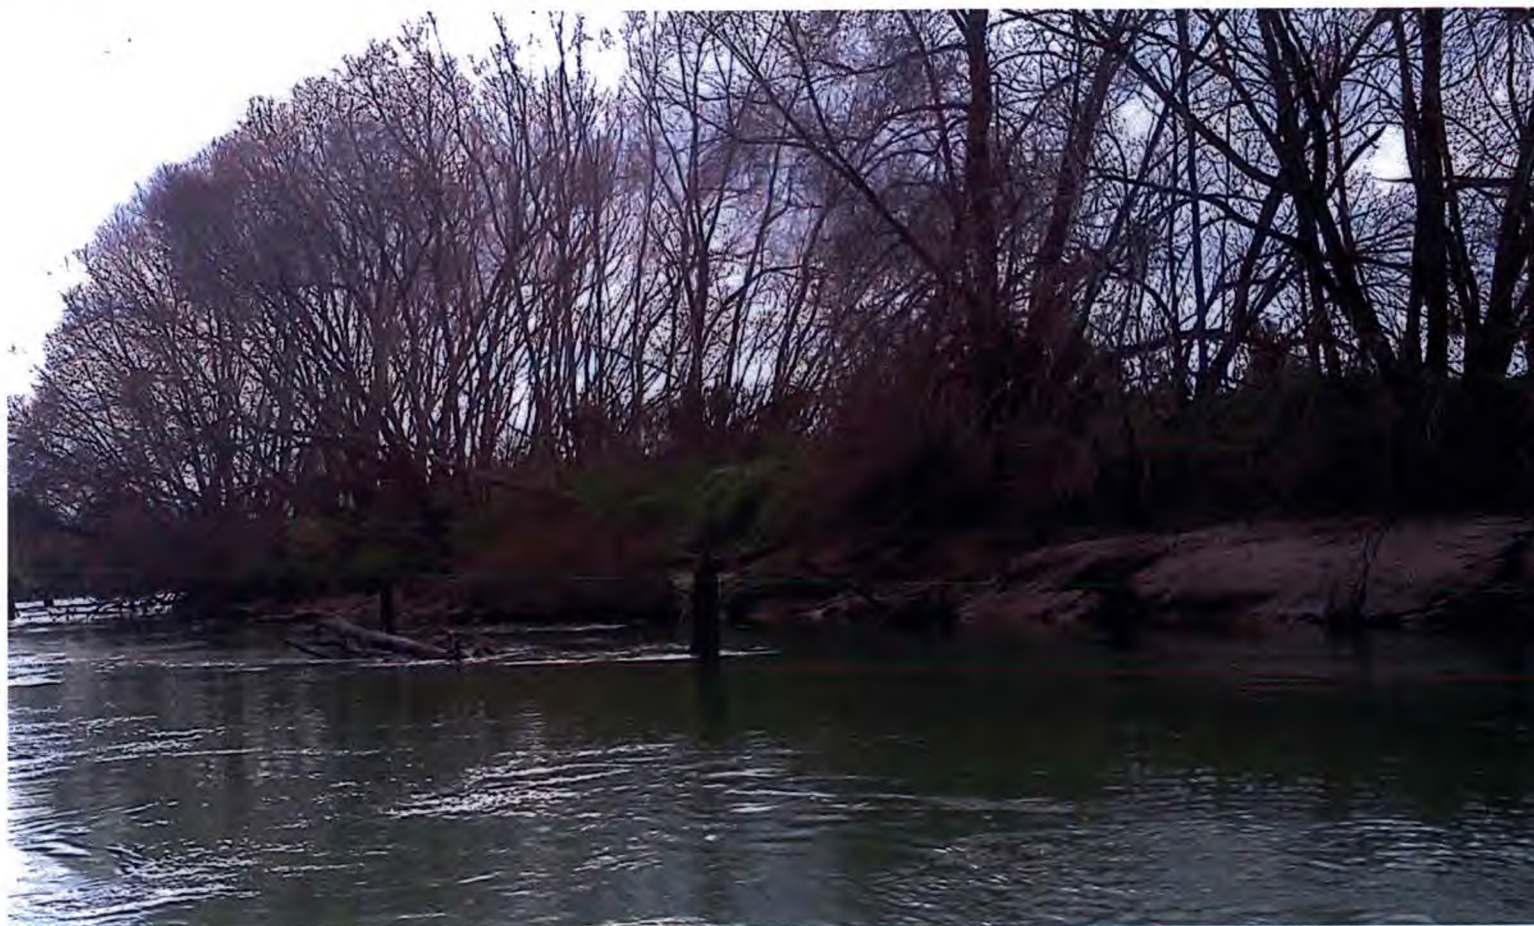
IMG577 (10 August 2011), 21.6km, Reach 2, Right bank: Bare river bank through the regular fluctuation zone. Erosion and undermining of trees occurring.

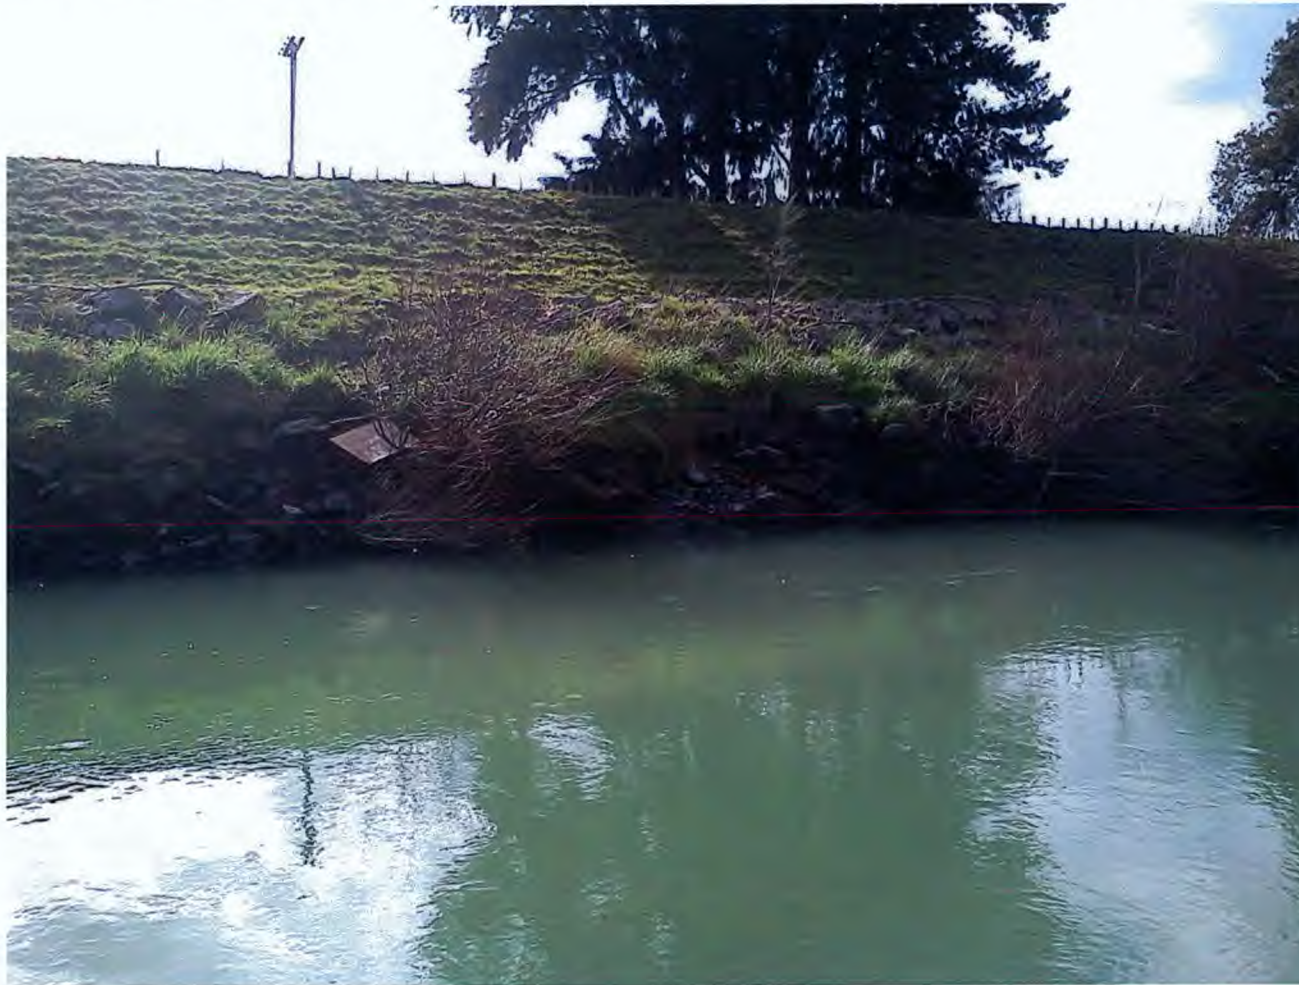
IMG614 (10 August 2011), 15.45km, Reach 2, Left bank: Erosion of rock works at fluctuation zone. Rock works in good condition above the fluctuation zone despite being subjected to several large flood events. This site (Eruera) is a 2004 Flood Repair work completed in 2005.

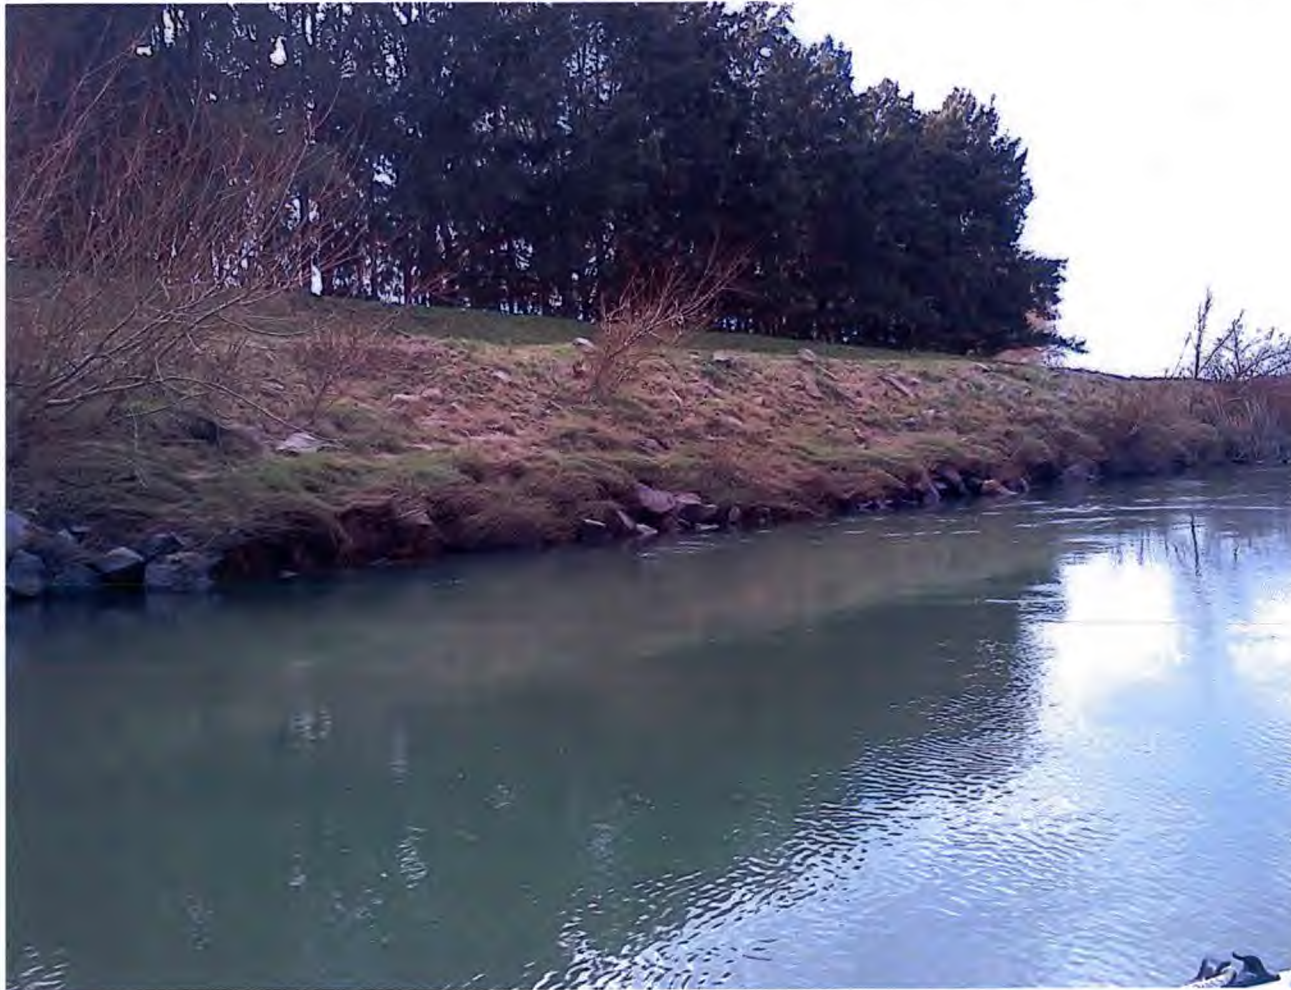
IMG617 (10 August 2011), 15.3km, Reach 2, Left bank: Erosion of rock works at fluctuation zone. Rock works in good condition above the fluctuation zone despite being subjected to several large flood events. This site (Eruera) is a 2004 Flood Repair work completed in 2005.
