PRELIMINARY INVESTIGATION OF THE
INFLUENCE OF MATAHINA POWER STATION ON
**RIVER BANK STABILITY ALONG THE
RANGITAIKI RIVER**

Prepared for
Electricity Corporation of New Zealand Ltd
Hamilton

Prepared by
J Dahm
M R Edwards
D N Jennings
WORKS Consultancy Services
Hamilton

May 1988

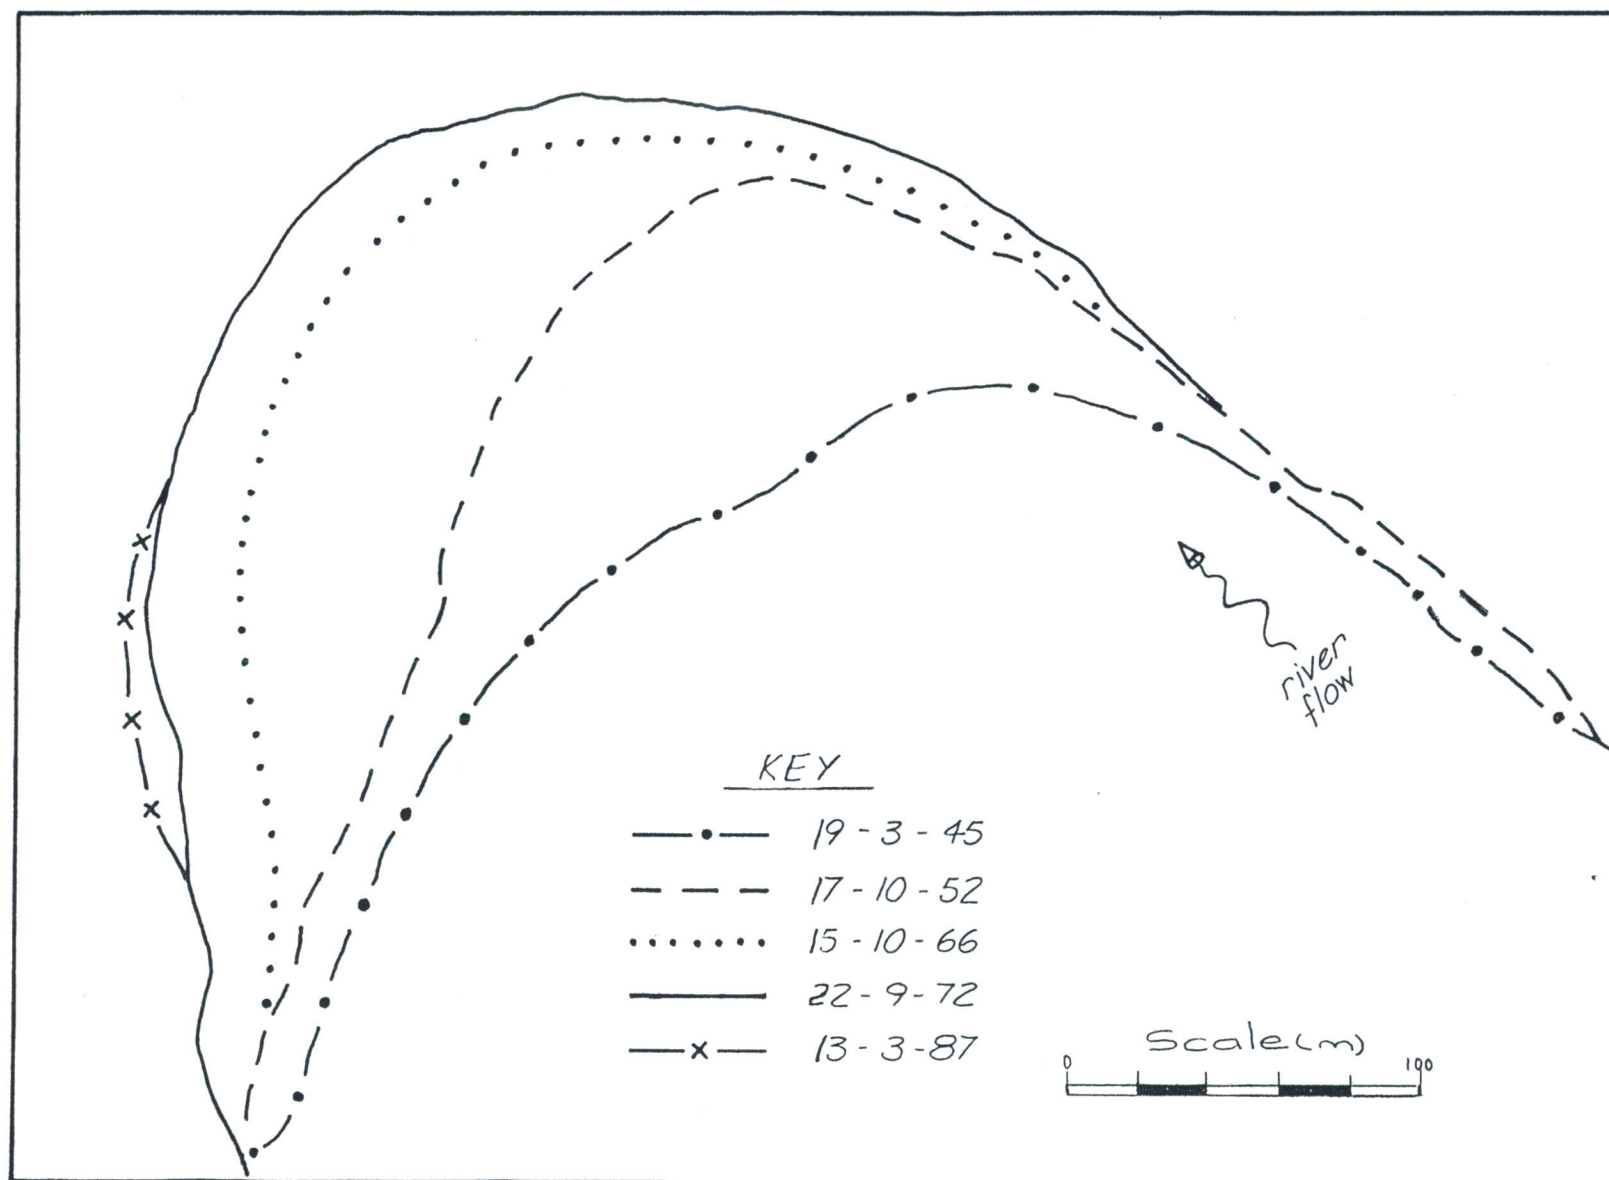
It is notable that a marked change in the pattern of bank retreat is evident in the period 1972-87 - the extent of erosion being markedly more restricted than observed in the preceding periods. (Figure 6.1). As the pattern of erosion between 1966 and 1972, predominantly a period of post-dam flow regime, was virtually identical to that occurring in the previous (pre-dam regime) periods, it seems unlikely that the change in pattern observed between 1972 and 1987 can be primarily attributed to the operation of the dam. More probably, the change reflects the relatively low frequency of large flows during this period (Figure 6.2).

Figure 6.1 : Pattern of bank retreat of site 6, 1945-1987

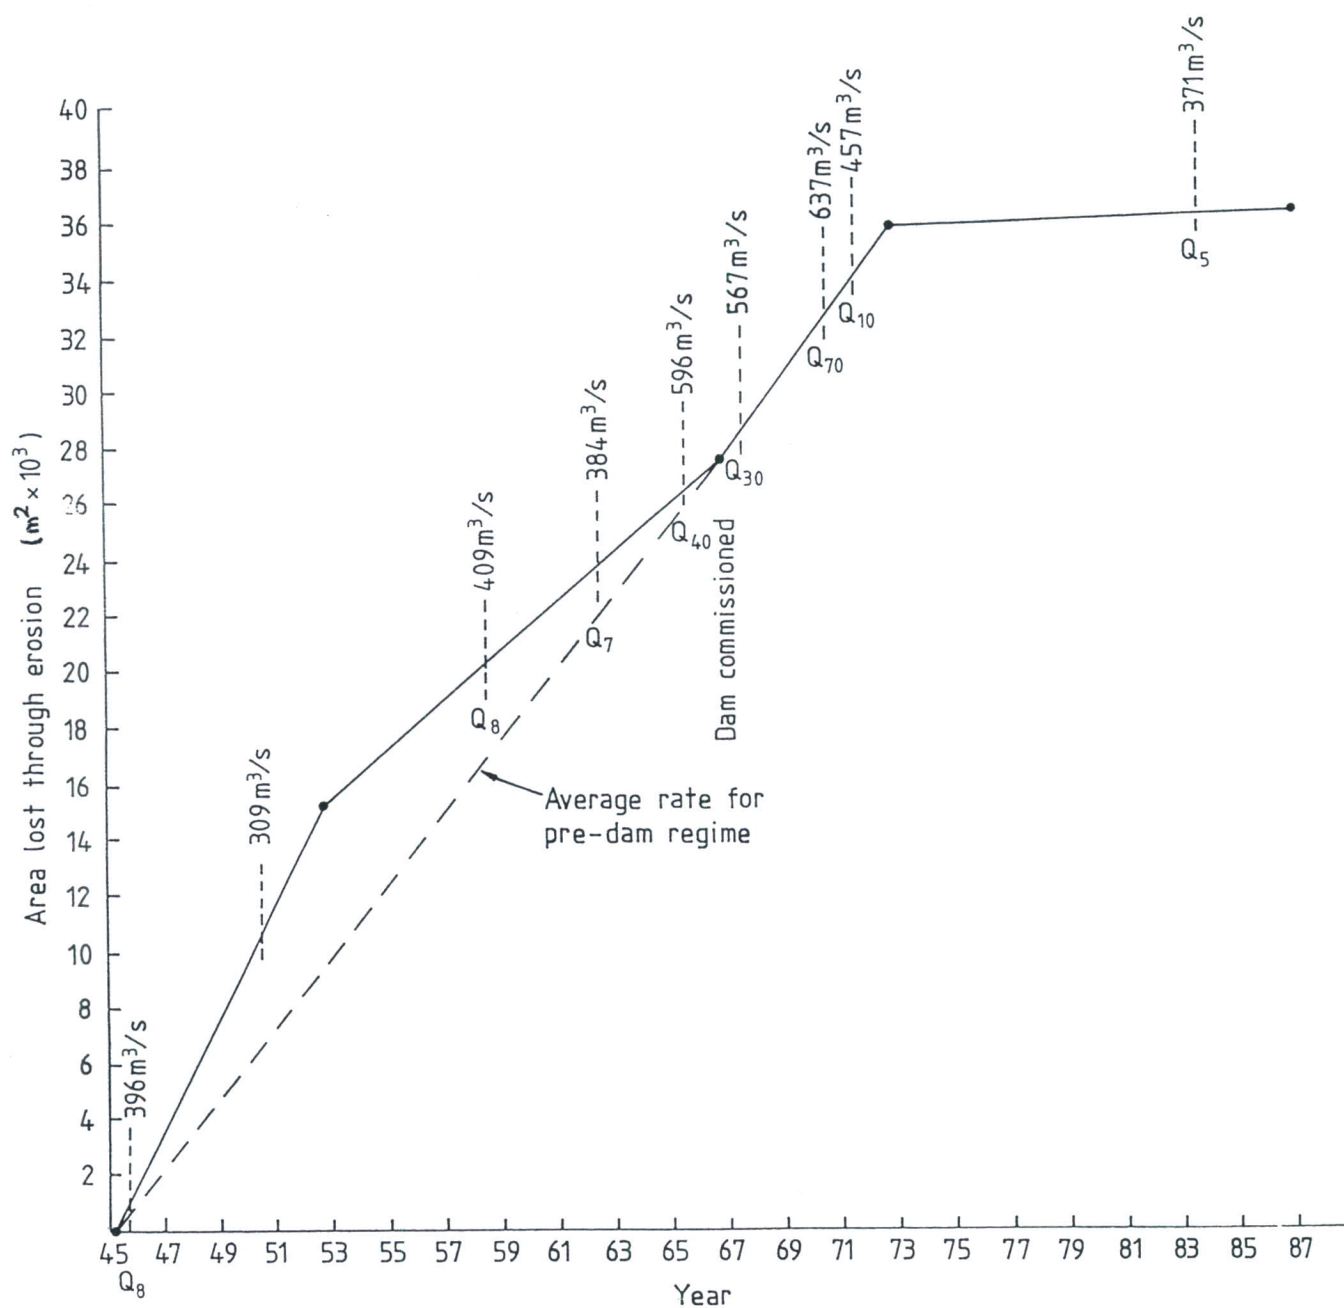
The rate of erosion shows a similar pattern with a marked reduction in the rate of bank retreat being evident between 1972 and 1987 (Figure 6.2). The rate of erosion in the post-dam period of 1966-72 ($1360 \text{ m}^2/\text{yr}$) is within the range ($889\text{--}2171 \text{ m}^2/\text{yr}$) observed in the preceding periods - and is, in fact, virtually identical to the average rate ($1316 \text{ m}^2/\text{yr}$) observed over the total 1945-66 period of pre-dam regime. Thus, the rate of erosion appears to be primarily related to the occurrence of large flows rather than the presence or absence of the dam.

Figure 6.2 : Rate of retreat along right bank at site 6 during period 1945-87

An apparent anomaly in this explanation is the rapid rate of bank retreat ($2171 \text{ m}^2/\text{yr}$) noted between 1945 and 1952 - a period with only two significant floods, only one of which was in excess of Q_5 (Figure 6.2).

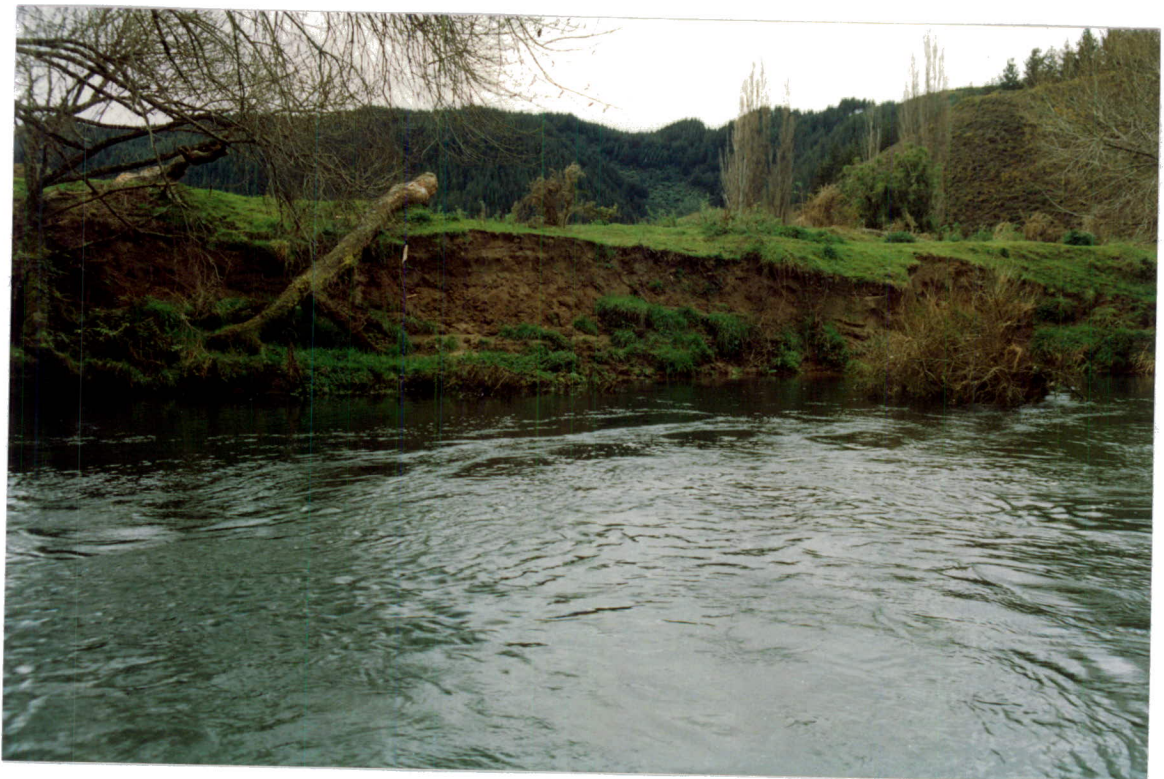
However, it is possible that erosion at one site is accentuated by eddying and turbulence in the lee of local willow trees.

Figure C1. Site 1.

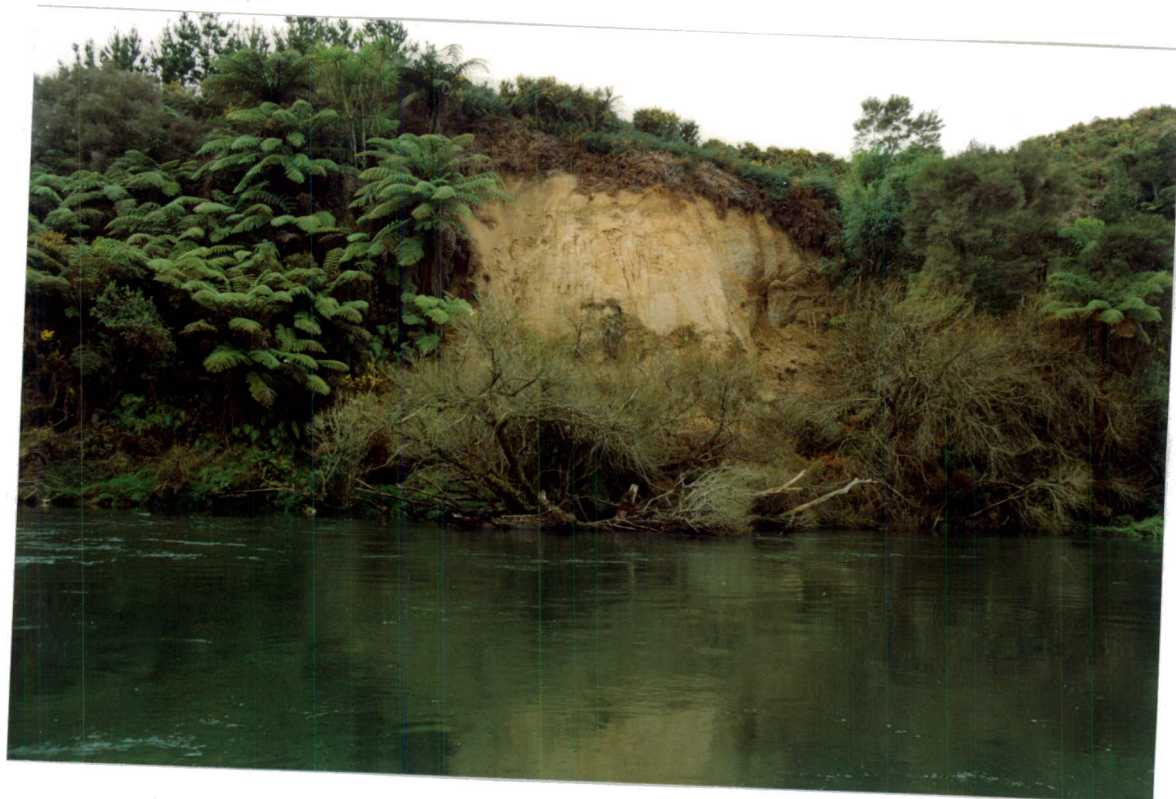
Location of the instability on the outside of a sharp bend suggests basal erosion as the initiatory mechanism. The recent nature of the slump evident in figure 2 suggest that the erosion may also have been aggravated by the recent earthquake. Erosion of the right bank is also clearly related to basal scour - associated with redirection of flow across the channel.

Figure C2. Site 2.

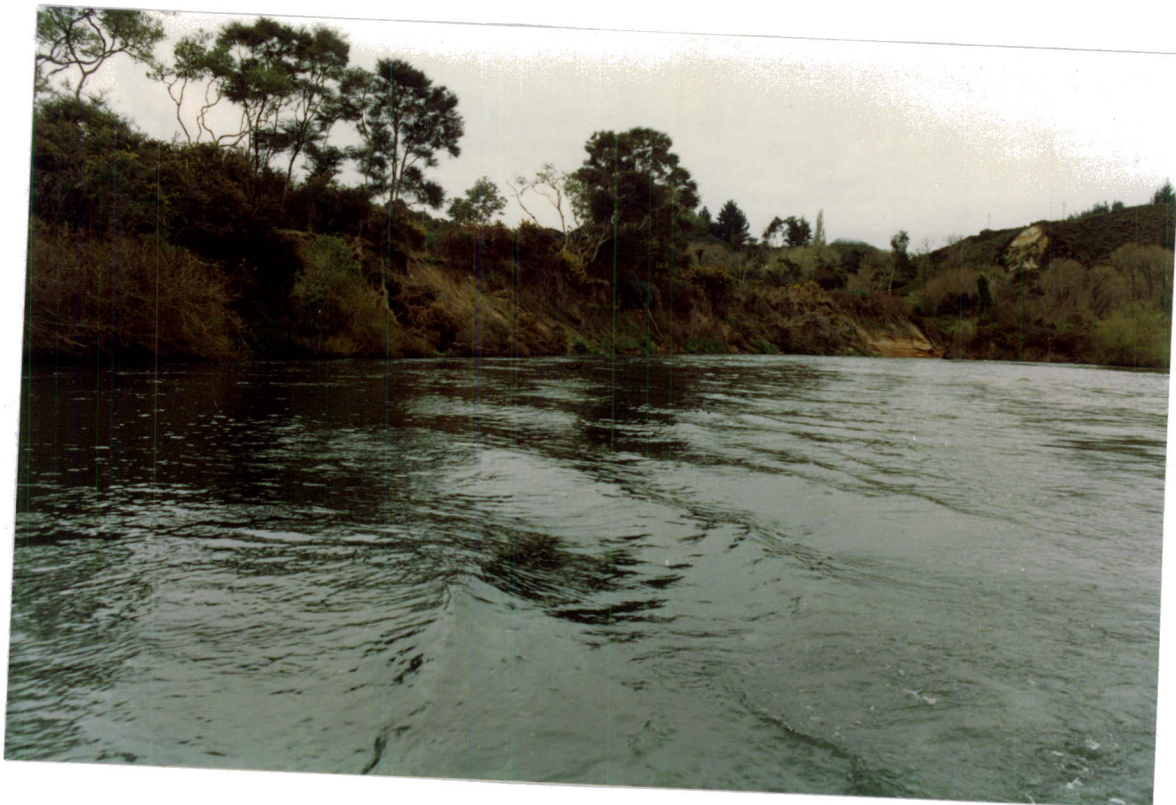
The presence of cohesionless materials at the base of the bank, together with location of the site on the outside of a bend with medium to high velocities and evidence of bed scour, suggests basal erosion is the principal reason for bank instability. The presence of highly permeable sands and gravels (ie rapidly draining) up to a height of 2.5m above water level, suggests water level fluctuations associated with station operation are unlikely to significantly aggravate the existing erosion.

Figure C3. Site 3.

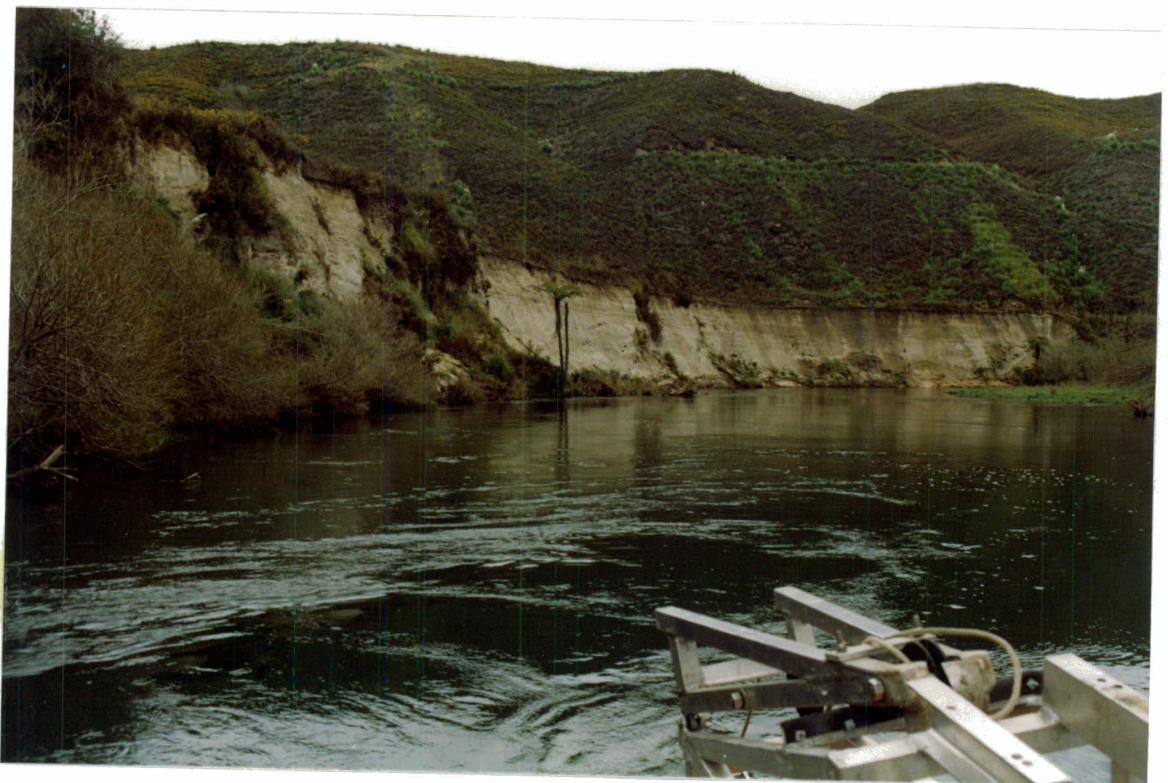
The location of the instability on the outside of a bend, together with the depth profile measured adjacent to the bank, suggests basal scour is the primary mechanism responsible for bank erosion. An anomalous factor in this explanation is the weathered ignimbrite at the base of the bank which would not be expected to be readily erodible. However, the measured depth profile and the absence of a bench adjacent to the base of the bank, does suggest that the material has been eroded or undermined. Nonetheless, it is probably that this ignimbrite does limit erosion at the site.

Figure C4. Site 4.

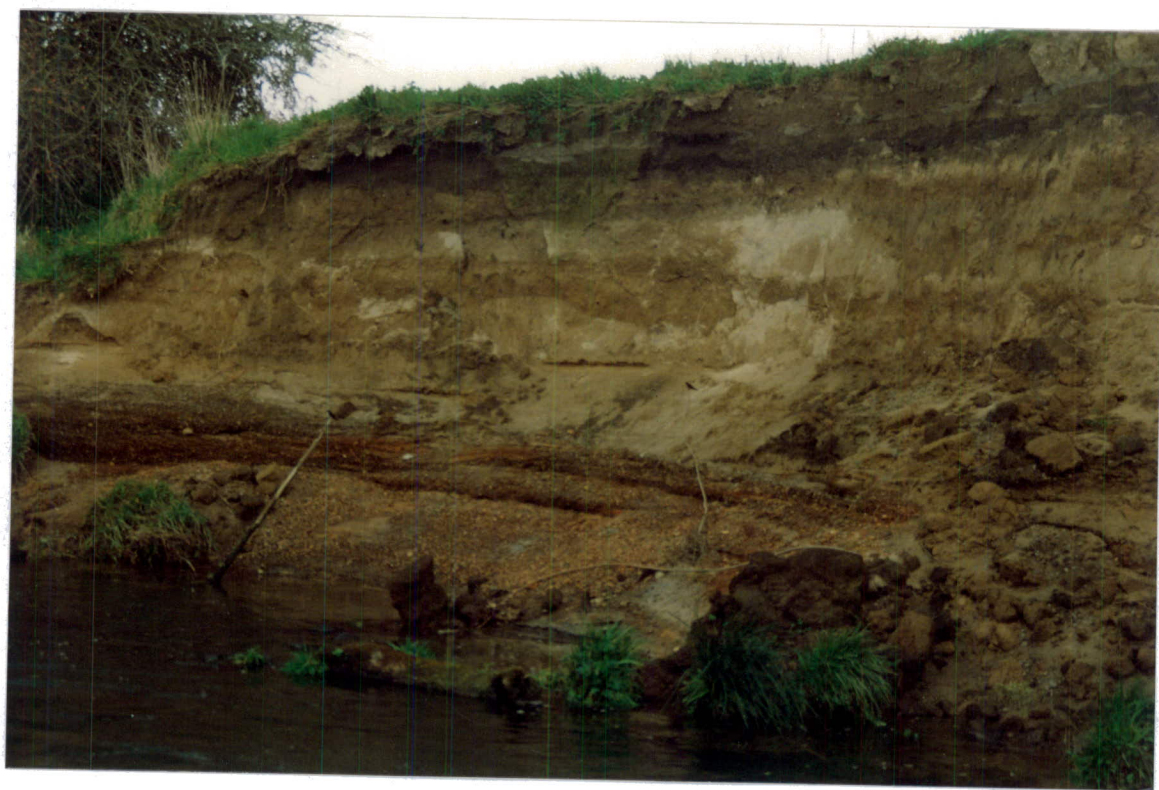
FIGURE 8 : SITE 7

At the time of the field visit to this site, the water level at the Te Teko gauge was at about 1.0m R.L. (gauge datum). As water levels below this stage occur frequently during power generated fluctuations (Appendix B), it is probable that the water surface at site 7 frequently drops below the level of the paleosol. Hence, seepage pressures could be a secondary mechanism affecting the rate of bank retreat at the site.

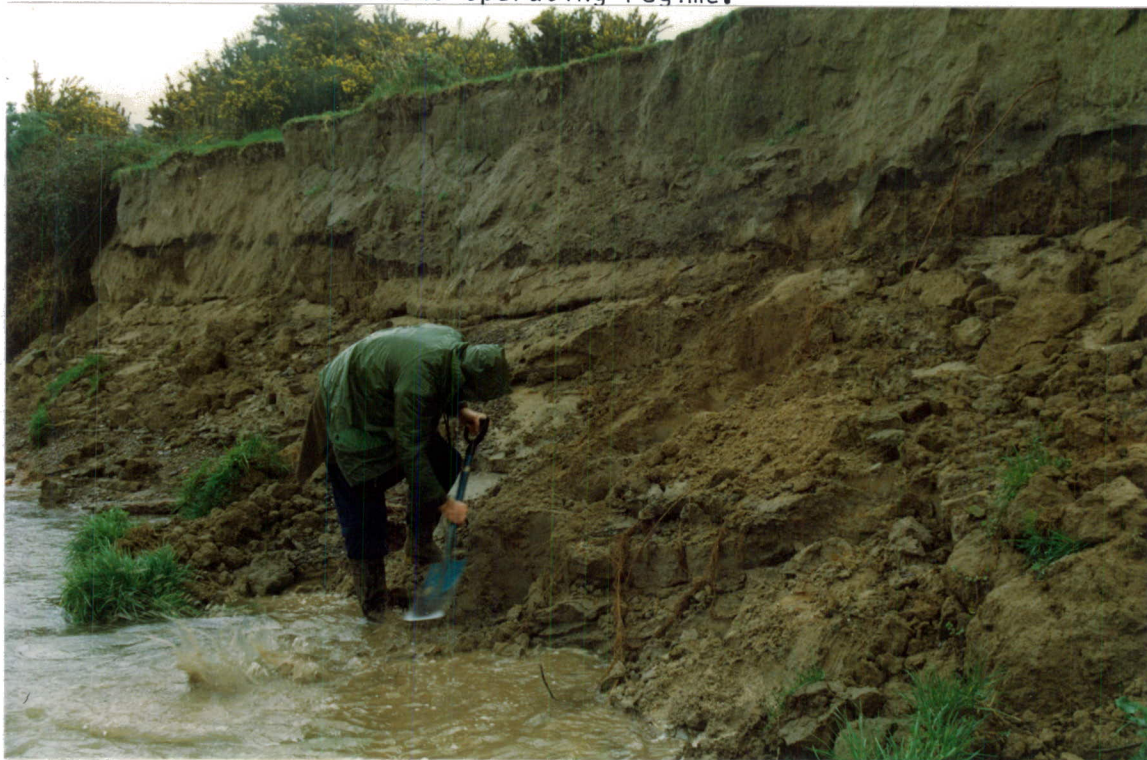
The bank retreat is primarily related to the erosion of basal sediments by flow diverted into the right bank by the point bar development. An earlier survey conducted by the BOPCC in 1980 noted active erosion of the upstream left bank and commented that the "bottom end" of this break directed current into the right bank (BOPCC, 1980). It is thus possible that this earlier erosion, which has now stabilised, was responsible for development of the point bar now observed in this relatively straight reach. Water level fluctuations could generate seepage pressure in the sandy layers interbedded with less permeable materials at the base of the bank. However, the absence of any notable benching suggests the rate of bank retreat is primarily controlled by the erosive removal of material from the base of the bank. Thus, there is no evidence that draw-down effects play a significant role at this site under the current operating regime.

Figure C9. Site 8.

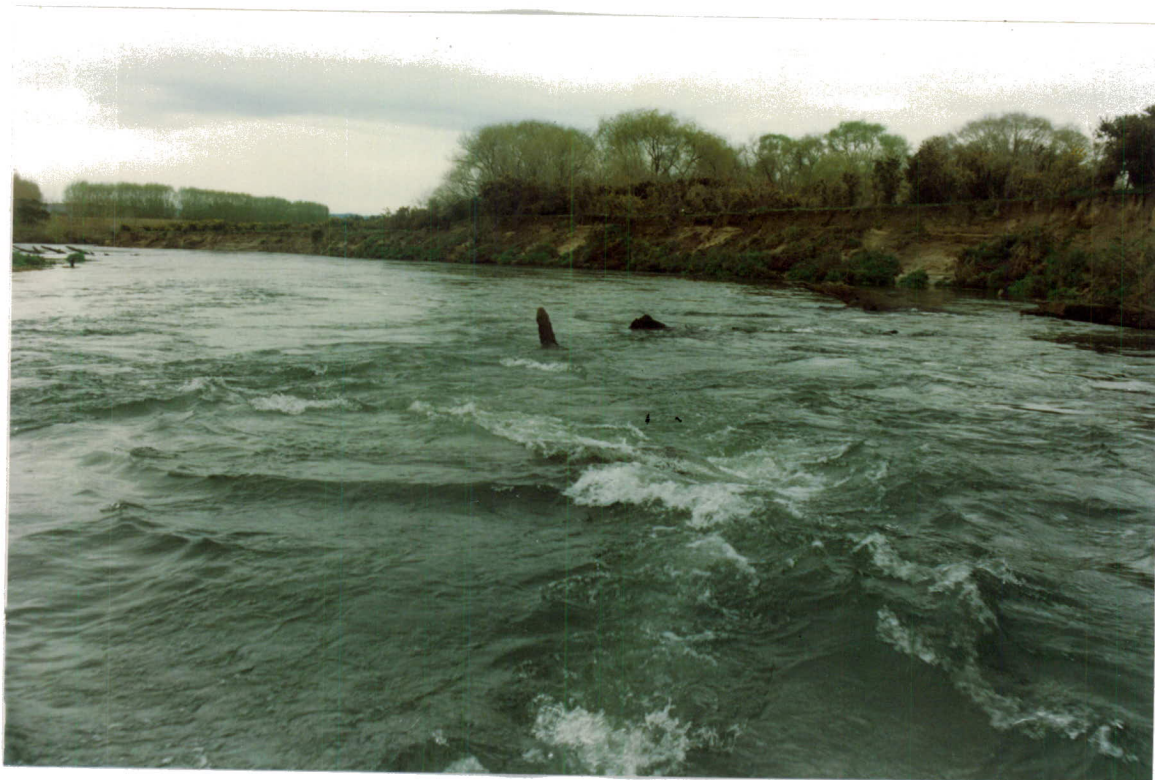
The location of the bank on the outside of a bend with readily erodible materials at and above water level suggests basal erosion is the primary mechanism responsible for bank instability. The bench observed just below water level indicates less readily erodible (and probably less permeable) materials. The sharp increase in depth beyond the narrow bench suggests this material is in turn being removed by undermining due to scour of more readily erodible materials lower in the bank. Water level fluctuations extending below the bench may induce removal of material by piping at the interface between the less permeable bench layer and the overlying sands. Thus, it is possible that draw-down effects could slightly aggravate bank instability at this site. However, more probably, the rate of bank retreat is controlled predominantly by the removal of loose sediments, above the bench, by lateral corrasion.

Figure C16. Site 13.

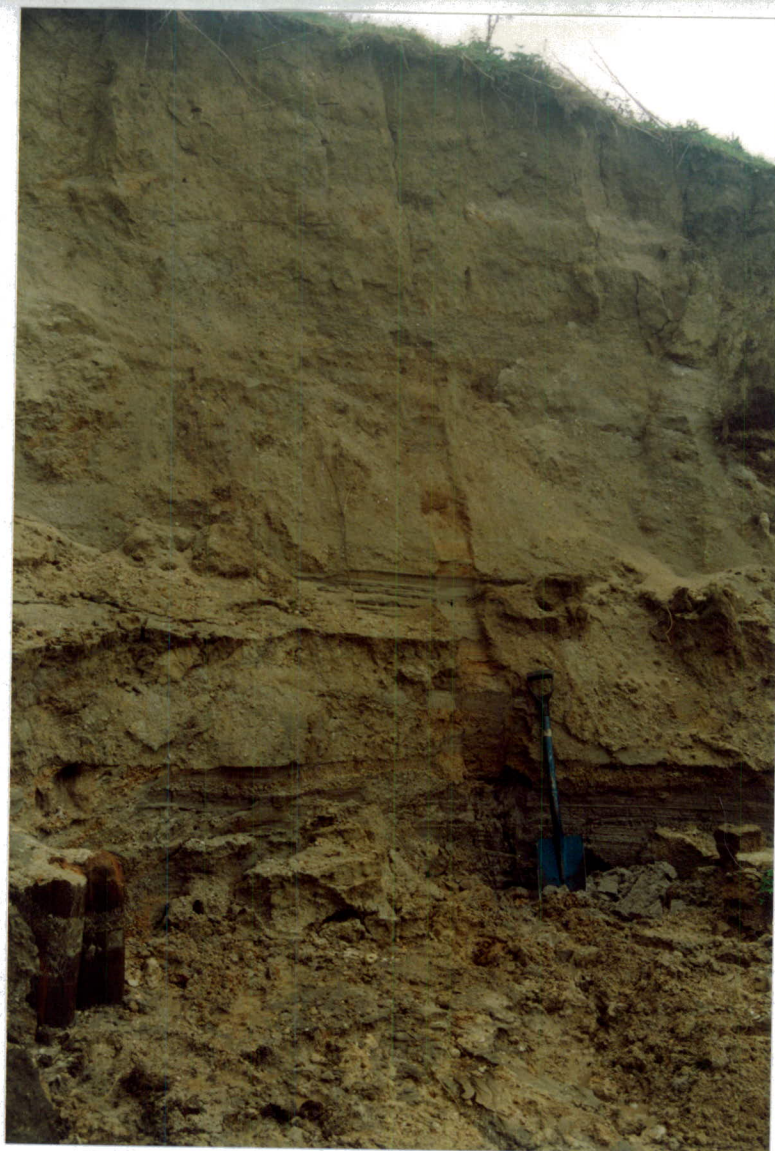
FIGURE C20 : SITE 15

The location of the bank and the adjacent depth profile both suggest basal scour is the primary mechanism initiating and controlling bank retreat at this site. Seepage of ground water above the pug layer may also contribute to the instability but the absence of a bench in this region suggests the effect of basal scour is predominant. There is however some evidence in the photos of the BOPCC report that this seepage influenced bank stability - a slump of the upper bank being evident, suggesting failure above the pug layer.

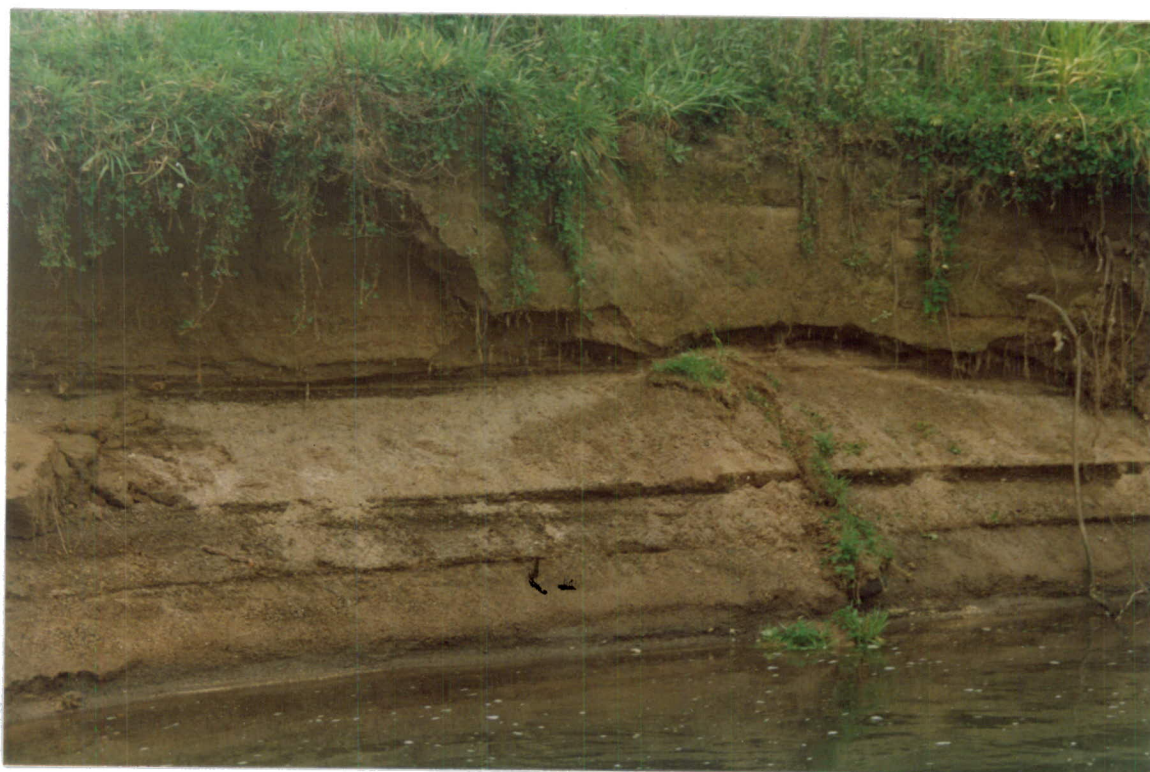
The location of the site, the depth profile adjacent to the bank and the presence of erodible cohesionless materials at the base all suggest that erosive removal of the basal sands is the primary cause of bank instability. A bench previously cut at the base of this bank associated with an attempt at bank protection has also been eroded away (D Roberts, BOPCC, pers. comm.) further supporting the contention that basal erosion is the primary mechanism. Removal of the underlying sands leading to undermining and block failure of the overlying silts is also evident in figure C23.

Figure C23. Site 17.

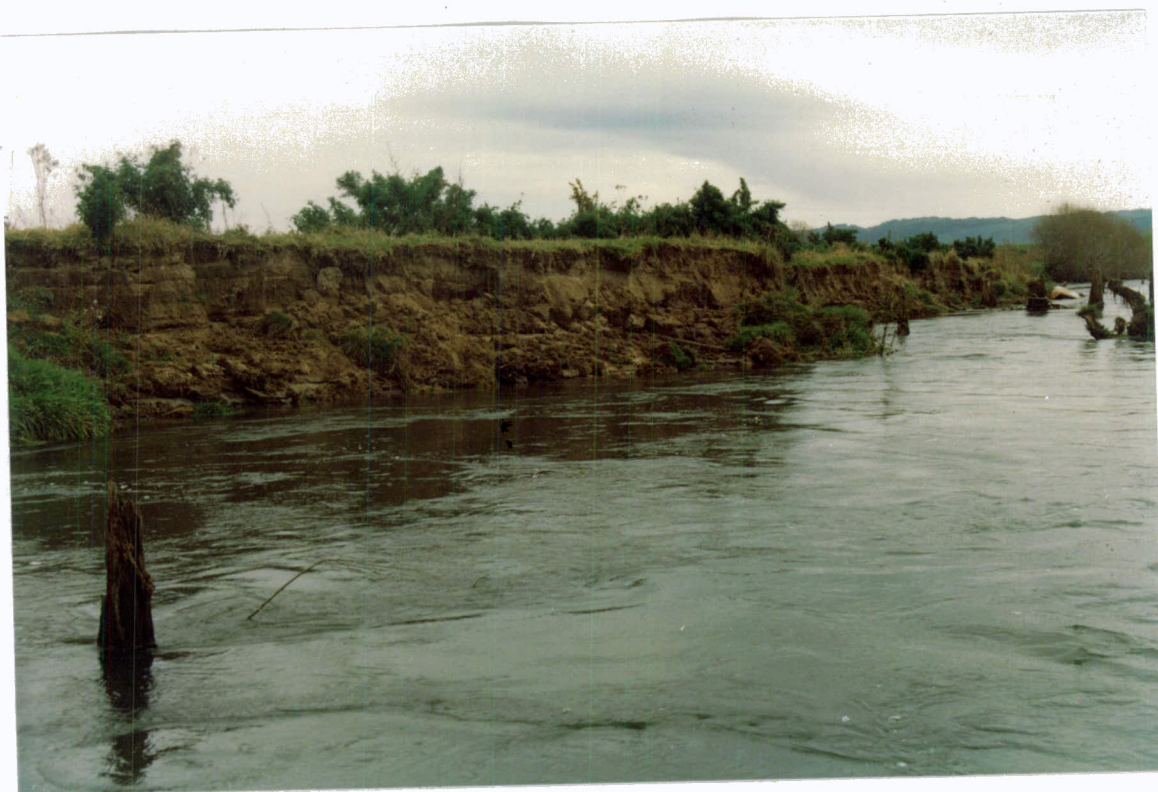
FIGURE C24 : SITE 18

The presence of a relatively coarse free draining basal layer up to 0.6m above water level at the time of our observation (at the same time water levels at the Te Teko gauge were 1-1.1m R.L.) suggests that draw down effects associated with power generated fluctuations are unlikely to a significant influence at this site.

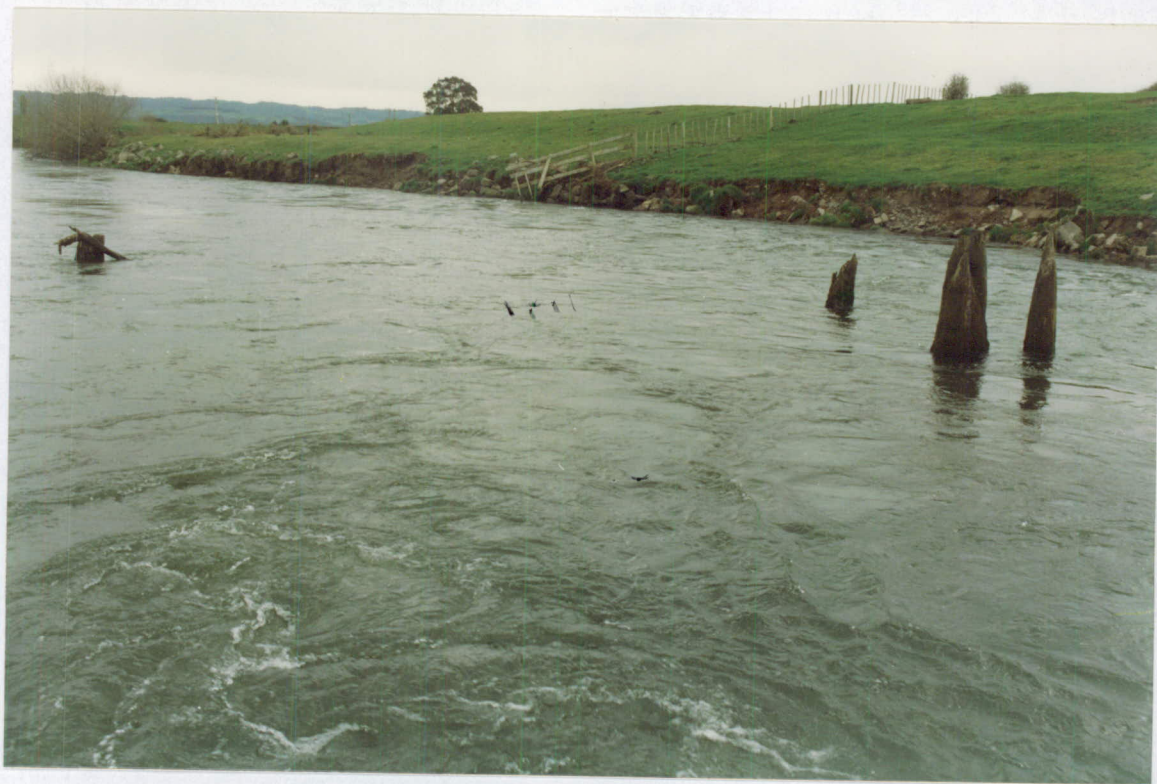
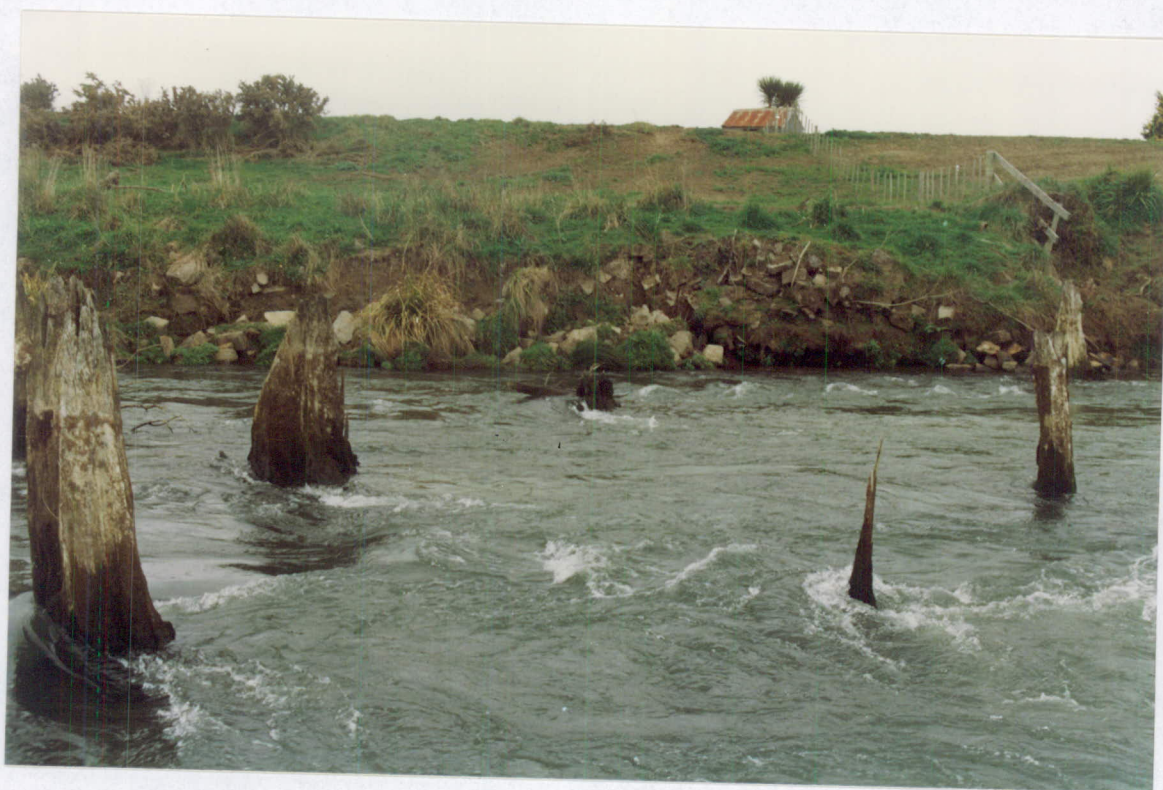
A number of factors are apparently involved in initiating bank instability in this region. The site was noted as undergoing erosion in the BOPCC report of 1980, with the most notable erosion at that time also occurring on the downstream right bank. It appears that flow impinged on the right bank in this region at that time. Thus basal scour was probably the primary mechanism. However rock protection was subsequently placed and the present problems appear to have originated largely as a consequence of the recent earthquake. This has resulted in increased velocities adjacent to the banks, particularly at the downstream end. Bed degradation has occurred as a consequence of the increased velocities, undermining the existing rock protection. This latter effect is particularly evident in figure C28 where recently undermined rock protection, at the point of incipient failure, is arrowed. Erosion, particularly as a consequence of the increased velocities and turbulence associated with the numerous stumps in this region can be expected to aggravate the erosion of any exposed banks.

Figure C27. Site 19.

Figure C28. Site 19.

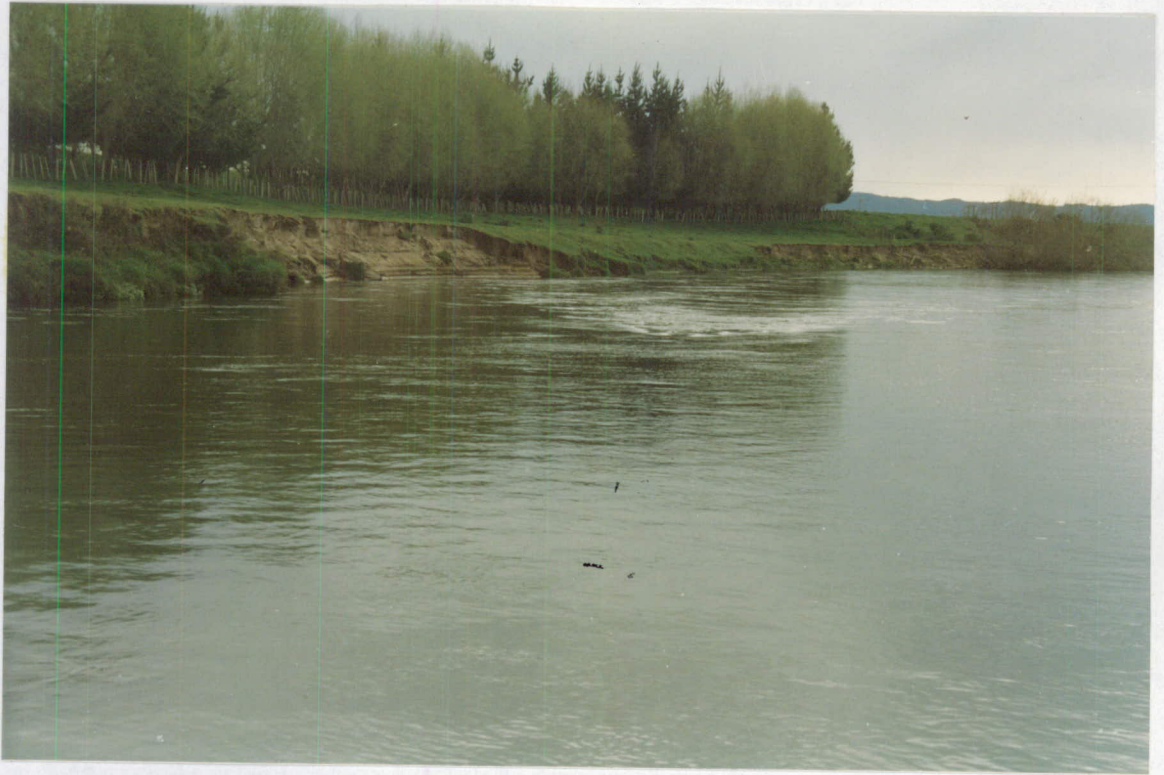
The restriction to drainage through the lower profile provided by the peat suggests that the erosion could be aggravated by water level fluctuations. In particular seepage out of the bank above the peat following draw down could remove sandy material from this area - undermining the overlying bank. However if this mechanism was very significant then the overlying bank would retreat more rapidly than the area of bank incorporating the peat and underlying materials. This did not appear to be the case in the field with only a relatively narrow (generally less than 1m) peat shelf being evident. Hence it appears that the rate of bank retreat is controlled by the basal erosion.

Figure C32. Site 21.

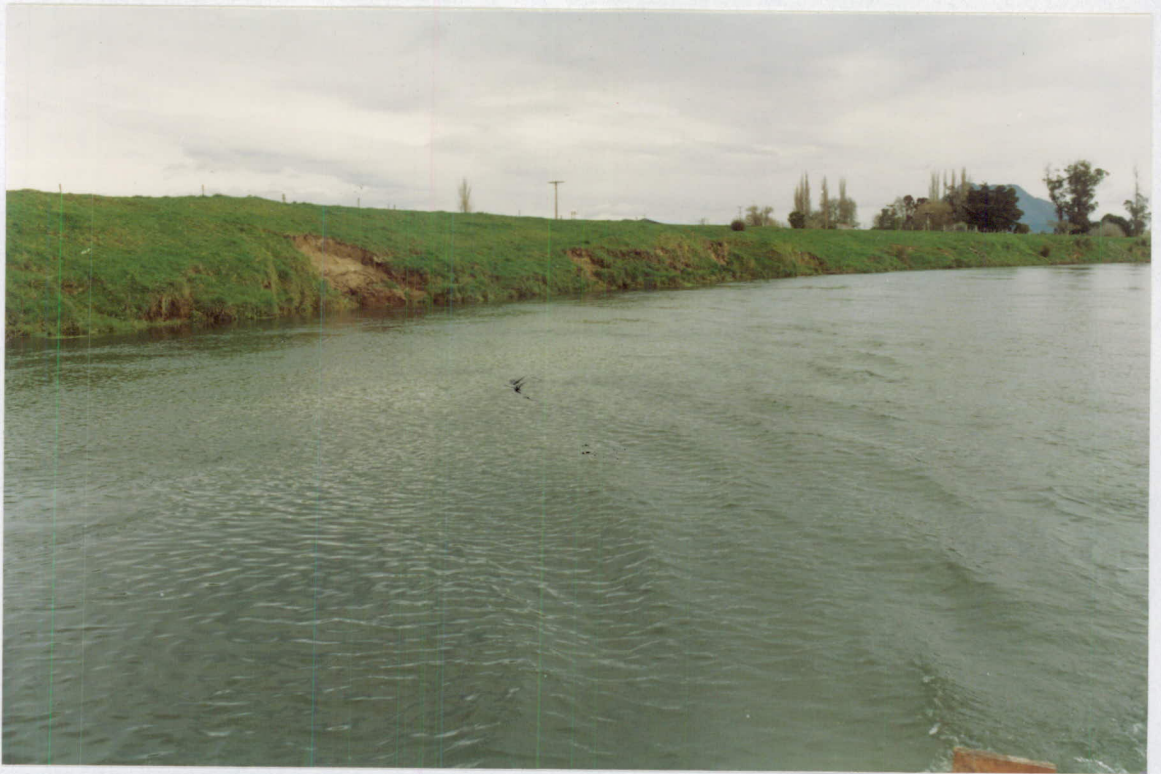
The BOPCC report of 1980 speculated that some recent breaks observed at that time were attributable to the operating regime of September/October 1980. However, they also noted that aggravation of the erosion by stock appeared to be severe. Hence at least three mechanisms - basal scour, stock damage and possible draw down effects - have been implicated at this site. As the rate of erosion has never been severe it is difficult to isolate the relative contribution of each mechanism historically. However, as noted above, any effect of basal erosion could be significantly reduced in the future. Hence water level fluctuations (due to tidal effects or power generation) could be the more significant factors in any future erosion. However there is presently no evidence to suggest that significant erosion can be expected.

Figure C33. Site 22.

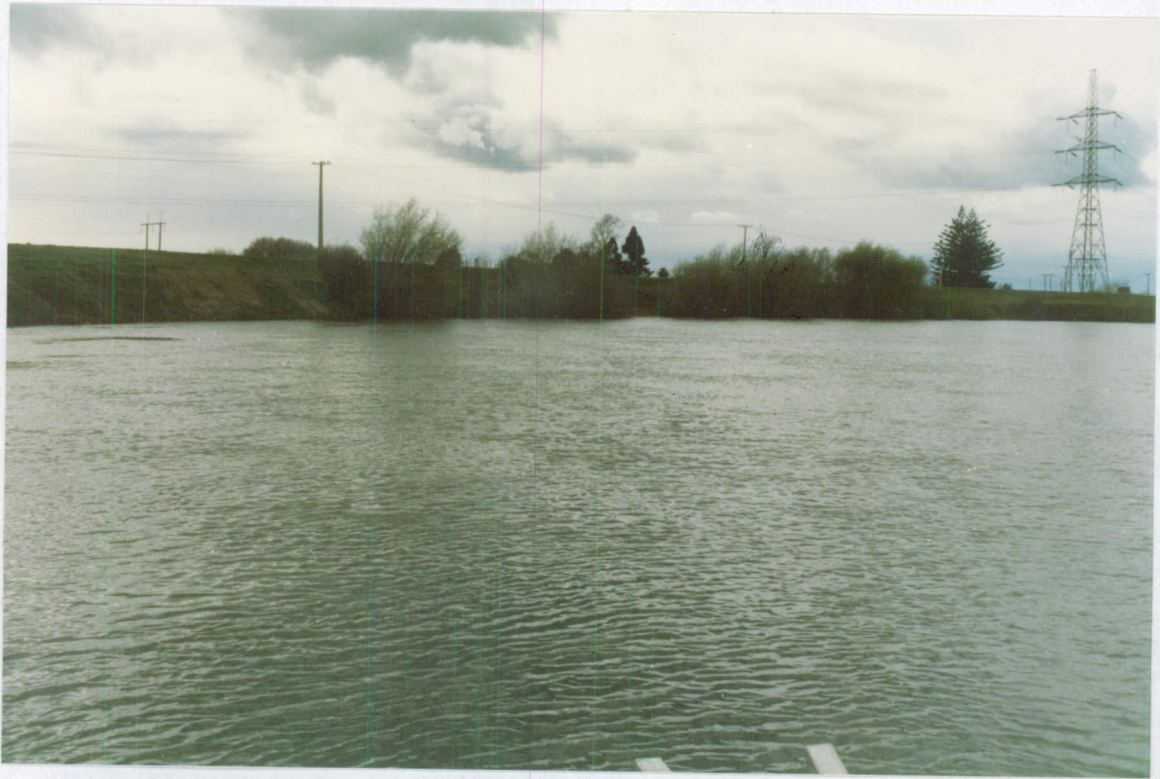
As the recent earthquake has increased water level relative to the banks - water level fluctuations now influence materials higher in the bank profile. As such materials tend typically to be less permeable materials (having a higher percentage of silts and fine sands than lower bank materials) the bank may be more susceptible to draw down effects in the future.

Figure C35. Site 23.

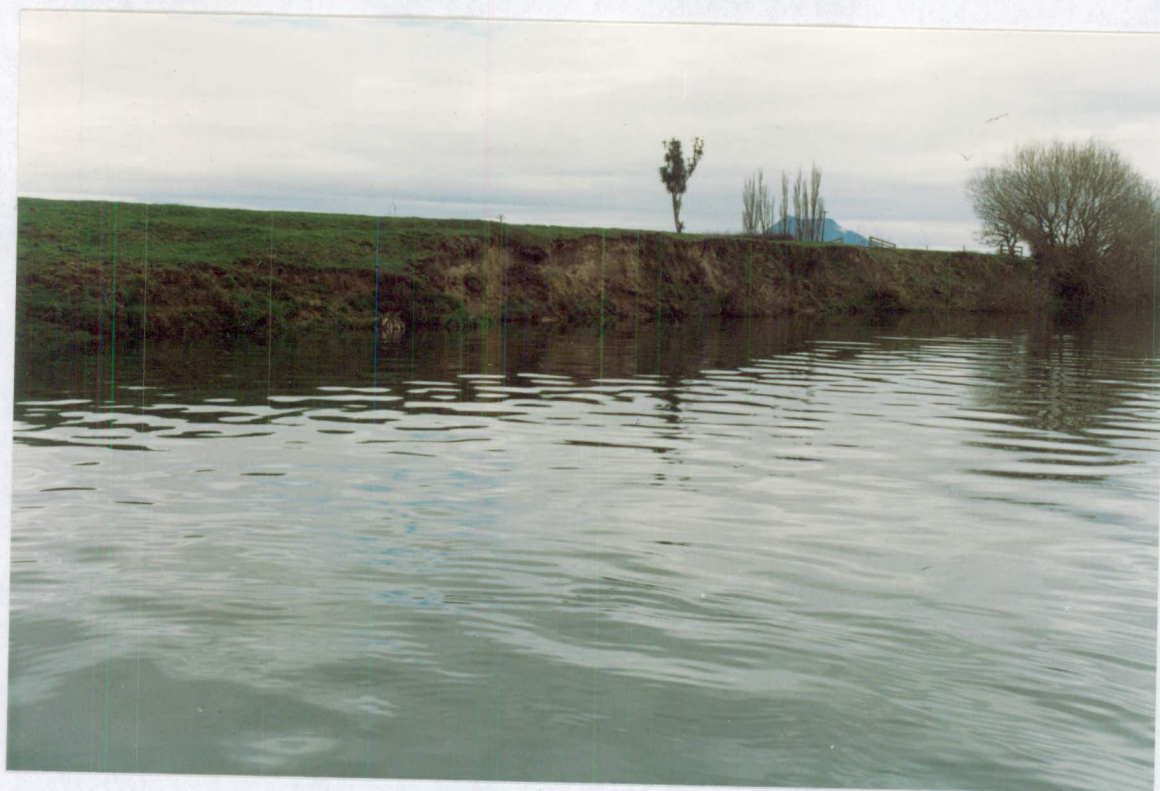
FIGURE C37 : SITE 24

Although water level has risen relative to the banks due to the March earthquake, coarse relatively free draining sediments were evident up to 0.8m above water level (1.1m RL at Te Teko at the time (near high tide) of the site visit (Figure C38). Consequently typical power generated water level fluctuations, which generally do not exceed 1.8m RL at Te Teko (chapter 3), are unlikely to saturate the lower permeability material higher in the bank. Therefore draw-down effects associated with power station operation are not normally likely to significantly influence bank stability. Water level fluctuations associated with flood flows may however have some influence.

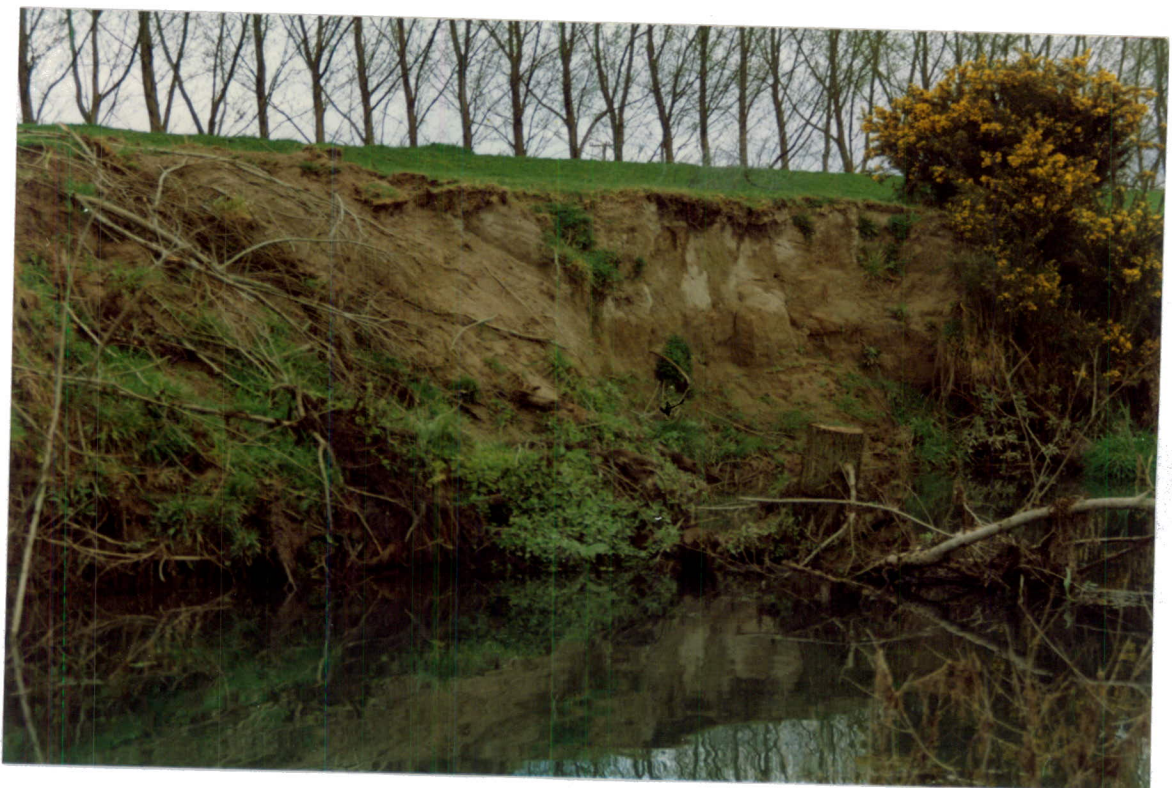
The location of the bank and the nature of slump faces evident in earlier photographs (BOPCC report of 1980) suggests the bank instability was originally initiated by basal scour. The decrease in river gradient following the March 1987 earthquake suggests that basal scour could be less important in the future. However given the relatively impermeable nature of the bank sediments it is also possible that water level fluctuations influence bank stability, although the relative roles of power and tidally generated fluctuations would be difficult to assess. If basal scour is significantly reduced in the future then any slump deposits due to draw down effects will probably tend to accumulate and stabilise the bank.

Figure C39. Site 25.
