PRELIMINARY INVESTIGATION OF THE
INFLUENCE OF MATAHINA POWER STATION ON
**RIVER BANK STABILITY ALONG THE
RANGITAIKI RIVER**

Prepared for
Electricity Corporation of New Zealand Ltd
Hamilton

Prepared by
J Dahm
M R Edwards
D N Jennings
WORKS Consultancy Services
Hamilton

May 1988

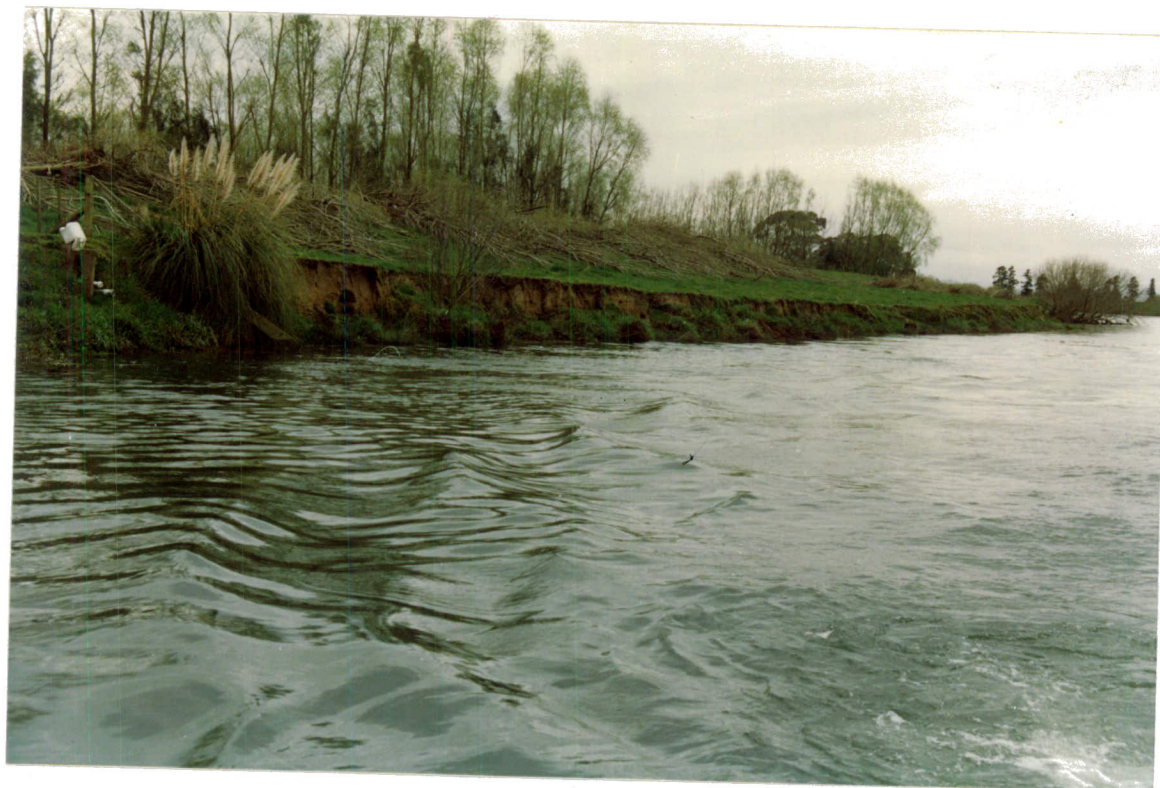
The aerial photographic evidence noted above suggests that basal scour may have played a role in initiating the instability. However the nature of the bank materials is such that water level fluctuations may also have been important. The recent nature of much of the slumping evident in figure C40 may indicate that the March 1987 earthquake has also aggravated the problem.

Figure C40. Site 26.

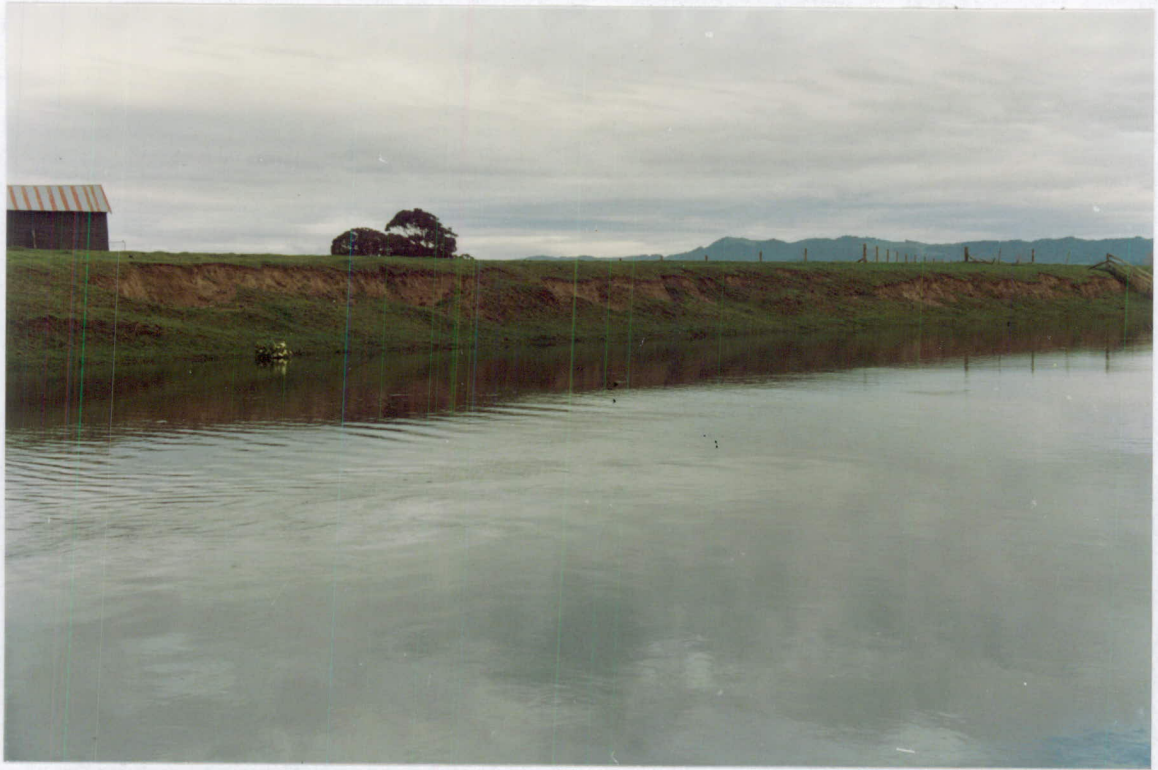
Given the location of the site on the inside of a bend and the persistence of the apparent slump deposits (Figure C41) it does not seem that basal scour is an important mechanism at the site. Nonetheless, this mechanism cannot be entirely ruled out on the basis of the existing data. For instance, the evident damage might be a part rotational slump initiated by a combination of flood scour in the channel and saturated loading of the bank. Without more detailed study it would be difficult to confidently assess the mechanisms primarily responsible for the instability noted in this reach.

Figure C41. Site 27.
