Rangitaiki River Stopbanks Assessment

Moore Road Seepage Problems

Prepared for
Environment Bay of Plenty

July 2007

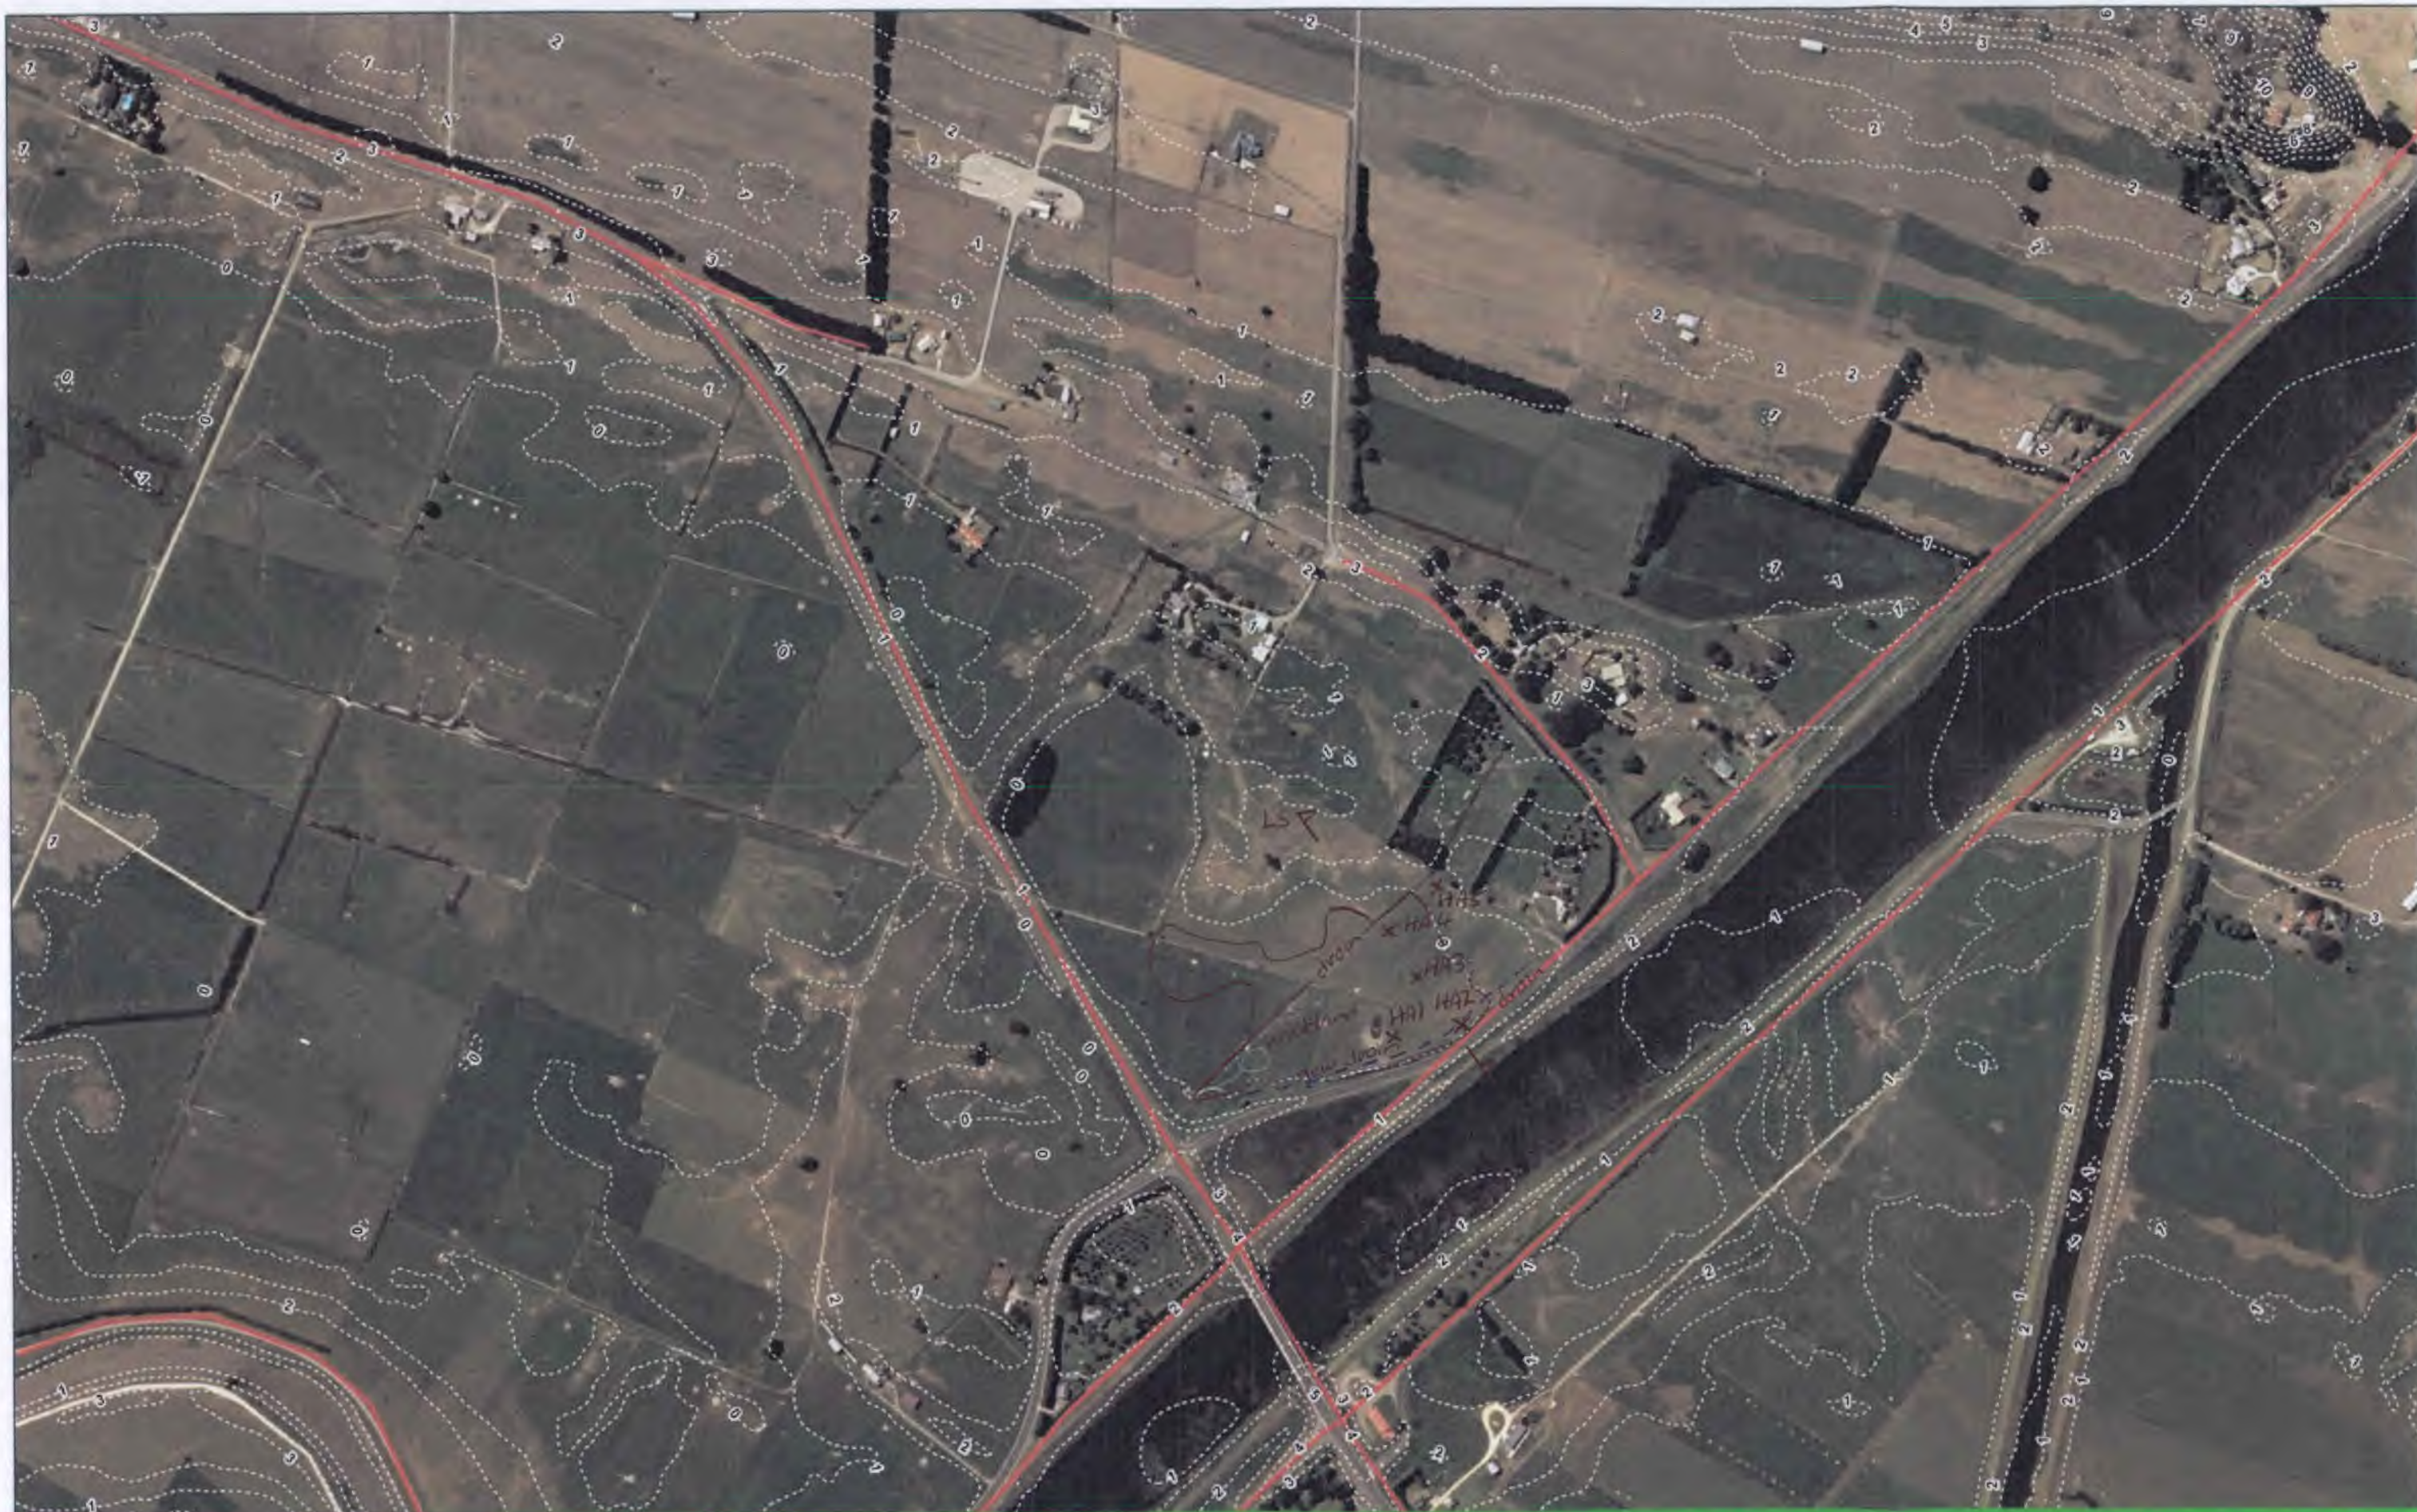
Figure 1: Site Plan

The owner of the farm bounded to the south by Thornton Road and to the east by the West Bank Road, has reported springs in the base of his farm drains to Environment Bay of Plenty (EBOP) (Figure 1). Initial investigations by EBOP staff found there were six springs in a 100m length of drain issuing up to an estimated 20 litres/minute each. The farmer also commented on his inability to establish good pasture in this part of the farm. The EBOP staff found that the water in the farm drains had roughly half the salinity of salt water.

The subsurface investigations carried out consisted of three hand augers along the cross section shown in Figure 1, one near the small wetland and one towards the higher ground to the north. The logs of the augers are included in Appendix A.

To reduce the problems above, a wetland could be developed with a water level at 0.0m if an additional drain is dug down to the sand layer parallel to and about 15m from the road side drain. This additional drain is to relieve the uplift pressures under the paddock and it will require lining with drainage metal. To reduce the flooded area and drainage problems for the surrounding land, the wetland at 0.0m could extend to the line of the existing farm drain and a small bund formed beyond this drain. A second wetland with a lower water level, say -0.3m, could be formed as shown on Figure 1 to act as a buffer and to reduce the differential head at the wetland boundary.

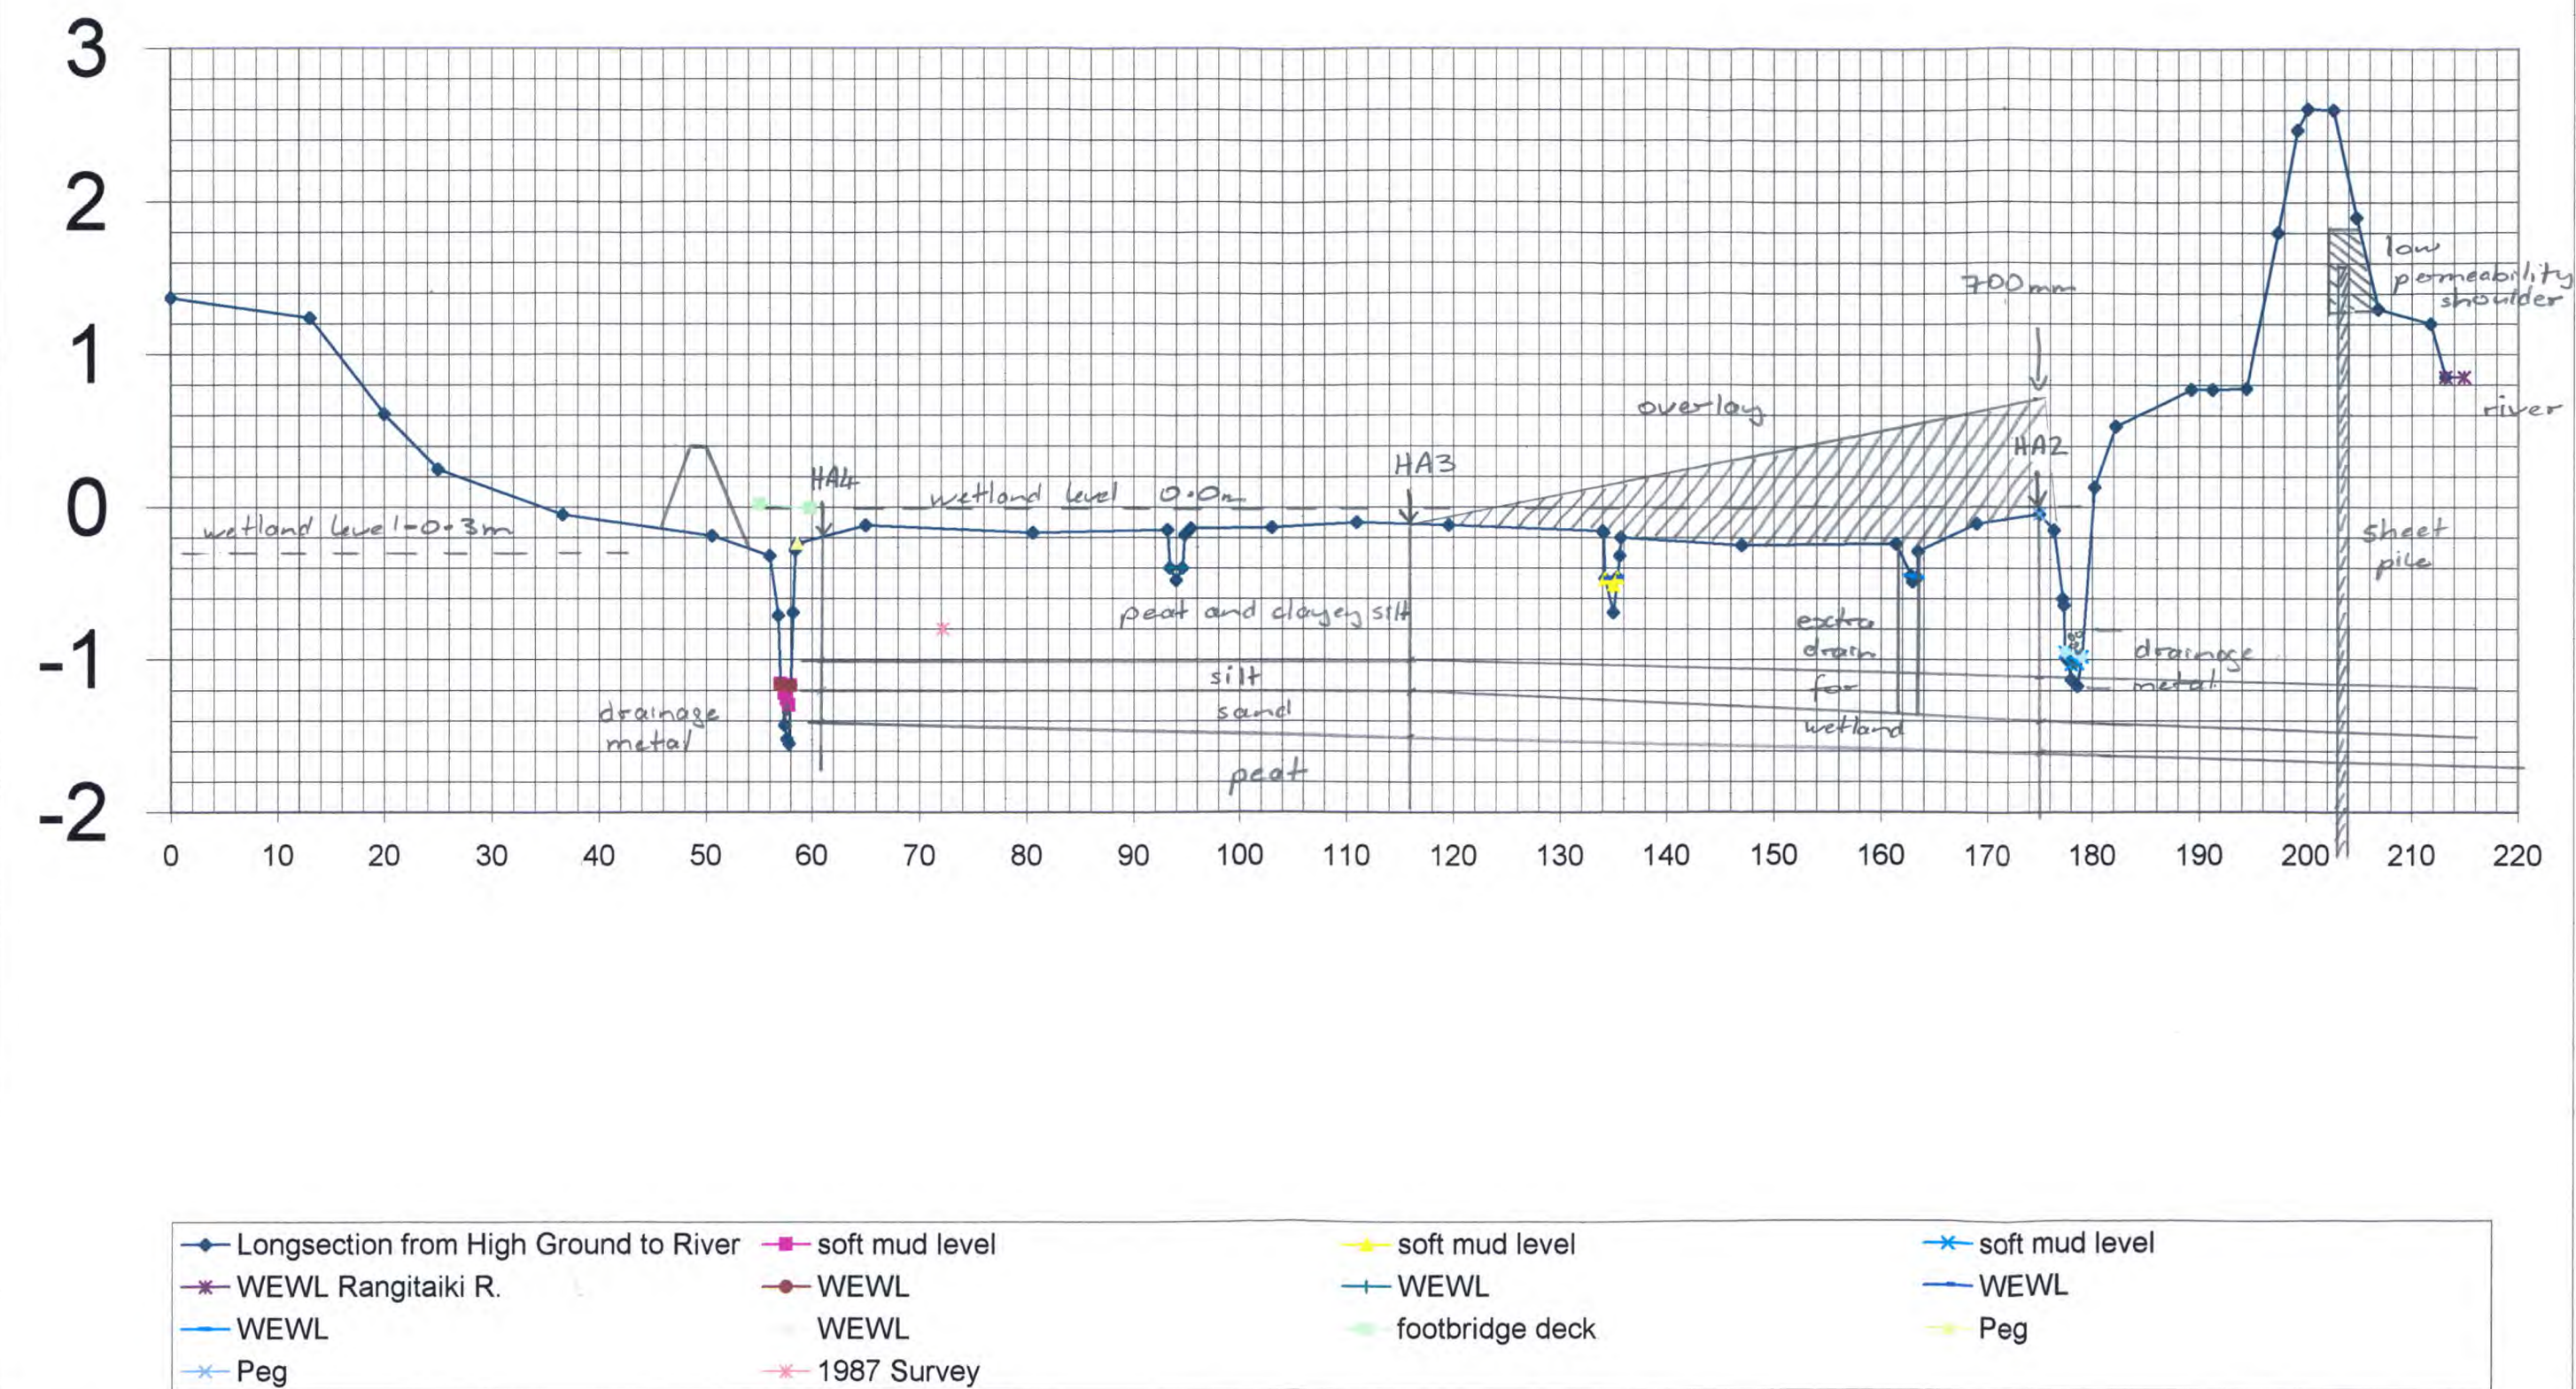
Figure 2: Long Section and Remedial Options

Figure 2 shows a cross section of the paddock surveyed in July 2007. It can be seen that the typical ground level is 0.1 to 0.2m below the Moturiki Datum. Mean sea level at the Moturiki Datum is 0.07m, therefore the paddocks lie just below sea level. The mean high tide level is 0.79m therefore the invert of the farm drain at 57m on Figure 2 is 2.34m below the high tide level. The road side drain at 178m is about 200mm shallower. The invert of the farm drain is 3.85m below the estimated 100 year return period flood in the river which peaks at 2.3m Moturiki. The drains flow to the south side of the highway where there is a pumping station.

As can be seen in Figure 2 the depths of the various soil layers are reasonably consistent across the basin. The top of the sand layer is at between -1.2 and -1.35m (Moturiki). Consolidation due by the road formation could be the cause of the slight deepening of the sand layer towards the road. Below the sand is further peat up to at least 2.6m deep. The hand augers were stopped when the peat squeezed into the holes.

An alternative to a clay cut-off could be sheet piling. If this is carried out through the centre of the stopbank there would be no pressure or hydraulic gradient problems. The depth to the sand layer would have to be confirmed but it is likely that the sheet piles would have to be about 5m long and hence would be expensive. Shorter sheet piles could be used if they are installed below the upstream toe of the stopbank and the sandy stopbank material at the toe of the stopbank is replaced with low permeability soil (Figure 2).

Another means of preventing uplift of the paddocks is to place a soil overlay across them. The overlay should taper from 700mm thick adjacent to the road drain to natural ground level 60m away as shown on Figure 2. All the deep drains within 150m of the stopbank should be lined with drainage metal
