Rangitaiki River Stopbanks Assessment

Section 1

Left Bank 10300 to 10400m

Environment Bay of Plenty

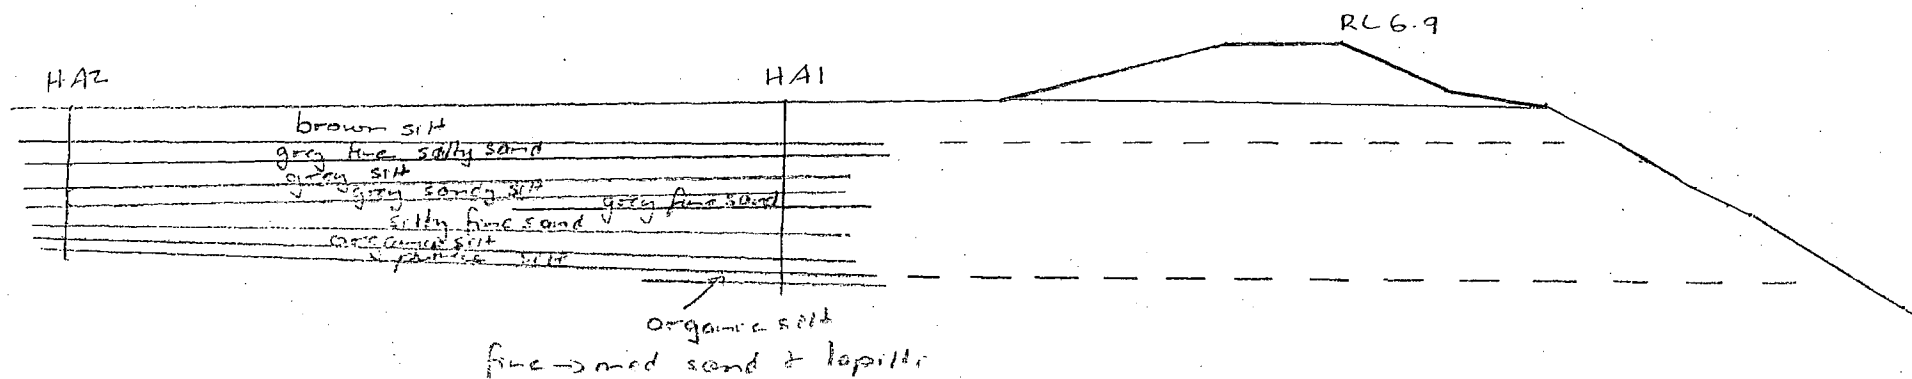
Figure 2

Now that the river berm has been eroded away the seepage path to the back of the property is only 15m long (Figure 2). The fact that there appears to have been high water pressure under the front lawn as well as the back suggests that there is a highly permeable layer extending under the house.

Figures 2 to 4 show the assumed soil profiles of three sections through the stopbank. The sections were surveyed by EBoP staff. Figure 5 shows an approximate long section along hand augers 1, 3 and 5. The surface soil layer was found to be a grey/brown silt, 0.6 to 1.1m thick, underlain by a higher permeability silty fine sand. Within the upper silt layer is a layer of gritty Tarawera Ash. In hand augers 1 and 2 at 35 College Road the silt layer was 0.8 and 0.7m thick respectively. The thinnest silt layer was found in the neighbouring property (HA3). Below the silty fine sand is typically another silt layer about 0.3m thick.

At about 3.5 days it was found that the water pressure below the upper low permeability silt layer at the inland toe of the stopbank was 11.5kPa. At the location of the scour hole that appeared in July 2004 (approximately 10m from the toe of the stopbank) the predicted pressure was 11kPa. The silt layer probably has a density of 15.5 to 16kN/m³. At this cross section the layer was found to be 0.7 to 0.8m thick, therefore the factor of safety against heave of the silt layer is less than 1.0. This confirms the jelly-like description of the soil given by the residents in the July 2004 flood.

At the toe of the stopbank the maximum hydraulic gradient was found to be 0.7. This is close to the critical gradient for pumice sands and silts with a specific gravity of 2.44 which is 0.75.

From the discussion above it appears that a soil overlay across 35 College Road remains the best option for improving the safety of the stopbank. A factor of safety against heave of 1.2 should be obtained with a 500mm overlay over 700mm of insitu silt. If the silt layer is 600mm thick the factor of safety should still be over 1.1. The maximum hydraulic exit gradient appears to be reduced to about 0.3 by the overlay. The overlay would have to extend to 25m from the inland toe of the stopbank. This would encroach on the house. The house is on short timber piles and could be lifted but the garage, driveway etc. would have to be demolished.

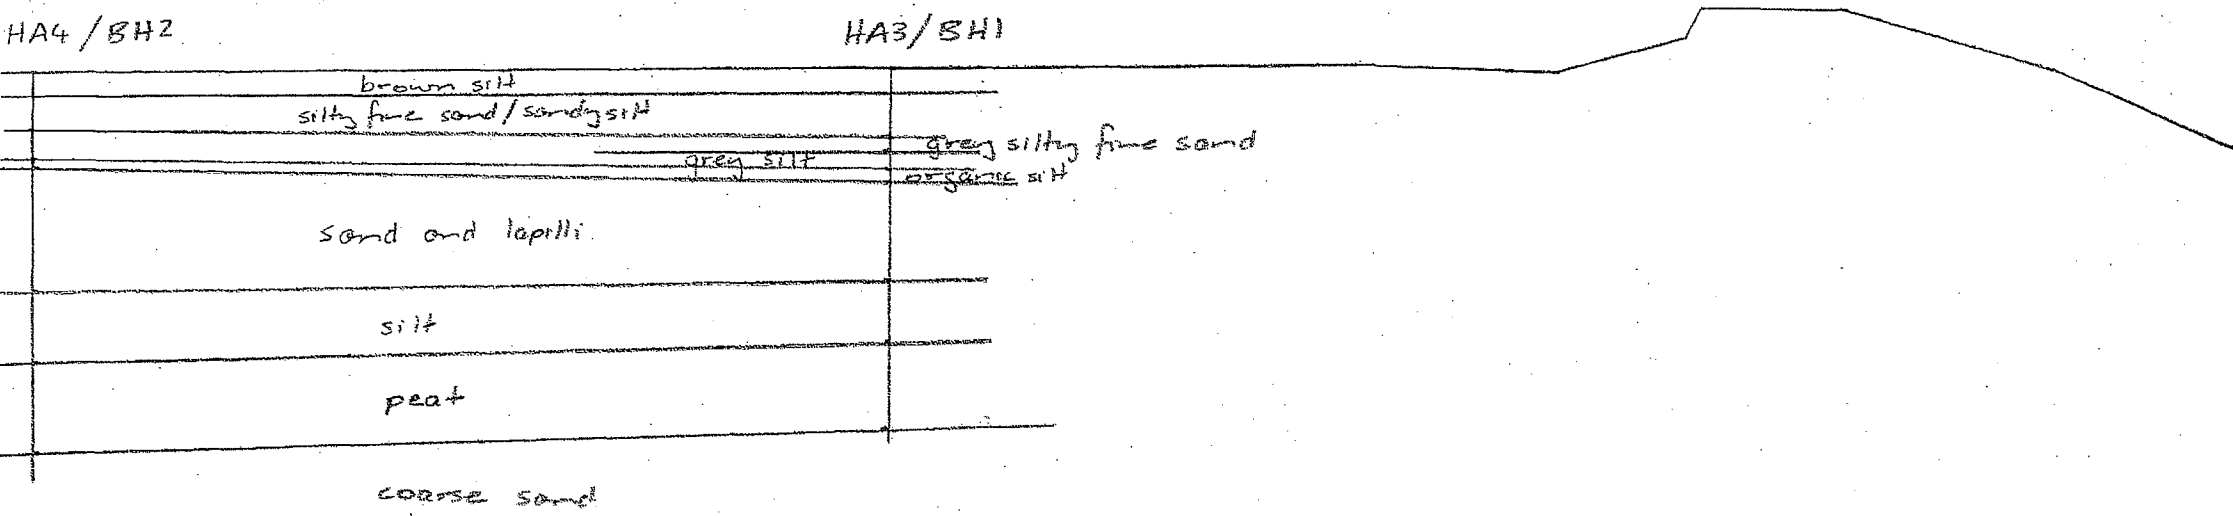
Cross Section 2
Scale 1:250

A seepage analysis has been carried out for Cross Section 2 through 37 College Road. The main difference between this cross section at that at 35 College Road is the absence of the fine sand layer at about 2.5m depth. Figure 8 shows the ground water level in Cross Section 2 at the same time step as that at Cross Section 1 in Figure 7. It can be seen that the absence of the sand layer has reduced the rise in the water level. The maximum pressure found below the upper silt layer was 5kPa. Therefore no problems are expected at this location and none were reported by the occupants of the house.

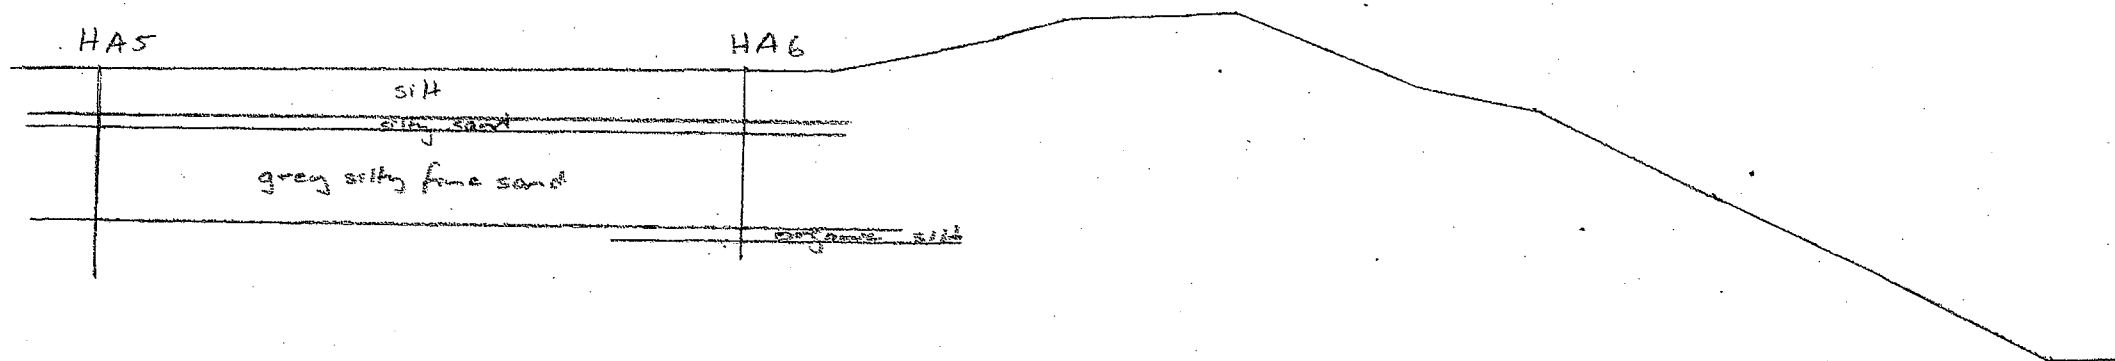
Figure 4

Figure 9 shows the seepage response of a cross section through 39 College Road at 90 hours. The maximum pressure head below the upper silt layer was found to be 11.5kPa. As the silt layer here was found to be at least 900mm thick the factor of safety against heave is above 1.2.

The maximum exit hydraulic gradient at the toe of the stopbank is about 0.4. It is therefore considered that no work needs to be carried out at this location.

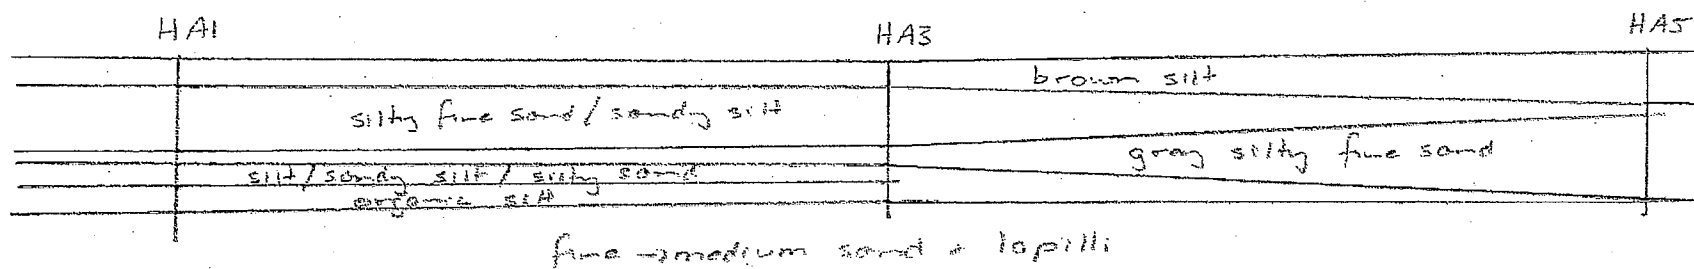
Long Section
Scale H1:400
V1:200

A layer of sandy pumice lapilli was found in all the holes at between 3.0 and 3.95m depth. HA5 was different to the remaining five hand augers in that there are no low permeability layers between the top of the fine sand at 1.4m depth and the pumice lapilli layer at 3.8m depth. Fortunately at this location the upper silt layer is 1.1m thick. The fine sand layer was also very thick in

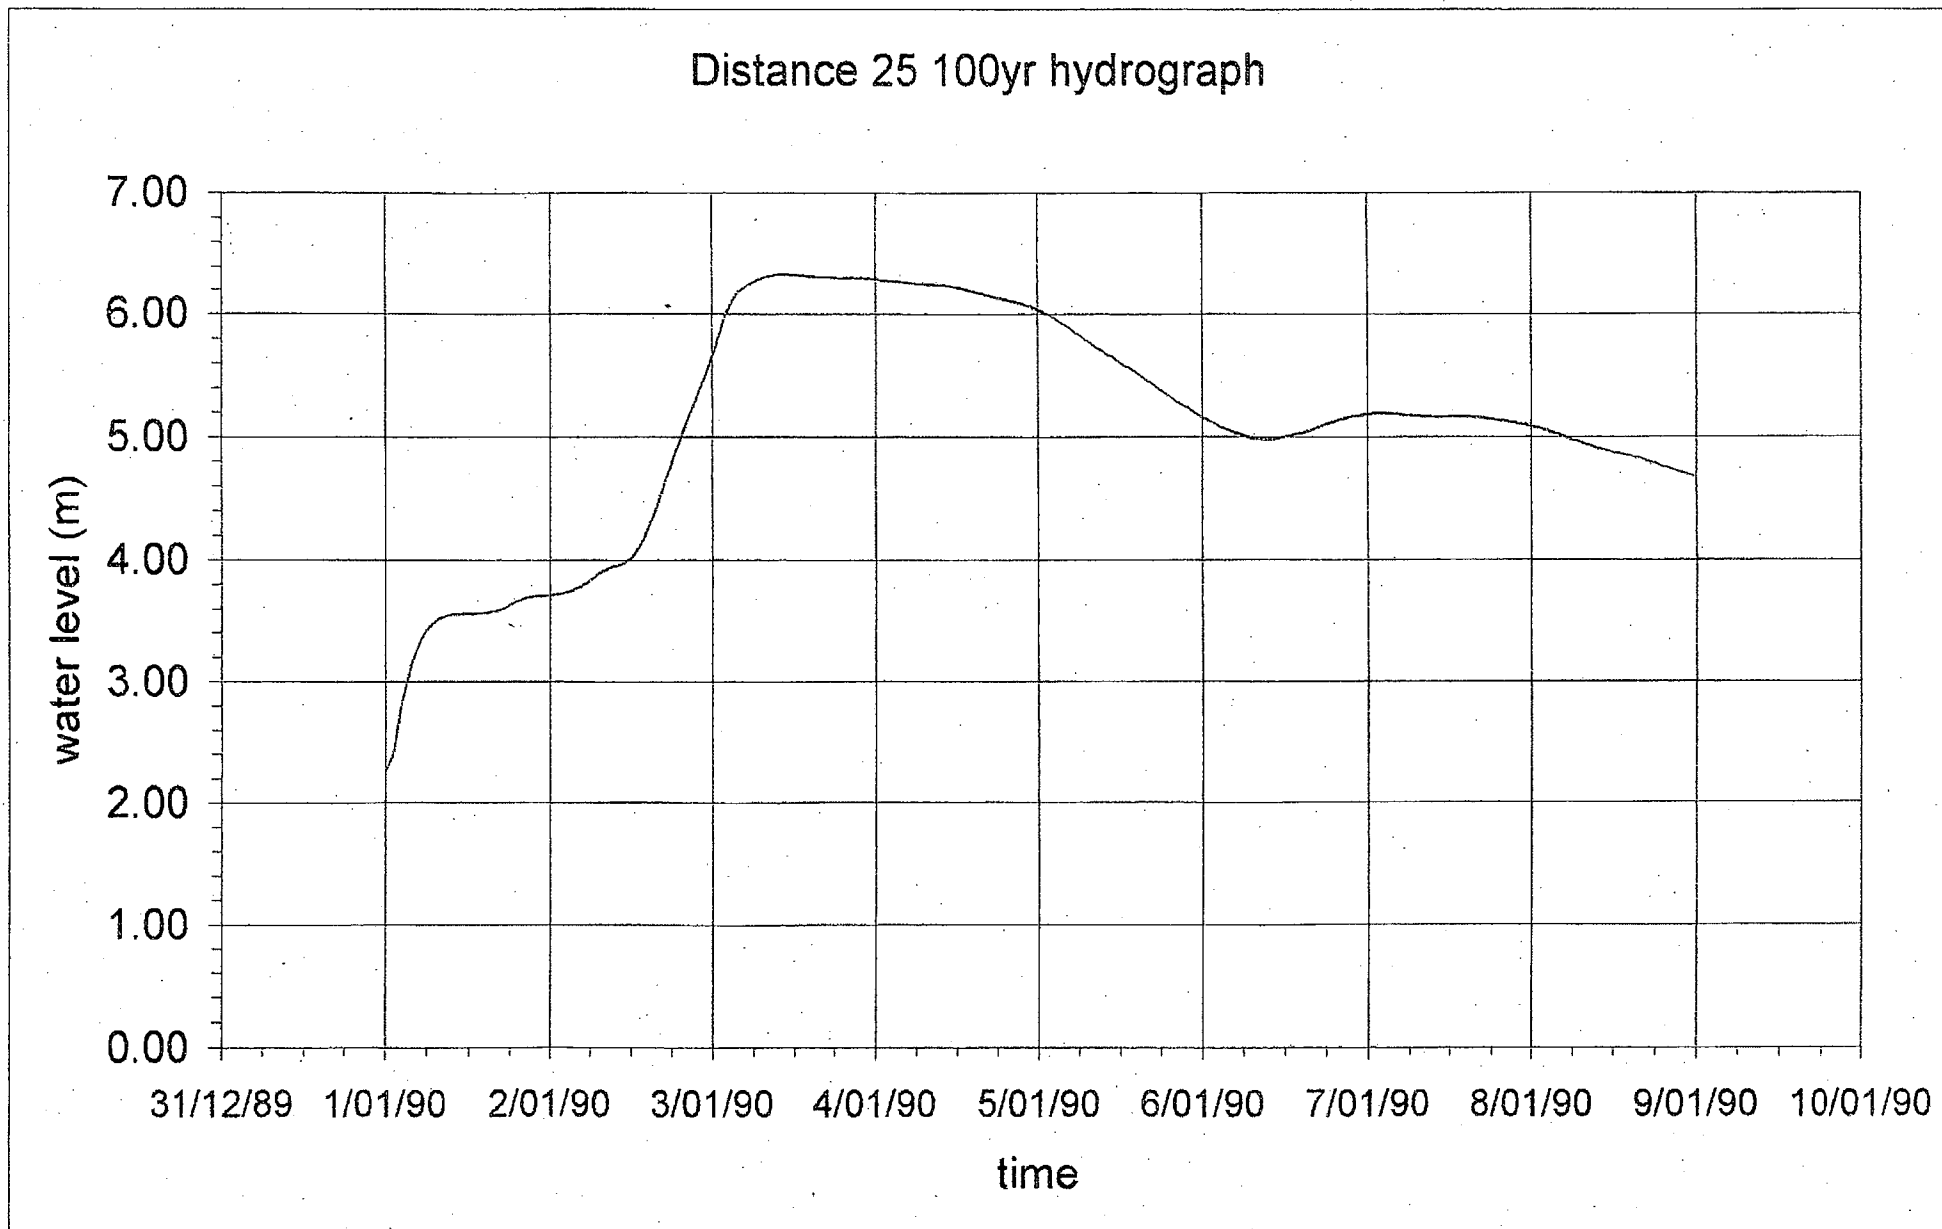
Distance 25 - 100 year flood flow hydrograph
Figure 6

EBoP has provided a 100 year return period flood flow hydrograph for the Rangitaiki River at their benchmark number 25, which is at the site (Figure 6). This is an eight day hydrograph which rises to a peak of RL6.35 on the third day of the flood. This would allow about 0.55m of freeboard at the site. During the July 2004 the residents say the water was lapping at the top of the stopbank. In the 100 year flood the water level stays close to the peak level for two days before beginning to drop.

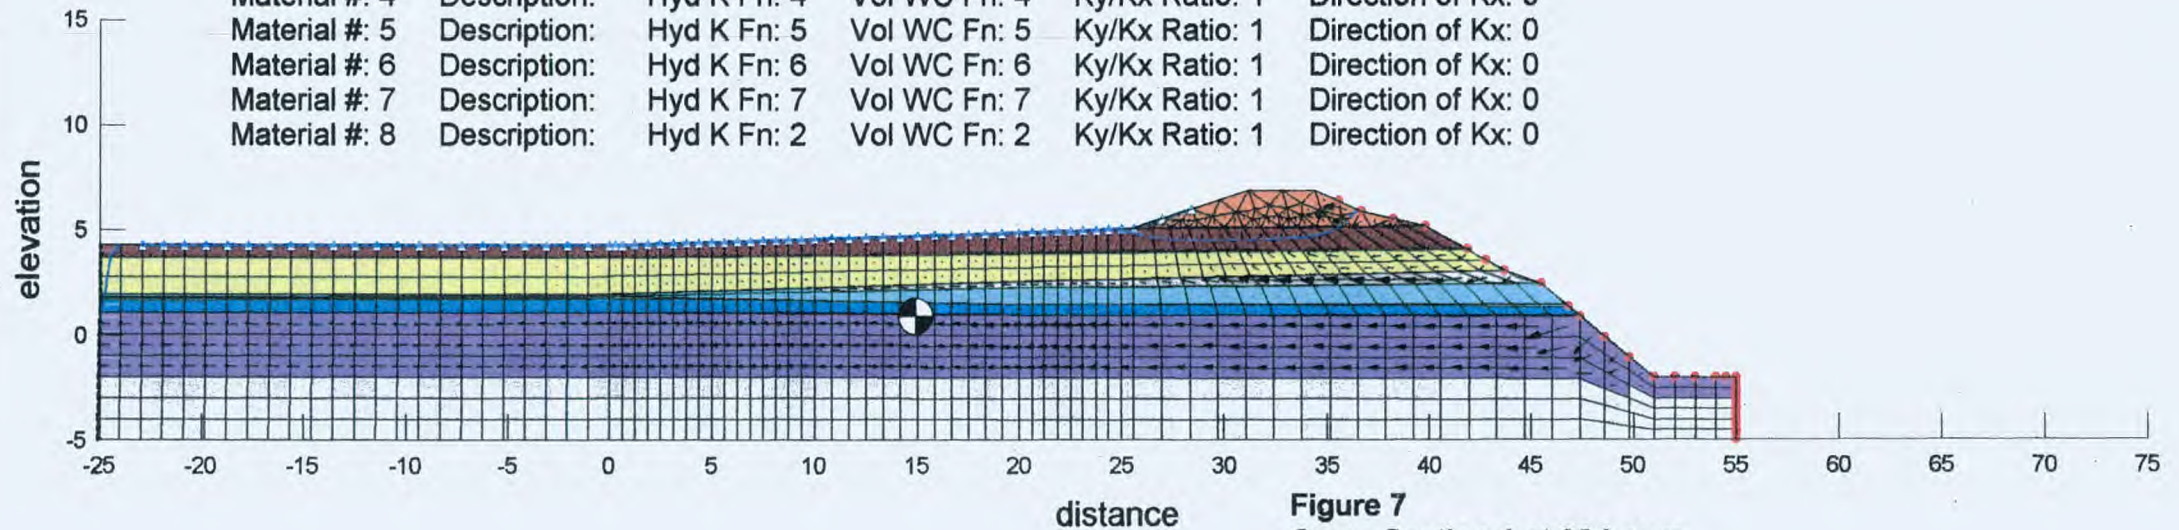
Figure 7
 Cross Section 1 at 90 hours

The analysis model allows some seepage from the ground surface which reduces the pressure build up below the low permeability silt layer. Where there is an impermeable concrete slab at the ground surface water pressure could become higher. This build up in pressure could be the reason for the observed flow and loss of soil from the edge of the concrete slab in July 2004.

A sensitivity analysis was carried out to estimate the river level at which the factor of safety against heave would become less than 1.0. It was found that if the river remains at RL5.8 or higher for more than one day there could be heave problems.

A pressure relief trench extending to the fine sand was modelled. This produced only a marginal reduction in uplift pressure out from the toe of the stopbank.

An alternative to a pressure relief trench is a low permeability cut off trench below the stopbank to virtually prevent flow from the river to the upper soil layers. It was found that a cut off down to RL1.5, 3.5m below natural ground level, would reduce the pressure head below the upper silt to an acceptable level. The problem with a cut off system is that in normal winter conditions it will prevent drainage of the upper soil layers towards the river and could cause surface flooding behind the stopbank.
