Sullivan's Breach, Rangitaiki River Stopbank

18 July 2004

A Review of the Causes of the Breach

Environment Bay of Plenty

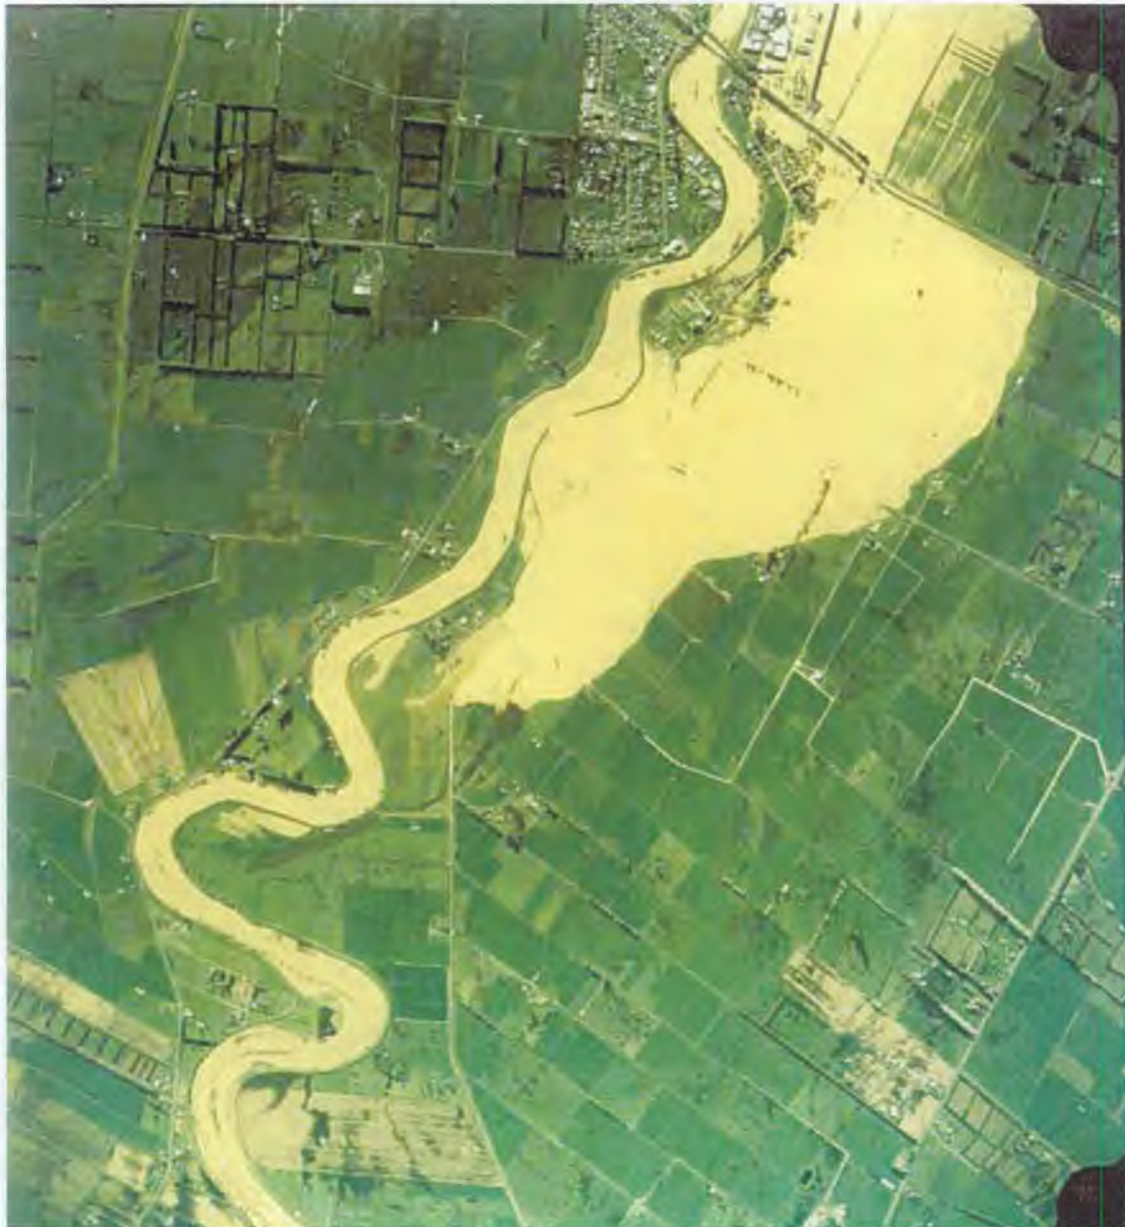
Photograph 1: Aerial view of breach 19 July 2004

A breach occurred in the Rangitiaki River stopbank adjacent to Hydro Road, just upstream of Edgecumbe, at approximately 10am on Sunday 18th July 2004. The river was flowing very high at the time and water poured through the breach causing serious flooding of farmland, the railway, roads, and buildings downstream. The breach in the stopbank widened to about 100m and water flowed through for several days. Photograph 1 shows the breach from the air and Figure 1, prepared by Environment Bay of Plenty (EBOP), shows the extent of the flooding which resulted. As the breach occurred on Sullivan's farm it is referred to as Sullivan's Breach.

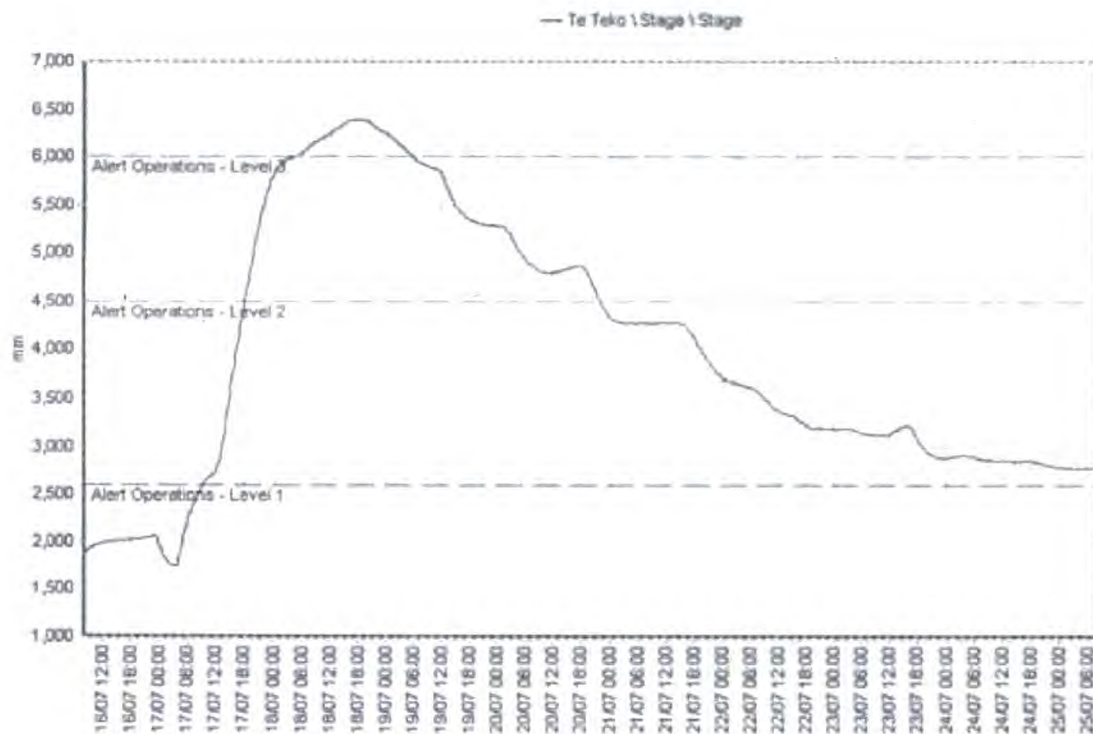
Figure 2: Flood hydrograph measured at Te Teko (EBOP)

The high rainfall caused a rapid rise in the Rangitaiki River. Figure 2 shows the hydrograph measured in the river at Te Teko, about 11km upstream from the breach site. Fortunately the upper catchment of the Rangitaiki River received only about 120mm of rain and not nearer the 300mm experienced in the rest of the catchment.

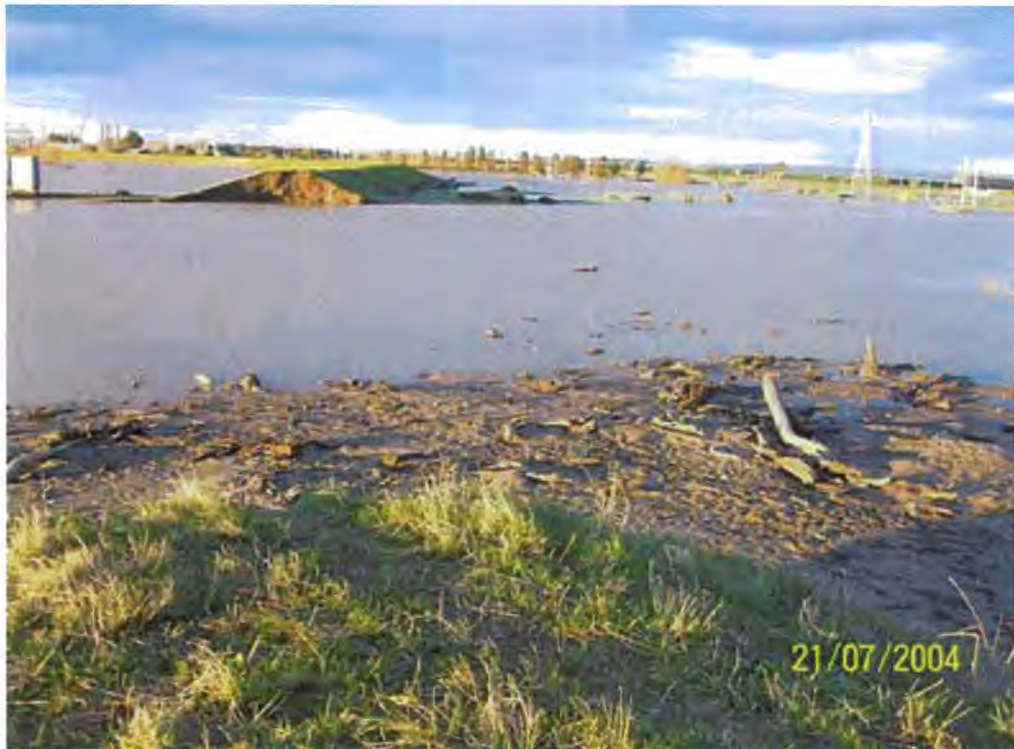
Photograph 2: Looking downstream three days after the initial breach

Another local was driving along McCracken Road towards the stopbank and saw what looked like a huge waterfall coming over the stopbank. This is consistent with the observations of the EBOP staff when they got closer to the site. The "waterfall" was in a confined area and it did not appear that the river had overtopped the stopbank. The EBOP staff observed that the breach was about 20m wide and that there were cracks about a third of the way up the stopbank face adjacent to the breach. In a short time the remains of the stopbank had eroded away and the water levels on each side of the line of the stopbank began to equalise. The exposed ends of the stopbank stood vertically until scour of the underlying soils caused slabs of stopbank to collapse into the flow. Photograph 2 shows the opening three days after the breach when the river level had dropped significantly.

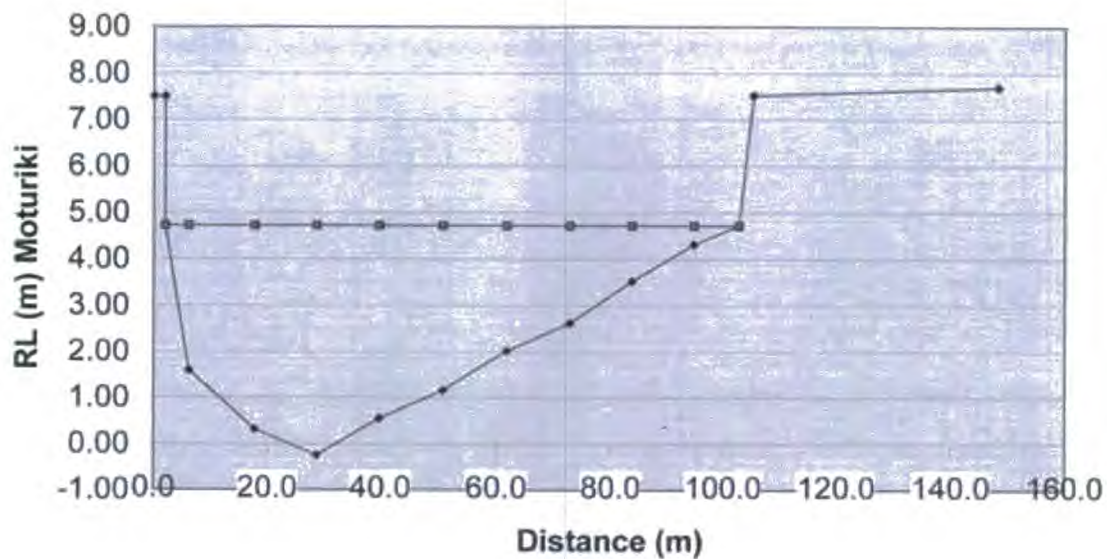
Figure 3: Cross section of scour hole along line of stopbank (EBOP)

The large volume of water which flowed through the breach scoured out a hole nearly 5m deep where the stopbank had been (Figure 3). The scour hole extended inland about 150m from the stopbank centreline, typically reducing in depth with increasing distance from the stopbank (Figure 4, Photograph 3). About 5m beyond the end of the scour hole was a shallow depression which was later found to be an old abandoned stream channel.

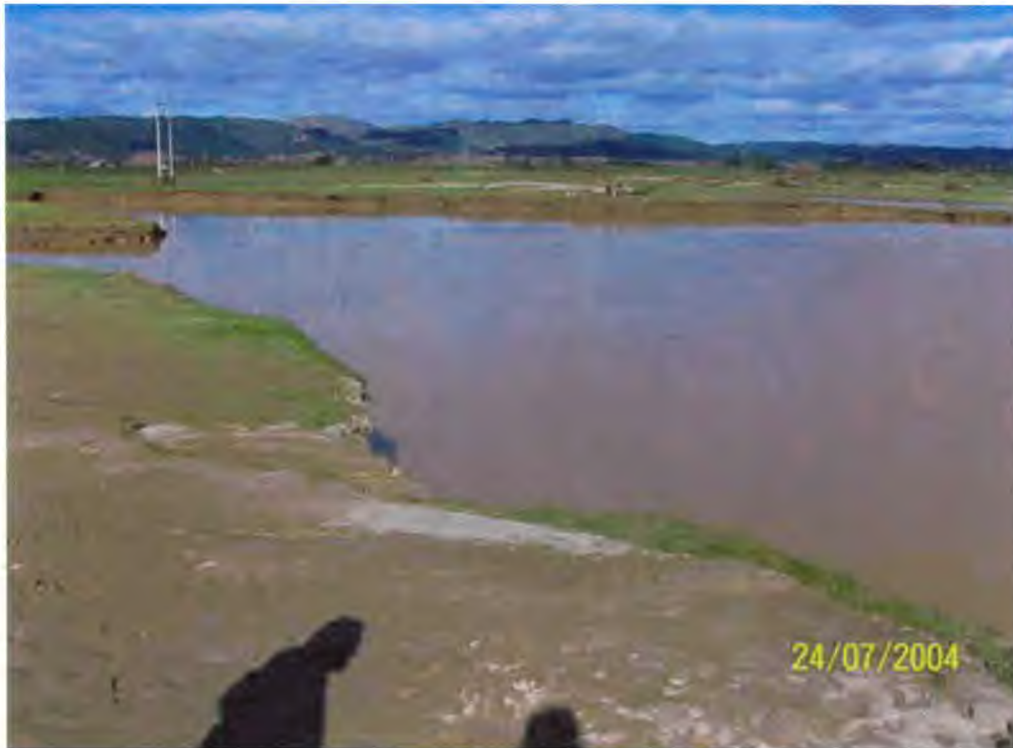
Photograph 3 : Scoured hole

There were large tree stumps and slabs of peat within the scour hole when the water level dropped. These slabs of fibrous peat were up to 2m across and 300mm thick. There were no signs of peat around the edges of the hole and none was found in the later subsurface investigations. It is assumed that the peat and stumps came from further upstream, possibly where the earthquake faultline crosses the river and stumps are exposed in the river bed.

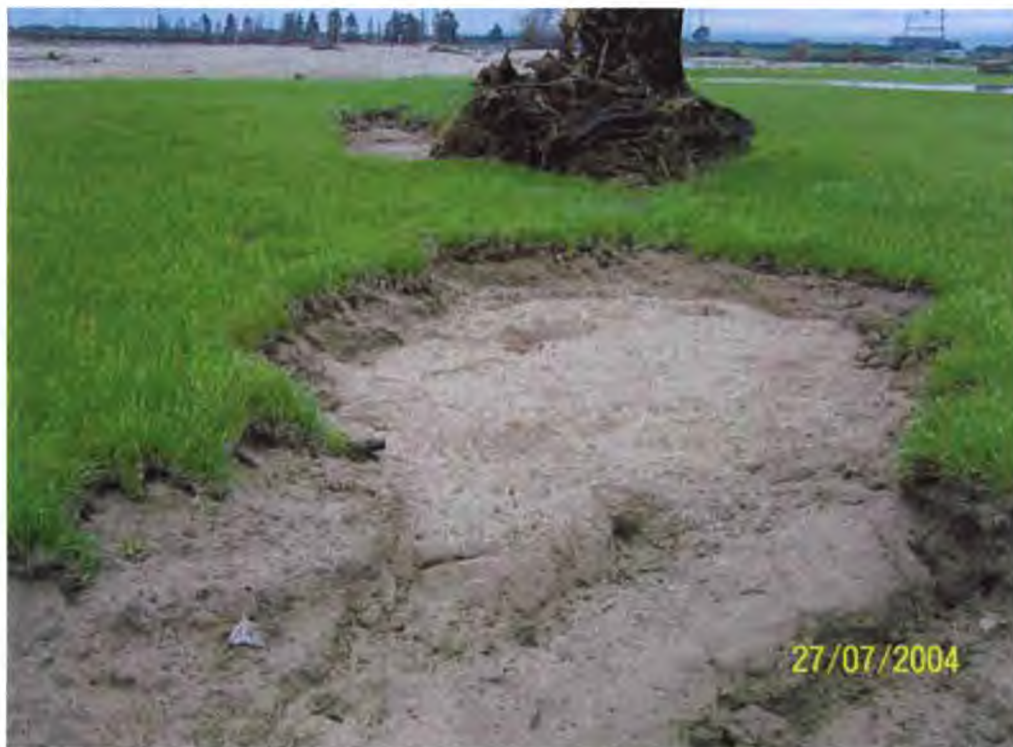
Photograph 4: Loss of upper soil layer

Around the edges of the hole there were fingers of ground where approximately the upper 200mm of soil had been removed. The paddock had

been ploughed, rotary hoed and re-sown in February 2004 following its use for growing water melons. The grass roots were not well established and the sown rows of grass were obvious. It is considered that the depth of soil lost in these fingers coincides with the depth of ploughing (Photograph 4).

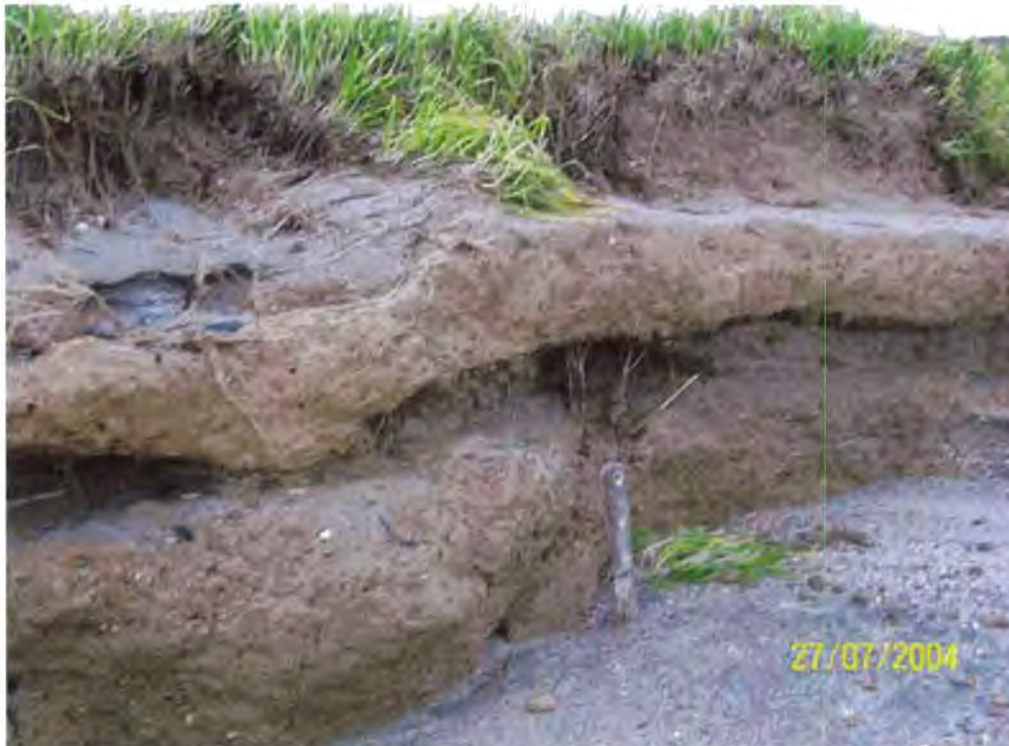
Photograph 5: Ploughed depth and Tarawera Ash layer

There was often another step in the depth of soil lost from the ploughed depth to about 300 to 400mm below the original ground level. This coincided with a layer of Tarawera Ash across the site. This ash was airfall deposited in 1886 and consists of a coarse abrasive black basaltic sand. It could be seen all around the edges of the scour hole and under the exposed end of the stopbank (Photographs 5 and 6). The thickness of the ash layer varies from about 70mm to 200mm. In some small areas there was a thin layer of fine sand within the predominantly silty soil above the Tarawera Ash.

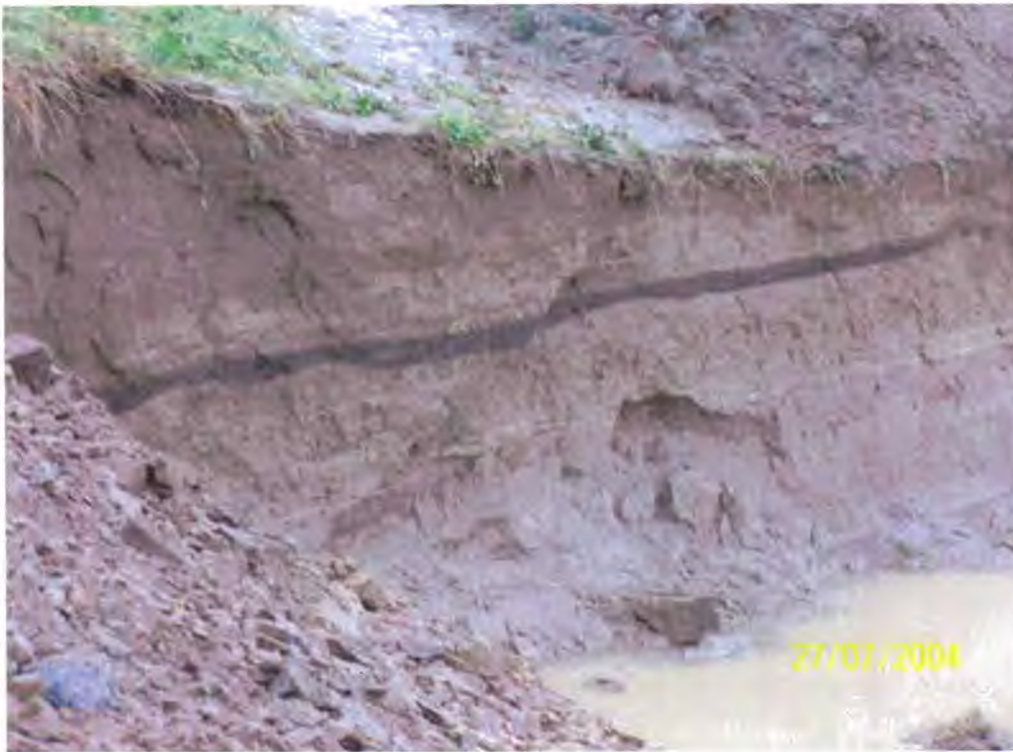
Photograph 6: Exposure at landward toe of stopbank, downstream end of breach showing black Tarawera Ash layer

At the toe of the stopbank on the downstream side of the breach it was observed that the surface soils consisted of about 300mm of silty fine sand overlying 75mm of Tarawera Ash and more silty fine sand (Photograph 6).

About 6m from the toe of the breach the combined thickness of these three layers was only about 600mm and they were underlain by a loose fine to medium grained sand. Around the scour hole it could be seen that this sand layer had been removed by water flow causing overhangs and cracks in the slightly cohesive layers above (Photograph 7). Eventually the sand removal would cause collapse of the upper layers. Further out from the stopbank toe the fine to medium sand layer was only about 400mm below the ground surface.

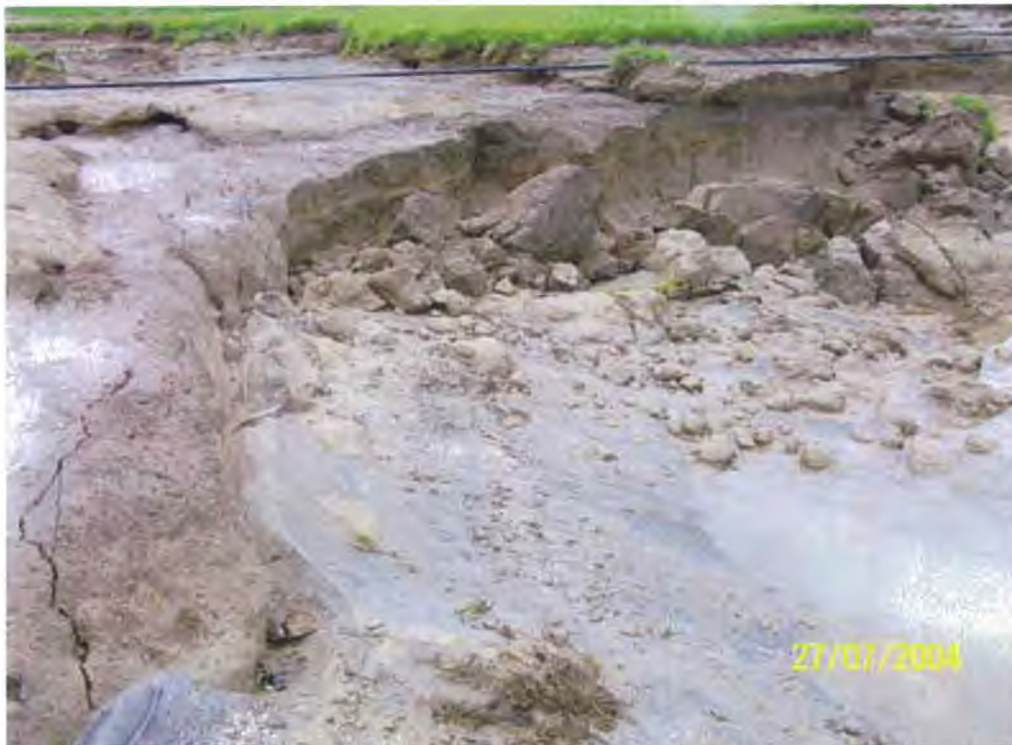
Photograph 7: Cracking and collapse of slightly cohesive upper soil layers at the far end of the scour hole

At the far end of the scour hole (Photograph 7) where about 200mm of the upper soil had been removed, pieces of broken glass, a large diameter steel rod and a piece of wire cable were found. It was thought these may have come from an old rubbish hole on the farm. Neither the present farmer or the previous owner can recall a rubbish hole in this vicinity. The previous owner did recall a spongy area in the paddock "50 to 80 yards" from the stopbank toe when the river was in flood. An alkathene pipe had been exposed at the end of the breach.

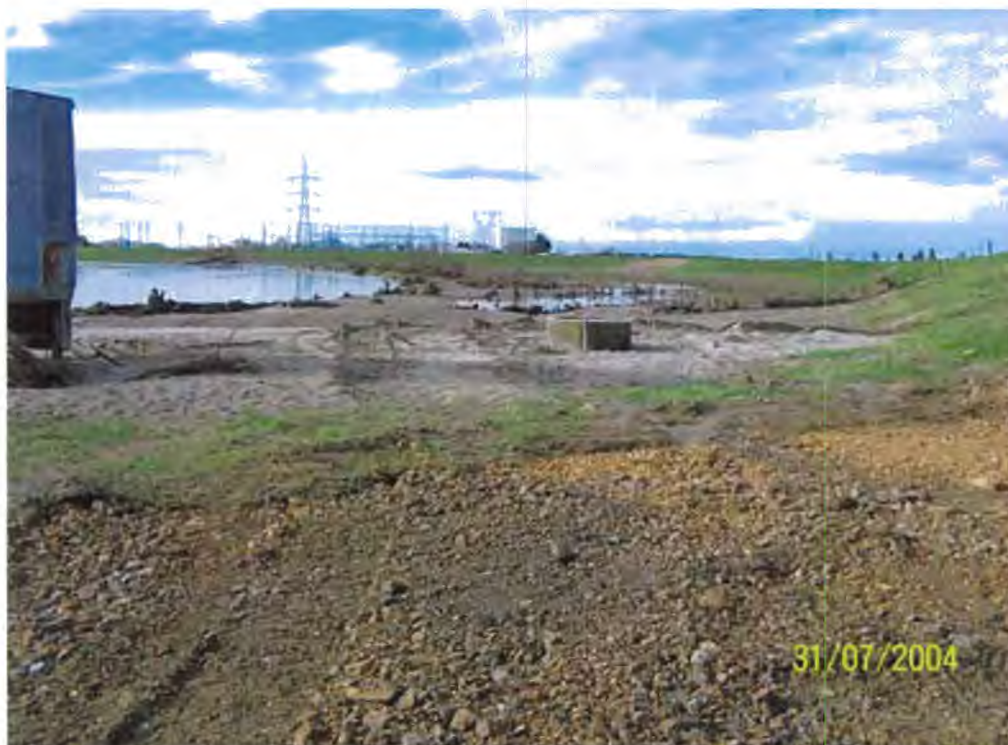
Photograph 8: Pump shed and river berm

After the water had receded it could be seen that the small pump shed on the berm just to the downstream side of the breach was on a mound 1 to 2m higher than the berm further downstream or upstream. It was later found that this is because there was an old bend in the river downstream from the pump shed and the berm upstream had been used as a borrow area (source of fill) during stopbank construction. The berm between the river and the stopbank widens downstream from the breach site (Photograph 8).

Near the pump shed were pieces of steel intake pipe and alkathene pipe. Improperly installed pipes passing through stopbanks can cause stopbank failures. It was later found that the pipe from this pump shed crosses towards the top of the stopbank downstream from the breach.
