Report To: Operations, Monitoring and Regulation Committee
Meeting Date: 22 February 2012
Report From: Ken Tarboton, Group Manager Environmental Hazards

1 January 2012 Flood Event

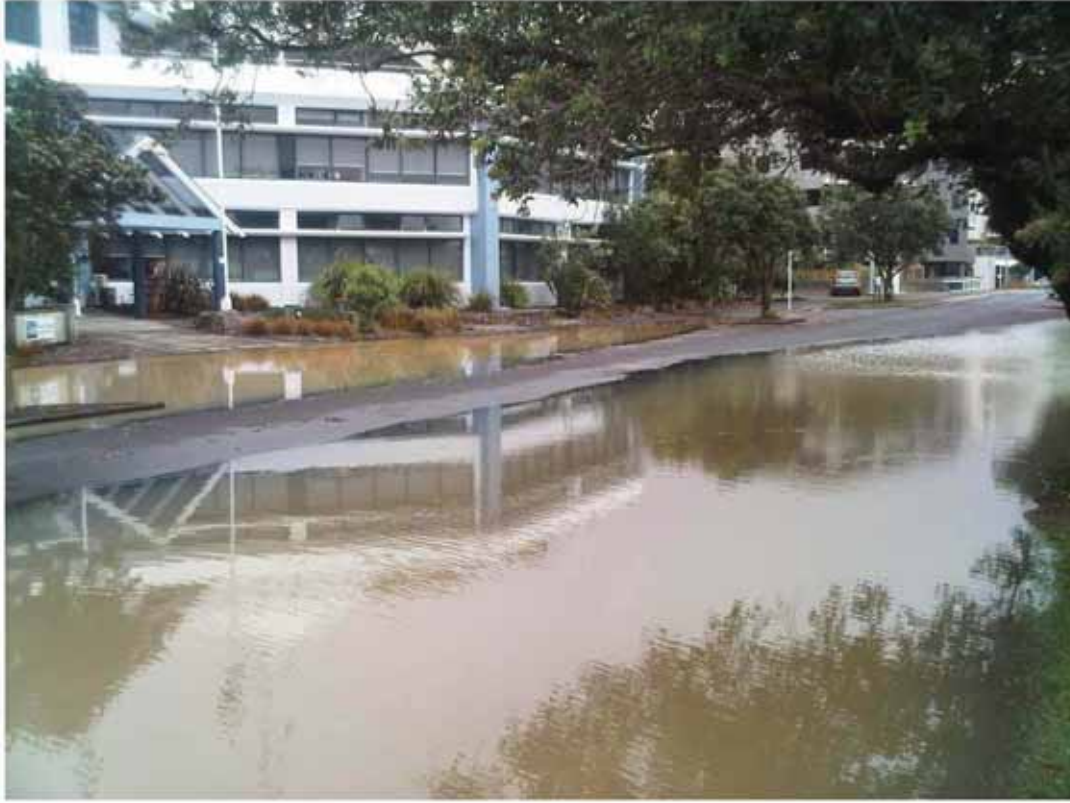
Engineering staff monitored seepage and bank stability throughout New Year's Day. Seepage caused heaving of the tarmac around the Regional Council offices, and ponding occurred around Quay Street.

Photo 1: Ponding caused by combination of surface water runoff and seepage

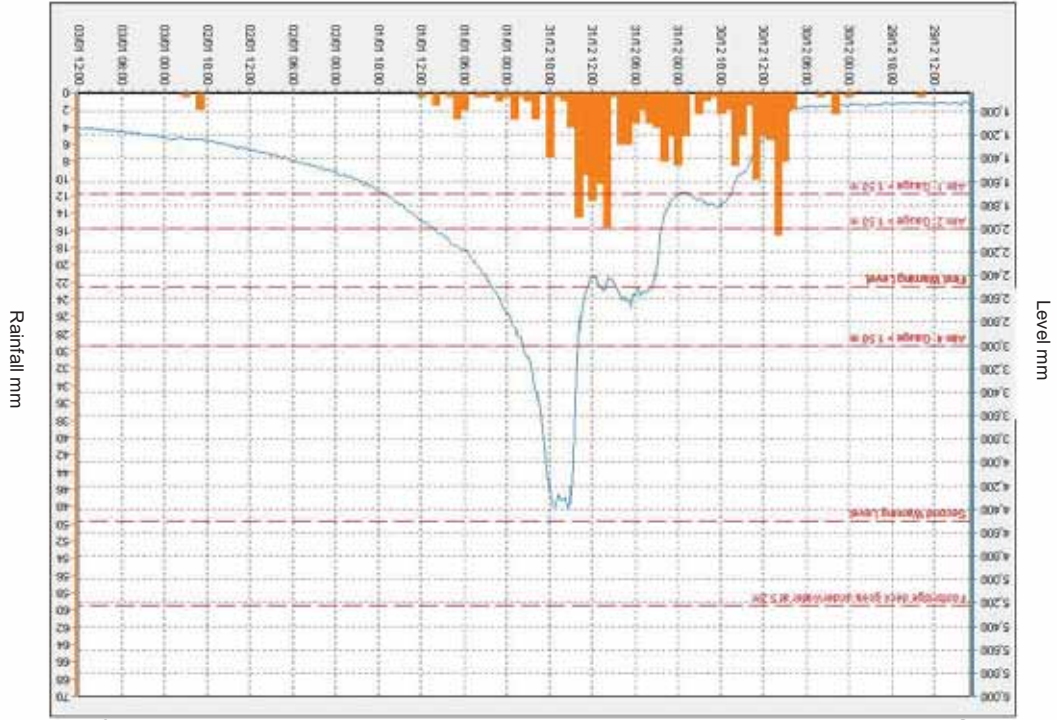
Kaituna at Te Matai gauge exceeded first and second warning levels (as shown in plot 1 below), and the appropriate flood warnings were put out according to Regional Council Flood Manual. The Kaituna Right bank at Te Matai flood gate was jammed open during these high river levels, which caused local flooding. Residents alerted Regional Council and the problem was resolved.

Plot 1: Kaituna at Te Matai Level and Rainfall – 29 December 2011 to 2 February 2012

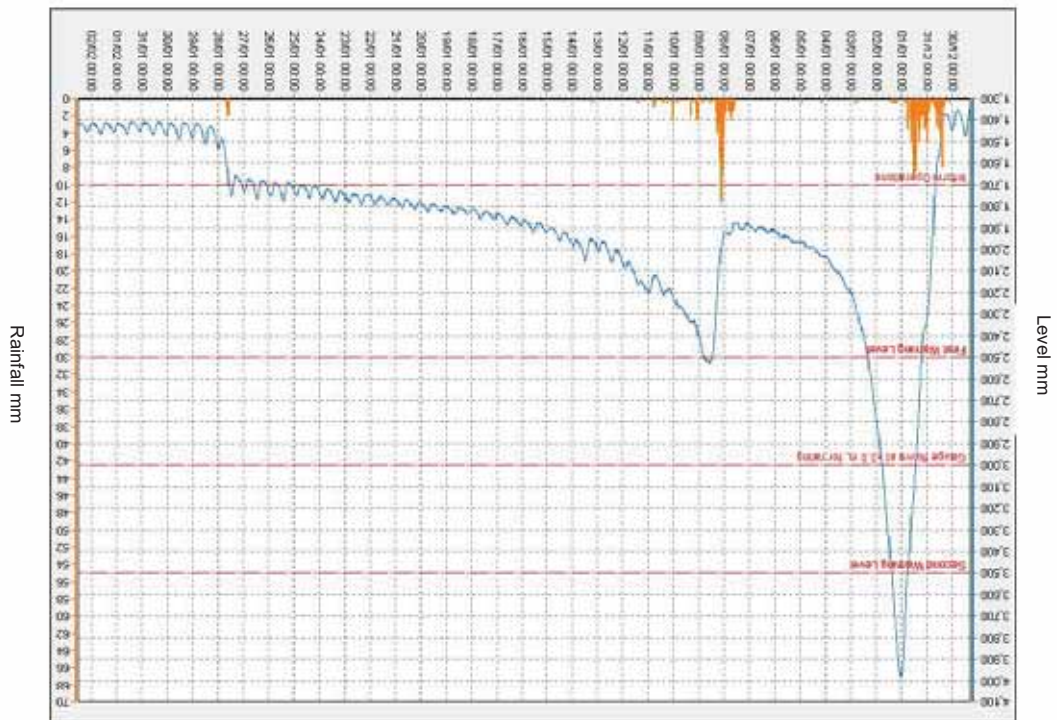
Plot 2: Mangorewa at Saunders Level and Rainfall – 29 December 2011 to 3 January 2012

Mangorewa at Saunders gauge exceeded first warning level and peaked just below the second warning level (as shown in plot 2 below).

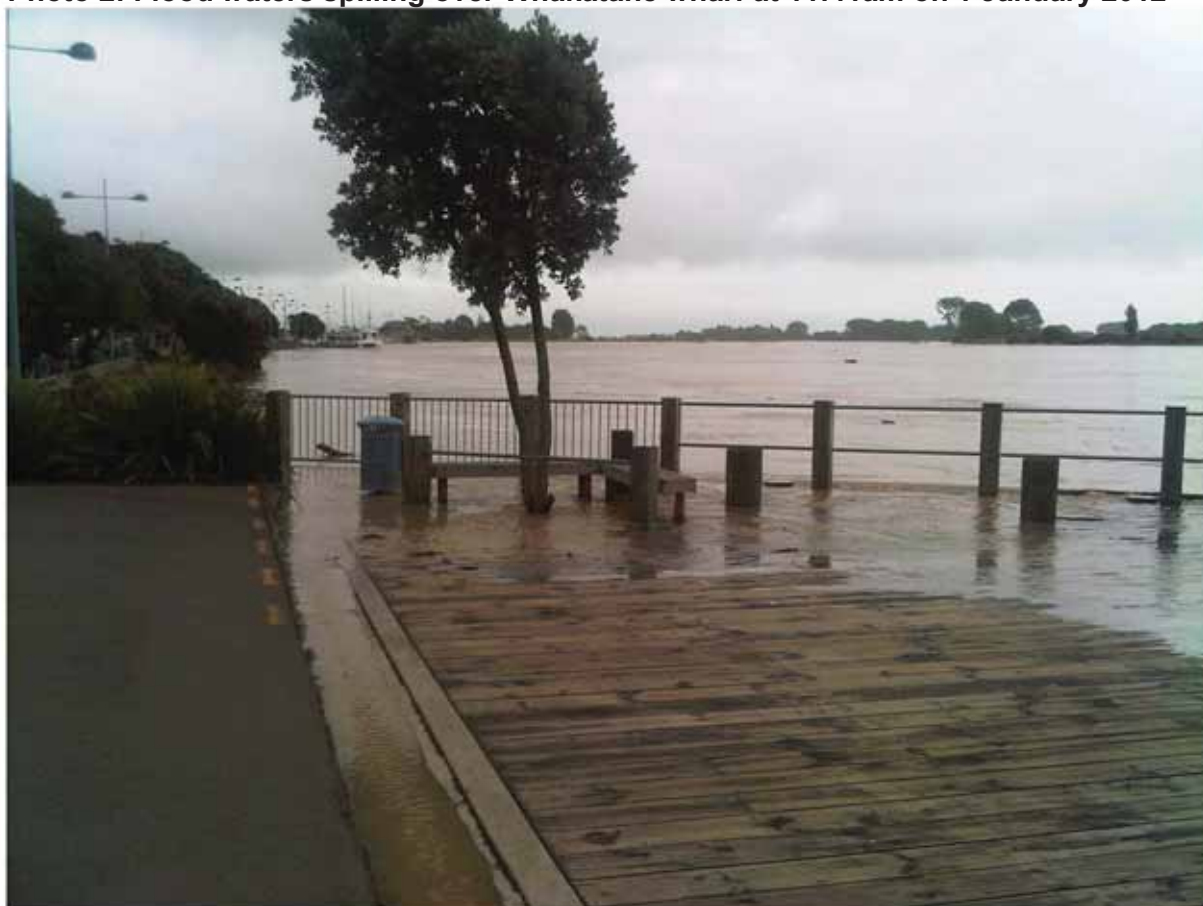
The flood peak passed safely on the Whakatāne River with a 2,594m³/s flood passing high tide at 13:25 on 1 January – only 220m³/s short of the previous 2004 100-year flood discharge. Stop-logs were left in place around the wharf overnight as a precaution and to allow clean up at the Harbour Master's request.

Photo 2: Flood waters spilling over Whakatāne wharf at 11:41am on 1 January 2012

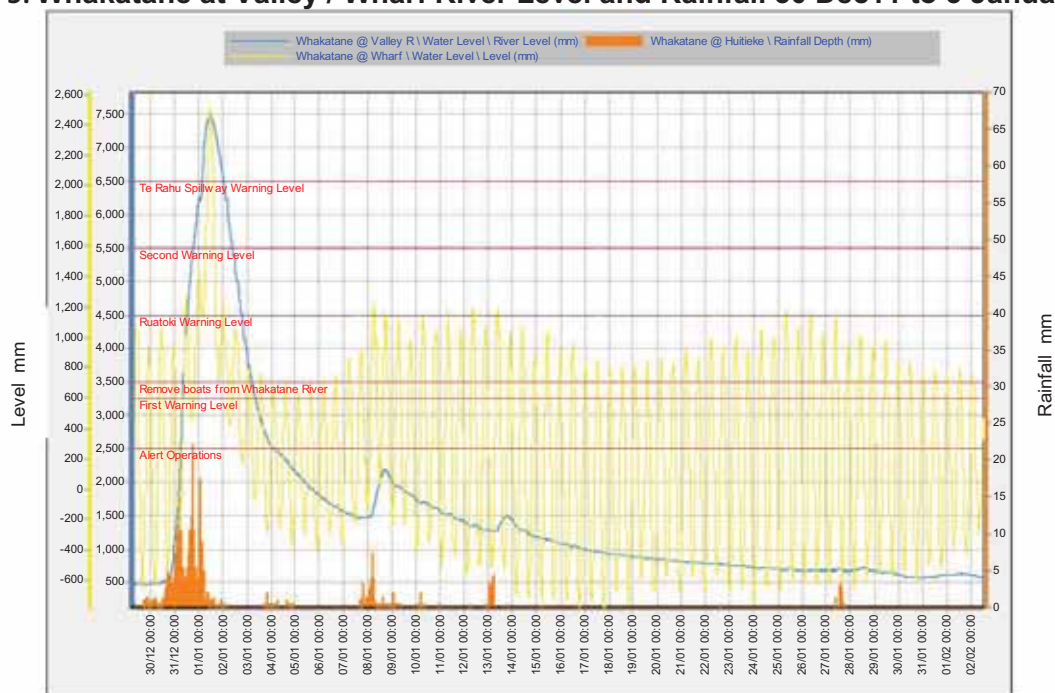
Plot 5: Whakatane at Valley / Wharf River Level and Rainfall 30 Dec11 to 3 January 2012

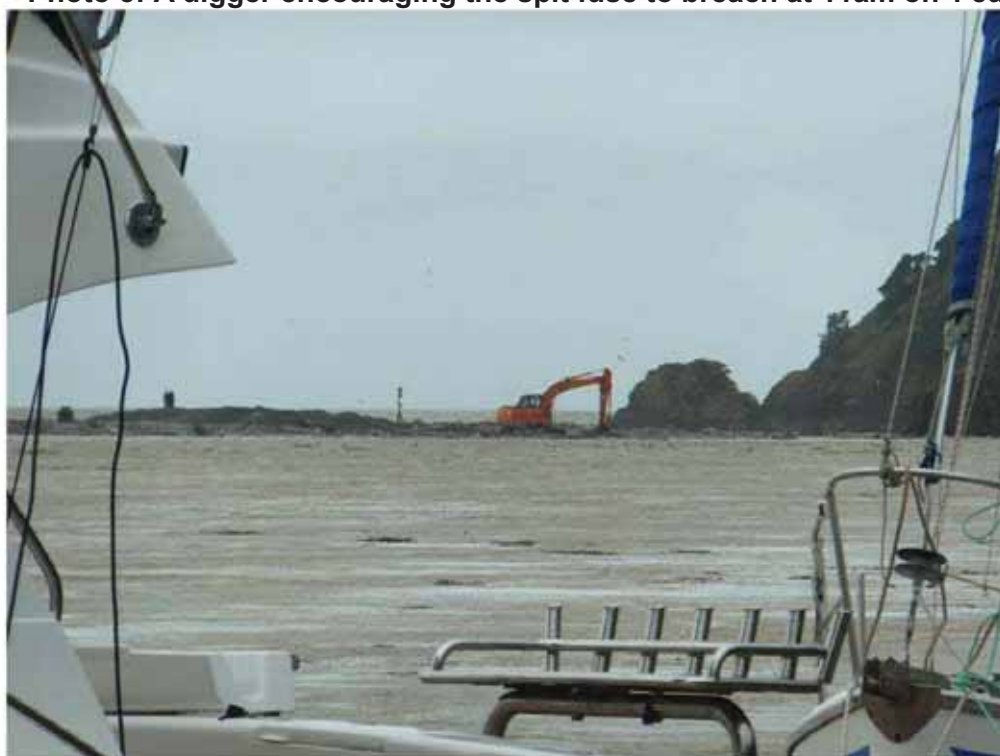
The duty flood manager instructed WDC to lower the spit with a digger at 08:00 on New Year's Day. The fuse at the Whakatāne River mouth did not breach until just before high tide at 13:25 on Sunday 1 January 2012, having the effect of instantaneously stabilising water levels as measured at the wharf.

A key issue was that the Whakatāne River spit was observed to have an adverse effect on flood levels, as the freeboard remaining was only 600 to 800mm (equivalent to a 100-year flood) before the spit breached.

Photo 3: A digger encouraging the spit fuse to breach at 11am on 1 January

The Whakatāne spit at the mouth of the Whakatane River continues to cause great concern for Regional Council and the community. Whakatāne District Council has undertaken to investigate the implementation of their resource consent to maintain the spit fuse, and to clarify how the required height will be maintained, and when this will occur in advance of an event. This will be written up as a guideline.

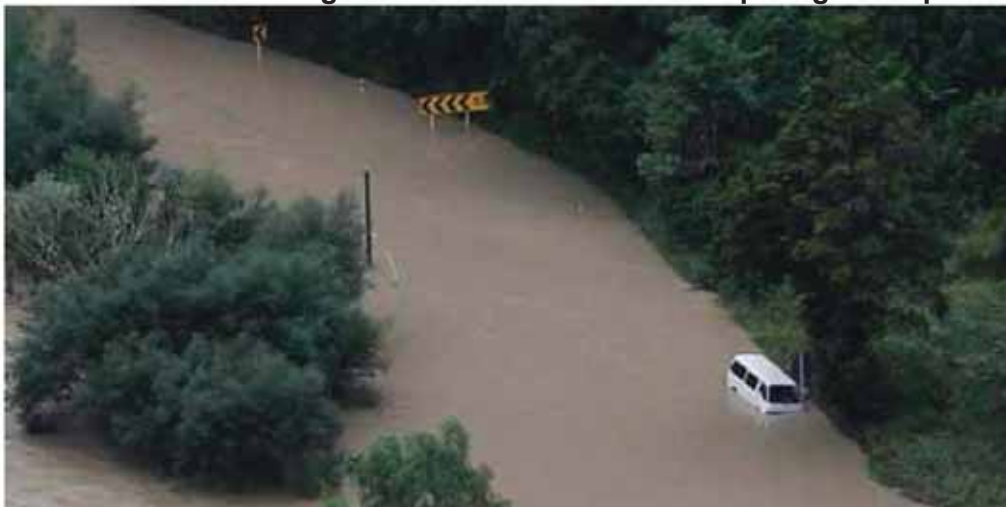
Photo 5: Waimana Gorge tourist vehicle stranded requiring helicopter rescue

There was an incident where tourists apparently disregarded warnings, and put their lives at risk.

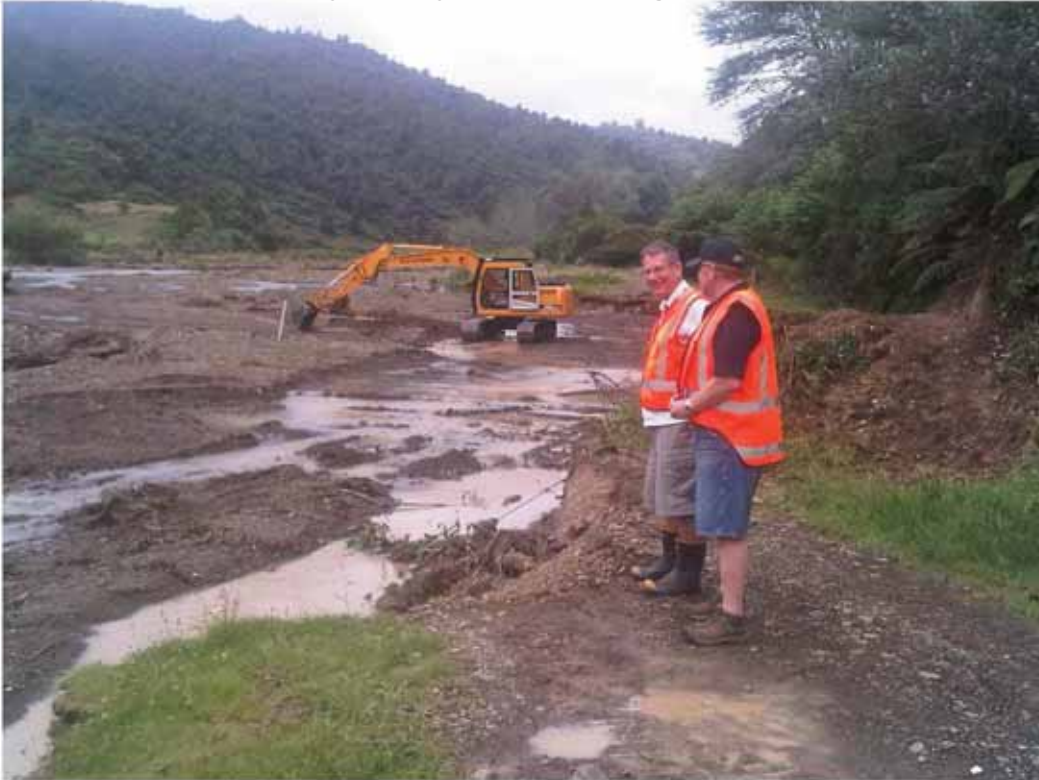
Photo 6: Tony Dunlop with Mayor Tony Bonne viewing Waimana River flood damage
