Flood Inspection Records

Night shift – 7pm Wednesday 5th April 2017 to 7am Thursday 6th April 2017

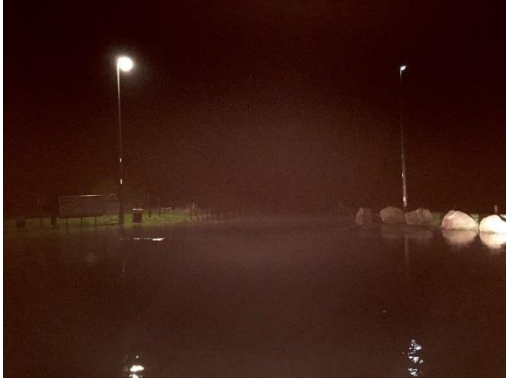
01:55	Thornton Boat Ramp <ul style="list-style-type: none">River level is up to road levelGeneral surface flooding water around toilets coming across road to meet the river level

No action required – continued to next site
≈2:05	Grieg Road Flood wall <ul style="list-style-type: none">River Level is approximately 1.2m below top of floodwallNo obvious signs of seepage	No action required
≈5:27	College Road Floodwall <ul style="list-style-type: none">No obvious signs of seepage	No action – continued on to Hydro Road inspections
