# **Reid's Canal: Right Bank Cross Section 4**

## **Geotechnical Assessment**

**Environment Bay of Plenty**

**August 2008**

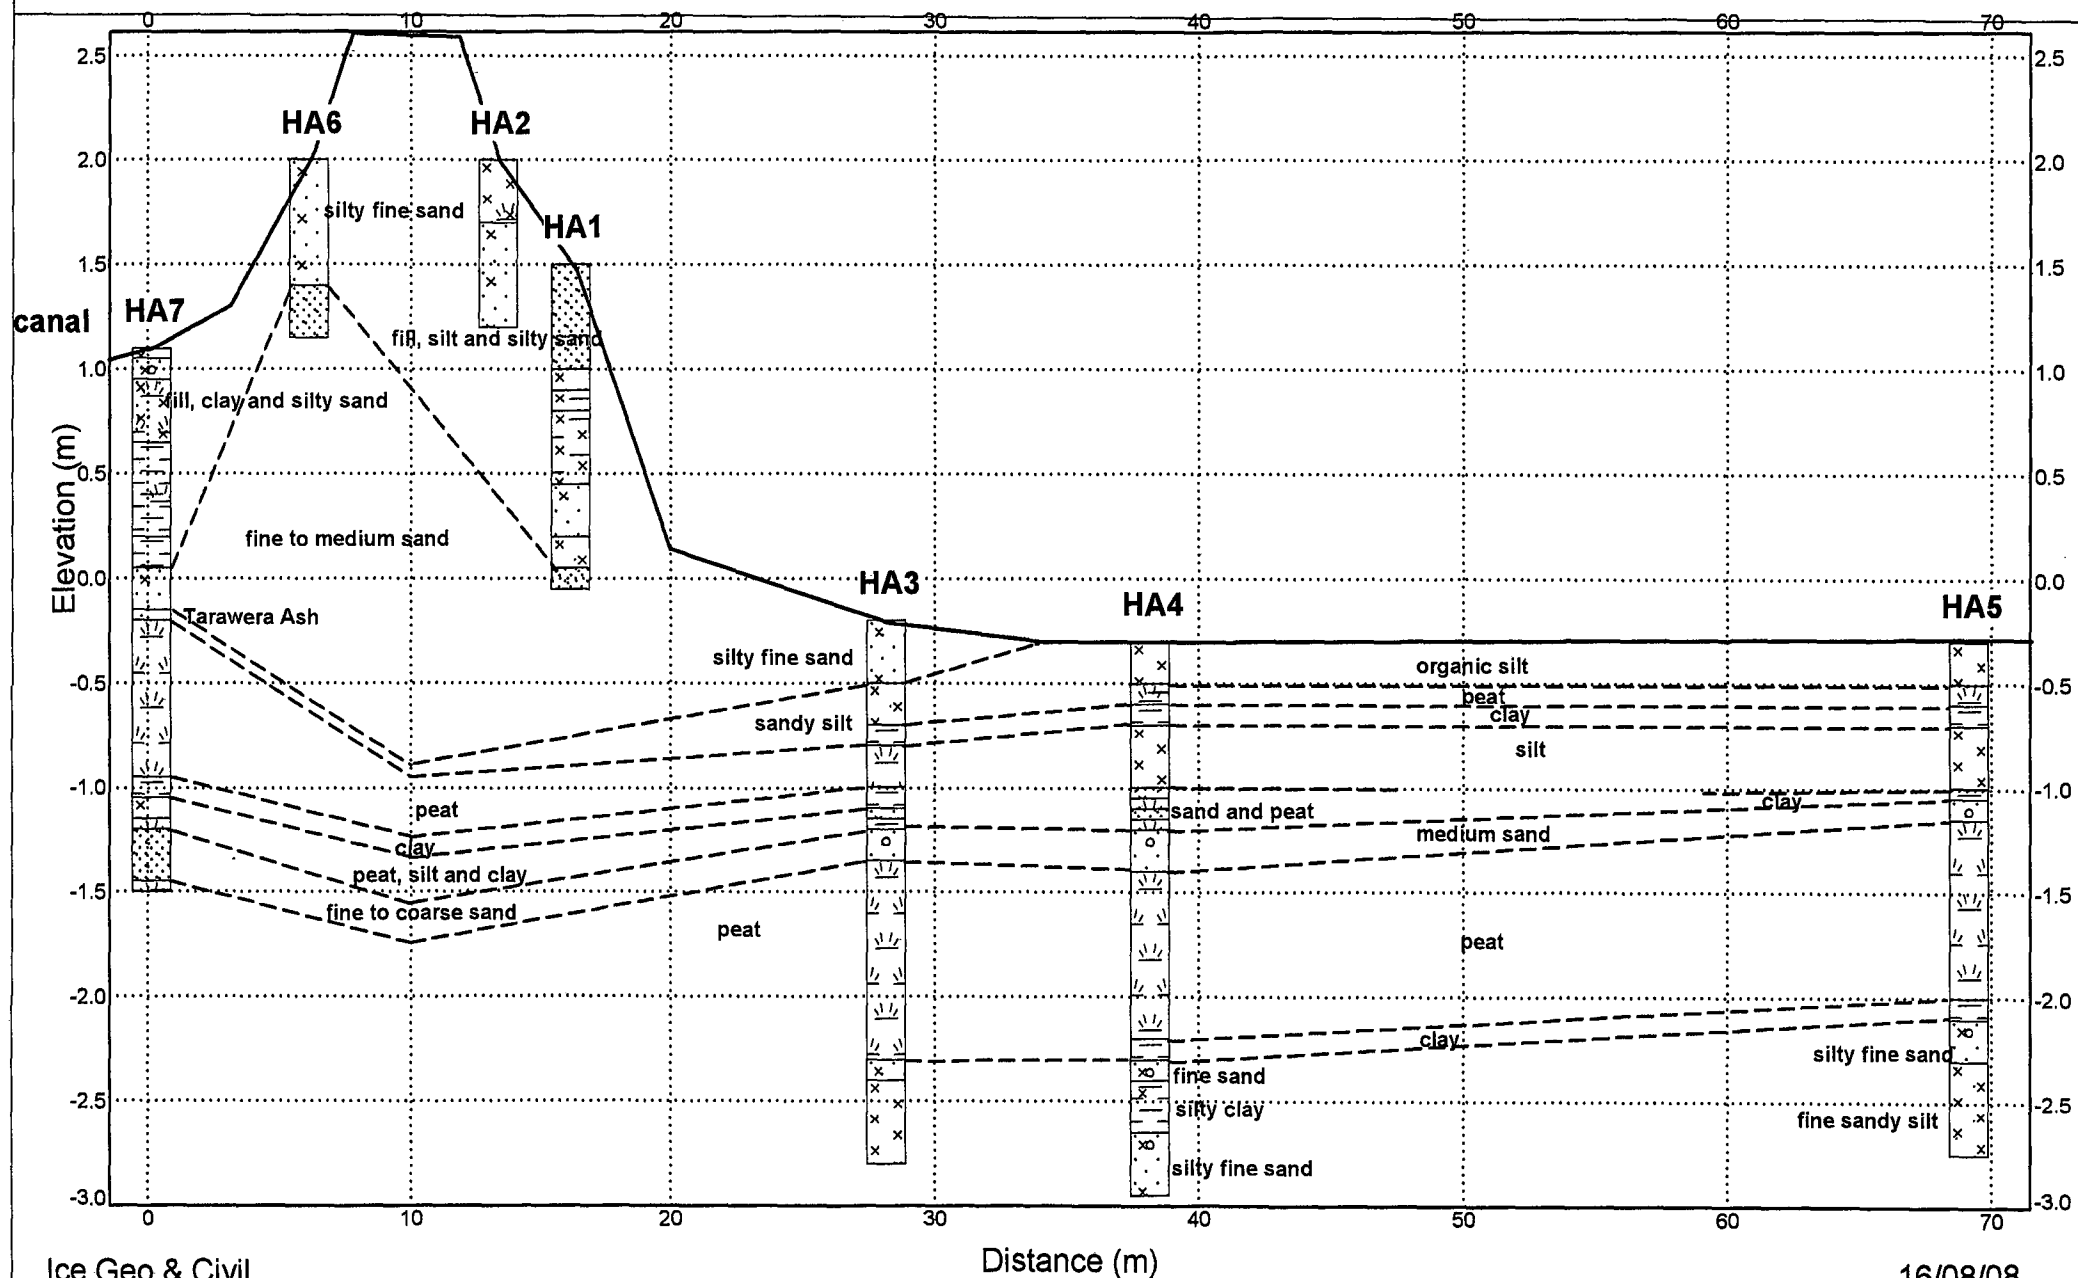
**Figure 1: Subsurface Cross Section Reid's Canal**  
**Cross Section 4**

The subsurface investigations consisted of seven hand augers carried out along the cross section as shown in Figure 1. No hand augers could be carried out through the crest of the stopbank due to a compacted gravel surface. The investigations were carried out a few days after the canal water level had risen across the berm and the day after heavy overnight rain. There appeared to be seepage coming from the inland toe of the stopbank below the water level in the canal. This part of the stopbank and the adjacent paddock were water logged.

The subsurface cross section in Figure 1 suggests that this sand layer could be exposed in the side of the canal and may form another permeable seepage path under the stopbank.

The upper stopbank fill was found to consist of silty fine to medium sand and gravel. Some clay was found on the inland side of the stopbank. A fine to medium sand layer was found at RL0.1 on both sides of the stopbank and at RL1.4 within the stopbank. It is considered that the observed seepage was coming through the stopbank in this layer.

It appears from HA7 that the canal berm has been built up since the stopbank was built. A thick layer of ash (from burnt trees?) was found and layers of clay. The first layer that could be identified as being undisturbed was the black coarse sand, Tarawera Ash, at RL-0.15. Although this layer was not found on the land side of the stopbank, the ash was found mixed with the silt at RL-0.5 in HA3. This mixing is consistent with ploughing as the ash is often found at about 0.3m depth below an undisturbed surface. Above the Tarawera Ash in HA7 is the fine to medium sand layer that extends under the stopbank. It is possible that this sand layer is the result of canal cleanings being spread out before the stopbank was built.

Below the Tarawera Ash in HA7 is a 0.75m layer of peat then thinner layers of clay, silt and peat. A 0.25m thick medium grained pumice sand layer was found at RL-1.2. Further peat was found below this.

On the inland side of the stopbank hand augers 3, 4 and 5 showed surface layers of organic silts, peat and clay. Hand augers 4 and 5 show a layer of silt not found in HA3. This variation in layers is not uncommon in alluvial situations. The deep medium sand layer found in HA7 is also found at a similar depth in hand augers 3, 4 and 5. Due to its consistent presence it is considered that this layer could be an airfall deposit, rather than an alluvial deposit, and is possibly an earlier Tarawera or Kaharoa Ash. This sand layer was also found sandwiched between peat layers along the Eastern Drain.

The subsurface cross section shown in Figure 1 was simplified slightly for the seepage and stability analyses. The computer programmes Geo-Slope Seep/W and Slope/W (Version 6.19) were used in the two dimensional analysis of the stopbank. An initial steady state seepage analysis was carried out to model the normal flow conditions towards the paddocks, assuming the canal water level was at RL0.8. A transient analysis was superimposed on the steady state analysis to assess the effects of a flood in the canal. The seepage pressure conditions at the peak flow in the canal were then imported into the stability analysis of the inland face of the stopbank. Seepage from the ground surface was allowed for.

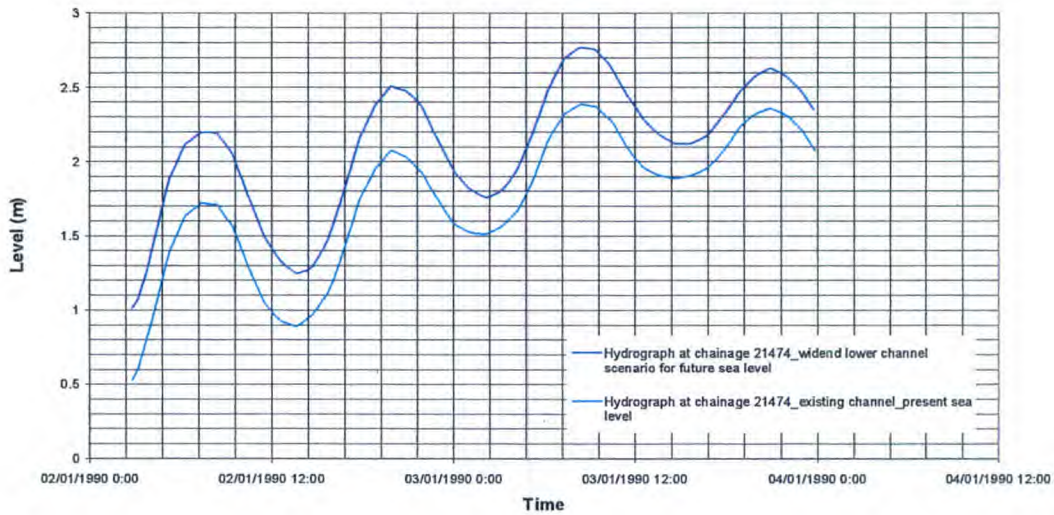
Figure 2: EBoP hydrograph

EBoP have estimated a flood flow hydrograph for the canal after it has been widened (Figure 2). This includes an allowance for climate change.

Reids Floodway: Hydrographs for 100 year Flood Events

For the purposes of the transient seepage analysis this hydrograph has been simplified and extended to about 80 hours to allow for the estimated time that the Rangitaiki River would be high enough for water to flow down the canal. It can be seen from the hydrographs that the stopbank will have to be raised to provide some freeboard in the design flood.

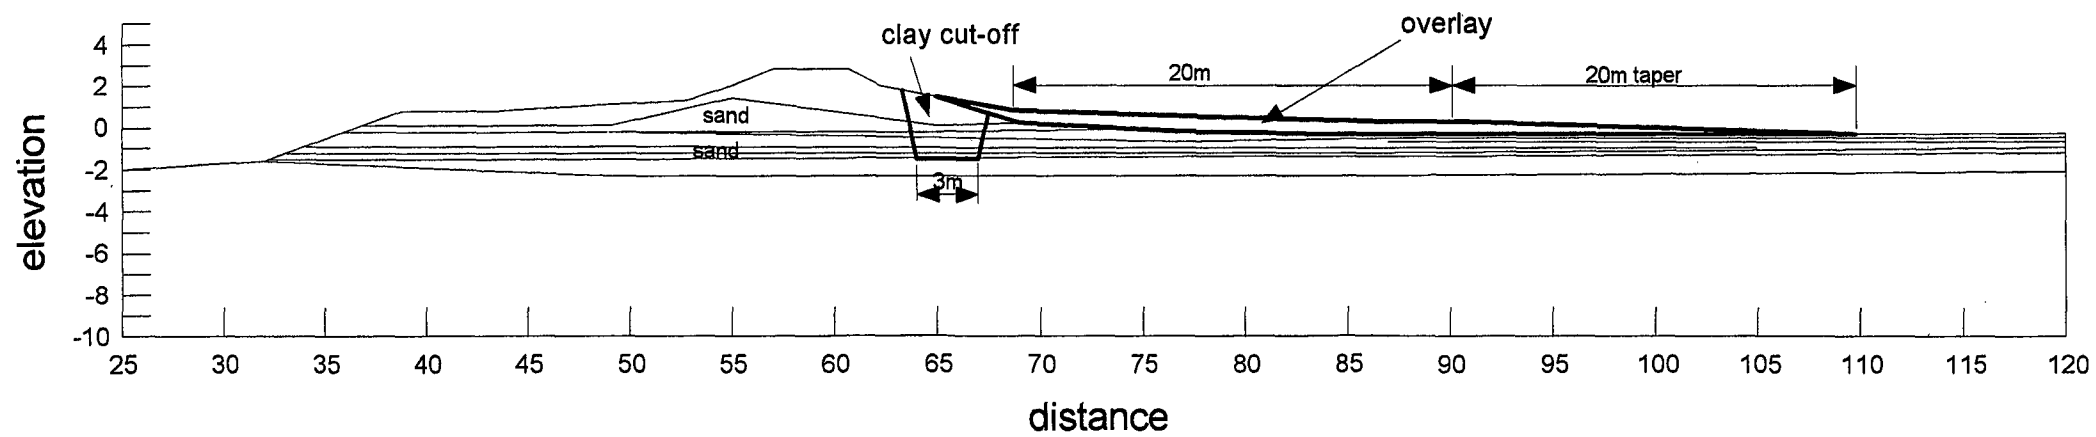
Figure 4: Reid's Canal Cross Section 4 remedial measure

The crest of the stopbank is at about RL2.8. There is a berm about 15m wide between the canal side toe of the stopbank and the canal bank at normal flows. This berm is 1.3m higher than the land on the opposite side of the stopbank. The slope of the sides of the stopbank is typically at 2.5-3.0H to 1V (Figure 4).

In the transient analysis it was found that the factor of safety against heave of the peat and silt layers above the medium to coarse sand was less than 1.0. The clay cut-off was therefore extended into this layer (Figure 4). This improved the factor of safety against heave of the upper layers to approximately 1.0.

An analysis was carried out with a 600mm overlay from the inland toe of the stopbank to 20m from the toe, then tapering to ground level 40m from the toe (Figure 4). The minimum factors of safety against heave were found to be between 1.1 and 1.2.

Flow from the fine to medium sand layer at the base of the stopbank under normal canal water level conditions was considered to be unacceptable. A clay cut-off through this layer was therefore modelled at the inland toe of the stopbank. The inland toe was chosen as the depth of excavation here would be less here than on the canal side.

An analysis was run with the overlay but without the clay cut-off. It was found that without the cut-off heave of the upper layers was still possible. An assessment was made to see if a thicker overlay would be more cost effective than a clay cut off. However without a cut-off the overlay would have to be very thick to counteract the uplift pressure due to over 3.5m head of water in the sand layer.

1. A clay cut-off to about RL-1.5 is required to restrict the seepage through sand layers under the stopbank. This will probably have to be formed by mixing bentonite with the in situ soils in place.
2. A 40m wide, 600mm thick, overlay is required at the inland toe of the stopbank.
3. The stopbank will need to be raised to provide some freeboard above the design level flood. Extra height should be added to allow for the settlement of the peat due to the increased stopbank load.
4. Further investigations are required to confirm the lateral extent that the remedial works are required along the stopbank.

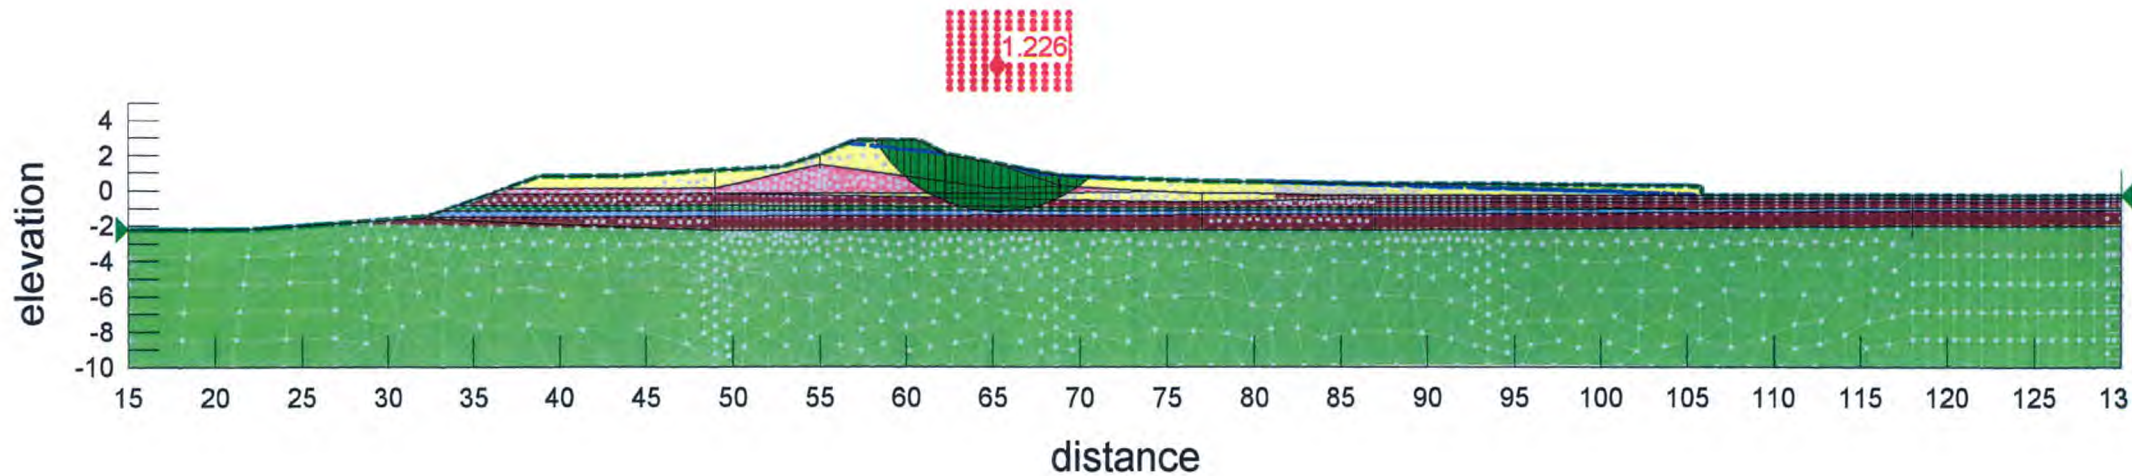
Name: CS4trans overlay.gsz  
 Title: Reid's Canal Cross Section 4  
 Comments: Transient Analysis  
 Date: 21/08/2008 Time: 6:49:01 p.m.

Material #:	1	Description: fill	Model: MohrCoulomb	Wt: 17	Cohesion: 0	Phi: 33
Material #:	2	Description: sand	Model: MohrCoulomb	Wt: 14	Cohesion: 0	Phi: 35
Material #:	3	Description: silts	Model: MohrCoulomb	Wt: 15.5	Cohesion: 2	Phi: 24
Material #:	4	Description: peat	Model: MohrCoulomb	Wt: 10.5	Cohesion: 2	Phi: 20
Material #:	5	Description: banded	Model: MohrCoulomb	Wt: 14	Cohesion: 1	Phi: 22
Material #:	6	Description: sand	Model: MohrCoulomb	Wt: 14	Cohesion: 0	Phi: 35
Material #:	7	Description: sands and silt	Model: MohrCoulomb	Wt: 14	Cohesion: 1	Phi: 22

A stability analysis of the inland face was carried out with the highest seepage pressures from the seepage analysis of the canal in flood and the soil strength and density parameters given in Table 1. The lowest factor of safety against a failure which includes the crest of the stopbank was found to be 1.2. This surface is shown in Appendix B. This factor of safety is considered to be on the low side of acceptable under these extreme conditions. Increasing the overlay thickness at the toe of the stopbank would improve this factor of safety.
