Rangitaiki River Stopbanks Assessment

Otakiri Road to Kokohinau

Left Bank 12300 to 16100m

Environment Bay of Plenty

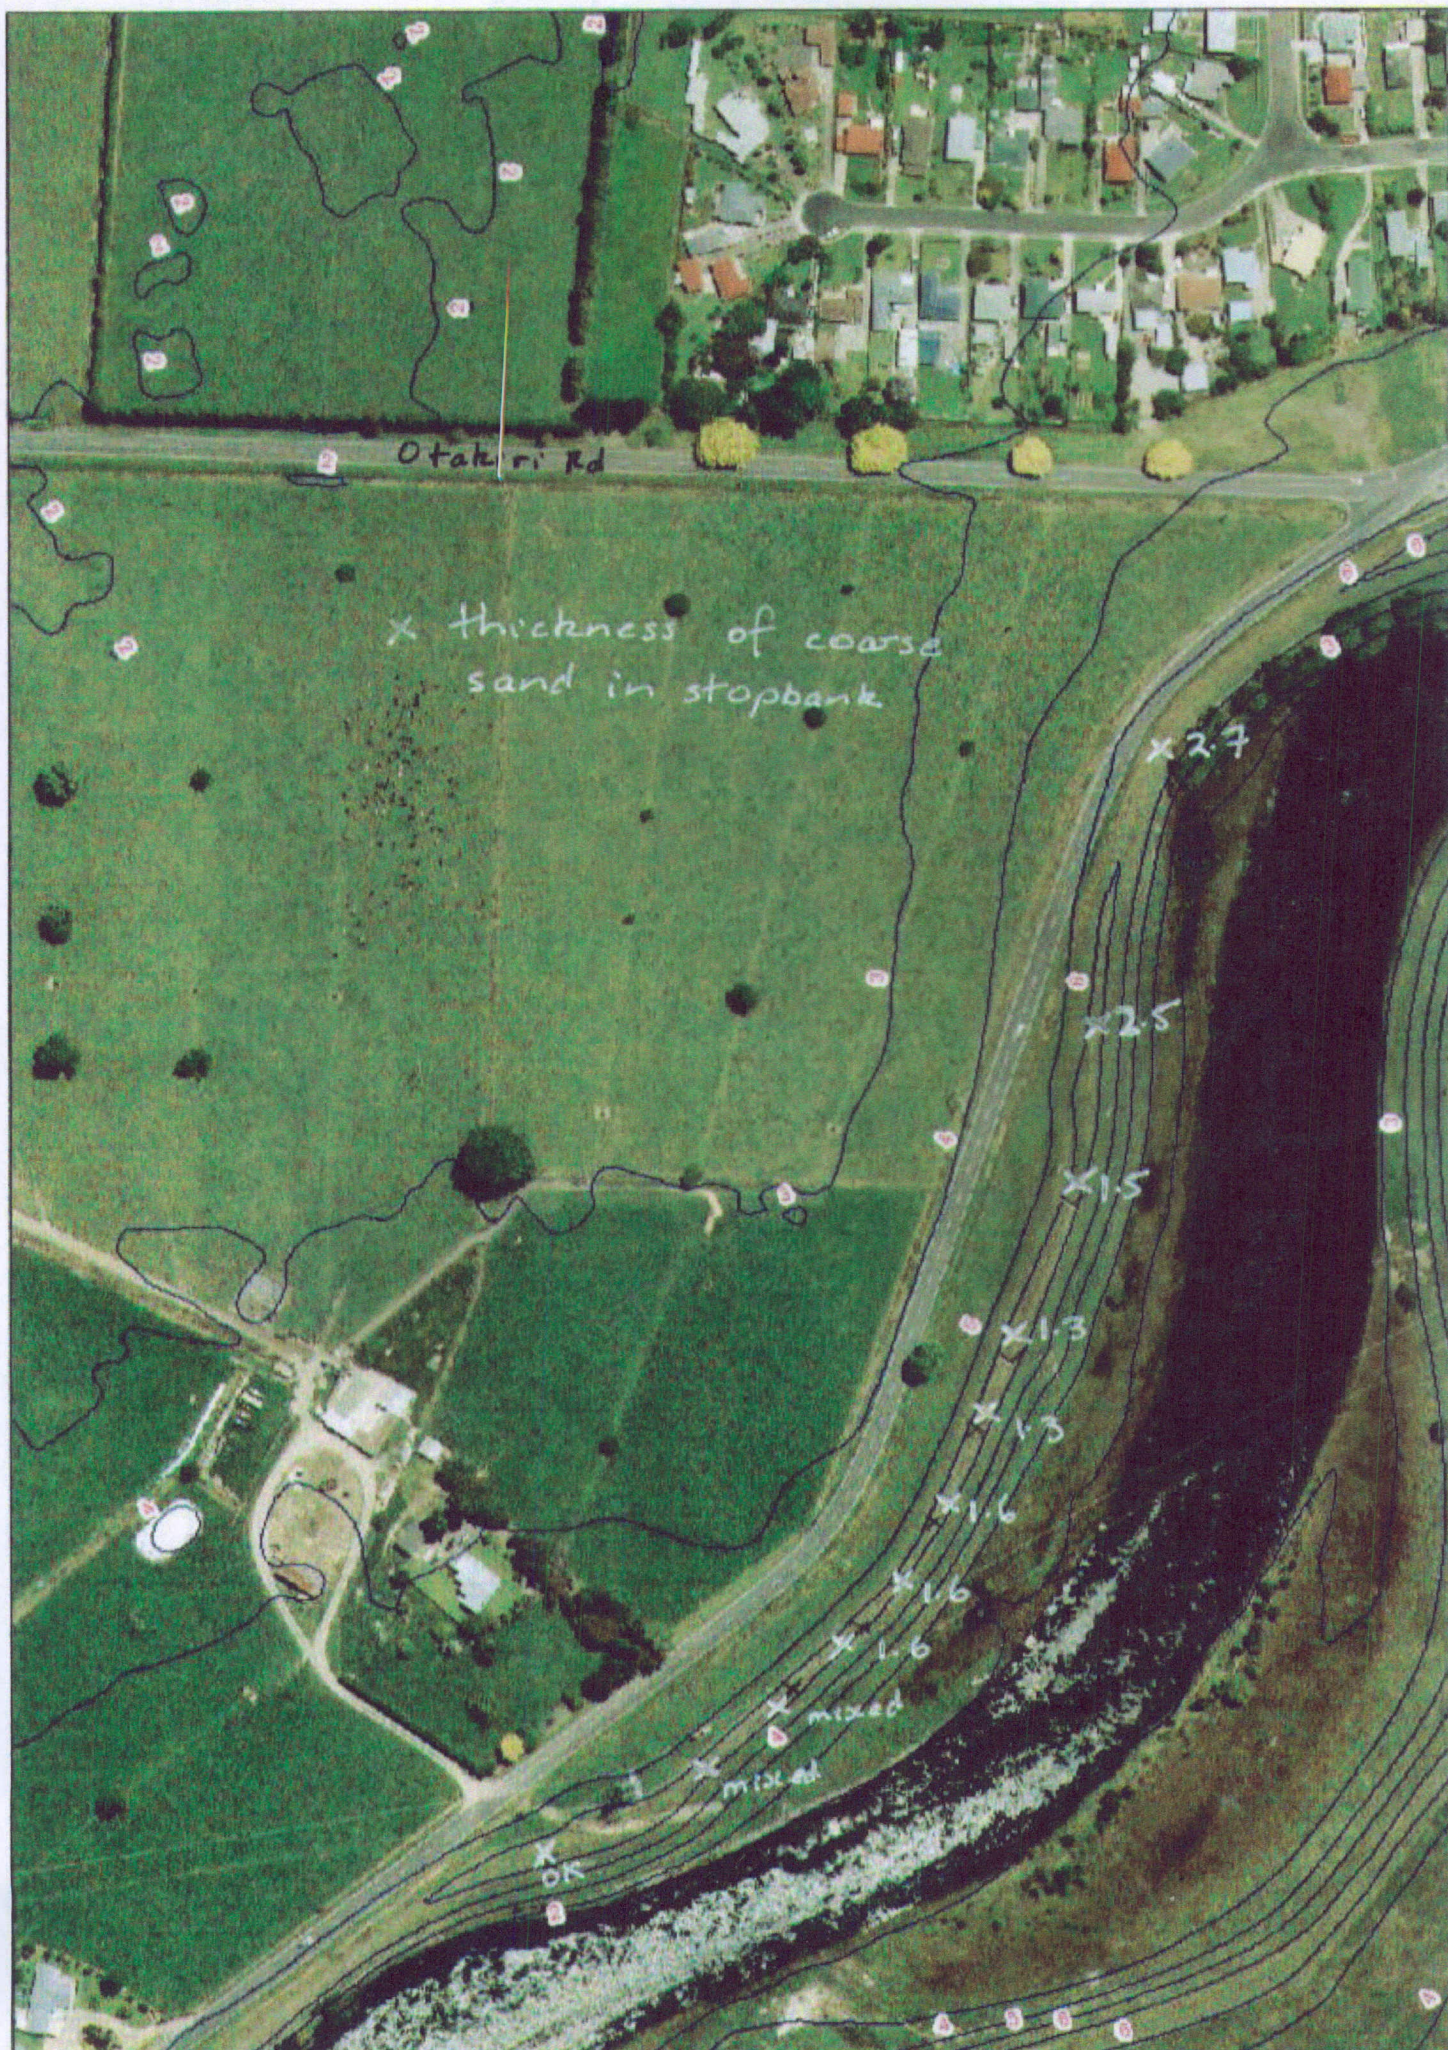
Thickness of coarse sand in stopbank

At Otakiri Road the coarse sand layer was found to be up to 2.7m thick (the stopbank at this point is about 3.5m high). It is thought that the coarse layer was placed soon after the Edgecumbe Earthquake to reinstate the stopbank levels after this area settled by about 2.05m. At Black's Bend the coarse sand was typically 2.5m thick and upstream it varied from about 1m to 1.8m thick. At the downstream end of Campbell's Bend the thickness of coarse sand increased again to 2.4m, whereas there was no coarse sand at the upstream end. It is possible that due to the lack of river berm, a section of stopbank collapsed into the river during the earthquake and had to be topped up.

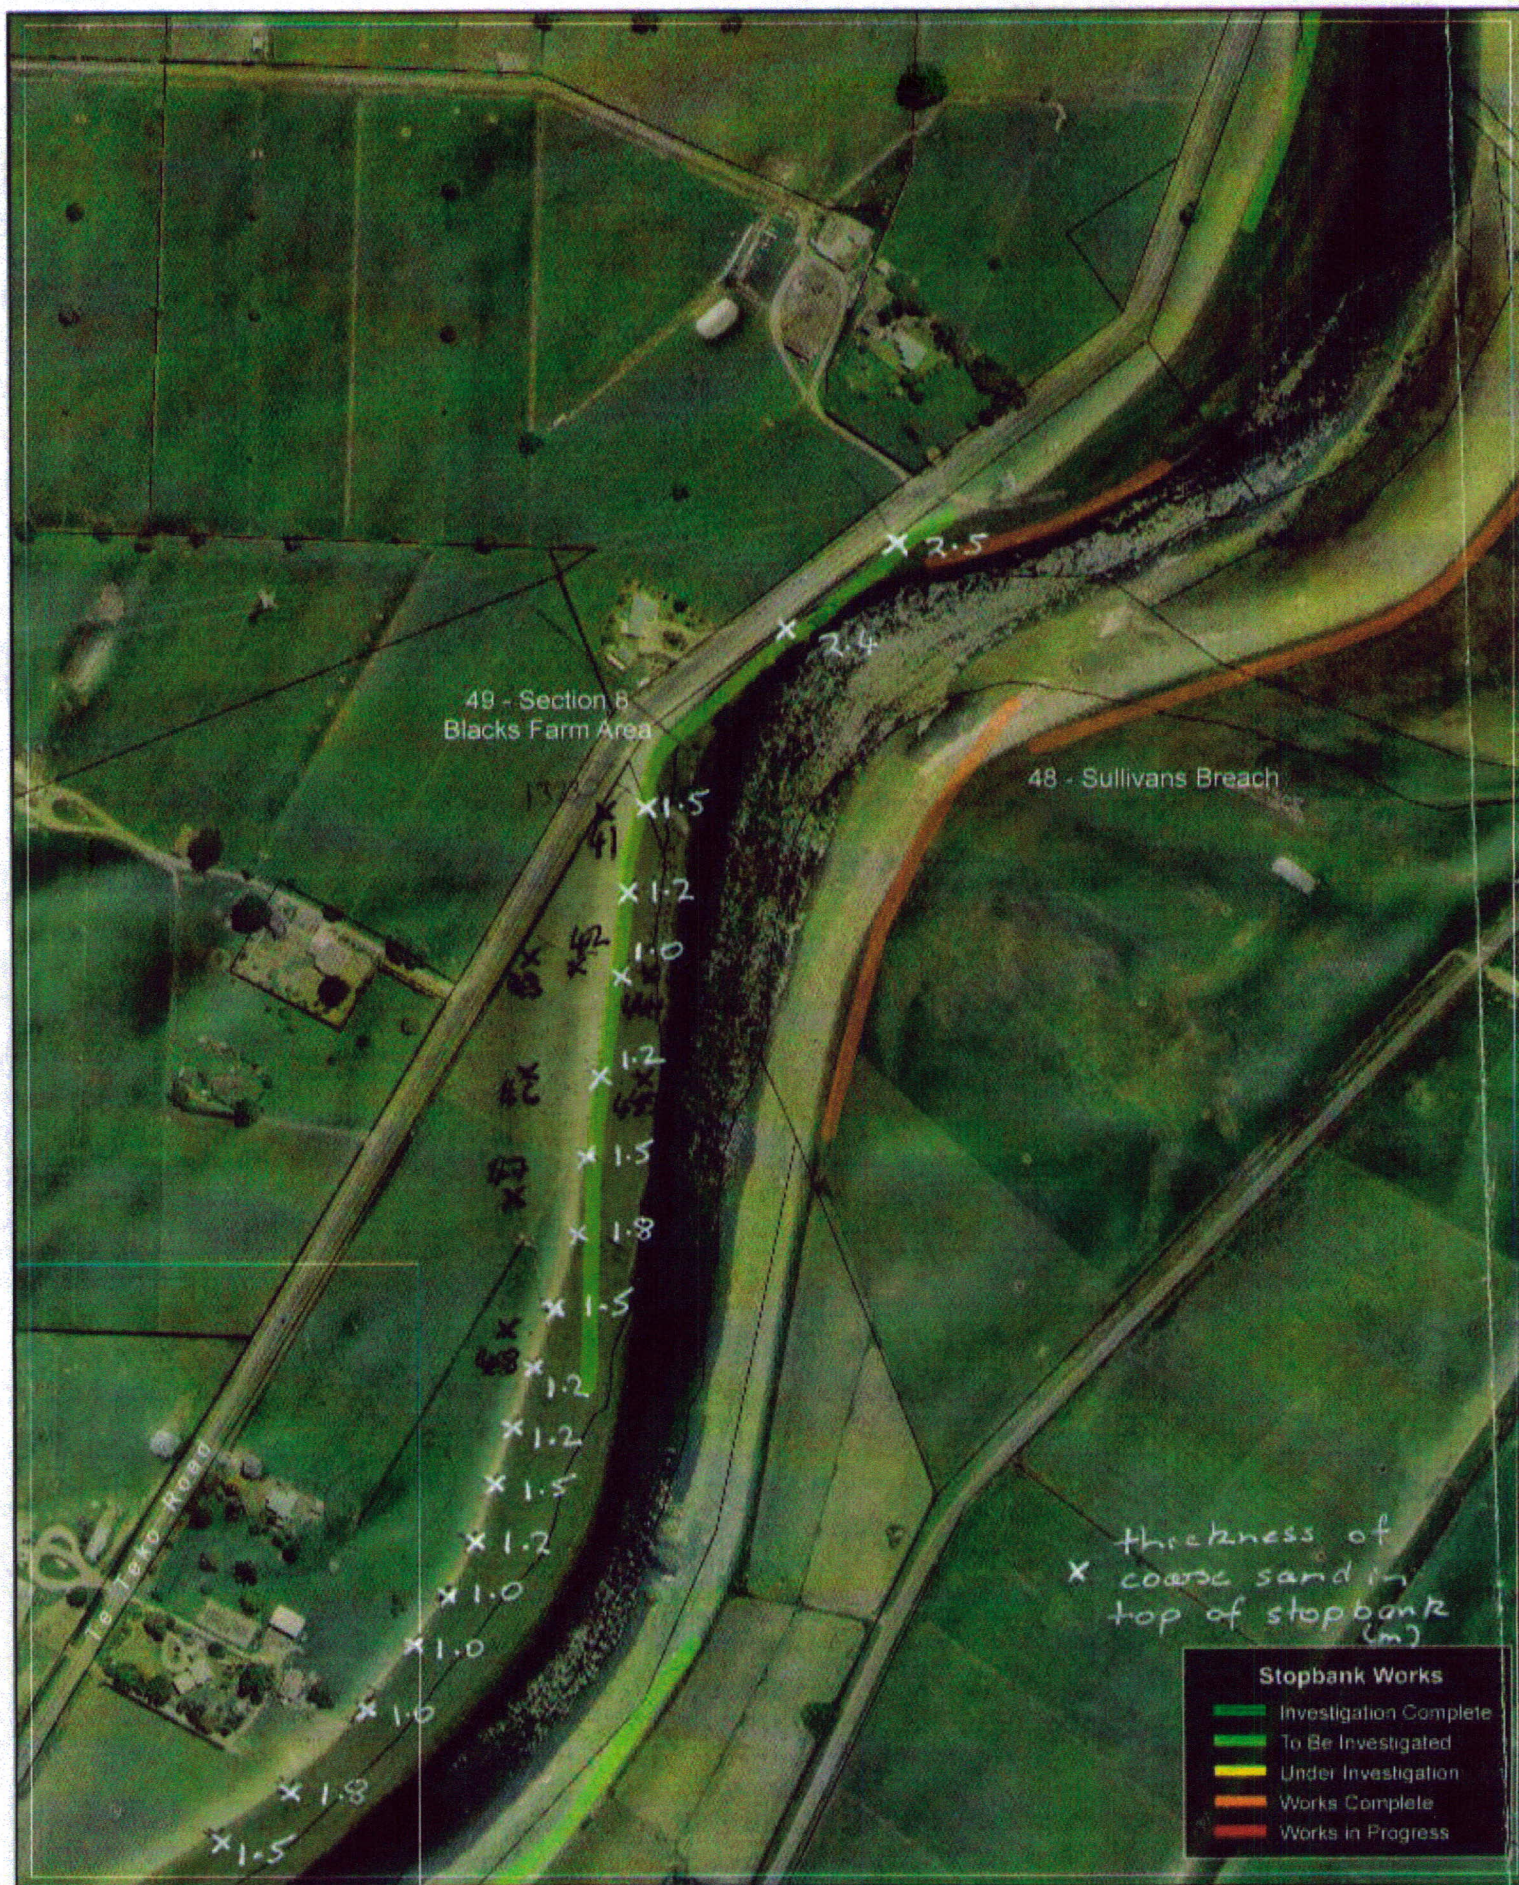
Otakiri Rd Section

The layout of the hand augers carried out at the Otakiri Road Bend and the cross sections interpolated from the subsurface investigations are given in Appendix B. The cross sections show that the levee nearest the stopbank consists predominantly of silty sands and silts, whereas the low lying area consists of silts, clays and peat. In some of the hand augers (Cross Section 4) the black Tarawera Ash layer (coarse sand) was quite distinctive in the surface silts. Elsewhere this ash had been mixed in by ploughing. A medium to coarse pumice sand layer up to about 200mm thick was found above fibrous peat in the investigations below RL1.0. Fine pumice lapilli were found at most locations below RL0. The thickness of this layer was considered critical in the stopbank seepage analysis.

The three augers carried out in the river berm showed silty fine sands overlying coarser sands and lapilli. It is possible that the clayey silts and peat originally found at a similar level on the landward side of the stopbank have been eroded out during floods and replaced by more recent sediment. One of the silty fine sand layers exposed on the river side of the stopbank is particularly light and is favoured by rabbits for their burrows.

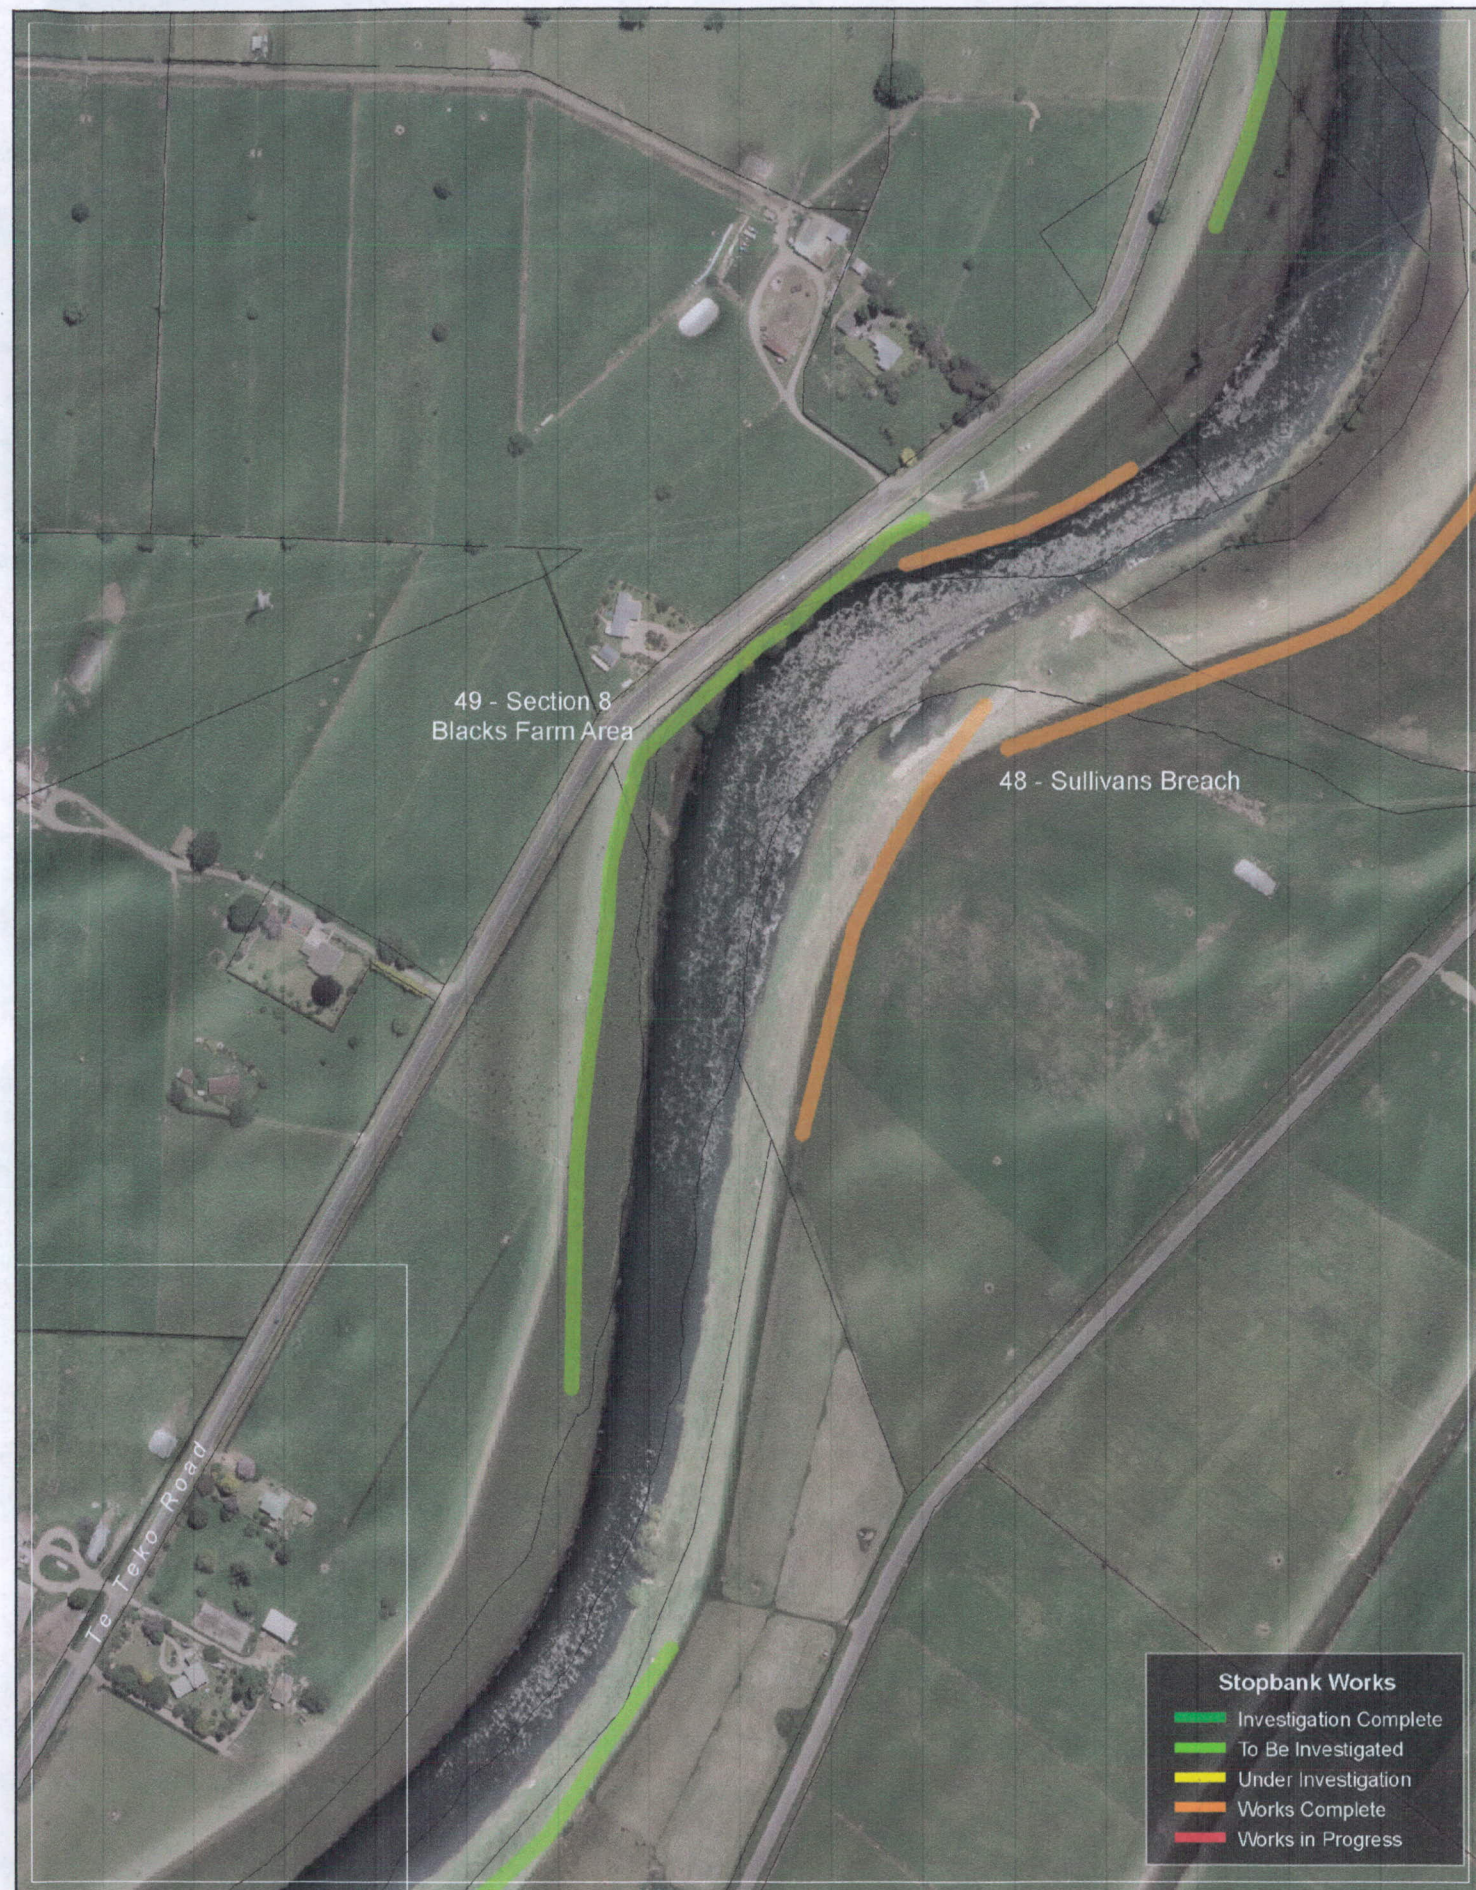
Black's Bend Hand Augers

The layout of the in situ investigations at Black's Bend is shown in Appendix C. The borehole was drilled close to Hand Auger 3. The soils found are similar to those at the Otakiri Road Section except more silty fine sands were found due to the river levee here being broader and less steep than at Otakiri Road. This can be seen in the LIDAR plot included in Appendix C. Similarly less organic material was found within the depth of the hand investigations. Where the peat and overlying coarse sand layers were found, they are at about the same RL as further downstream.

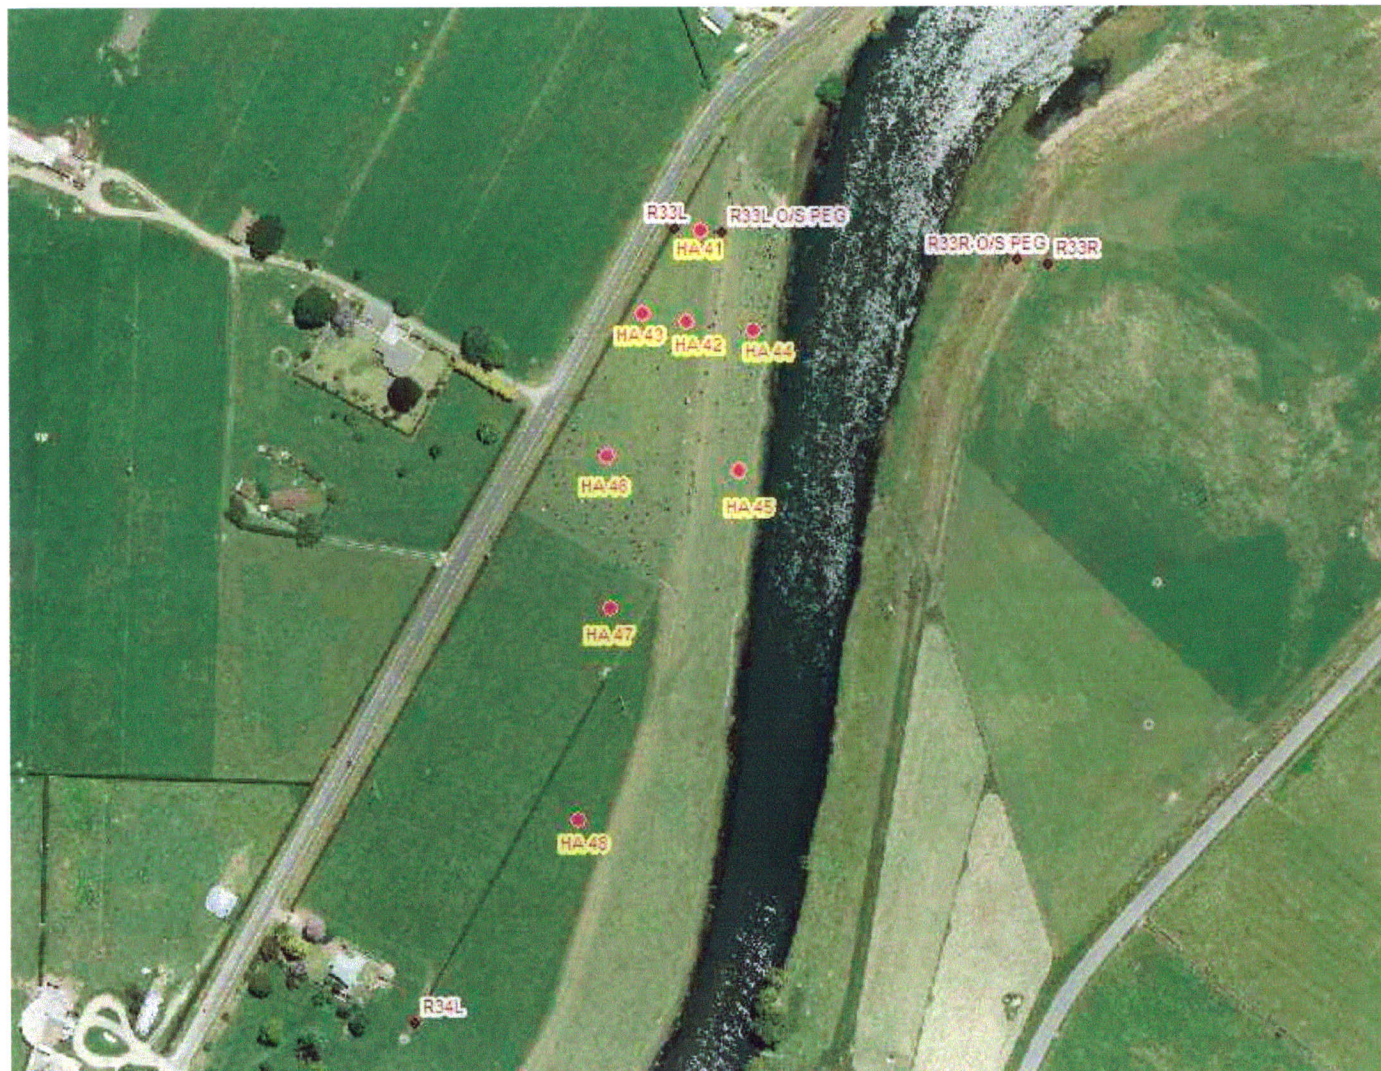
Campbell's Straight Hand Augers

Coarse sand was found at between 1.7 and 2.5m depth in the old river bed. This is underlain by pumice lapilli at between 2.8 and 3.7m depth. The coarse sand is overlain by the very light fine sand and silty fine sand that the rabbits were burrowing into. Little correlation in soil layers was found between augers on the inside and the outside of the stopbank. The river berm consists predominantly of silty fine sand. Extensive layers of coarse sand and lapilli were found below RL 0 in the borehole. These layers were interleaved with layers of pumiceous silt and below RL-5 some organic rich clay.

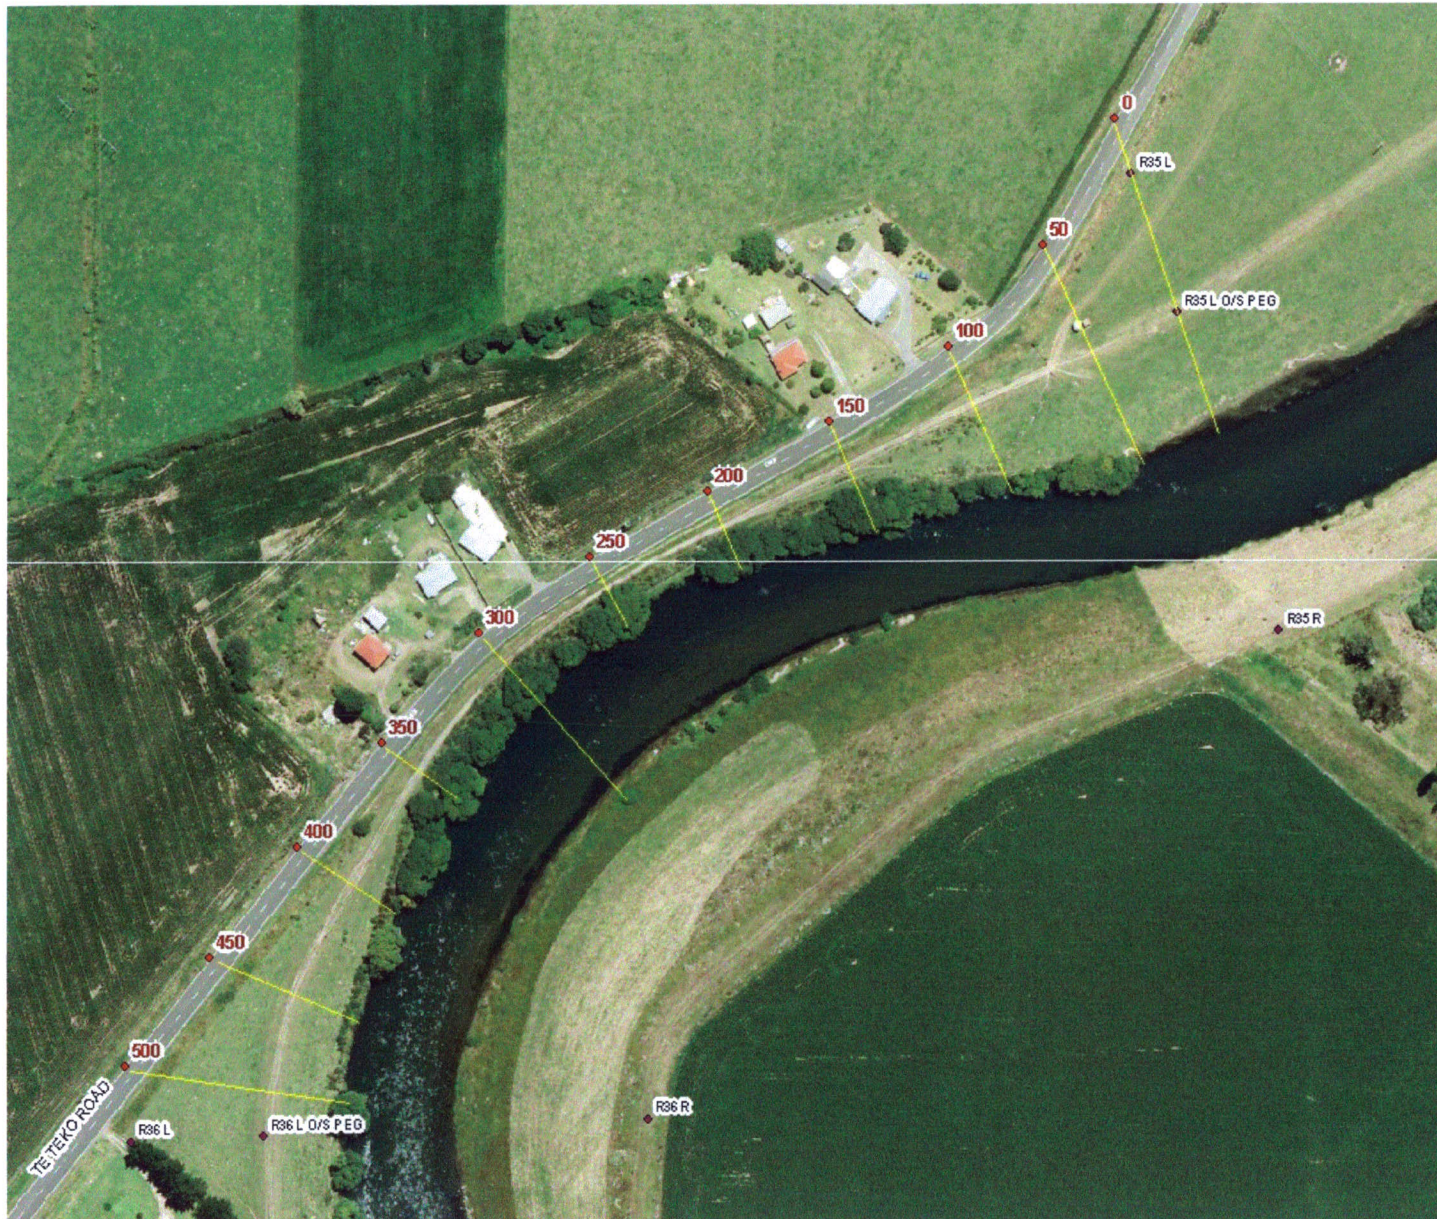
At Campbell's Bend the river bank was covered in vegetation which was hiding the lack of a river berm and the failures within the river bank. Appendix E includes five cross sections through the stopbank that show about 150m of very steep river bank from Cross Sections 2 to 4. Eleven hand augers were carried out along these five cross sections as shown on the plan. A deep borehole was carried out through the stopbank at Cross Section 3, which was considered to have the most critical subsurface soil profile.
