Review of the Flood Carrying Capacity of the Rangitaiki River Below Edgecumbe

Report prepared by P L Blackwood, Manager Technical Services

Environment B O P
Quay Street
P O Box 364
Whakatane
NEW ZEALAND

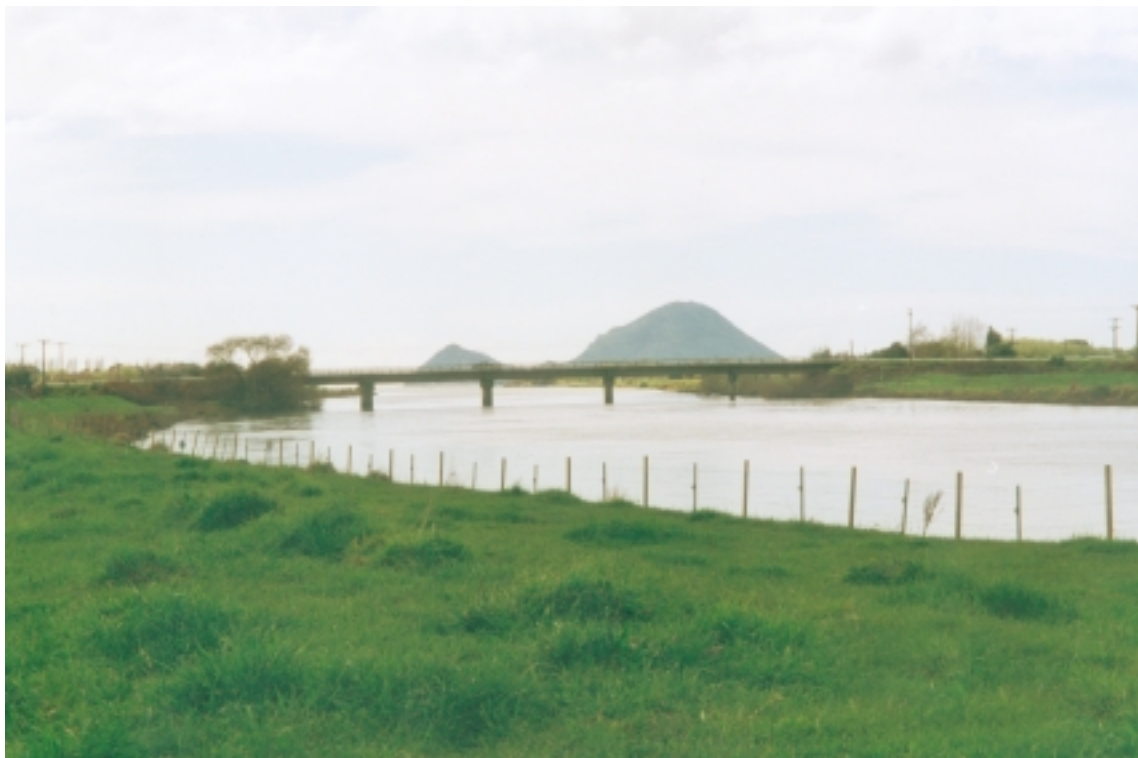
Figure 8 Thornton Bridge

The observed flood level of 2.64 m at cross-section number 6 cannot be matched unless a very high resistance value (far outside the range of those in that reach of river) is applied. Possibly the value is erroneous, or it is due to the hydraulic restriction imposed by the Thornton Bridge. This restriction is reasonably minor (refer to Figure 8) and no significant efflux was observed during the 12 July 1998 flood.

The Thornton Bridge should be explicitly modelled to account for the hydraulic impacts of the abutments and piers. Similarly, at some stages the bridge at
