Geotechnical Report No 2447

# Reids Central Floodway Stopbank Stability Assessment

Environment Bay of Plenty

Date: 14 August 2006  
Reference: 2-89230.00  
Status: Issue 1 - Draft

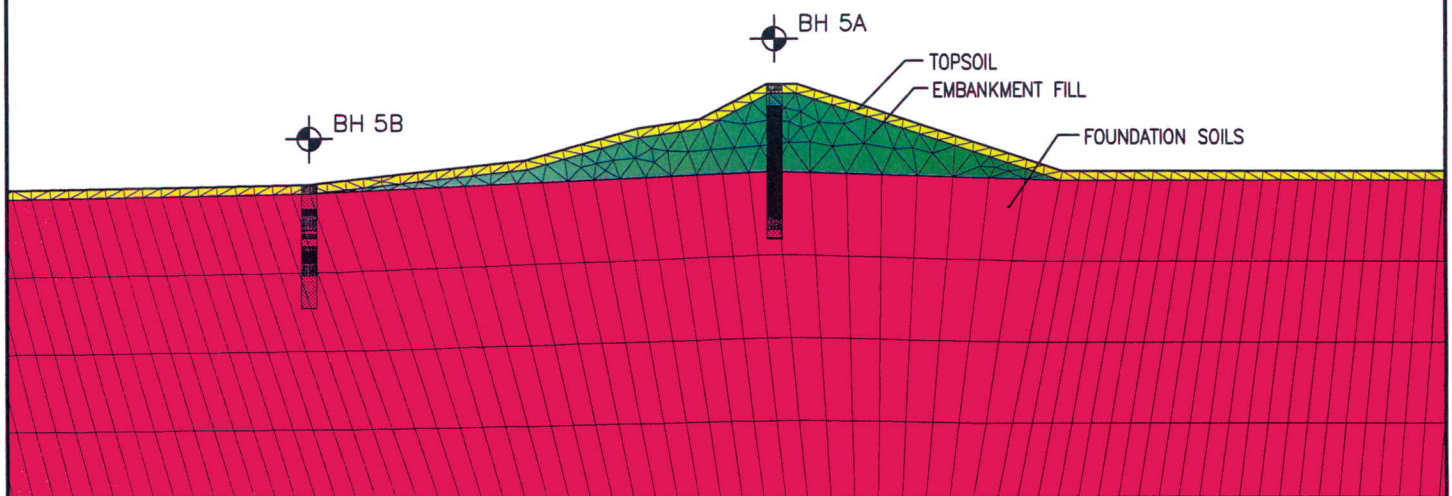
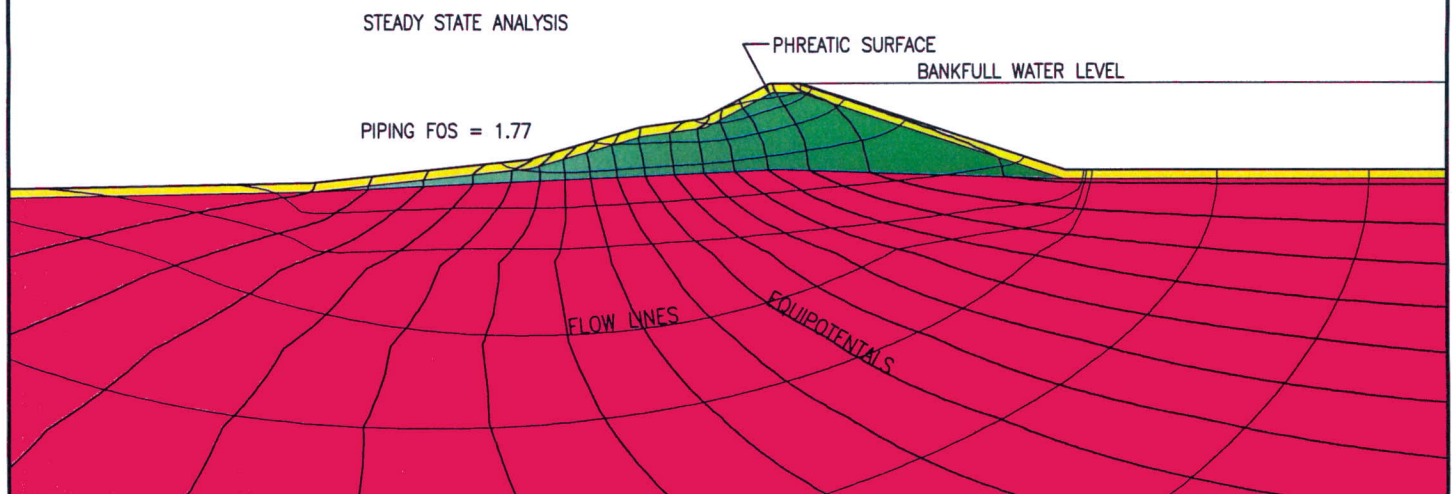
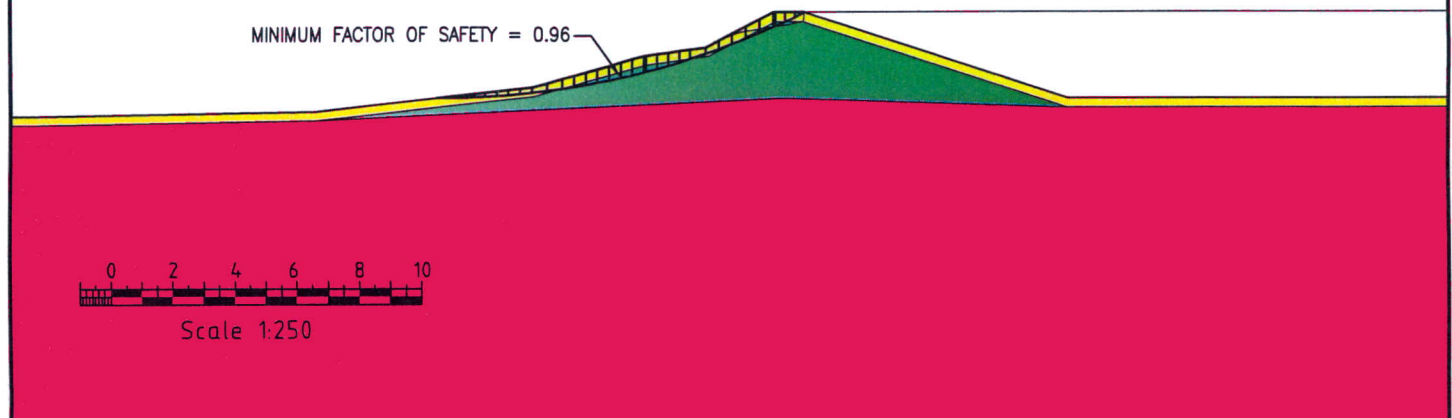
**FIGURE 1**

MORGENSTERN PRICE STABILITY METHOD  
USING POREWATER PRESSURES FROM SEEPAGE MODEL

CROSS SECTION 5  
SEEPAGE AND STABILITY MODELS

Ground surface profiles for the three trial sections were provided by Environment Bay of Plenty, as shown on Figures 1 to 3.

Seepage and slope stability models for the three trial sections are shown in Figures 1 to 3. Results of the modelling are summarised in the following table:

Section	River Level	Stability FoS	Piping FoS
Section 5 3.2H:1V	Bankfull 500mm Freeboard	0.96 1.31	1.77 -
Section 6 4.0H:1V	Bankfull	1.29	1.30
Section 7 10H:1V	Bankfull	4.2	27

Section 7, which has is buttressed by a very flat slope, shows little risk of failure. Section 5 is the highest and steepest of the trial sections. It is unstable at bankfull river levels, but has a reasonable degree of safety when the flood level is 500mm below the crest level.

The analysis did not highlight any stability issues with the trial sections for flood levels up to the top of the bank for Sections 6 and 7. Section 5 can handle flood levels up to 500mm below the crest, but may become unstable in floods up to the crest level. We recommend that future investigations of the stopbanks in the Reids Floodway below Edgumbe should concentrate on the following areas:

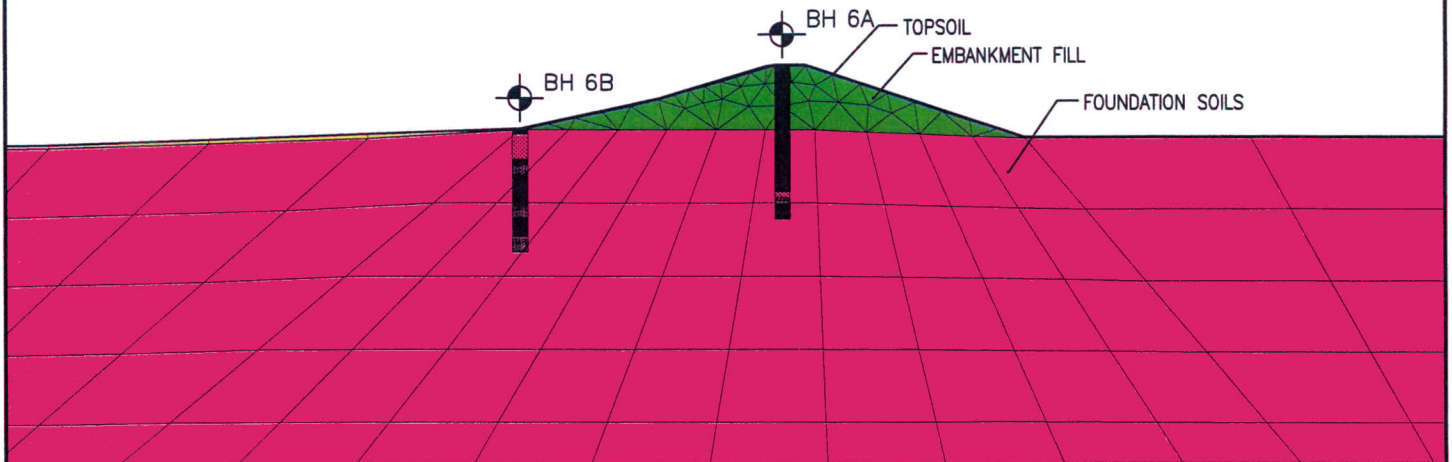
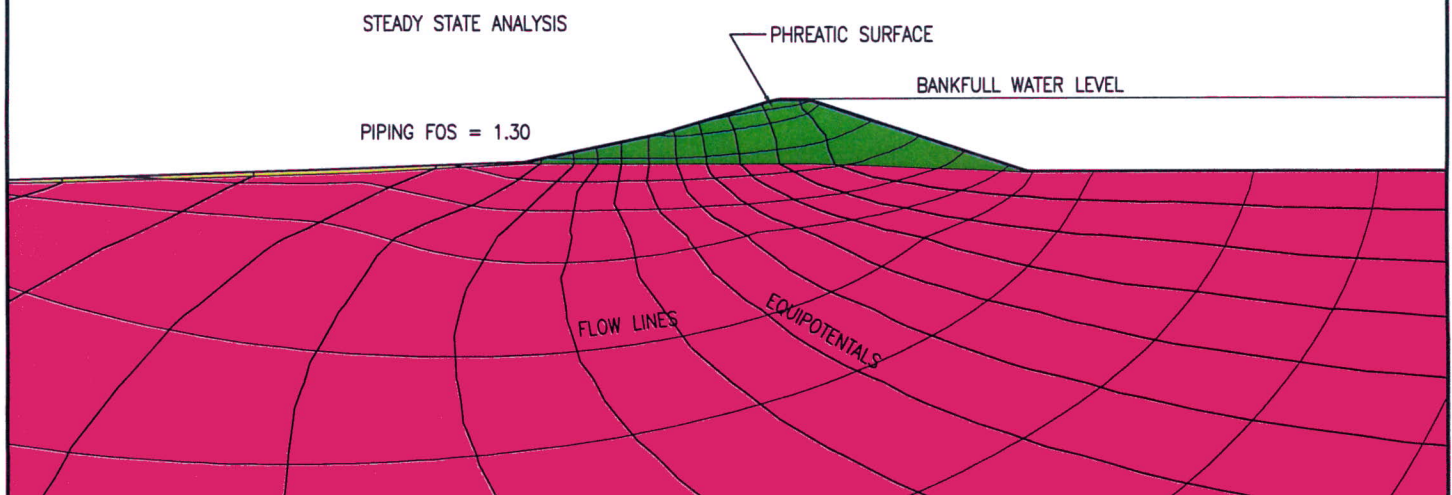
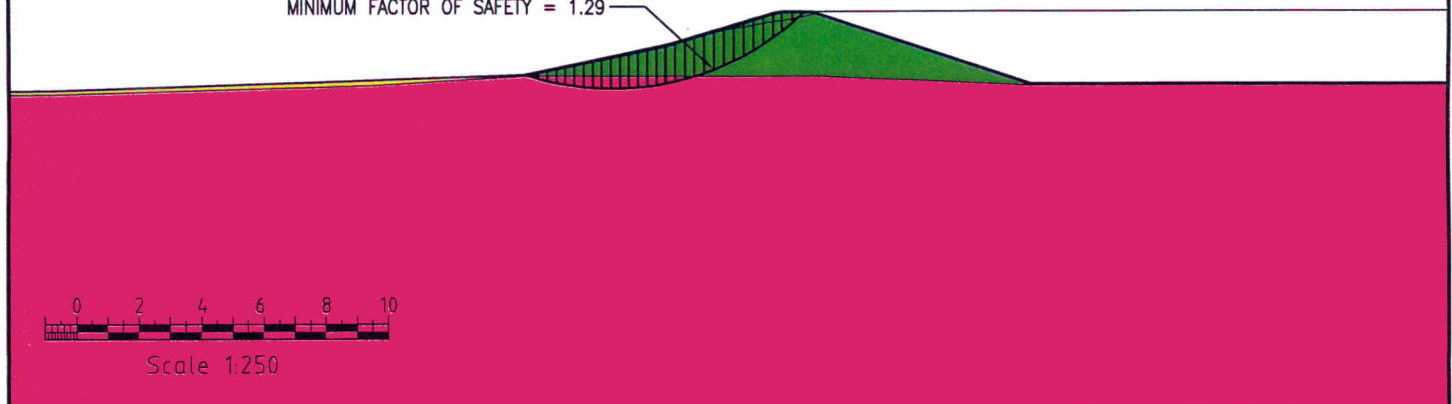
**FIGURE 2**

MORGENSTERN PRICE STABILITY METHOD  
USING POREWATER PRESSURES FROM SEEPAGE MODEL

MINIMUM FACTOR OF SAFETY = 1.29

CROSS SECTION 6  
SEEPAGE AND STABILITY MODELS

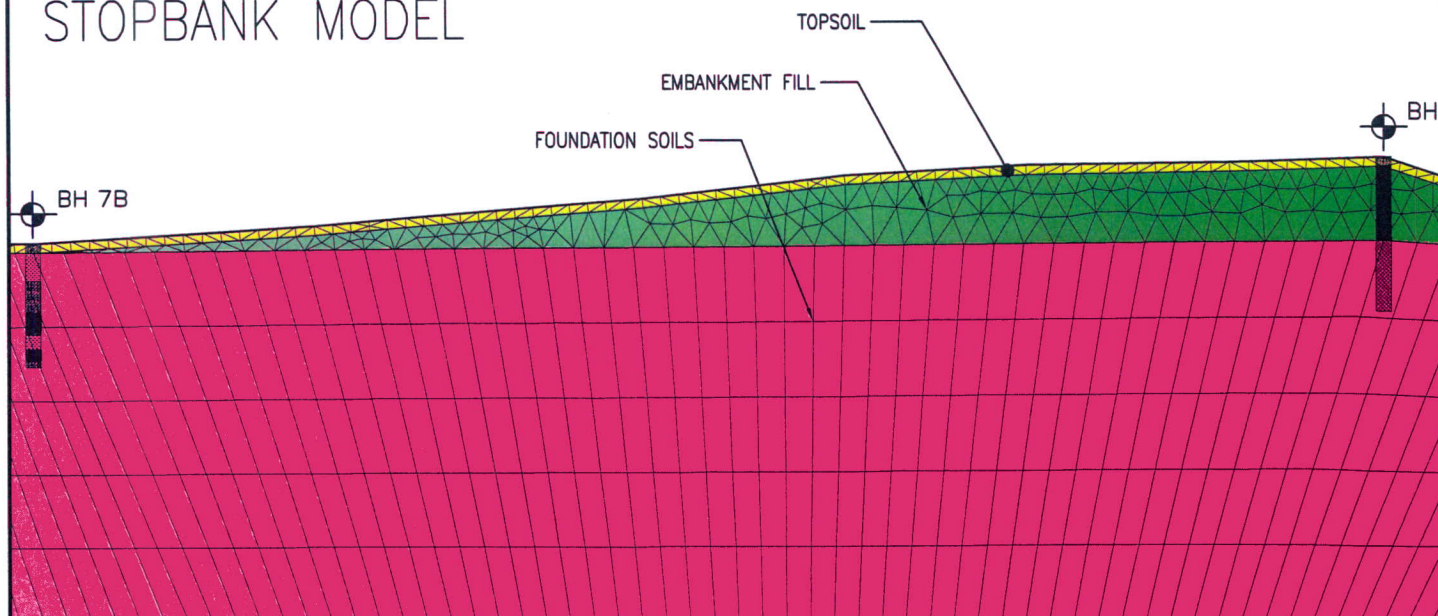
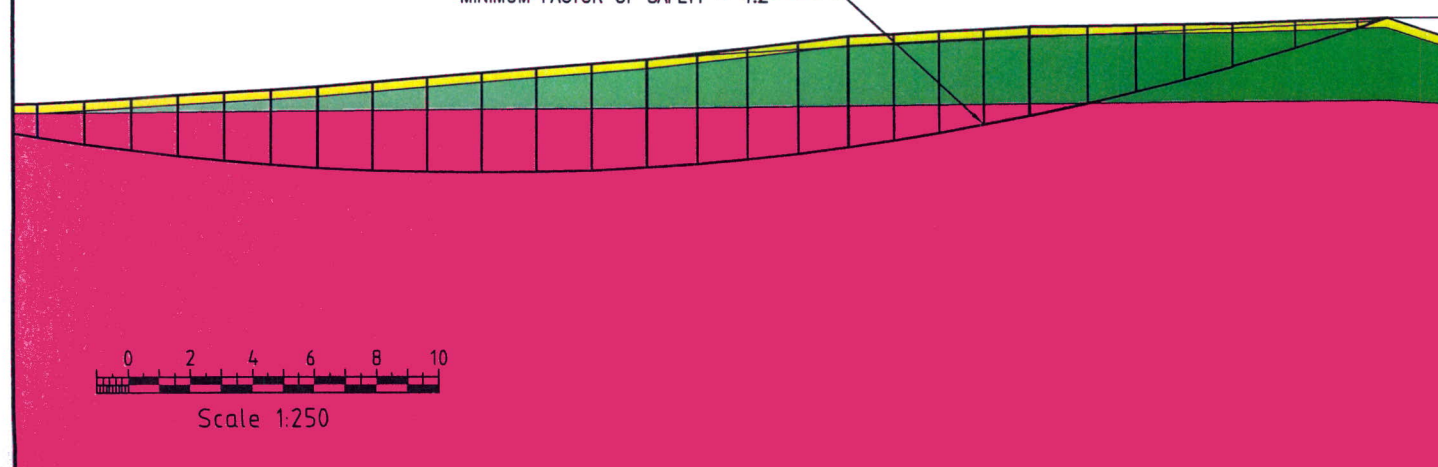
**FIGURE 3**

STEADY STATE ANALYSIS

MORGENSTERN PRICE STABILITY METHOD  
USING POREWATER PRESSURES FROM SEEPAGE MODEL

MINIMUM FACTOR OF SAFETY = 4.2

CROSS SECTION 7  
SEEPAGE AND STABILITY MODELS

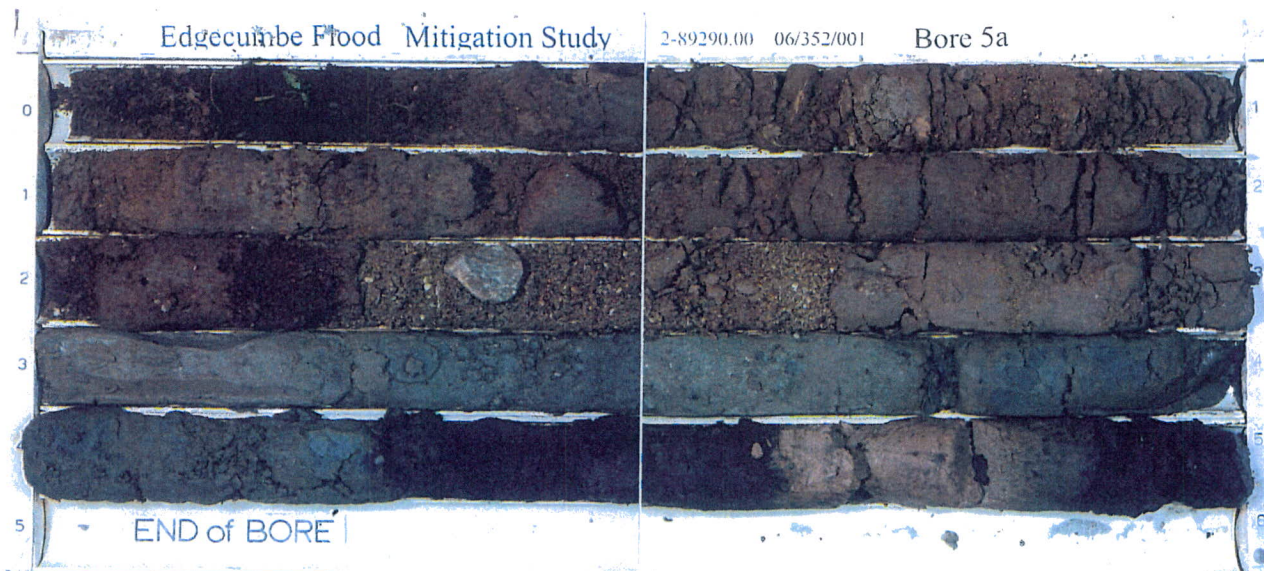
**Borehole Number:** BH5a

Depth	Drilling Method	Casing	Ground Profile		Samples		Additional Lab Tests/Notes	Piezometer Installation
			Description	Graphic Log	Depth/Elev	Type Recovery		
0			Ground Surface		0.00			
			<b>TOPSOIL</b> Brown SILT (TOPSOIL), moist, soft-firm, slightly plastic.					
			<b>Sandy SILT</b> Light brown white flecked very fine Sandy SILT, dry-moist, firm, slightly plastic.		0.20	A 67		
			<b>SAND</b> Grey very fine SAND, dry-moist, "loose", non plastic.		0.70			
			<b>SAND</b> Brown white flecked medium SAND, trace of fine Gravel, dry-moist, "loose", non plastic. Some fine Sand beds at 1.0-1.05, 1.02-1.25, 1.1-1.15, 1.9-1.95		0.80	A 100		
						A 100		
			<b>Silty SAND</b> Brown white flecked Silty SAND, dry-moist, "loose", non plastic.		2.00			
			<b>SAND</b> Grey coarse SAND, some fine-coarse pumice Gravels, "loose", dry-moist, non plastic.		2.25	A 100		
			<b>SAND</b> Grey orange mottled fine Sand, some Silt, trace white flecks, moist-wet, "loose-medium dense", non plastic.		2.80	A 100

A 100		
			<b>Organic SILT</b> Brown organic SILT, slightly fibrous, moist-wet, soft, slightly plastic.		4.30			
			<b>SILT</b> Very light greyish brown SILT, moist-wet, soft, slightly plastic-moderately plastic.		4.70	A 100		
			<b>Organic SILT</b> Brown organic SILT, slightly fibrous, moist-wet, soft, slightly plastic.		4.95			
			End of Log

Descriptions of boreholes in the embankment (BH5a, 6a and 7a) indicate that the stopbank fill is generally fine to medium sand, with some layers of silty soils and a few zones of coarse sand.

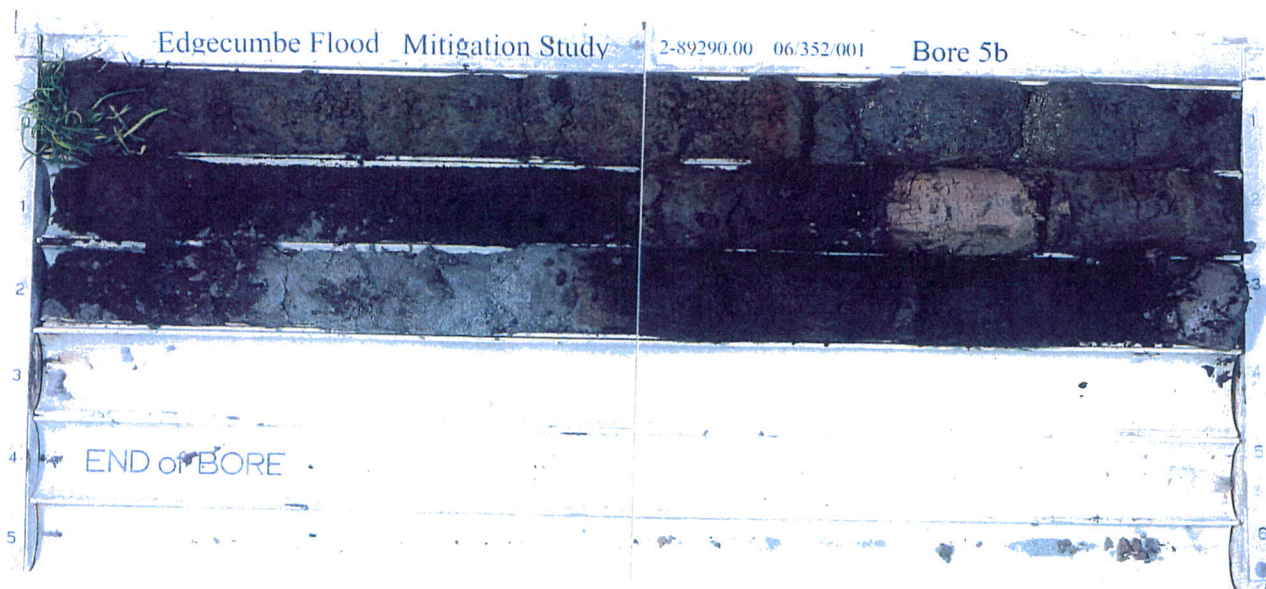
**Borehole Number:** BH5b

Depth	Drilling Method	Casing	Ground Profile		Samples		Additional Lab Tests/Notes	Piezometer Installation
			Description	Graphic Log	Depth/Elev	Type Recovery		
			Ground Surface					
0			<b>TOPSOIL</b> Brown SILT (TOPSOIL), wet, soft, slightly plastic.	x x x	0.00			
			<b>Sandy SILT</b> Grey orange mottled fine Sandy SILT, trace medium-coarse Sand, moist-wet, firm, slightly plastic.	x x x	0.20			
			<b>Sandy SILT</b> Grey orange mottled fine-medium Sandy SILT, trace coarse Sand and fine Gravel, moist-wet, firm, slightly plastic.	x x x	0.37	A 100		
			<b>Silty SAND</b> Grey Silty fine SAND, moist-wet, "loose-medium dense", non plastic.	x x x	0.75			
1			<b>SAND</b> Grey fine-medium SAND, some fine pumiceous Gravels and coarse Sand, saturated, "loose", non plastic.	x x x	1.00	A 100		
			<b>Organic SILT</b> Dark brown organic SILT, wet, soft, slightly plastic-non plastic.	x x x				
			<b>SILT</b> Greyish brown SILT, wet-saturated, soft, slightly plastic.	x x x	1.48

<b>Organic SILT</b> Brown organic SILT, moist-wet, firm, slightly plastic, some fibrous material.	x x x	1.60			
			<b>SILT</b> Greyish brown SILT, wet, very soft, slightly plastic.	x x x	1.75	A 100		
2			<b>Organic SILT</b> Brown organic SILT, moist-wet, firm, slightly plastic, some fibrous material.	x x x	2.00			
			<b>SAND</b> Greyish white medium-coarse SAND, saturated, "loose", non plastic.	x x x	2.15			
			<b>PEAT</b> Dark brown fibrous PEAT, wet, very soft, slightly plastic-non plastic.	x x x	2.55	A 100		
3			<b>Sandy SILT</b> Grey very fine Sandy SILT, some fine-coarse pumice Gravels, wet, firm, slightly plastic.	x x x	2.95			
				x x x		A 0		
				x x x		A 0		
4			End of Log		4.00			
5								
6

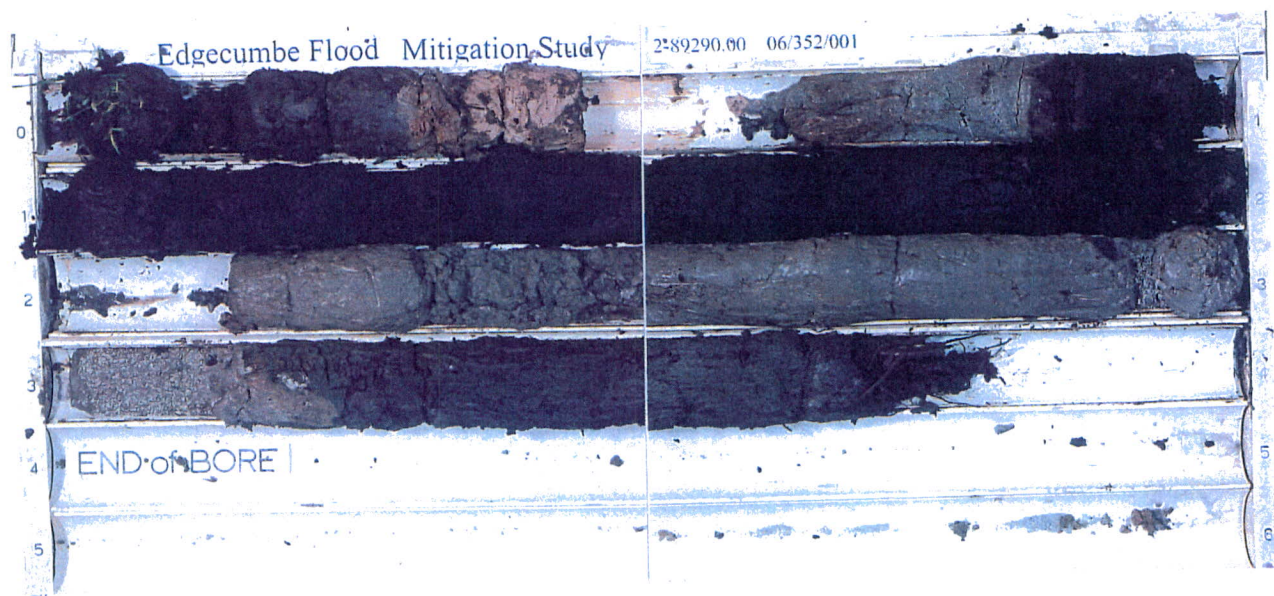
**Borehole Number:** BH5c

Depth	Drilling Method	Casing	Ground Profile		Samples		Additional Lab Tests/Notes	Piezometer Installation
			Description	Graphic Log	Depth/Elev	Type Recovery		
			Ground Surface					
0			<b>TOPSOIL</b> Brown SILT (TOPSOIL), wet, soft, slightly plastic.	x x x x	0.00			
			<b>SILT</b> Brown grey orange mottled SILT, moist-wet, soft, slightly plastic.	x x x x	0.20	A	53	
			<b>SAND</b> Grey medium SAND, trace of fine black flecks, saturated, "loose", non plastic.	x x x x	0.40			
1			<b>PEAT</b> Dark brown PEAT, slightly fibrous, wet, very soft, slightly plastic-non plastic.		1.00	A	87	
						A	73	
2			<b>Silty SAND</b> Grey Silty very fine SAND, some fine pumice Gravels, wet, "loose", slightly plastic-non plastic.	x x x x	2.00	A	100	
				x x x x				
3			<b>SAND</b> Grey medium-coarse pumiceous SAND, saturated, "loose-medium dense", non plastic.	x x x x	2.90			
			<b>Organic SILT</b> Lightish brown organic SILT, some fresh tree root, saturated, very soft, slightly plastic.	x x x x	3.20	A	67

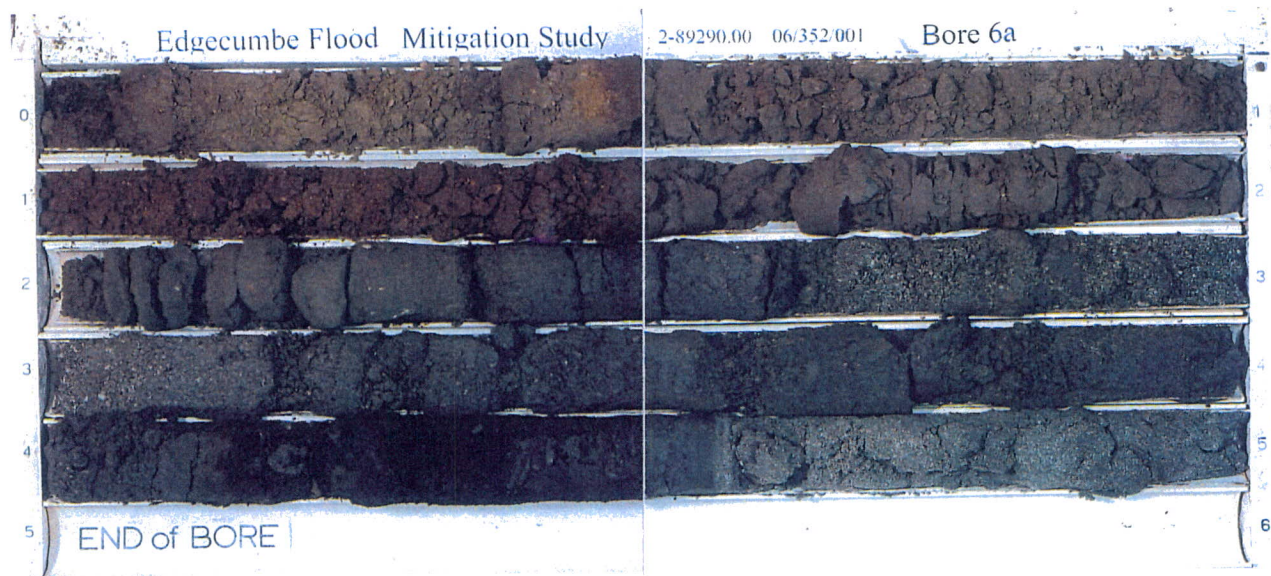
**Borehole Number:** BH6a

Depth	Drilling Method	Casing	Ground Profile		Samples		Additional Lab Tests/Notes	Piezometer Installation
			Description	Graphic Log	Depth/Elev	Type Recovery		
			Ground Surface		0.00			
			<b>TOPSOIL</b> Brown SILT (TOPSOIL), moist, soft, slightly plastic.					
			<b>SAND</b> Light brown very fine SAND, some coarse white Gravel, moist, "medium dense", non plastic. 2cm thick colour change to orange, then as above		0.45	A 100		
1			<b>SAND</b> Brown medium SAND, some Silt, trace fine Gravel, moist, "medium dense", non plastic.		1.00	A 100		
			<b>Silty SAND</b> Brown Silty fine SAND, wet-saturated, "medium dense", non plastic.		1.40			
2			<b>SAND</b> Grey very fine SAND, some Silt, dry-moist, "medium dense", non plastic.		2.00	A 73		
			<b>SAND</b> Grey medium-coarse SAND, some fine pumice Gravel, wet, "loose", non plastic.		2.56	A 100		
3								
			<b>SAND</b> Dark grey fine SAND, moist, "medium dense", non plastic.		3.50

<b>SAND</b> Grey medium-coarse SAND, some fine pumice Gravel, wet, "loose", non plastic.		3.70			
4			<b>SAND</b> Grey medium SAND, some coarse pumice Sand, moist-wet, "medium dense", non plastic.		4.10	A 100		
			<b>SILT</b> Brown organic SILT, moist, firm, slightly plastic.		4.30			
			<b>PEAT</b> Dark brown PEAT, wet, soft, slightly plastic-non plastic.		4.40			
			<b>SILT</b> Brown SILT, moist, soft-firm, slightly plastic.		4.50	A 100		
			<b>SAND</b> Grey pumiceous medium to coarse SAND, "loose", saturated, non plastic.		4.90			
5			Becoming fine SAND					
			End of Log		5.00			
6

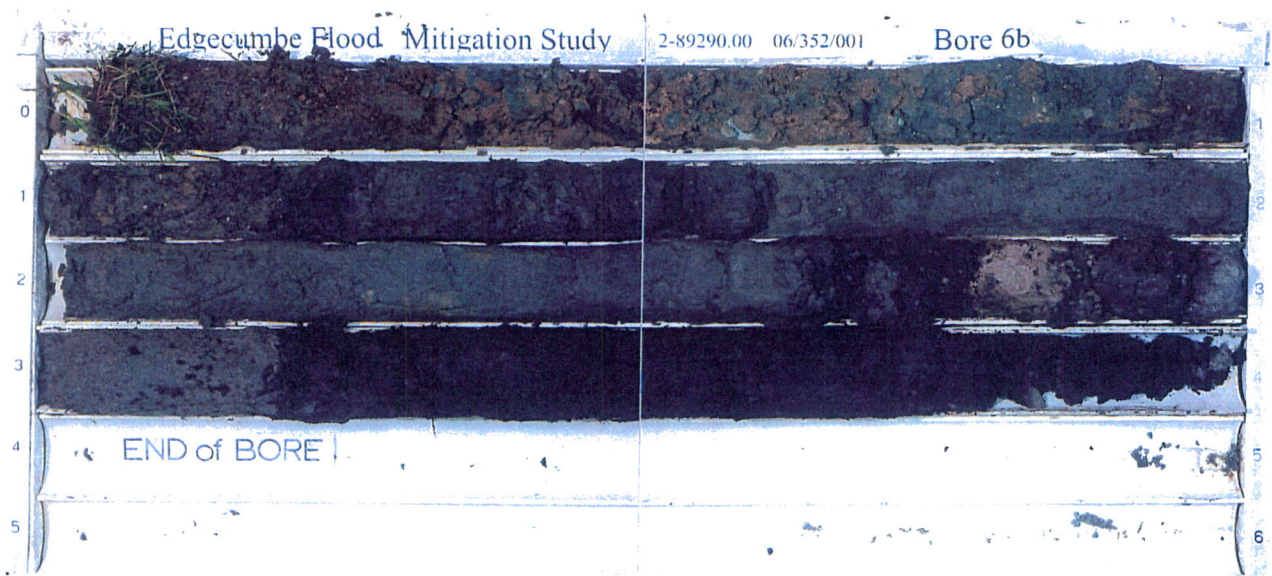
**Borehole Number:** BH6b

Ground Profile				Samples		Additional Lab Tests/Notes	Piezometer Installation
Depth	Drilling Method	Description	Graphic Log	Depth/Elev	Type		
	Casing						
		Ground Surface					
0		<b>TOPSOIL</b> Brown SILT (TOPSOIL), saturated, soft, slightly plastic, some roots.		0.00			
		<b>SAND</b> Grey medium-coarse SAND, wet, "loose", non plastic.		0.22	A	93	
		<b>SILT</b> Brown SILT, wet, soft, slightly plastic.		0.42			
		<b>Sandy SILT</b> Dark grey very fine Sandy SILT, moist, soft, slightly plastic.					
		<b>SILT</b> Brown SILT, wet, soft, slightly plastic.					
1		<b>Sandy SILT</b> Dark grey very fine Sandy SILT, some fine-medium Gravels and orange white clay/silt intrusions, moist, soft, slightly plastic.		1.00	A	100	
		<b>SAND</b> Grey fine-coarse SAND, some white pumice flecks, saturated, "loose", non plastic.		1.20			
		<b>Organic SILT</b> Brown organic SILT, wet, very soft, slightly plastic.		1.45

<b>SILT</b> Brown SILT, some very fine Sand, wet, soft, slightly plastic.			A	80	
2		<b>SAND</b> Grey very fine SAND, "loose", saturated, non plastic.					
		<b>SILT</b> Grey SILT, moist, soft, slightly plastic.		2.50	A	100	
		<b>Organic SILT</b> Brown organic SILT, some sticks, moist, soft, slightly plastic.		2.60			
		<b>SILT</b> Grey brown SILT, moist, firm, slightly plastic.		2.70			
3		<b>Organic SILT</b> Brown organic SILT, some sticks, moist, soft, slightly plastic.		2.80			
		<b>SAND</b> Greyish white fine-medium SAND, saturated, "loose-medium dense", non plastic.		2.90			
		<b>Organic SILT</b> Brown organic SILT, some sticks, moist, soft, slightly plastic.			A	100

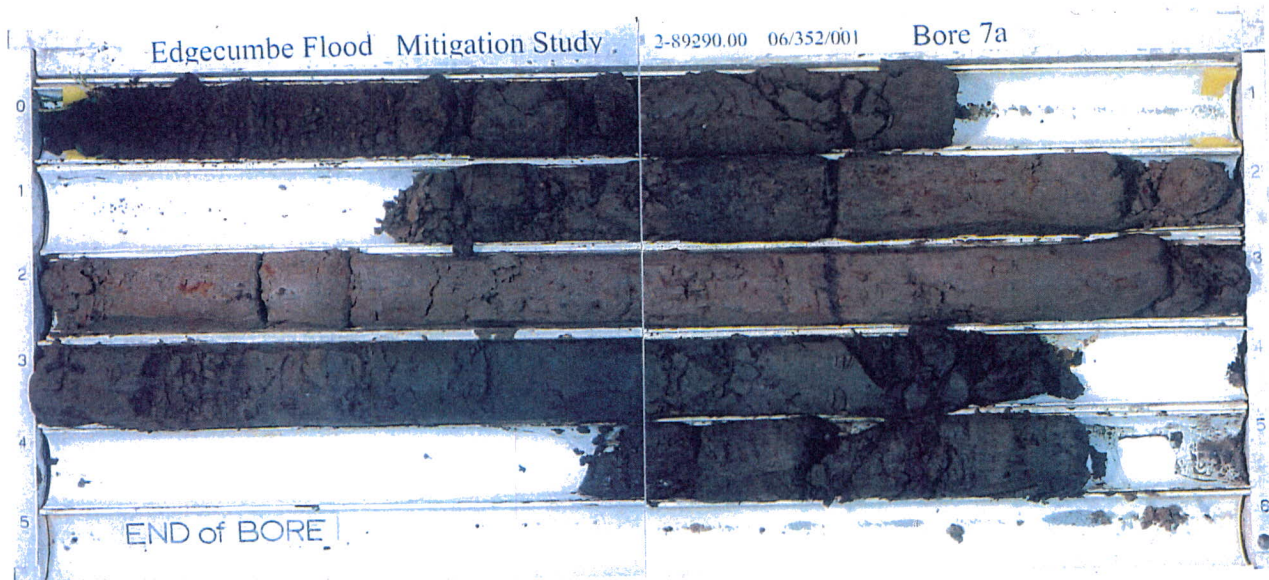
**Borehole Number:** BH7a

Depth	Drilling Method	Casing	Ground Profile		Samples		Additional Lab Tests/Notes	Piezometer Installation
			Description	Graphic Log	Depth/Elev	Type Recovery		
0			Ground Surface					
			<b>TOPSOIL</b> Brown SILT (TOPSOIL), dry-moist, firm, slightly plastic.	x x x x x	0.00			
			<b>SAND</b> Greyish brown orange mottled very fine SAND, trace Silt, dry-moist, "medium dense", non plastic.	x x x x x	0.30	A 93		
1						A 0		
			Becoming brown orange flecked		1.50			
			Becoming greyish brown orange mottled		1.64	A 100		
2								
			No Silt		2.30	A 100		
			<b>Silty SAND</b> Greyish brown orange mottled Silty very fine SAND, dry-moist, "medium dense", non plastic.	x x x x x	2.70			
3			<b>SILT</b> Greyish brown SILT, minor organics, wet, soft, slightly plastic.	x x x x x	2.95			
			Becoming brownish grey.	x x x x x	3.20	A 100		
			<b>Sandy SILT</b> Grey very fine Sandy SILT, wet, firm, slightly plastic-non plastic.	x x x x x	3.38

<b>SILT</b> Greyish brown SILT, minor organics, wet, soft, slightly plastic.	x x x x x	3.70			
4			<b>SILT</b> Grey SILT, some coarse pumice Sand and root material, saturated, soft, slightly plastic.	x x x x x	4.00	A 0		
						A 60		
			Wood material diameter of core barrell and 2cm thick	x x x x x	4.90			
5			End of Log		5.00			
6

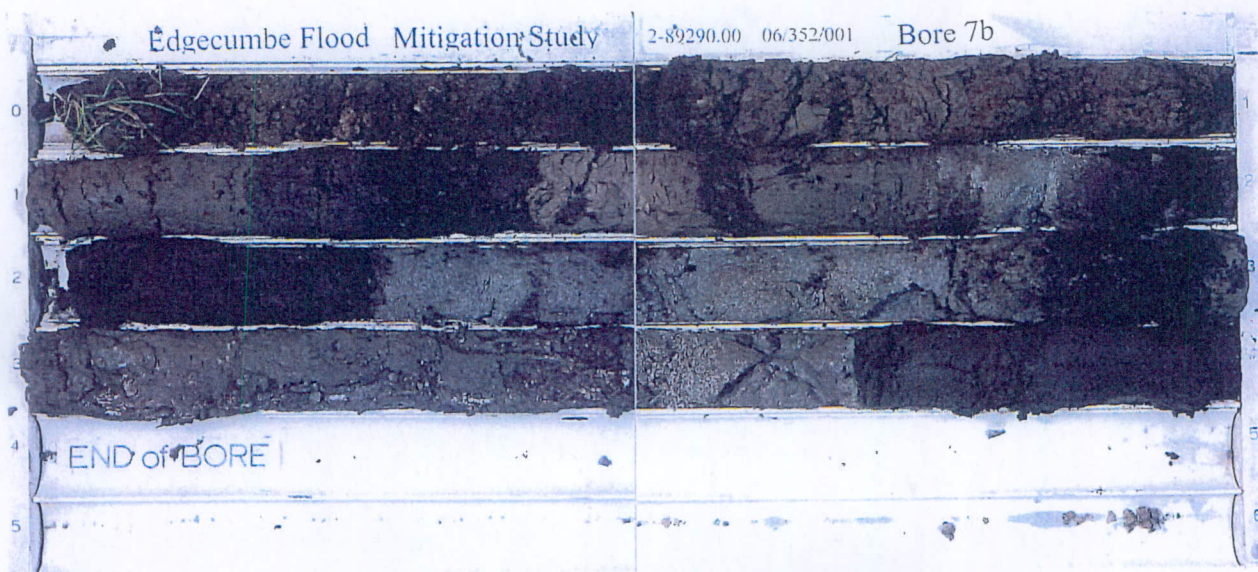
**Borehole Number:** BH7b

Depth	Drilling Method	Casing	Ground Profile			Samples		Additional Lab Tests/Notes	Piezometer Installation
			Description	Graphic Log	Depth/Elev	Type	Recovery		
			Ground Surface						
0			<b>TOPSOIL</b> Brown SILT (TOPSOIL), moist, soft-firm, slightly plastic.		0.00				
			<b>SILT</b> Brown orange mottled SILT, trace coarse SAND, moist, soft, slightly plastic.		0.30	A	67		
			<b>SILT</b> Dark brown SILT, trace coarse Sand, and orange mottles, wet, soft, slightly plastic.		0.55				
			<b>SAND</b> Brown medium-coarse SAND, saturated, "loose", non plastic.						
			<b>SILT</b> Greyish brown orange mottled SILT, moist, soft, slightly plastic.			A	100		
			<b>PEAT</b> Dark brown PEAT, fibrous, wet, very soft, slightly plastic-non plastic.		1.20				
			<b>Sandy SILT</b> Grey very fine Sandy SILT, moist, firm, slightly plastic.		1.50				
			<b>PEAT</b> Dark brown PEAT, fibrous, wet, very soft, slightly plastic-non plastic.		1.60

<b>PEAT</b> Dark brown PEAT, fibrous, wet, very soft, slightly plastic-non plastic.		1.80	A	100		
			<b>SILT</b> Light brown SILT, moist-wet, soft, slightly plastic.		1.95				
			<b>SAND</b> Light greyish white medium SAND, wet, "medium dense", non plastic.		2.25				
			<b>PEAT</b> Dark brown PEAT, fibrous, wet, very soft, slightly plastic-non plastic.			A	100		
			<b>SAND</b> Light greyish white medium SAND, wet, "medium dense", non plastic.						
			<b>PEAT</b> Dark brown PEAT, fibrous, saturated, very soft, slightly plastic-non plastic.		2.85				
			<b>SILT</b> Grey SILT, trace very fine Sand and fine-coarse pumice Gravels, wet-saturated, soft-firm, slightly plastic.		2.95				
			<b>SAND</b> Grey fine SAND, some fine-coarse pumice Gravel, wet, "medium dense", non plastic.		3.40	A	100		
			<b>PEAT</b> Dark brown PEAT, wet, very soft, slightly plastic.		3.80	A	100		
4			End of Log		4.00				
5
