# **Rangitaiki River Stopbanks Assessment**

**63A College Road, Edgecumbe**

**Environment Bay of Plenty**

**Rev A  
July 2006**

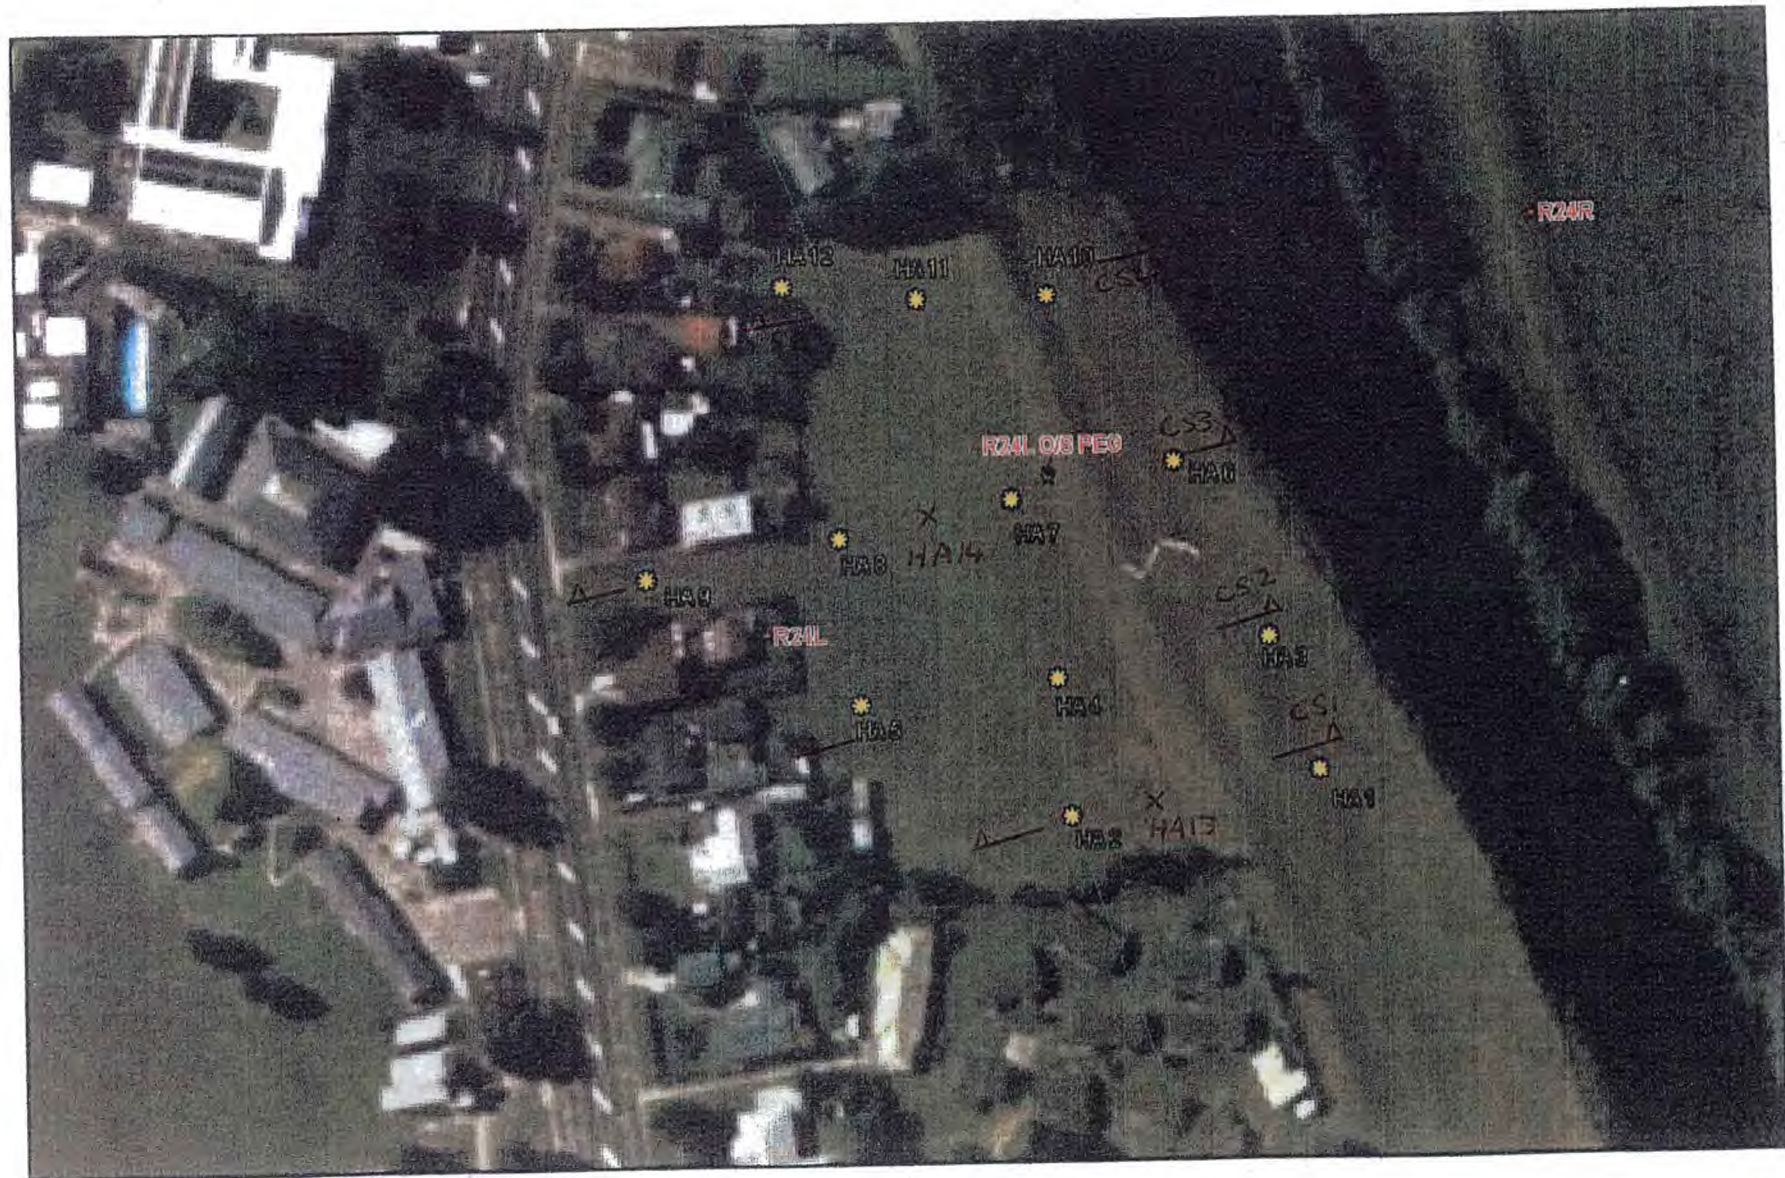
Figure 1

The initial insitu investigations consisted of 12 hand augers arranged in four cross sections as shown in Figure 1. Typically a hand auger was carried out in the river berm, inland from the toe of the stopbank and 40 to 50m further inland. One hand auger was carried out in the access way 85m from the stopbank.

Plan

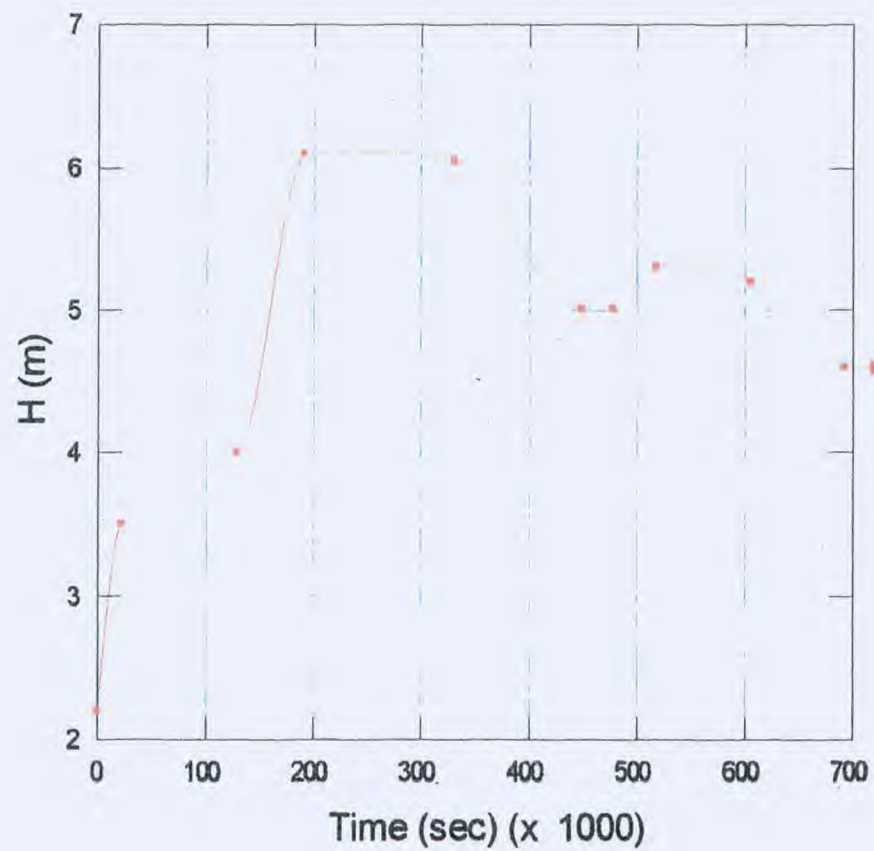
EBoP has provided a 100 year return period flood flow hydrograph for the Rangitaiki River at their benchmark number 24 (Figure 2). This is an eight day hydrograph which rises to a peak of RL6.1 on the third day of the flood.

The top of the stopbank ranges from RL6.4 to 6.6. In the 100 year flood the water level stays close to the peak level for two days before beginning to drop.

100 year flood flow hydrograph

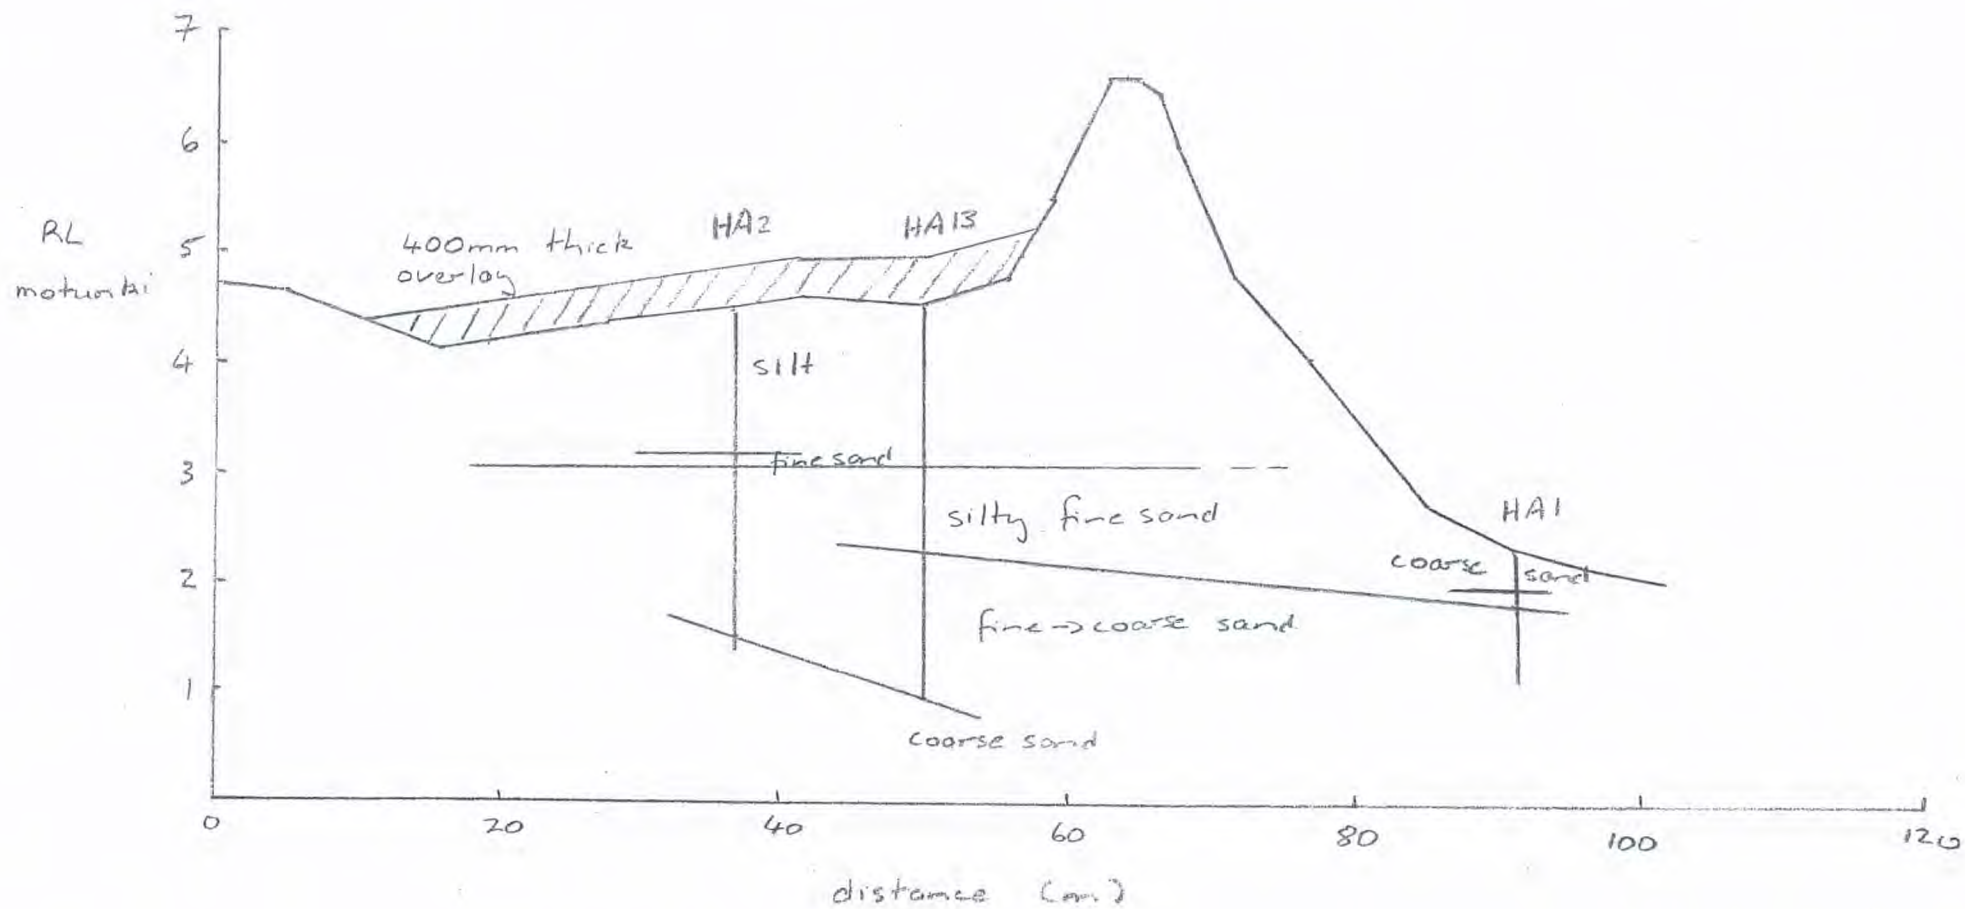
Cross Section 1 is at the upstream end of the property. The upper silt layer was found to be 1.3 to 1.5m thick. High permeability layers are 2.3 to 3.0m deep.

An initial static seepage analysis was carried out assuming a ground water level of RL2.5 on the inland side of the model and a river level of RL2.2. A transient seepage analysis was then carried out modelling the full eight days of the 100 year flood. A two hour time step was used.

An allowance was made in the soil model for seepage from the ground surface inland from the stopbank. Coarse sand was assumed below the depth of the investigations.

The transient flood analysis showed that the factor of safety against uplift would be in the order of 0.9 to 1.0. The high uplift pressures occur over about a 20 hour period during the flood. The maximum hydraulic exit gradient found during the flood was 0.4. The maximum hydraulic gradient considered acceptable in terms of piping potential is 0.4 and this does not allow for any binding effects of surface vegetation. It is therefore considered that there should be no piping problems at this cross section.

An analysis including a 400mm thick overlay inside the stopbank toe produced factors of safety against uplift of 1.15 to 1.2. This overlay needs to be about 40m wide and basically fills in a small depression on the site as shown in Figure 3. The maximum hydraulic exit gradient is reduced to about 0.25.

Cross Section 1

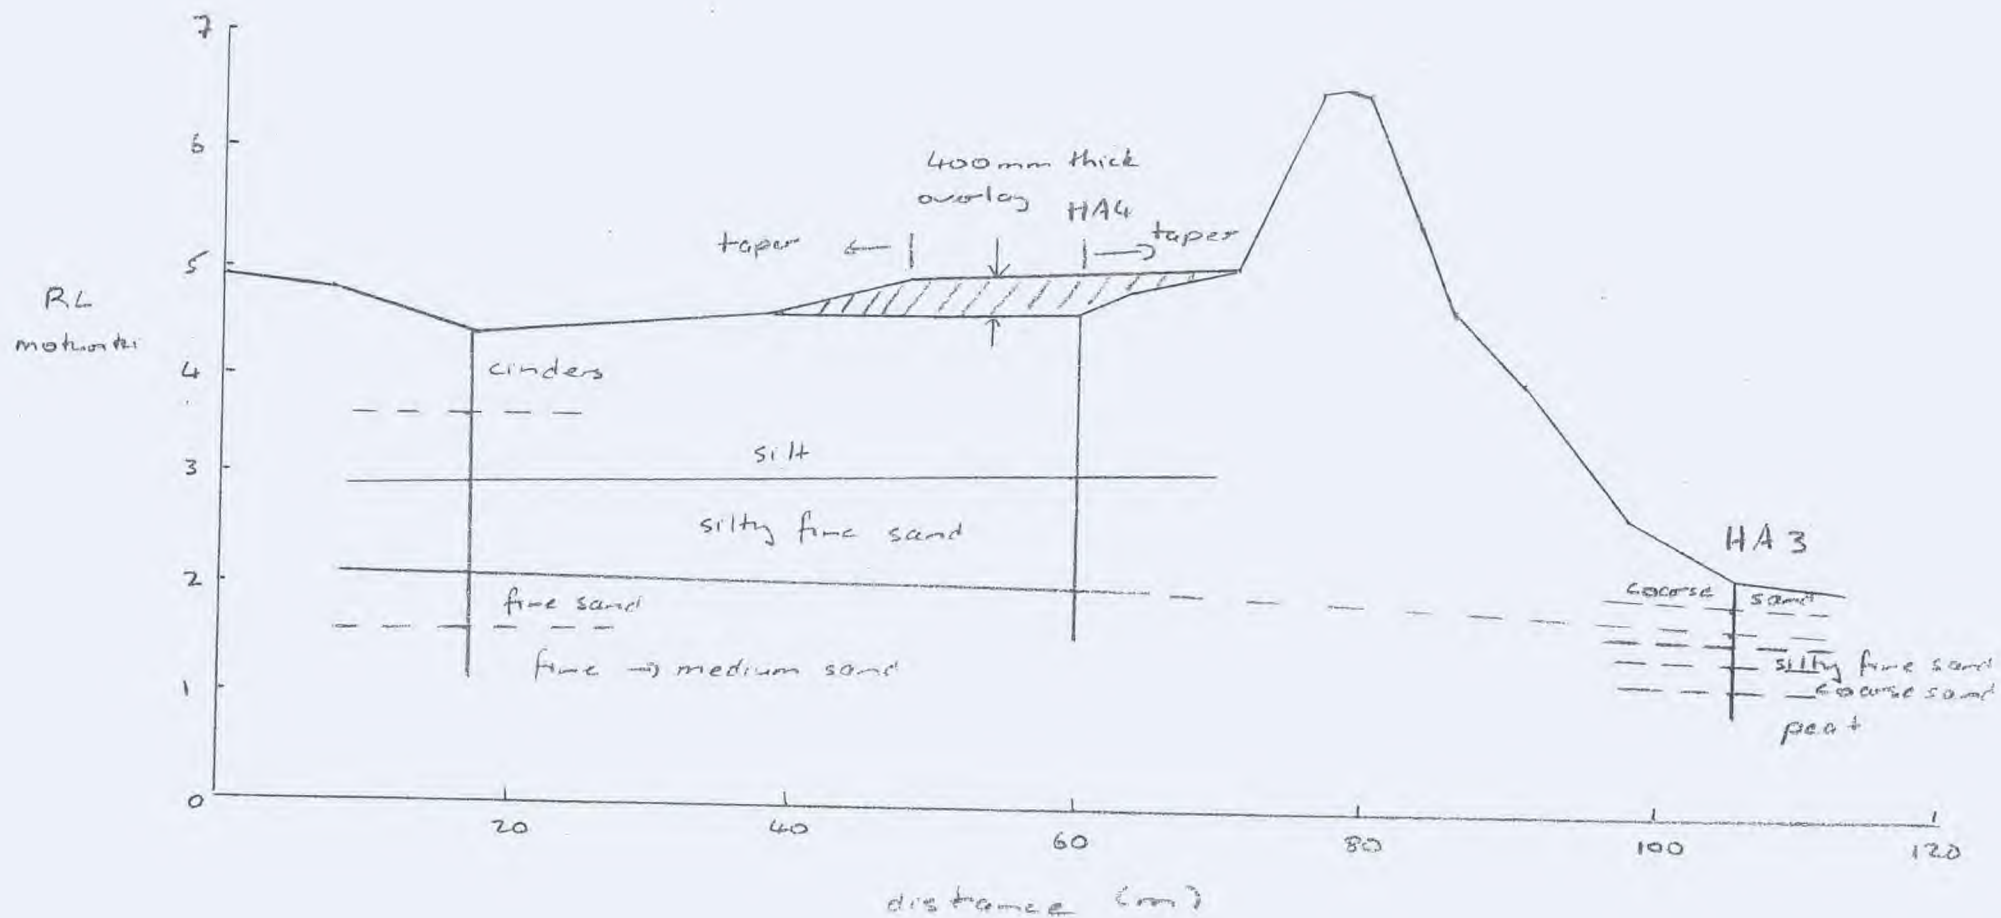
Figure 4

At cross section 2 the upper silt layer is thinner than at cross section 1. A hollow in the area of HA5 has been filled with cinders which were modelled as a fine sand. Coarse sand was found only in HA3 in the river berm above a layer of peat. Coarse sand was assumed to lie below the depth of all the hand augers.

In the transient analysis the factor of safety against uplift was found to be between about 1.0 and 1.1 over a strip 5 to 25m from the inland toe of the stopbank. A 400mm thick overlay placed in this area should increase the factor of safety to 1.2 (Figure 4). The maximum high hydraulic exit gradient was found to be 0.18.

Cross Section 2

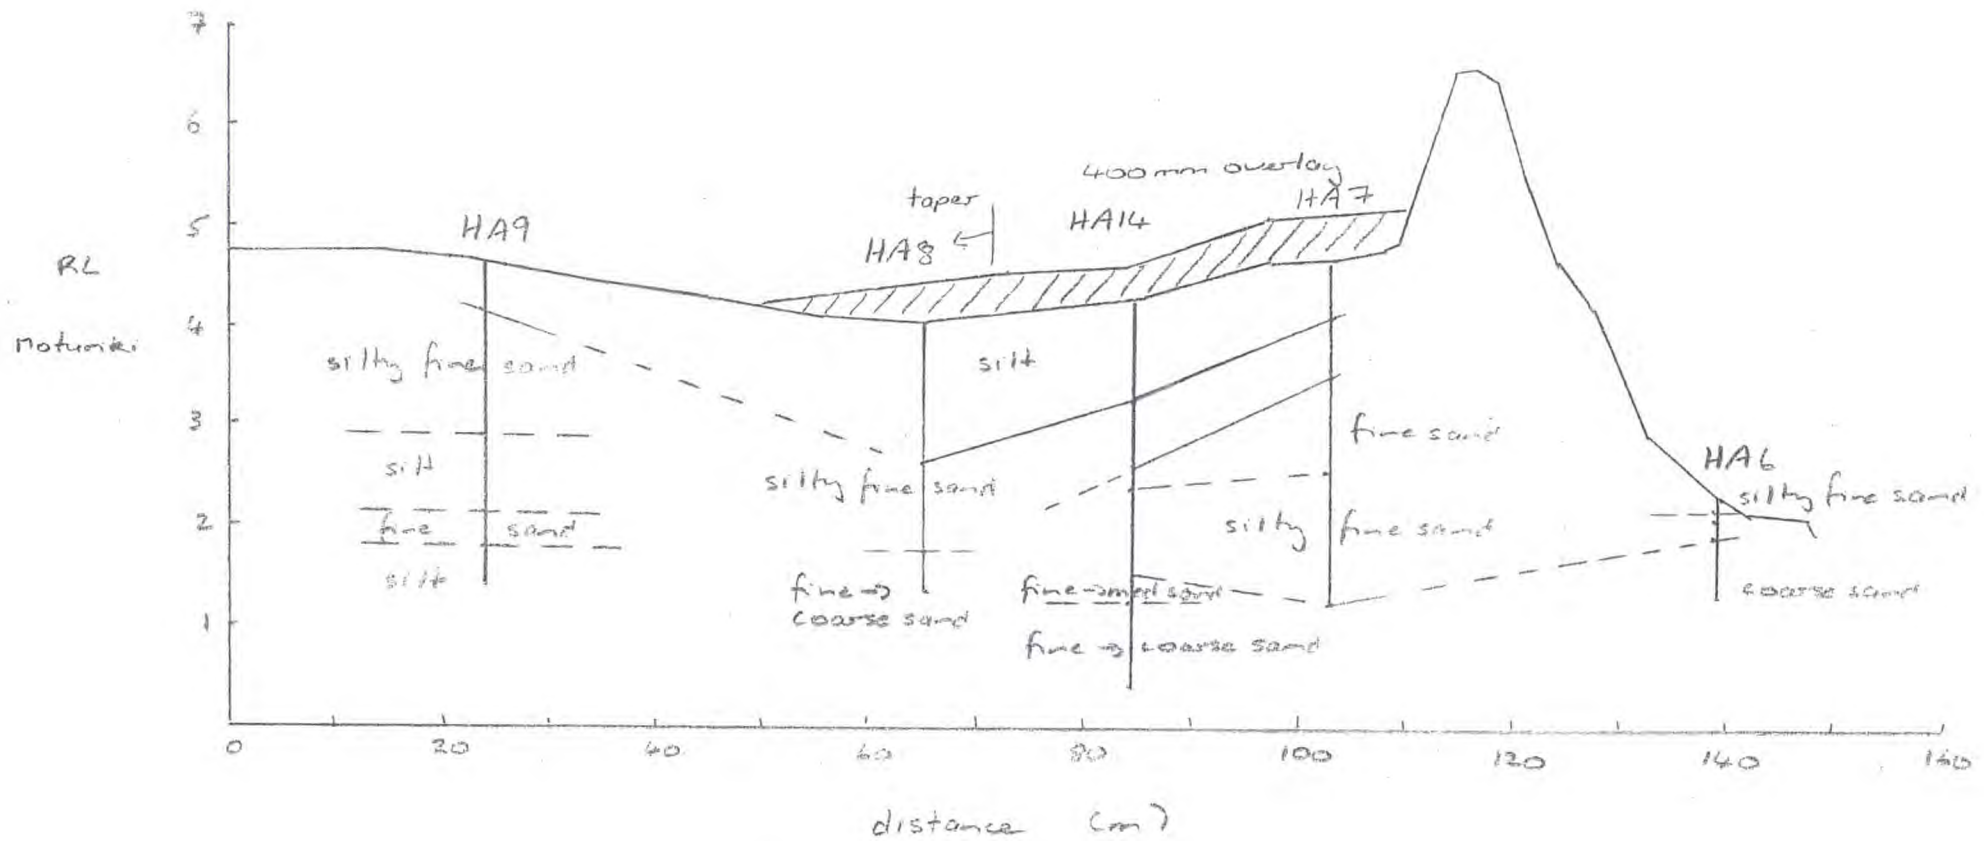
Figure 5

The thickness of the silt layer along this cross section varied from 600mm to 1.5m. Coarse sand was found at 2.4 to 3.1m depth. The auger carried out 90m away from the stopbank shows low permeability soils within the depth of the auger.

The transient analysis produced a factor of safety against uplift below 1.0 within about 40m of the inland toe of the stopbank. If the assumed deep coarse sand layer is only 4m thick the factor of safety is still unacceptable. The maximum hydraulic exit gradient was found to be 0.6. A 40m wide, 400mm thick overlay which tapers to meet the natural ground surface 60m from the stopbank toe will increase the factor of safety to 1.2 and reduce the hydraulic exit gradient to an acceptable level (Figure 5).

Cross Section 3

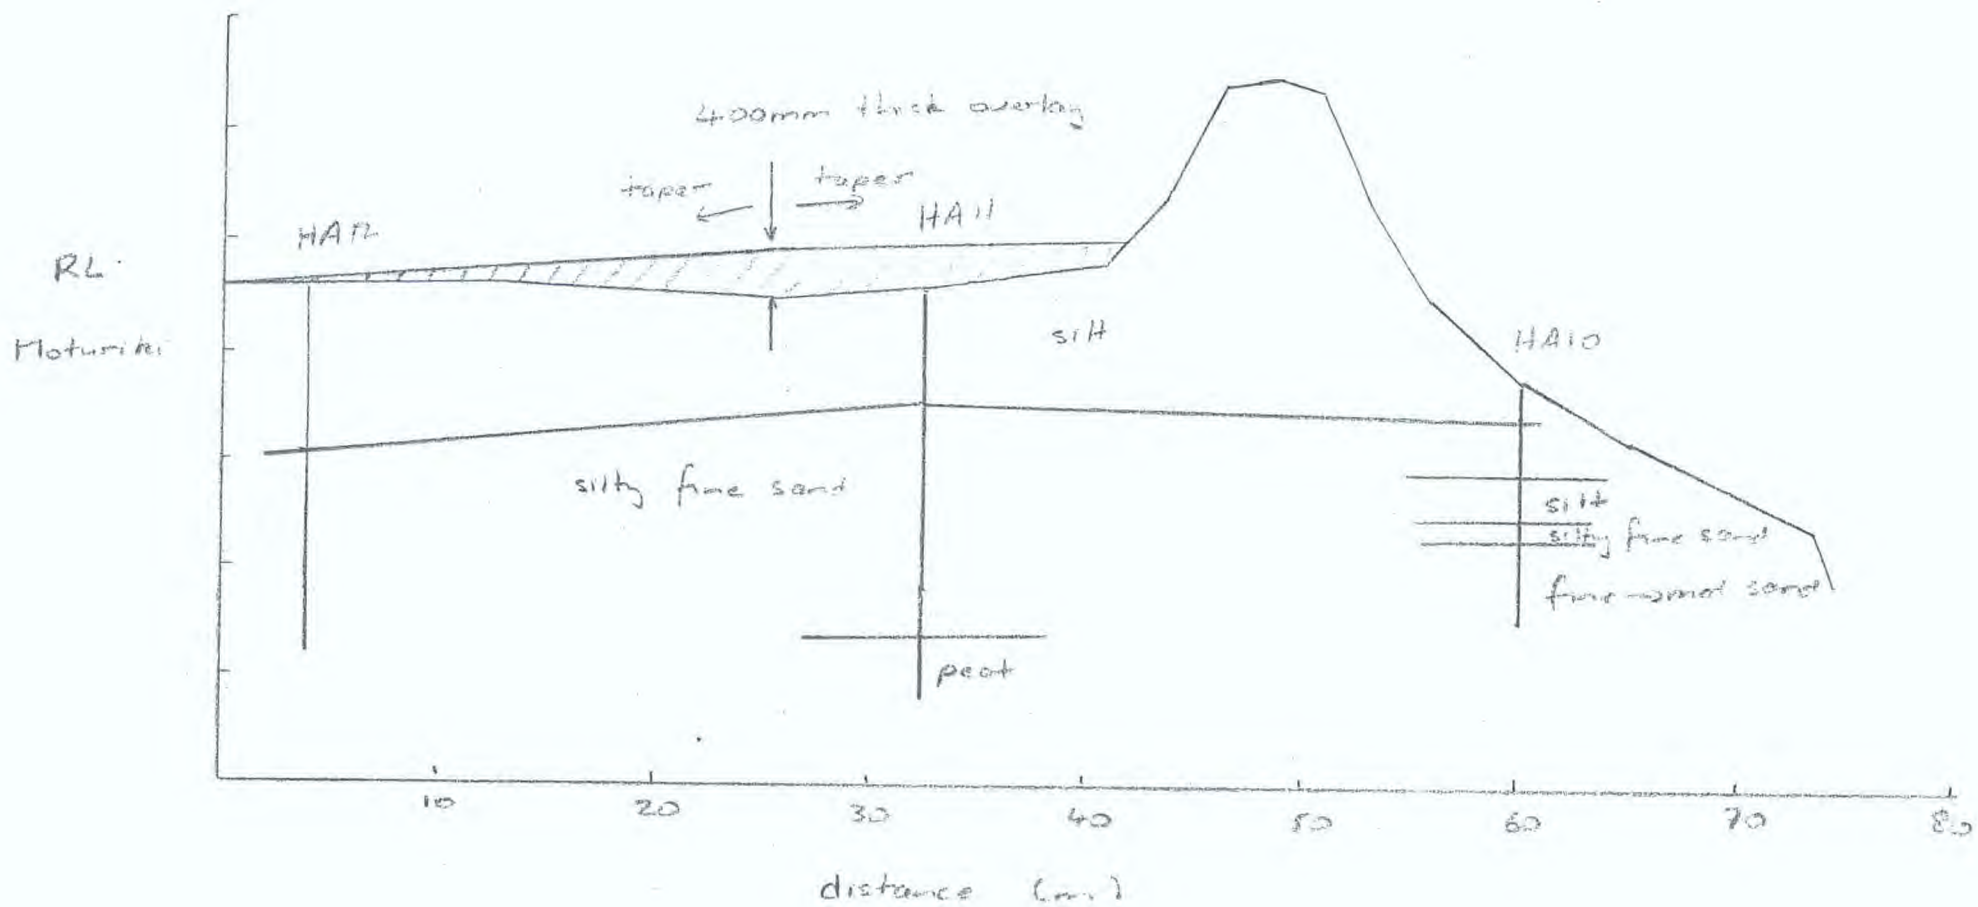
The ground at cross section 4 is slightly higher than elsewhere in the paddock which reduces the hydraulic gradient across the stopbank. The upper silt layer was found to be 1.0 to 1.3m thick. A peat layer at least 600mm thick was found in HA11 and no high permeability layers were found within the depth of the augers.

The factor of safety against uplift of the upper silt layer was found to be close to 1.0 from the toe of the stopbank to about 15m away. To achieve a factor of safety against uplift of about 1.2 an overlay should be 400mm thick 15m from the stopbank toe, tapering to 200mm thick at the stopbank toe and tapering to the natural ground surface 40m from the stopbank toe (Figure 6).

Cross Section 4

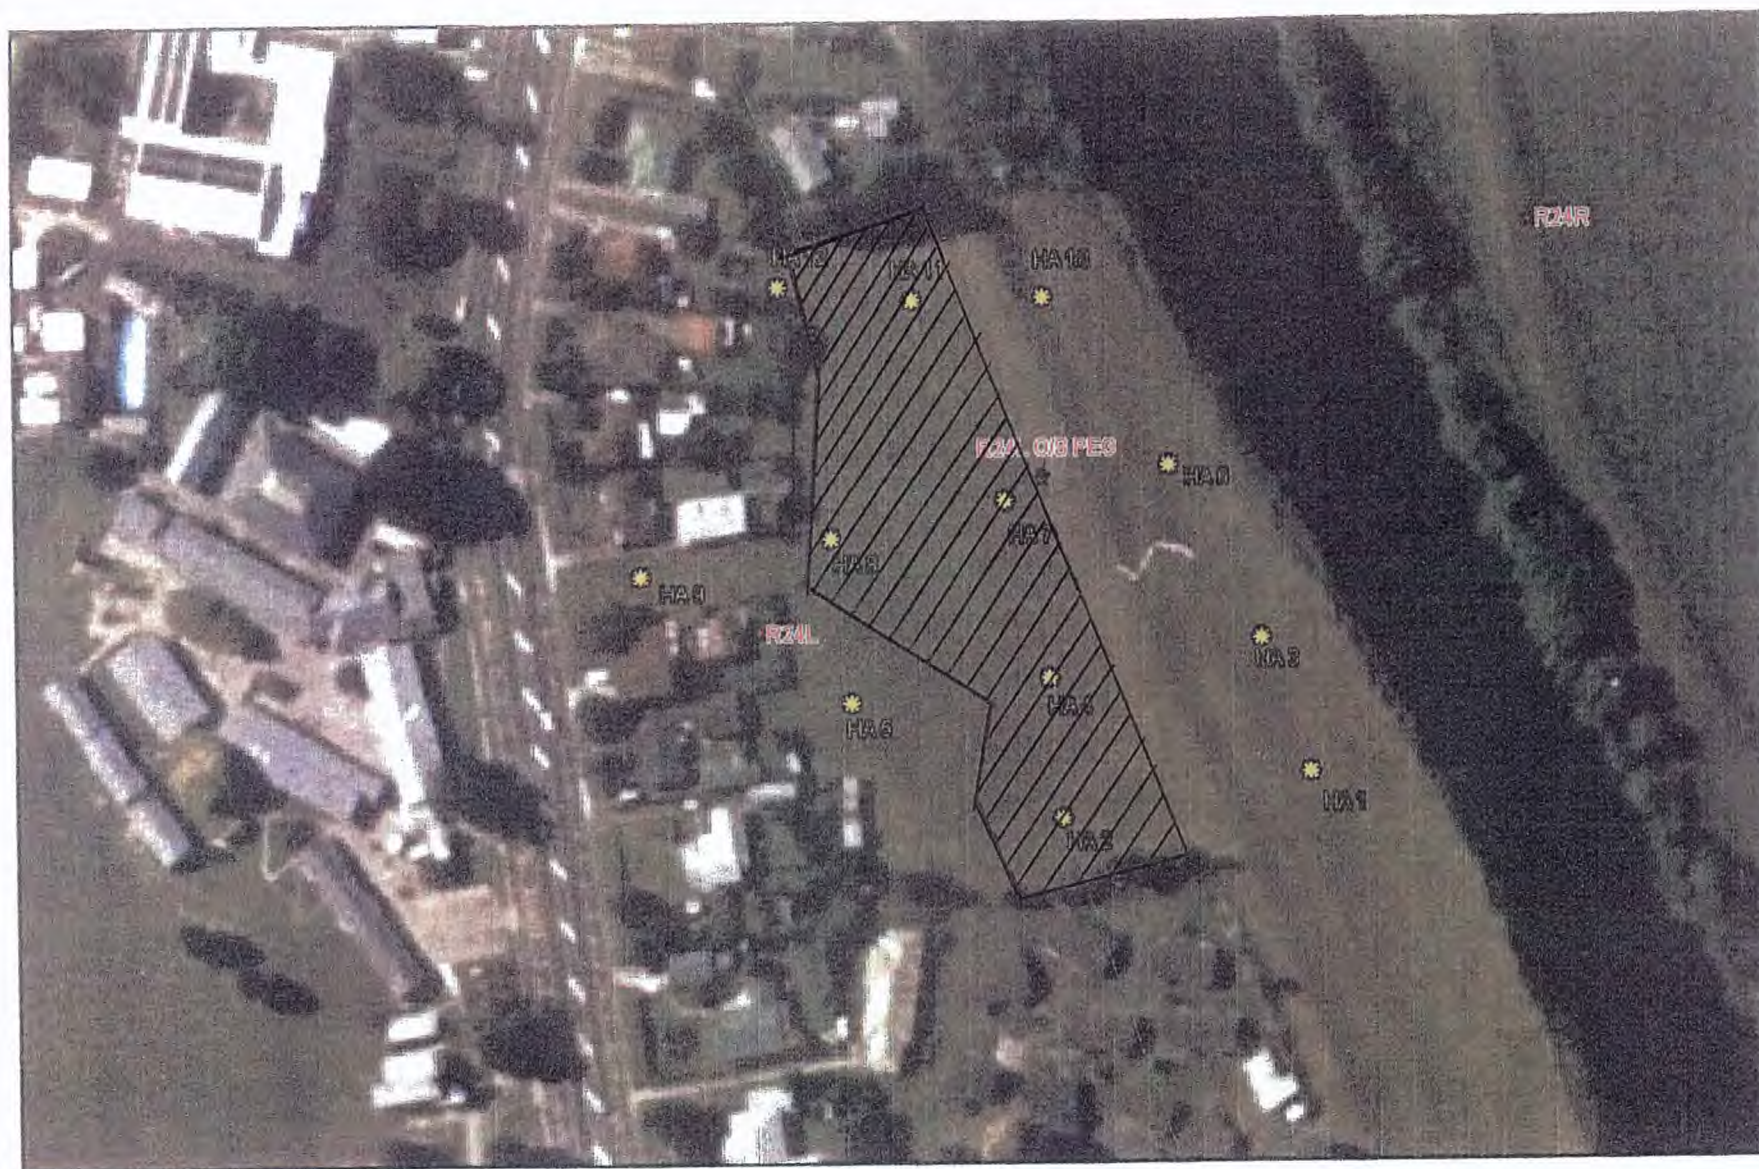
Extent of overlay

- The analyses indicate that the factor of safety against heave of the upper soil layer at this site would be less than 1.0 in some areas in the design 100 year flood.
- An overlay is recommended to increase to 1.2 the factor of safety against heave of the upper silt layer. The extent of this layer is shown on Figure 7
- There should be no excavation at the site for the construction of buildings or access-ways. Where it is necessary to remove surface organic material the volume of the soil removed should be replaced with something of equal or greater weight.
- Impermeable surfaces greater than 10m in width should be bounded by subsoil drains to allow seepage without the removal of fines from the soil Figure 8.

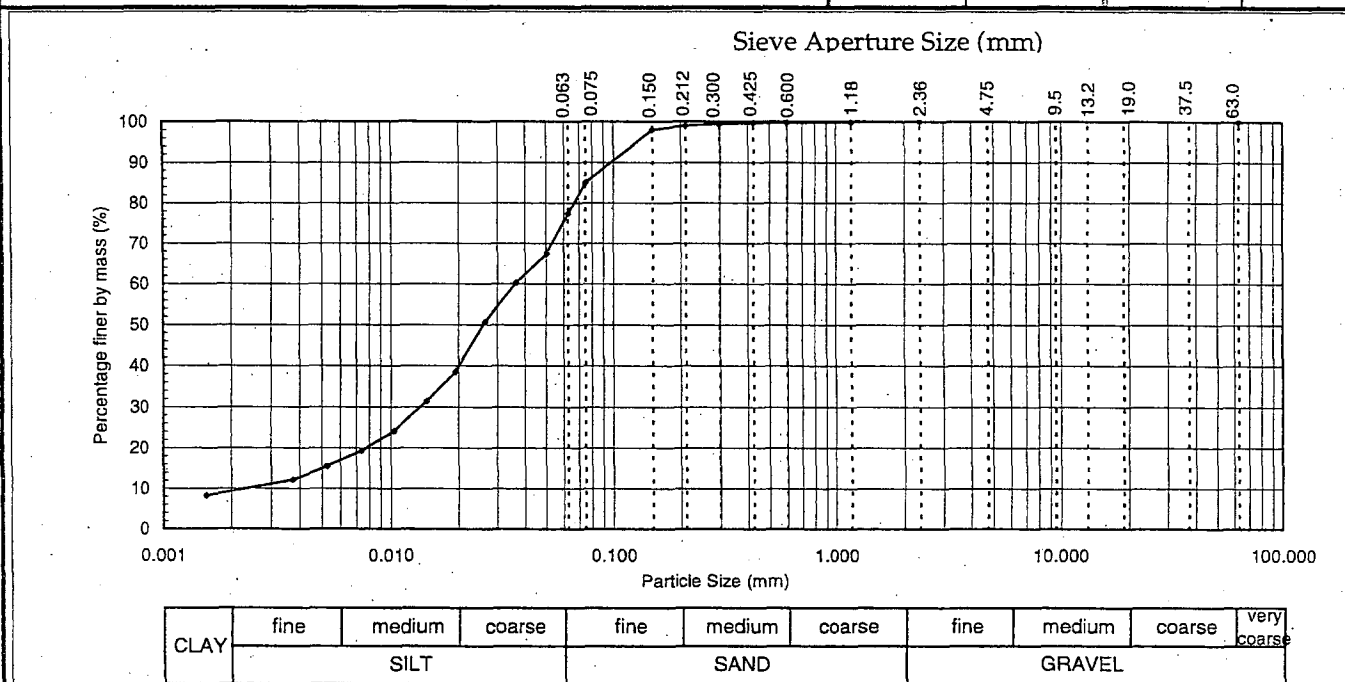
Project : 63 College Road  
 Location : Tauranga  
 Client : Ice Geo & Civil Ltd  
 Client/Sample Ref :  
 Contractor :  
 Sample ID: HA 2 Depth: 0.80 metres  
 Sampled by : M. O'Halloran  
 Date received : 6/06/06  
 Sampling method : Small sample bag  
 Sample condition : As received  
 Sample description : Brown fine sandy SILT.  
 Solid Particle Density ( $t/m^3$ ): 2.65 Assumed  
 Water Content (as received): 48.9 %

Test Methods	Notes
Particle Size Analysis: NZS 4402:1986: Test 2.8.4 (Hydrometer Method)	pH of suspension : 8.0 Whatmans Full Range pH indicator paper

Sample	Description	D <sub>10</sub> (mm)	D <sub>60</sub> (mm)	permeability
HA2 0.8	brown fine sandy silt	0.0022	0.037	$4.8 \times 10^{-8}$ m/s
HA2 2.5m	brown silty fine sand	0.012	0.089	$1.4 \times 10^{-6}$ m/s
HA4 2.3m	light grey silty fine-med sand	0.03	0.16	$9.0 \times 10^{-6}$ m/s
HA8 2.6m	brown grey silty pum sand	0.085	0.47	$7.2 \times 10^{-5}$ m/s
HA10 0.4m	grey brown silty fine – med sand	0.01	0.105	$1.0 \times 10^{-6}$ m/s
HA10 1.0m	grey brown fine-med sandy silt	0.0038	0.053	$1.4 \times 10^{-7}$ m/s

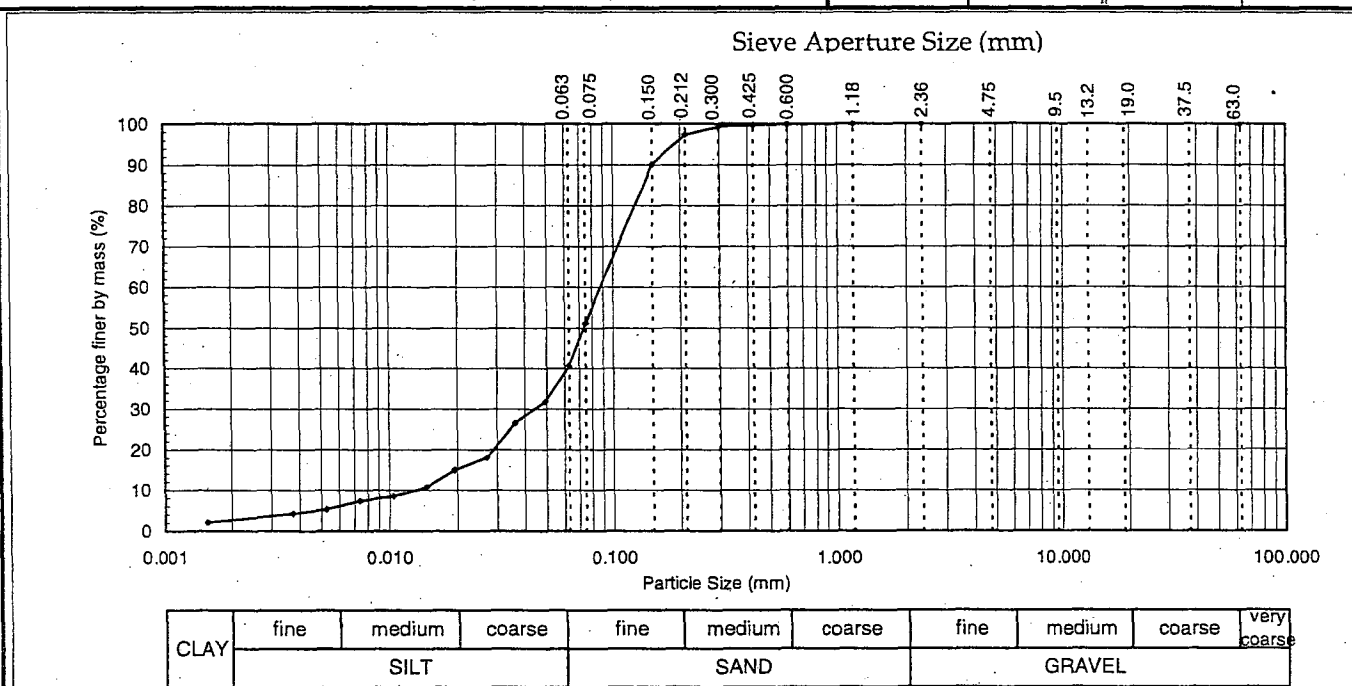
Project : 63 College Road  
 Location : Tauranga  
 Client : Ice Geo & Civil Ltd  
 Client/Sample Ref :  
 Contractor :  
 Sample ID: HA 2      Depth: 2.50 metres  
 Sampled by : M. O'Halloran  
 Date received : 6/06/06  
 Sampling method : Small sample bag  
 Sample condition : As received  
 Sample description : Brown silty fine SAND  
 Solid Particle Density ( $t/m^3$ ): 2.65      Assumed  
 Water Content (as received): 46.8 %

Test Methods	Notes
Particle Size Analysis: NZS 4402:1986: Test 2.8.4 (Hydrometer Method)	pH of suspension : 8.0      Whatmans Full Range pH indicator paper

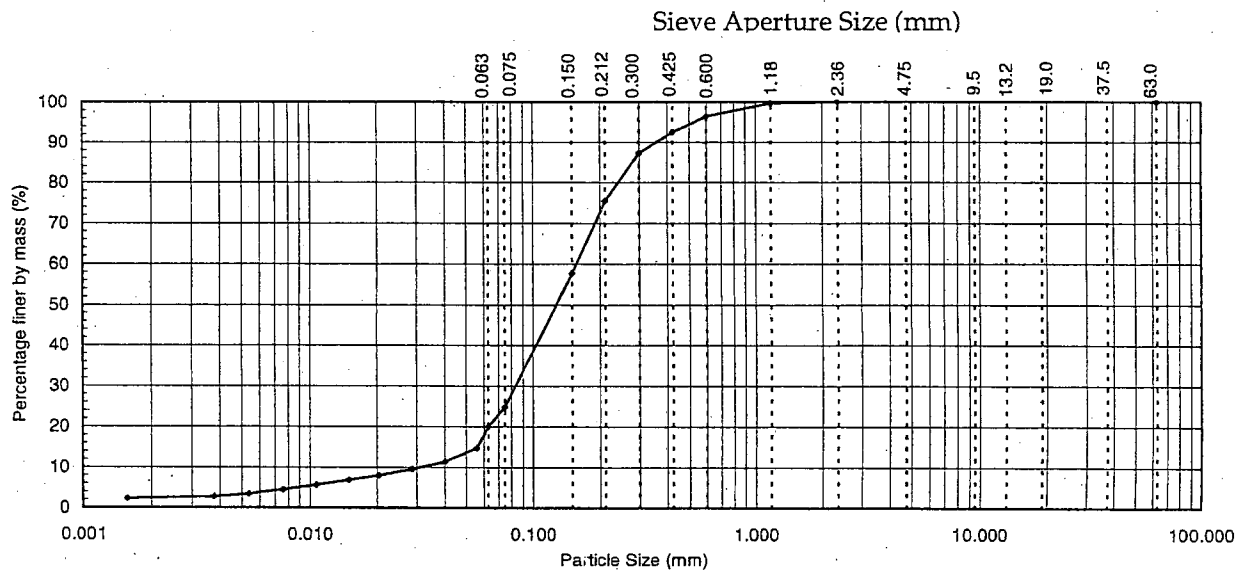
Project : 63 College Road  
 Location : Tauranga  
 Client : Ice Geo & Civil Ltd  
 Client/Sample Ref :  
 Contractor :  
 Sample ID: HA 4 Depth: 2.30 metres  
 Sampled by : M. O'Halloran  
 Date received : 6/06/06  
 Sampling method : Small sample bag  
 Sample condition : As received  
 Sample description : Lt grey silty fine-med SAND  
 Solid Particle Density (t/m<sup>3</sup>): 2.65 Assumed  
 Water Content (as received): 45.6 %

Test Methods	Notes
Particle Size Analysis: NZS 4402:1986: Test 2.8.4 (Hydrometer Method)	pH of suspension : 8.0      Whatmans Full Range pH indicator paper

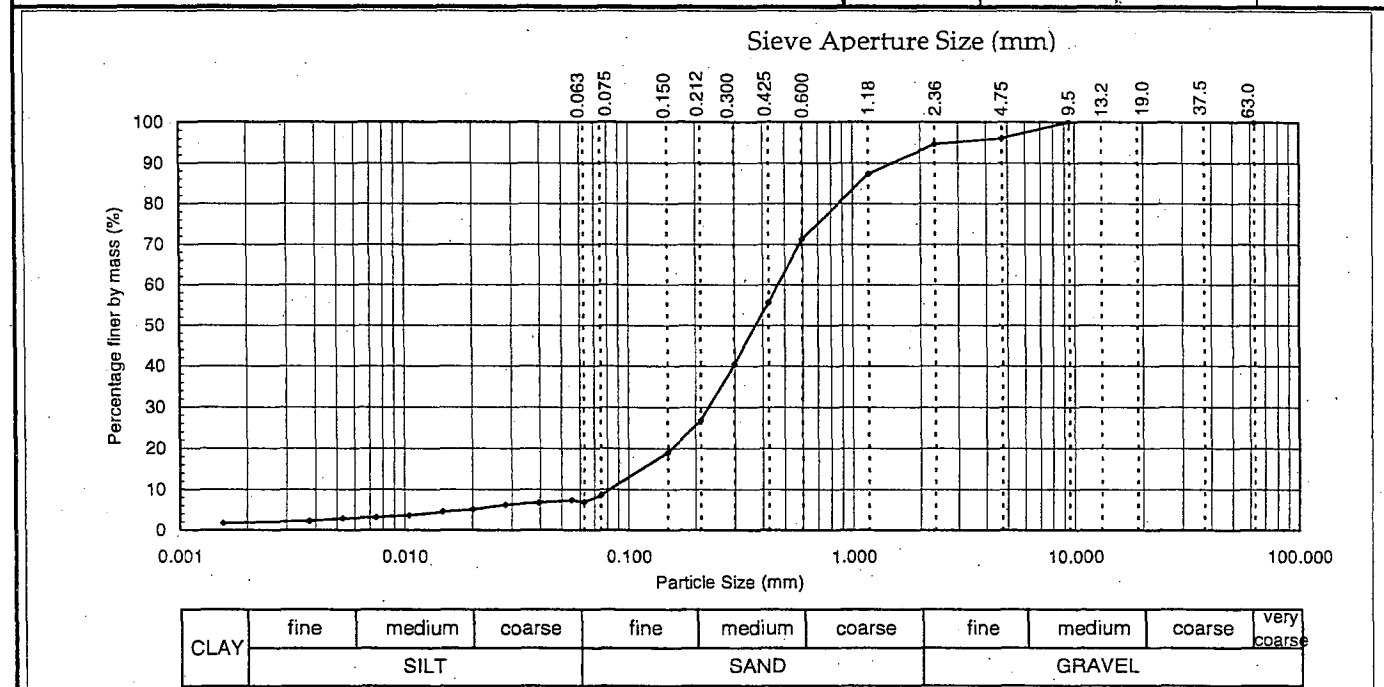
Project : 63 College Road  
 Location : Tauranga  
 Client : Ice Geo & Civil Ltd  
 Client/Sample Ref :  
 Contractor :  
 Sample ID: HA 8 Depth: 2.60 metres  
 Sampled by : M. O'Halloran  
 Date received : 6/06/06  
 Sampling method : Small sample bag  
 Sample condition : As received  
 Sample description : Brownish grey silty pumiceous SAND  
 Solid Particle Density ( $t/m^3$ ): 2.65 Assumed  
 Water Content (as received): 44.2 %

Test Methods	Notes
Particle Size Analysis: NZS 4402:1986: Test 2.8.4 (Hydrometer Method)	pH of suspension : 8.0    Whatmans Full Range pH indicator paper

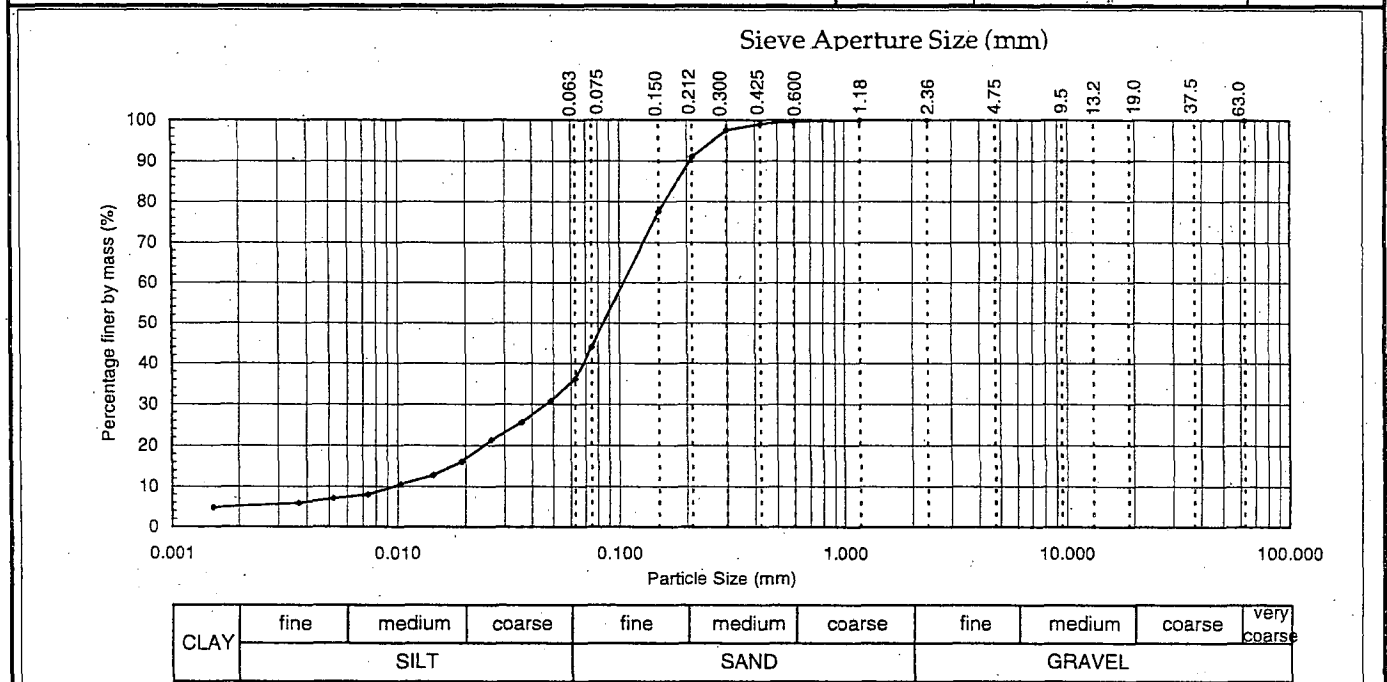
Project : 63 College Road  
 Location : Tauranga  
 Client : Ice Geo & Civil Ltd  
 Client/Sample Ref :  
 Contractor :  
 Sample ID: HA 10      Depth: 0.40 metres  
 Sampled by : M. O'Halloran  
 Date received : 6/06/06  
 Sampling method : Small sample bag  
 Sample condition : As received  
 Sample description : Greyish brown silty fine-med SAND  
 Solid Particle Density ( $t/m^3$ ): 2.65      Assumed  
 Water Content (as received): 30.2 %

Test Methods	Notes
Particle Size Analysis: NZS 4402:1986: Test 2.8.4 (Hydrometer Method)	pH of suspension : 8.0      Whatmans Full Range pH indicator paper

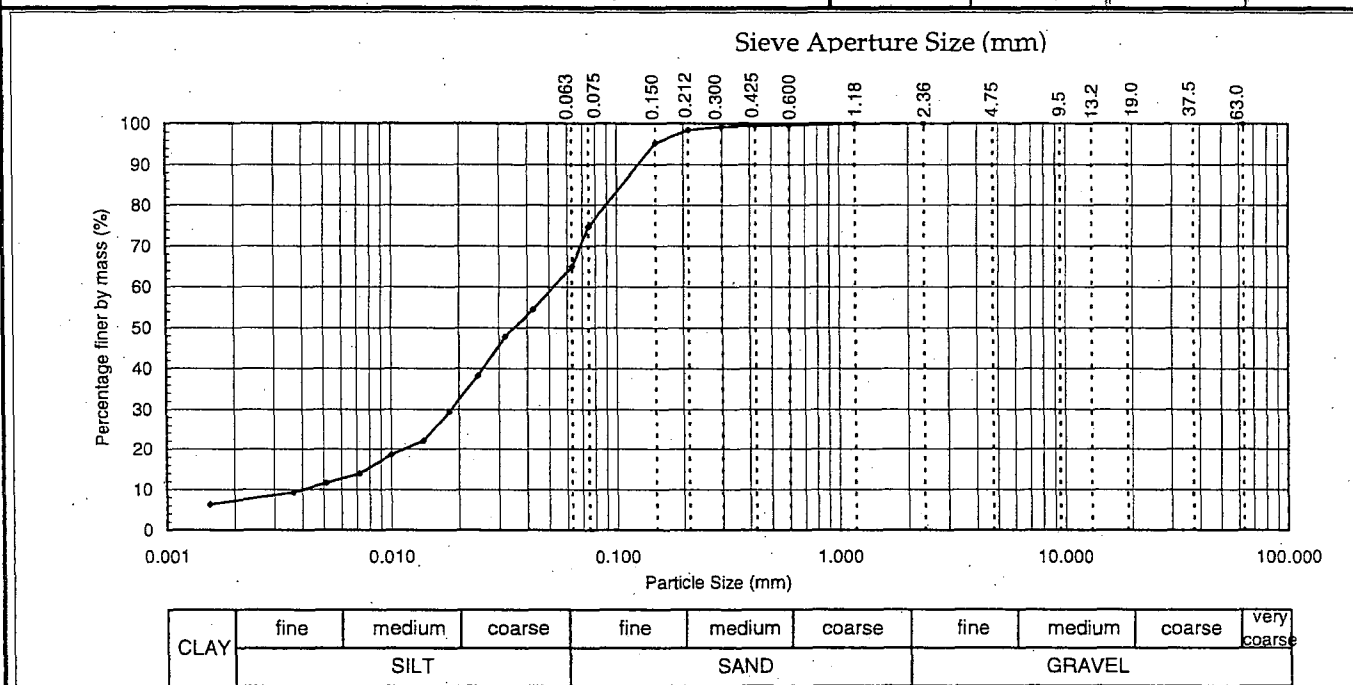
Project : 63 College Road  
 Location : Tauranga  
 Client : Ice Geo & Civil Ltd  
 Client/Sample Ref :  
 Contractor :  
 Sample ID: HA 10 Depth: 1.00 metres  
 Sampled by : M. O'Halloran  
 Date received : 6/06/06  
 Sampling method : Small sample bag  
 Sample condition : As received  
 Sample description : Greyish brown fine-med sandy SILT  
 Solid Particle Density (t/m<sup>3</sup>): 2.65 Assumed  
 Water Content (as received): 53.1 %

Test Methods	Notes
Particle Size Analysis: NZS 4402:1986: Test 2.8.4 (Hydrometer Method)	pH of suspension : 8.0 Whatmans Full Range pH indicator paper

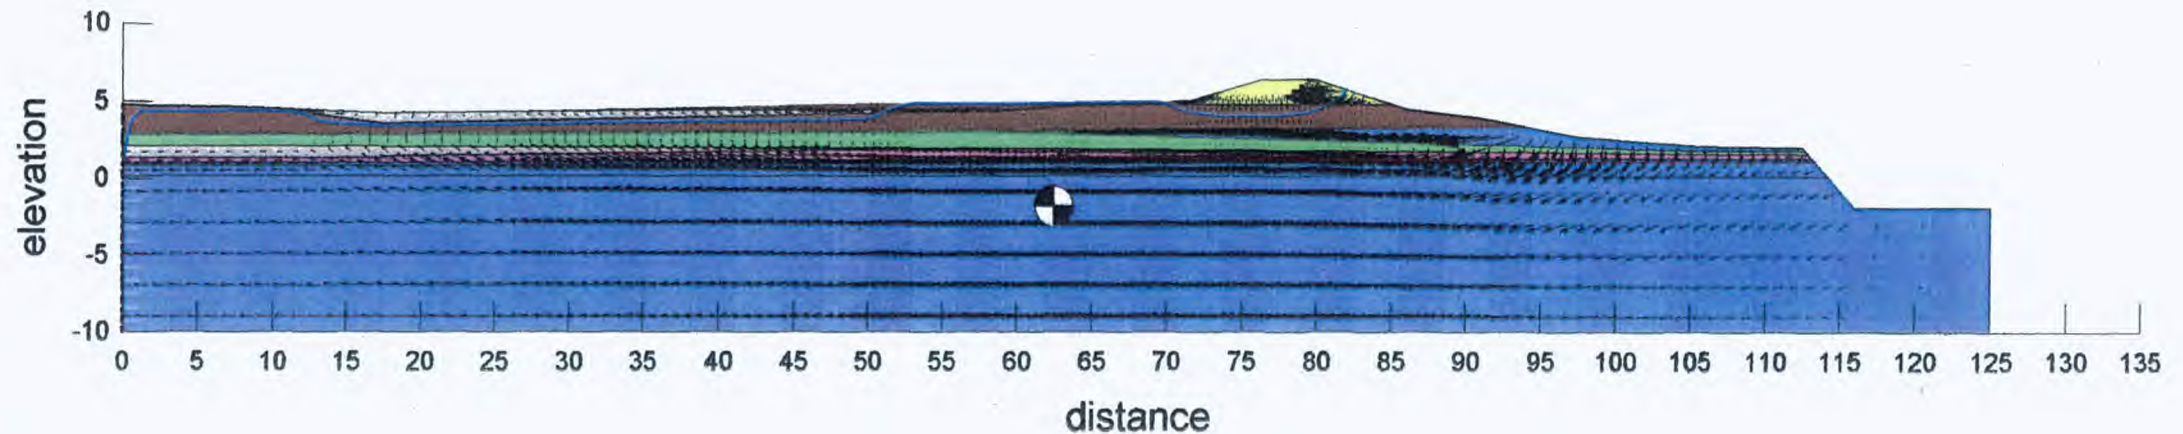
Name: cross section 2 overlay 100 yr.gsz  
 Title: Rangitaiki Stopbanks 63A College Rd  
 Comments: Cross Section 2 100 yr flood  
 Time: 2:24:14 p.m. Date: 19/07/2006

time step 48 - 96 hours

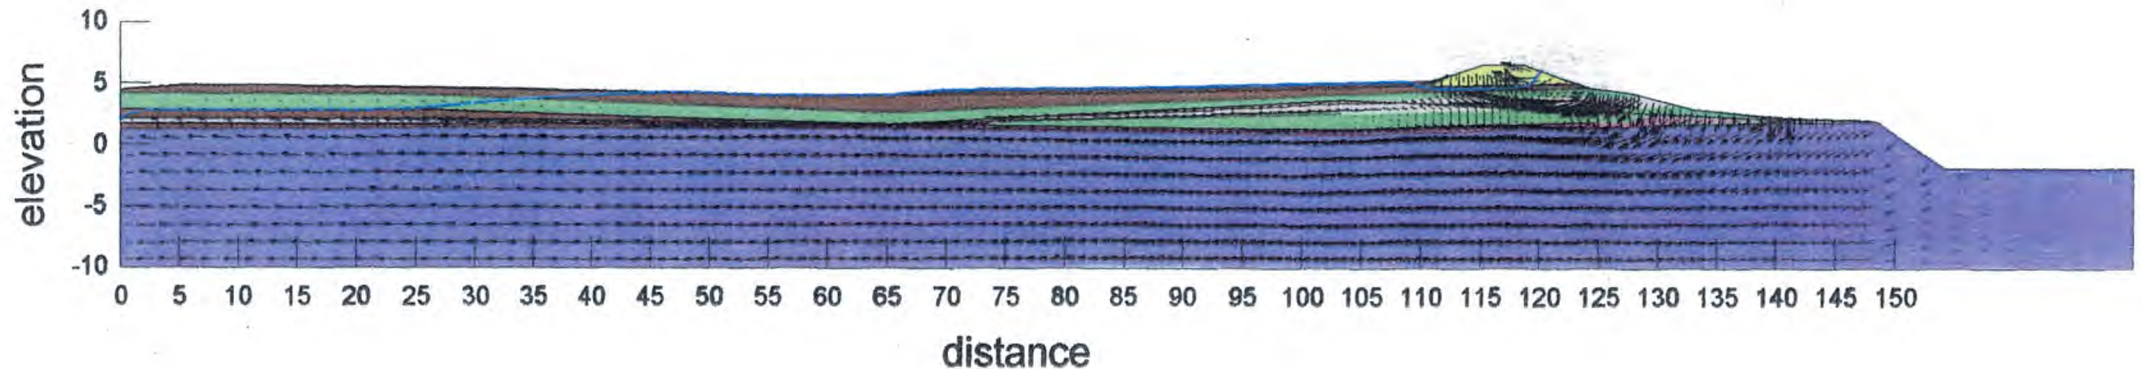
Name: cross section 3 overlay 100yr.gsz  
 Title: Rangitaiki stopbanks 63A College Road  
 Comments: Cross Section 3 overlay 100yr  
 Date: 18/07/2006 Time: 4:26:25 p.m.

time step 42 - 84 hours

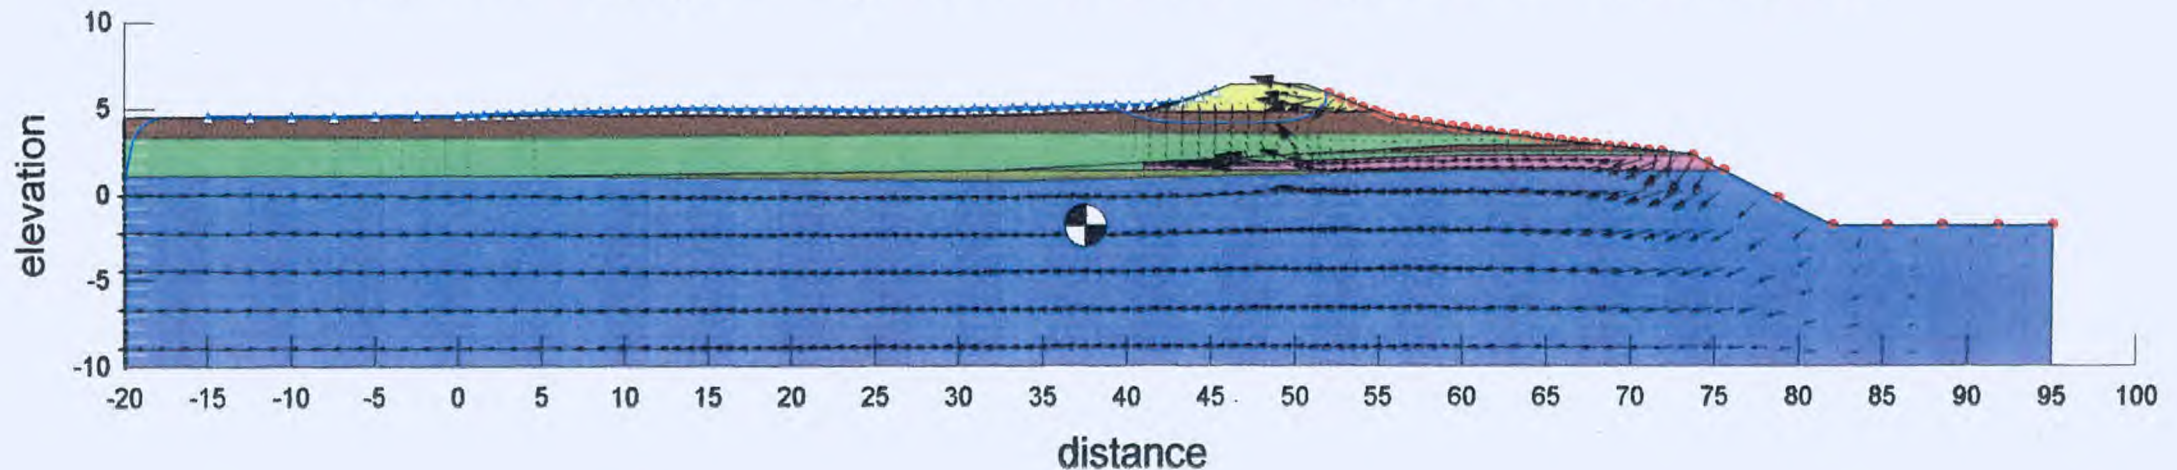
Name: cross section 4 overlay 100yr.gsz  
 Title: Rangitaiki Stopbanks 63 A College Road  
 Comments: Cross section 4 100 yr flood  
 Date: 20/07/2006 Title: Rangitaiki Stopbanks 63 A College Road

time step 42 - 84 hours
