Rangitaiki River Stopbanks Assessment

Miro Place

Right Bank 11200 to 11850m

Environment Bay of Plenty

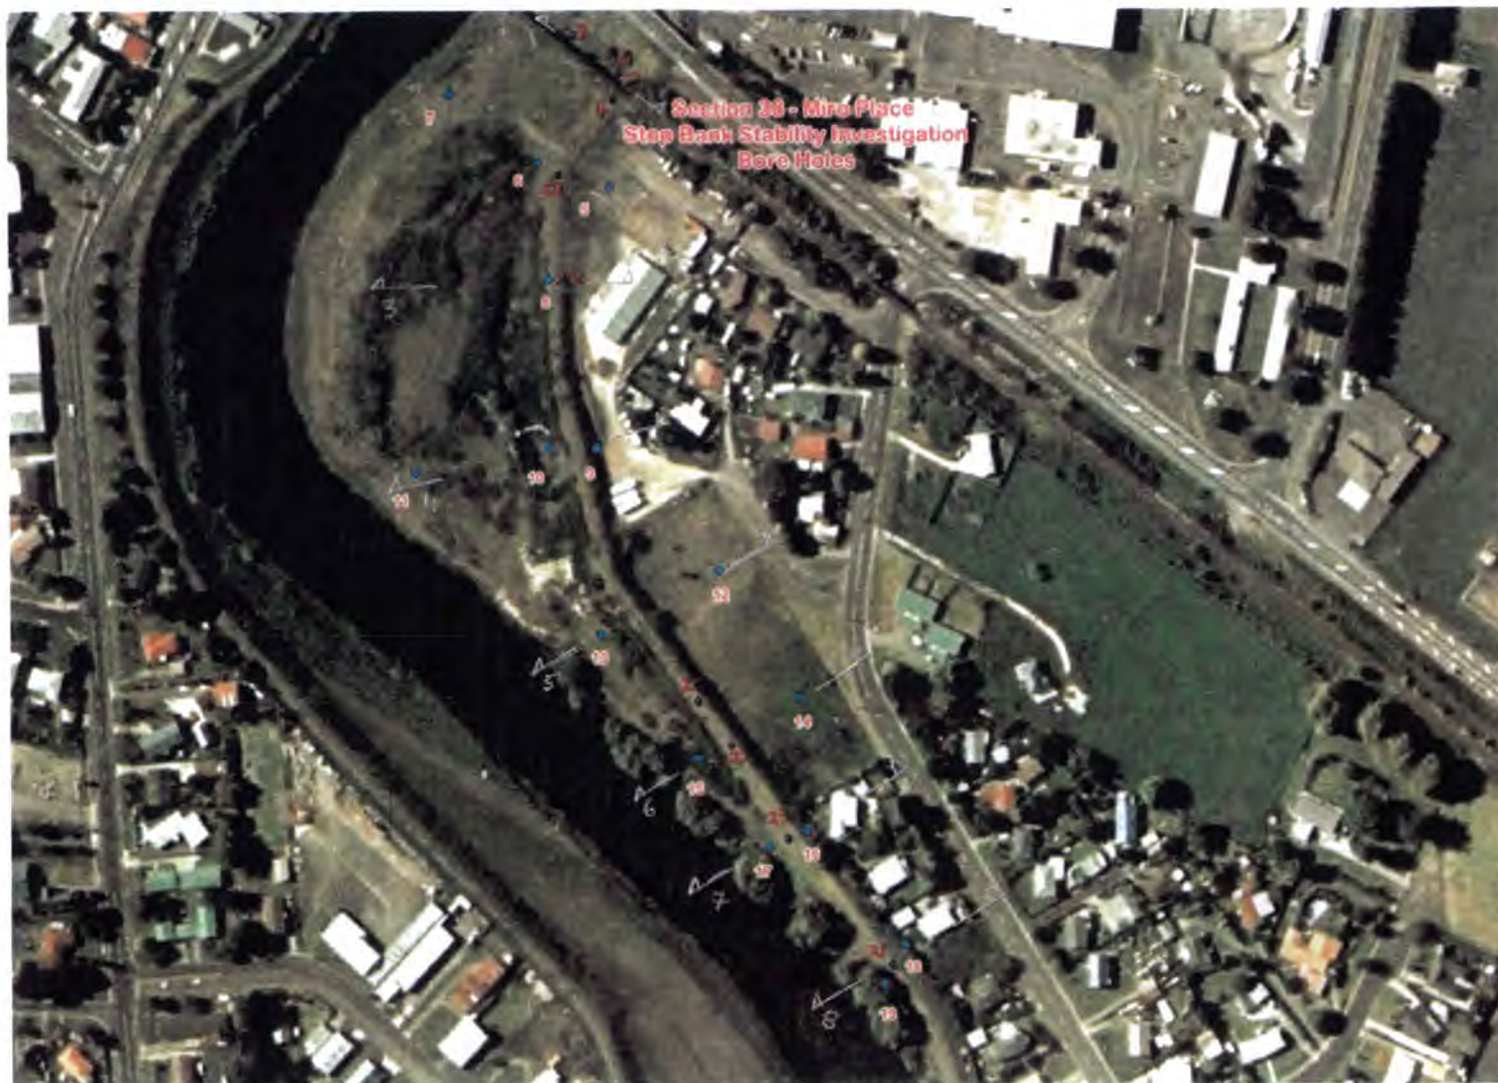
The ground falls away from the stopbank at most of the eight cross sections assessed (Figure 1). The greatest fall is at Cross Section 6 where there is 900mm fall within 35m of the stopbank. The ground in the resulting low area was very wet but it is considered that this was due to a leak in a Whakatane District Council water valve. The valve has recently been repaired and the ground has dried out.

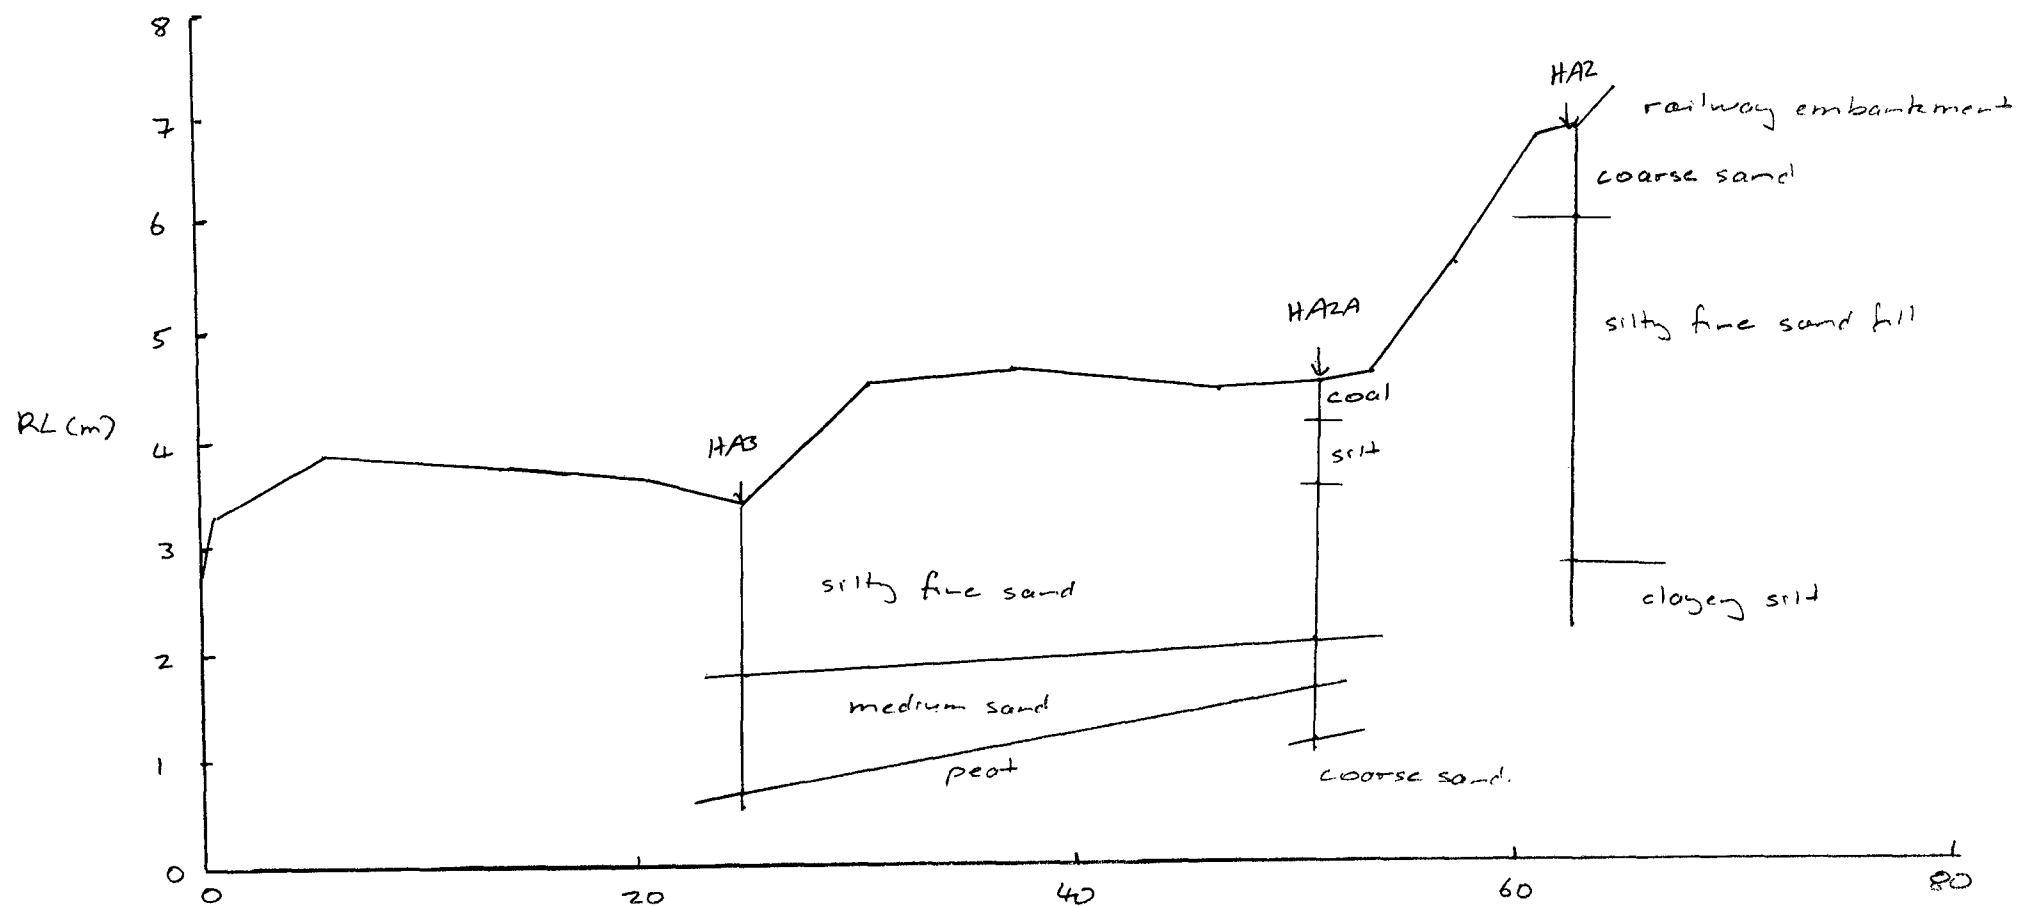
Figure 3

Cross section 1

Stopbank fill materials were found to extend to 4m below the top of the stopbank in TP2. Clayey silts were found below this. The two hand augers in the river berm showed silt and silty fine sand overlying a medium sand and peat. It was assumed that the medium sand layer extends under the stopbank.

It is therefore considered that the only work that is required along this length of stopbank is to remove the coarse sand and to replace it with a soil of lower permeability.

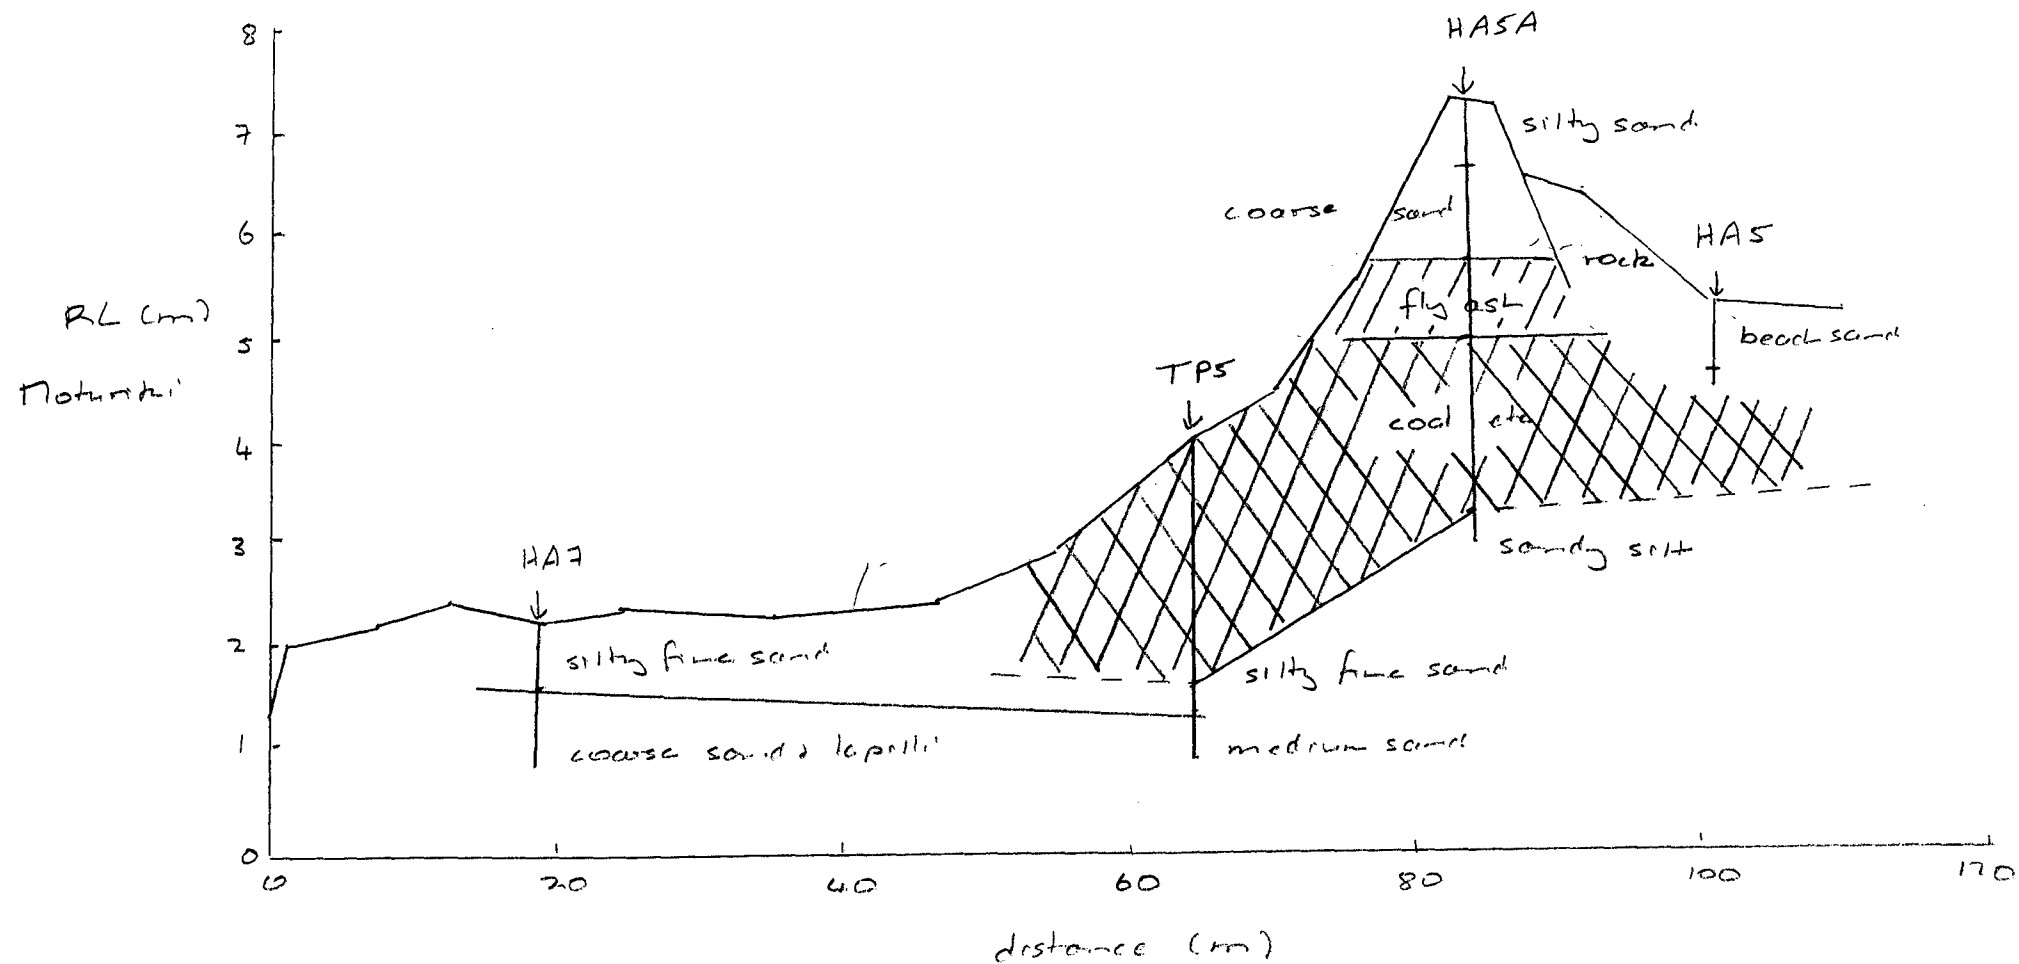
Cross section 2

Figure 4 shows Cross Section 2 with coal extending right under the stopbank and a 2m head difference between the top of the stopbank and the inland ground level. Seepage through the coal layer and the overlying flyash could result in inland contamination. The investigations showed silts, silty fine sand and medium sand underlie the coal. Coarse sand and lapilli were found at between RL1.6 and 1.0 in HA6 and HA7. The presence of the high permeability rock berm was ignored in the seepage analysis.

Under steady state conditions the flow through the coarse sand in the stopbank and that through the coal under the stopbank is an estimated $1.8\text{m}^3/\text{day}/\text{m}$ length of stopbank. There are low hydraulic exit gradients due to the presence of these high permeability layers.

A check was made to see if there was any risk of heave of a competent surface silt layer behind the stopbank with this option. Factors of safety in excess of 1.2 were found.

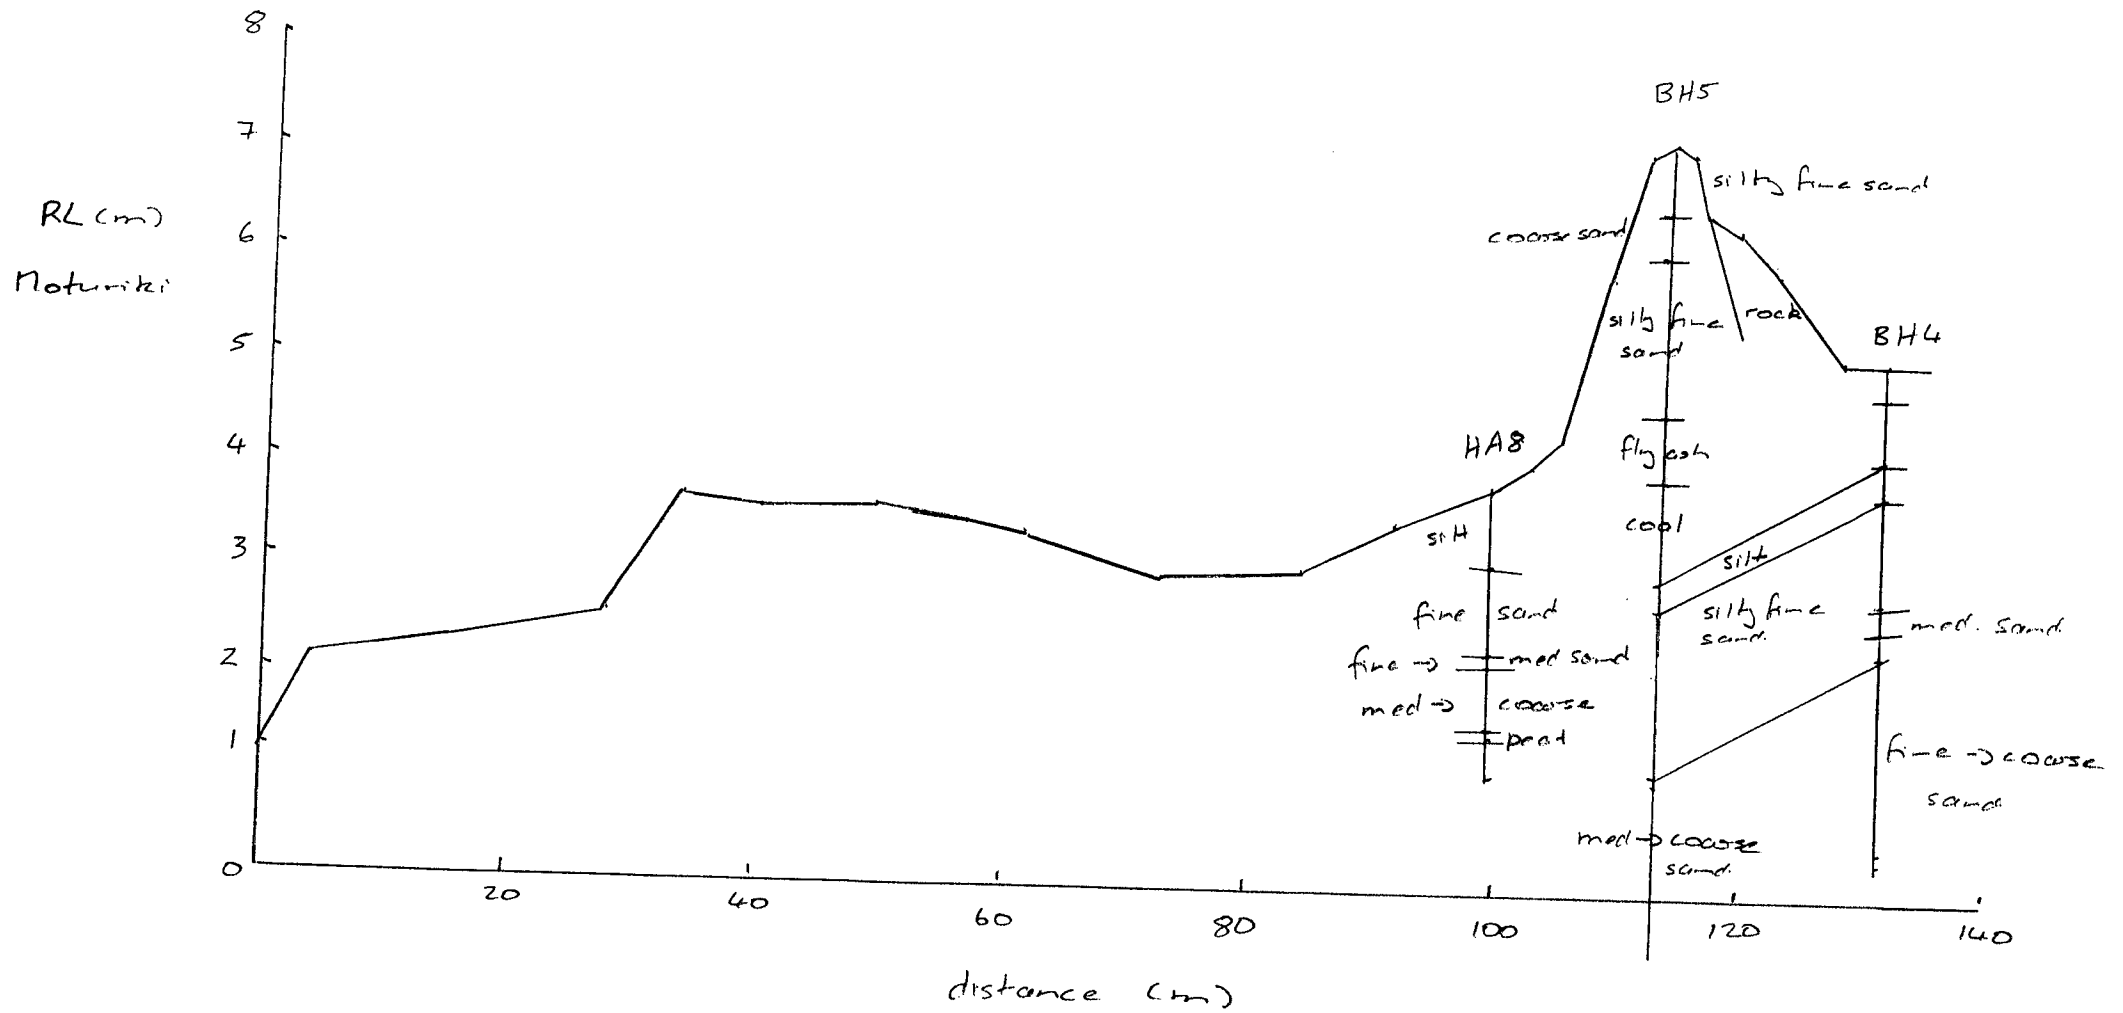
Cross section 3

an extent of coal and flyash as at Cross Section 2 but the underlying soils are similar with coarse sand and lapilli found at between RL1.1 and 2.4.

The combined flow through the coal and the coarse sand in the stopbank was found in the steady state analysis to be $0.9\text{m}^3/\text{day}/\text{m}$. An unacceptable high hydraulic exit gradient was found at the toe of the stopbank beneath the rock fill. The factor of safety against heave of the upper silt layer was also found to be marginal.

A 30m wide, 0.5m thick clay overlay on the river berm and up the face of the stopbank is recommended as a remedial option as for Cross Section 2. This recommendation is made on the assumption that the underlying clean coarse sands are less than 4m thick, as found in all the deep boreholes in the area.

High hydraulic exit gradients will remain at the toe of the stopbank even with the clay overlay. It is therefore recommended that the rock berm be removed, a geotextile filtration layer be laid and the rock berm replaced.

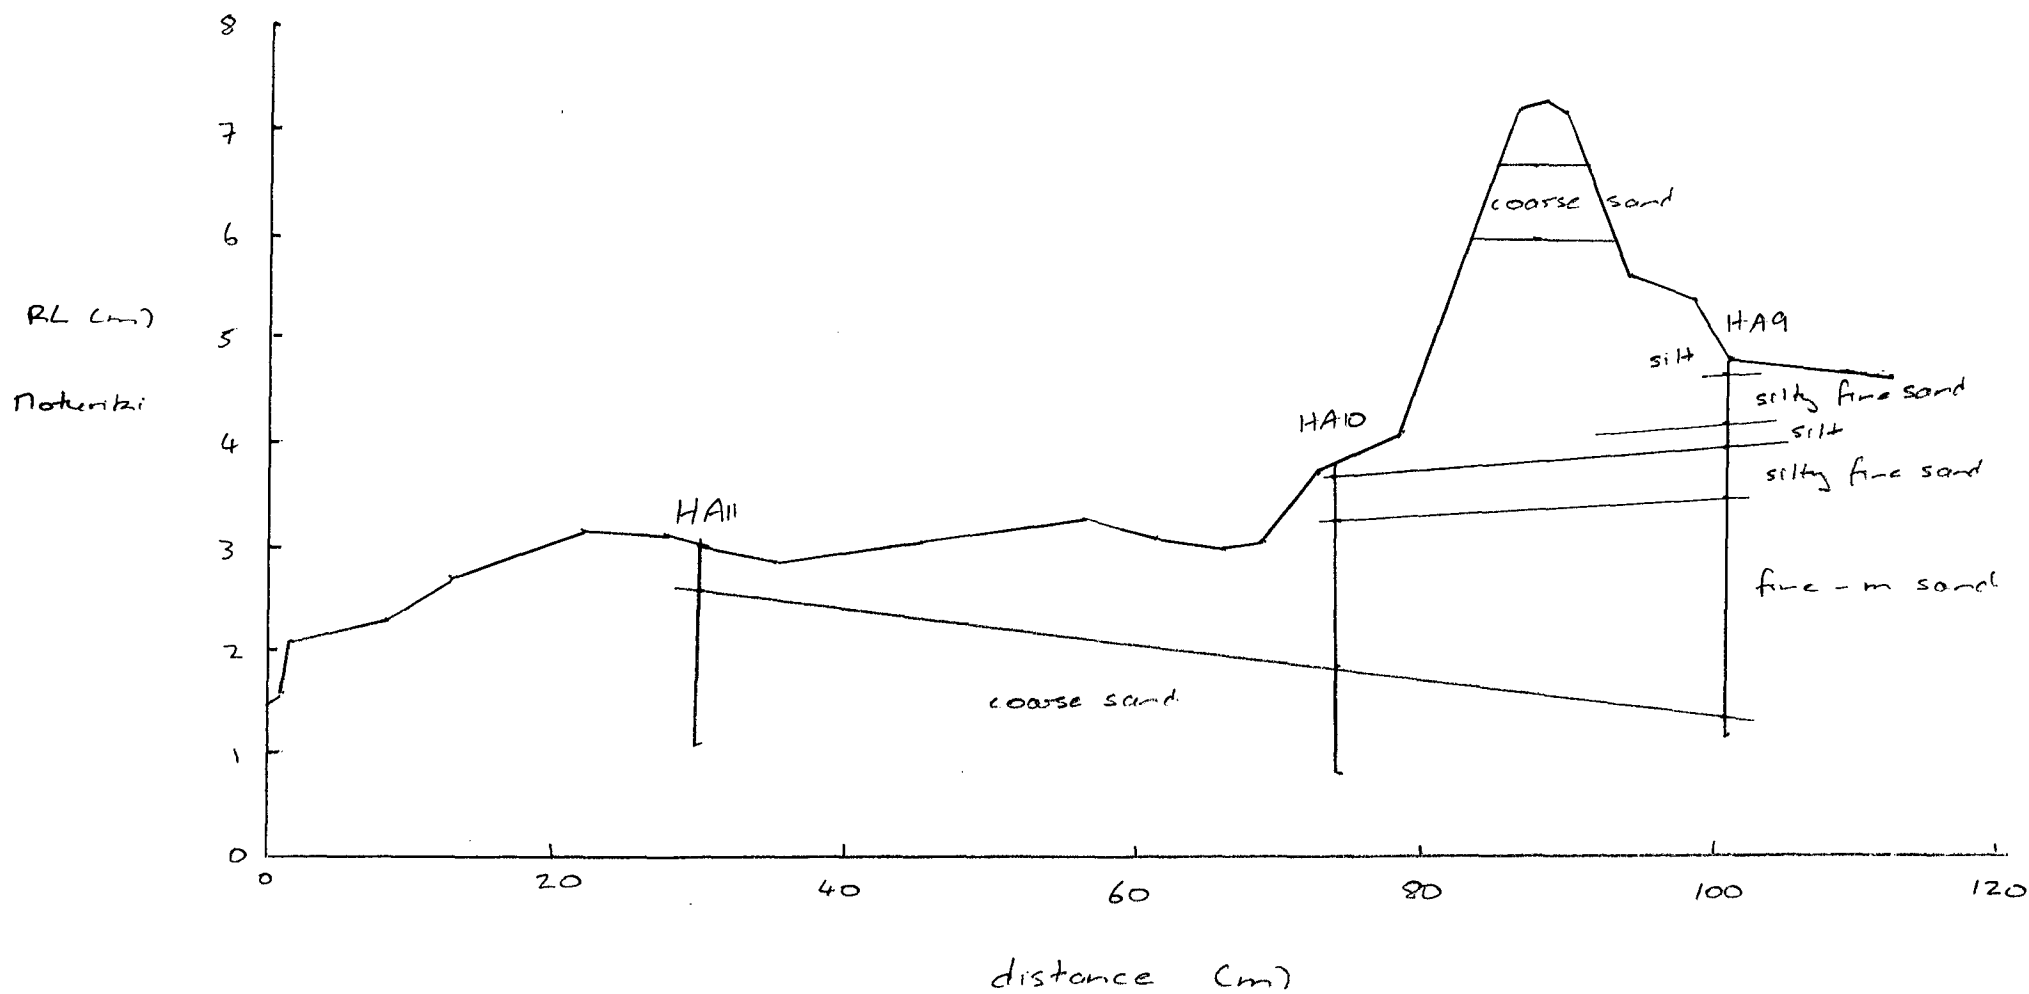
Cross section 4

There is still a rock berm at Cross Section 4 but no coal or flyash were discovered in the test pits. The soils are predominantly silty fine sands with a silt layer containing some clay found at 0.6m depth in HA9 at the inland side of the stopbank. The under-lying coarse sand layer appears to dip away from the river and is at RL1.3 on the inside of the stopbank (Figure 6).

As for Cross Section 3, under steady state conditions the analysis showed high hydraulic exit gradients below the rock berm. There is also a risk of heave of the surface soil layers. To reduce the flow through the stopbank and the risk of heave it is proposed to place a 25m wide, 0.5m thick clay overlay over the river berm and up the stopbank face, and to bring the ground level within 15m of the inside toe of the stopbank up to at least RL4.8. As this area is in a gravel yard it is recommended that gravel be used for this purpose.

As a precaution against piping at the toe of the stopbank it is recommended that the entire extent of the rock berm be removed and geotextile be laid under it before it is replaced. This will also enable the rock berm to be covered in soil to make it more usable for the adjacent land owners.

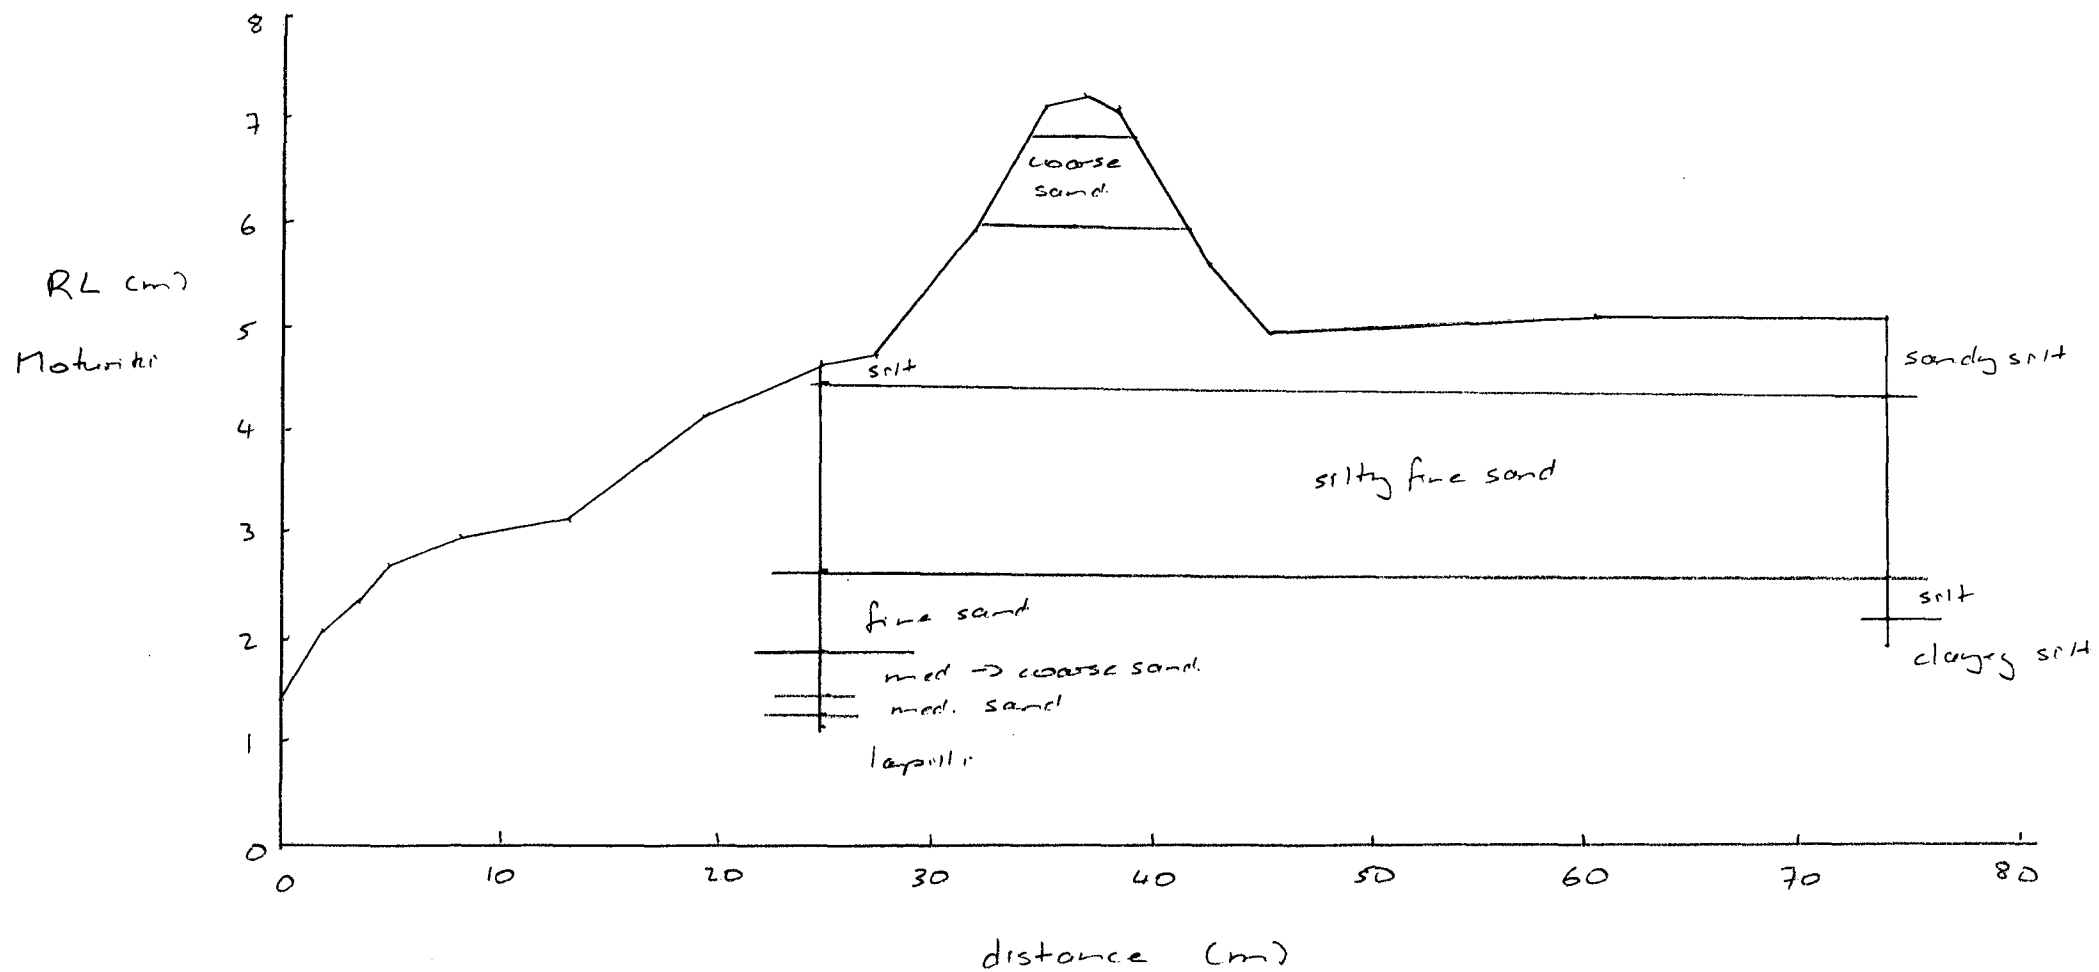
Cross section 5

At Cross Section 5 the river berm is much narrower than at the previous four cross sections and there is a 200mm deep dip at the inland toe of the stopbank (Figure 7). The soils under the stopbank are similar to those at Cross Section 4 with coarse sands found at RL 1.9m. Clayey silt was found at RL2.2 in HA12.

The steady state analysis showed potential problems with high hydraulic exit gradients and heave at the toe of the stopbank. As a river berm overlay will not seal the soil layers causing the high uplift pressures an internal overlay is recommended. It is considered that this overlay should be 600mm thick at the toe of the stopbank and taper down to 300mm thick 30m from the toe. It should be formed of a relatively high permeability material. The coarse sand that should be removed from the top of the stopbank could be used as an overlay with a topsoil cover.

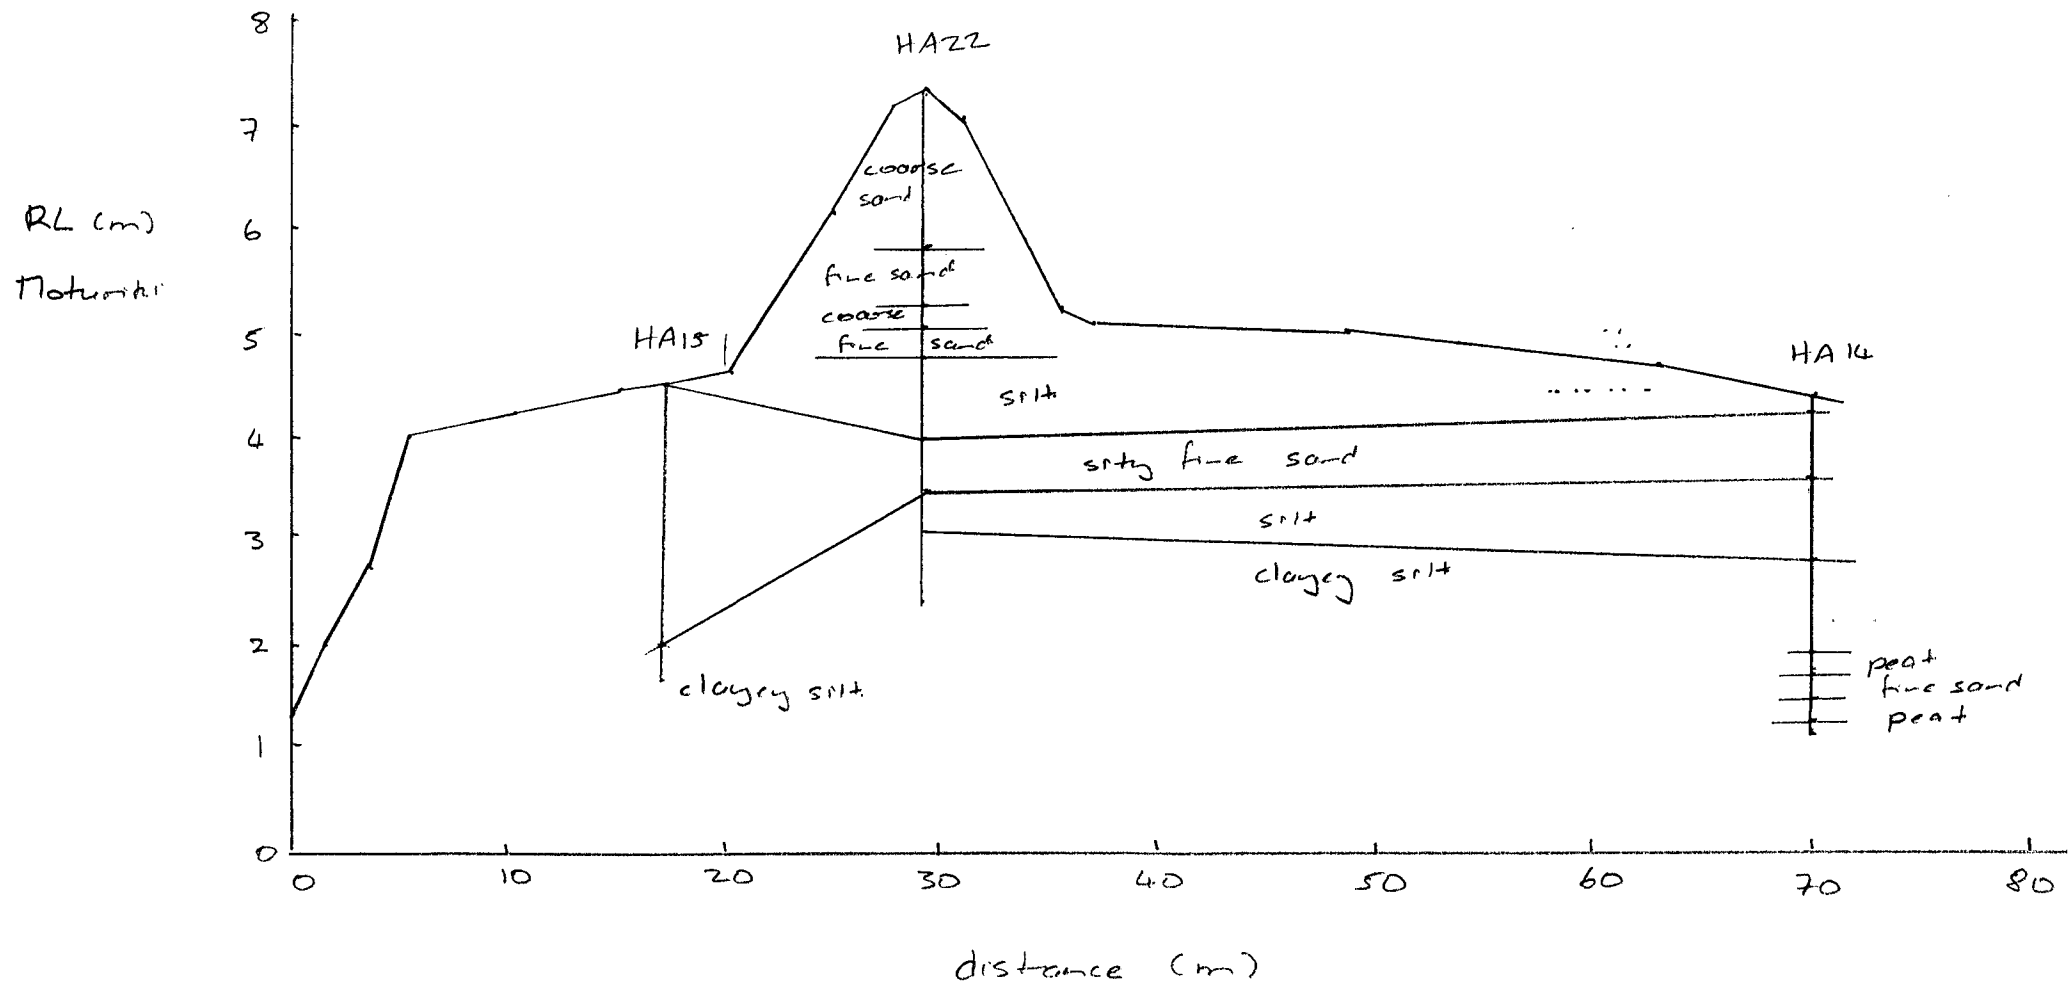
Cross section 6

At Cross Section 6 the river berm has reduced to about 15m width. The ground falls as low as RL4.4 between the stopbank and Hydro Road. This gives an effective head difference of 2.8m between the top of the stopbank and the ground level. Clayey silt layers were found in all three of the hand augers along this cross section and no coarse sands or lapilli were found within the depths of the hand augers. The steady state analysis was carried out assuming these high permeability layers below the depth of the investigations (RL 1.0). As these soils were found just upstream and downstream of this cross section their presence is considered a reasonable assumption.

The seepage analysis showed potential heave problems in the low area near the road. A sensitivity analysis was carried out varying the depth to the high permeability layers to see if a deep borehole would be justified to confirm the soil layers. It was found that even if the high permeability soil was below RL-4.0 the minimum factor of safety against heave still did not rise above 1.1. The use of an over-lay in this area by the road is considered impractical. An analysis was therefore carried out assuming a pressure relief well was installed in the road verge. This pressure relief should improve the factor of safety against heave to an acceptable level.

In reality a series of wells along the road verge would be required. It is suggested that these be placed at 12 to 15m spacings. Great care will be required in their installation as there is an 11kV cable in the verge, a water main and other services. Under bank full conditions the estimated flow from these wells would be in the order of 1.7m³/day/m.

The coarse sand within the stopbank should be removed and replaced with a fill with lower permeability.

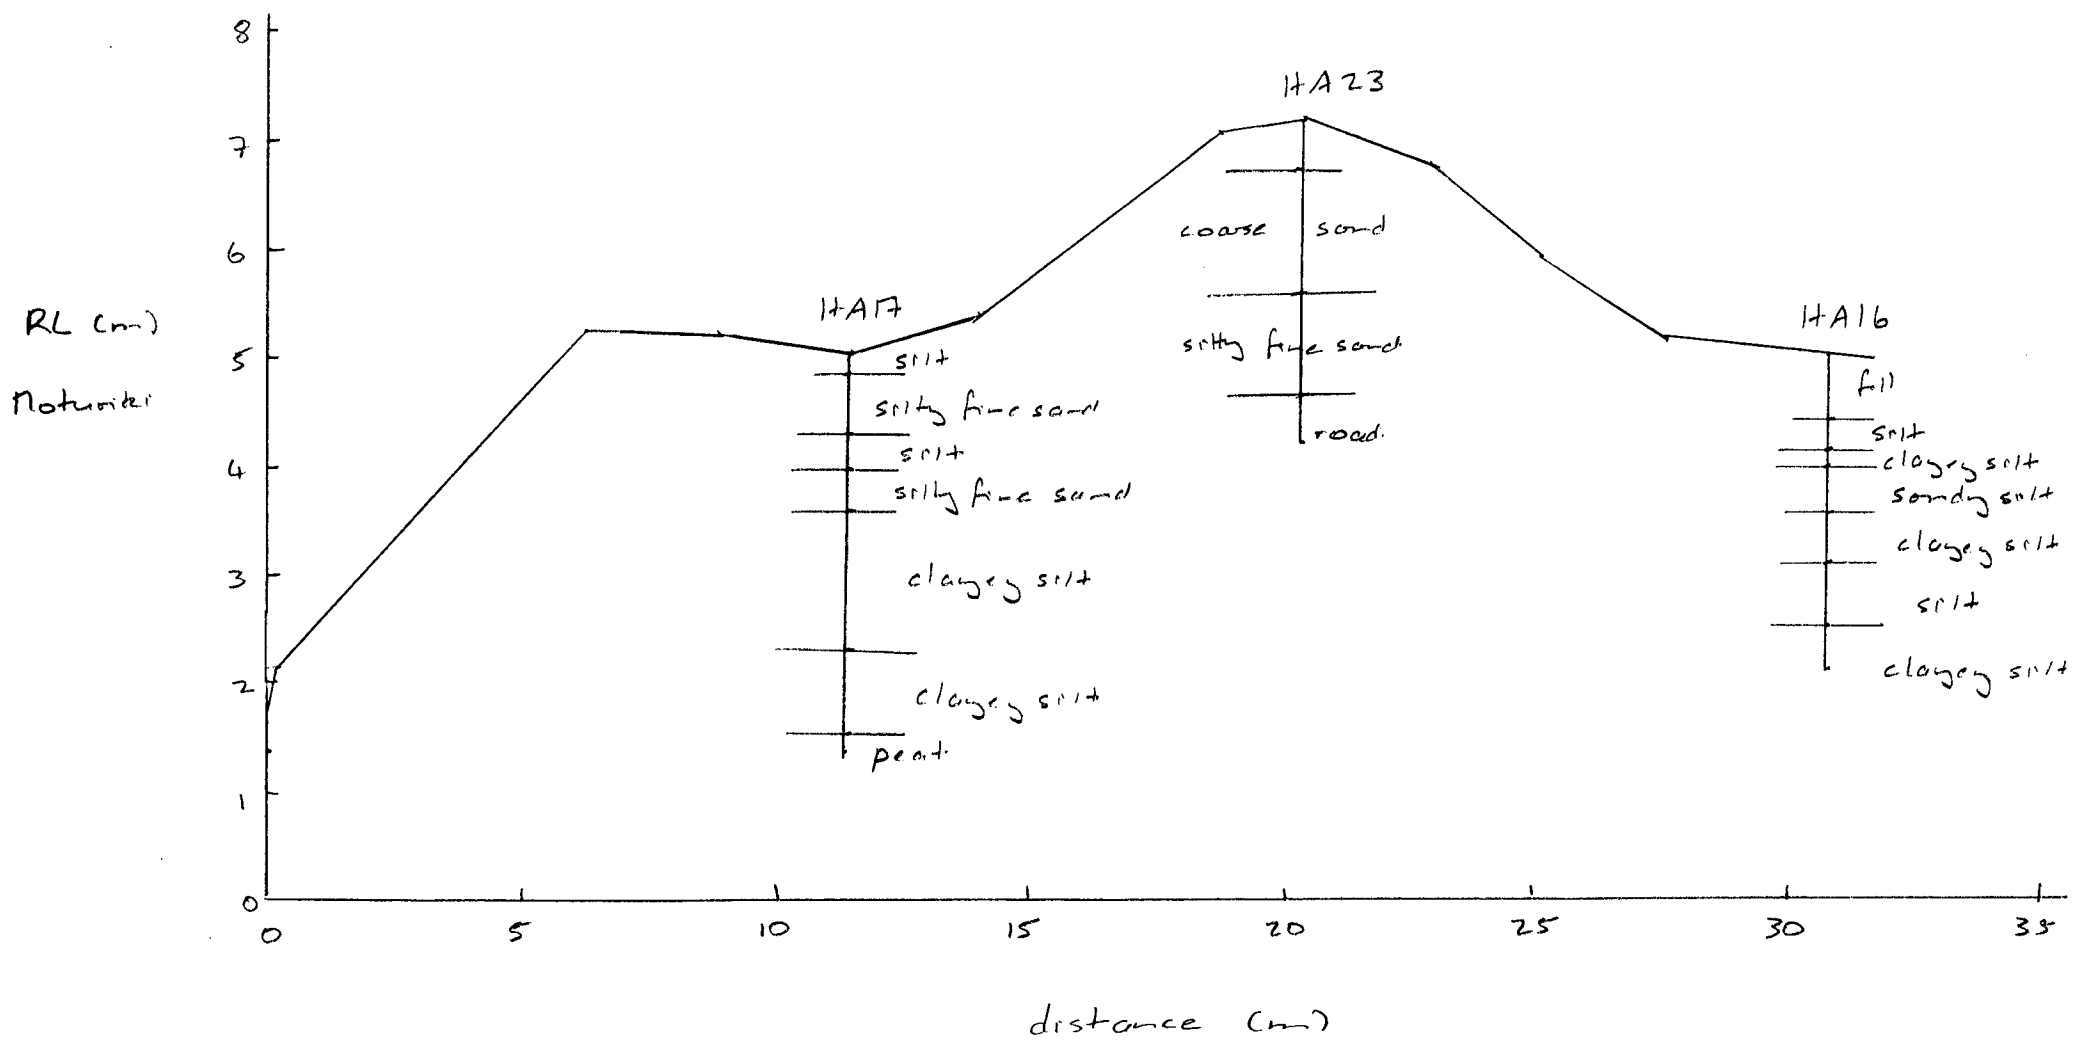
Cross section 7

At Cross Section 7 extensive layers of silt and clayey silt were found beneath the stopbank (Figure 9). An old road was found to extend inland from under the stopbank. The gravely silty sand forming the road could not be penetrated under the stopbank. As for Cross Section 6 no coarse sand was found within the depth of the investigations.

Under steady state bank full conditions there should not be any problems with high hydraulic exit gradients at this cross section. However if a coarse sand is assumed below the depth of investigations the factor of safety against heave could be marginal. A pressure relief well close to the road should reduce the uplift pressures to an acceptable level.

As for Cross Section 6 a sensitivity analysis was carried out varying the depth to a high permeability layer. It was found that if this layer was below RL-3.3 there is an adequate factor of safety against heave; however as coarse sands have been found above this level in all the deep investigations and as pressure relief wells are required at the two adjacent cross sections, it is considered that pressure relief wells should be installed here.

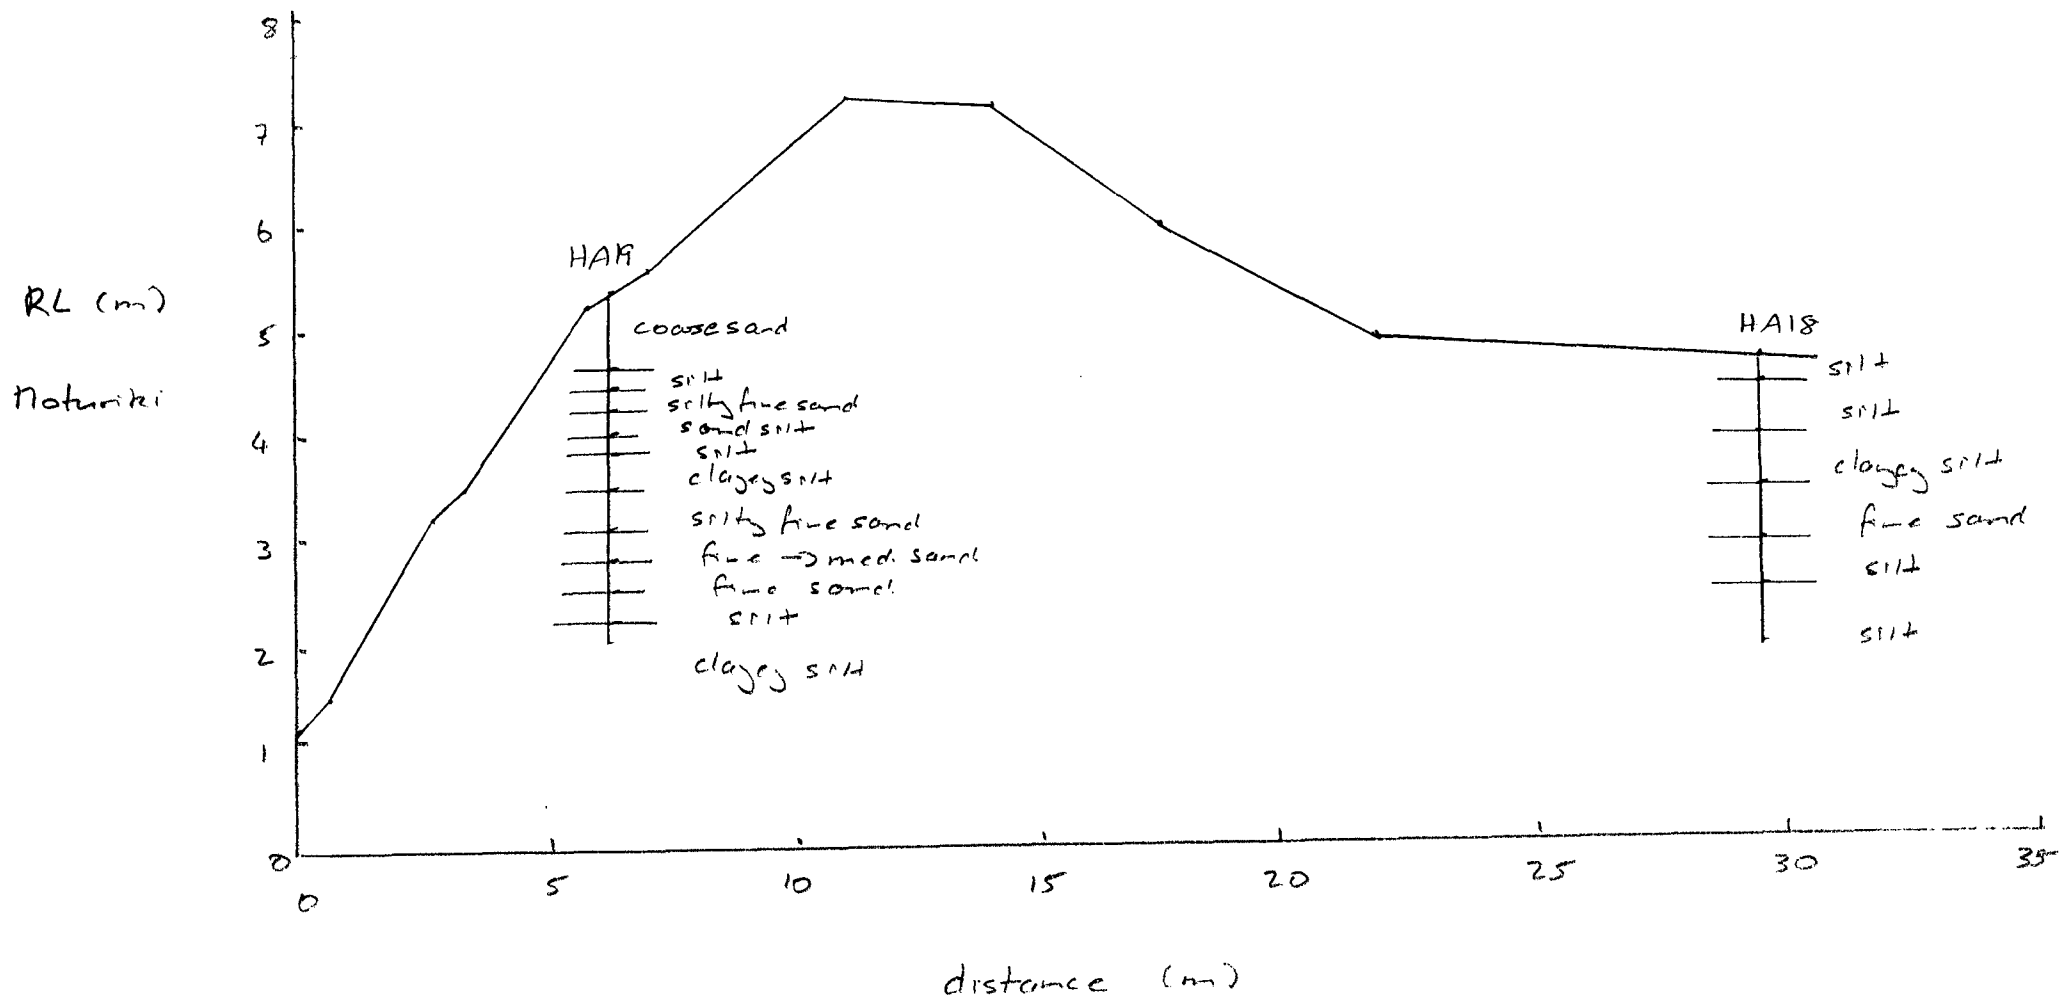
Cross section 8

At Cross Section 8 there is no river berm and there is a 2.6m head difference between the top of the stopbank and the adjacent land. A fine to medium sand layer was found to run below the stopbank. No coarse sands were found within the depth of the investigations but they were found at the adjacent cross section previously reported on in Section 6 of the Rangitaiki investigations (Reference 2). Coarse sands were therefore included at the base of the soil model.

It was found in the steady state bank full analysis that the fine to medium sand layer gives rise to high uplift pressures below the inland silt layers and a high hydraulic exit gradient. There is also a marginal factor of safety against heave of all the upper soil layers due to the coarse sand below.

It was found in the steady state analysis that the factors of safety against heave still did not reach above 1.1 when the river side of the sand layer was sealed with clay and a pressure relief well was installed near the road. The steady state analysis is however conservative as it assumes the river level is at the top of the stopbank for an indefinite time. A 10 day transient analysis was carried out and it was found that acceptable factors of safety against heave should be maintained with the river level high for at least 4 days. The factors of safety then slowly drop with time. It is therefore considered that the clay seal and pressure relief well as shown in Figure 10 should provide an adequate factor of safety in a 300 year return period flood.

It was found that the factor of safety against a slope failure which could reach to the crest of the stopbank under normal river flow condition is only about 1.1. Under bank full conditions the factor of safety increases to 1.3 as the river water helps to support the face. Under rapid drawdown conditions the factor of safety drops below 1.0. It is therefore considered that a rock berm is required along the river bank.

If a 5m wide rock berm is placed against the river bank up to RL3.0, under normal river flow conditions the factor of safety against slope failure should increase to 1.5. Under rapid drawdown from bank full conditions the factor of safety drops to about 1.2. This is considered acceptable in these extreme conditions. The clay seal across the fine sand layer can be placed at the same time as the rock berm.

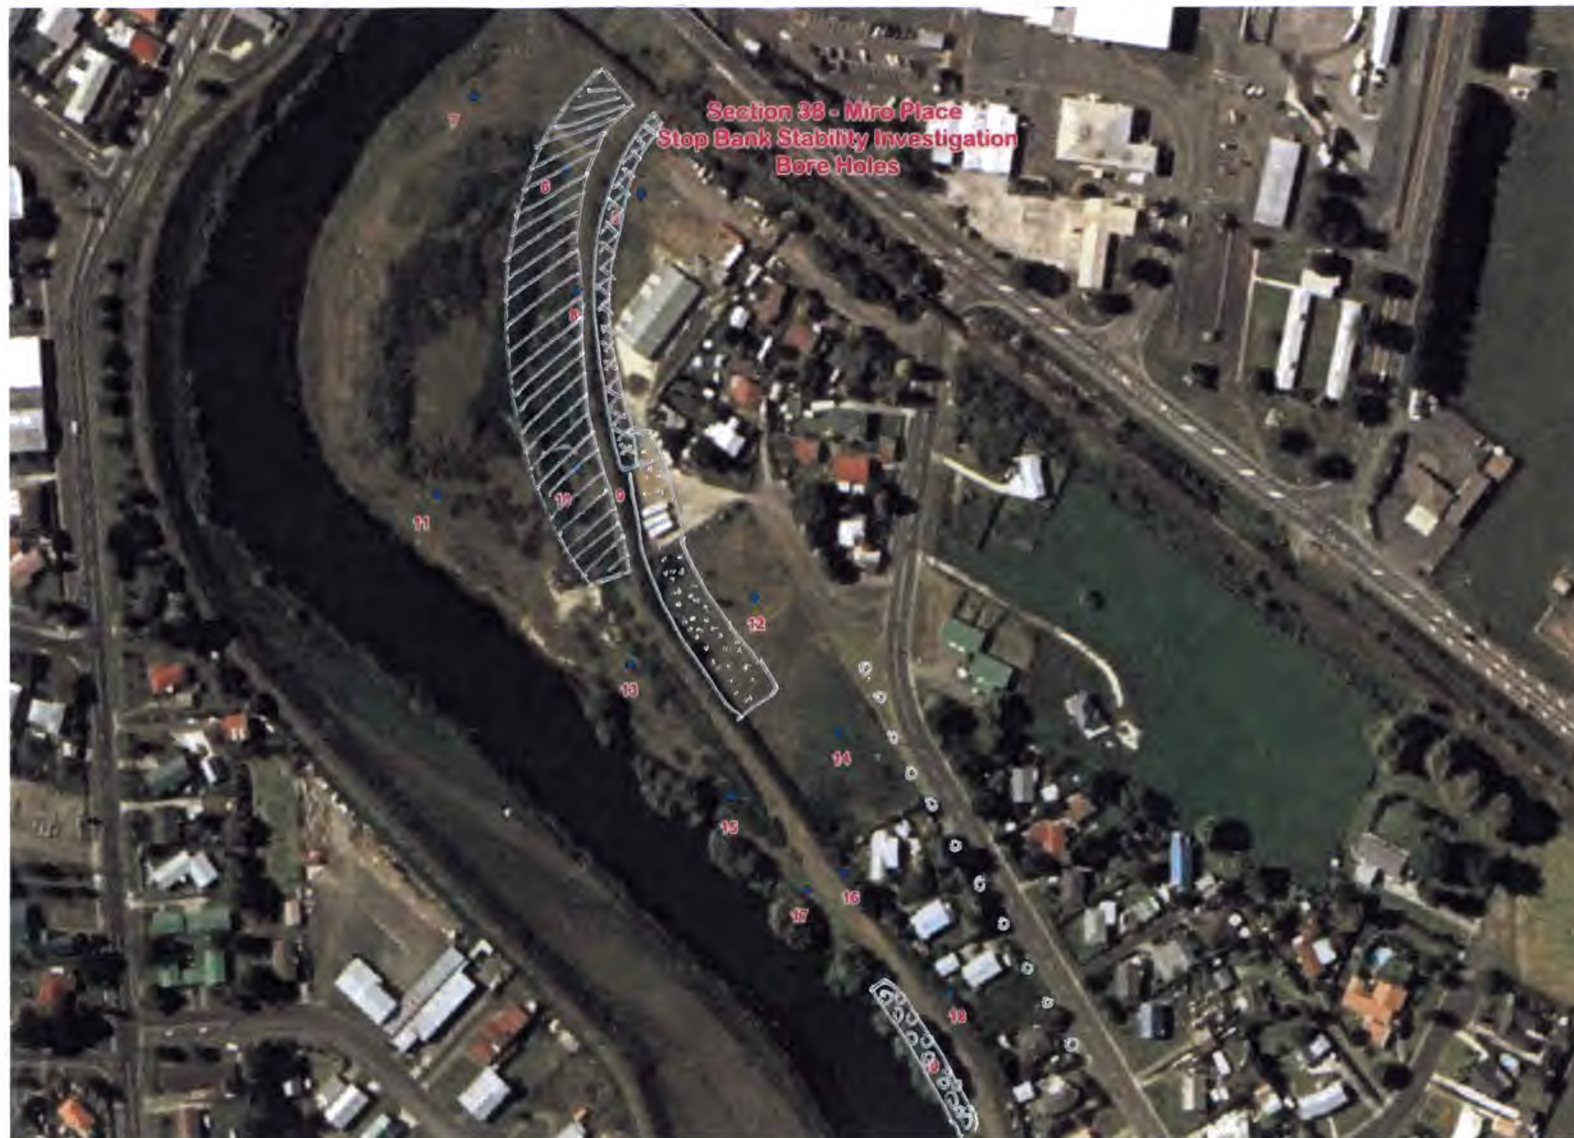
- clay overlay
- re-lay rock berm
- granular overlay
- rock berm
- pressure relief well

1. The coarse sand in the top of the stopbank should be removed and replaced by a lower permeability fill over the entire study length except where there is a clay overlay on the river side of the stopbank.

2. The existing rock berm on the inside of the stopbank should be uplifted, a layer of geotextile placed and then the rock berm replaced and shaped for ease of maintenance.
