Rangitaiki River Stopbanks Assessment

Section 13

Left Bank 10600 to 11200m

Environment Bay of Plenty

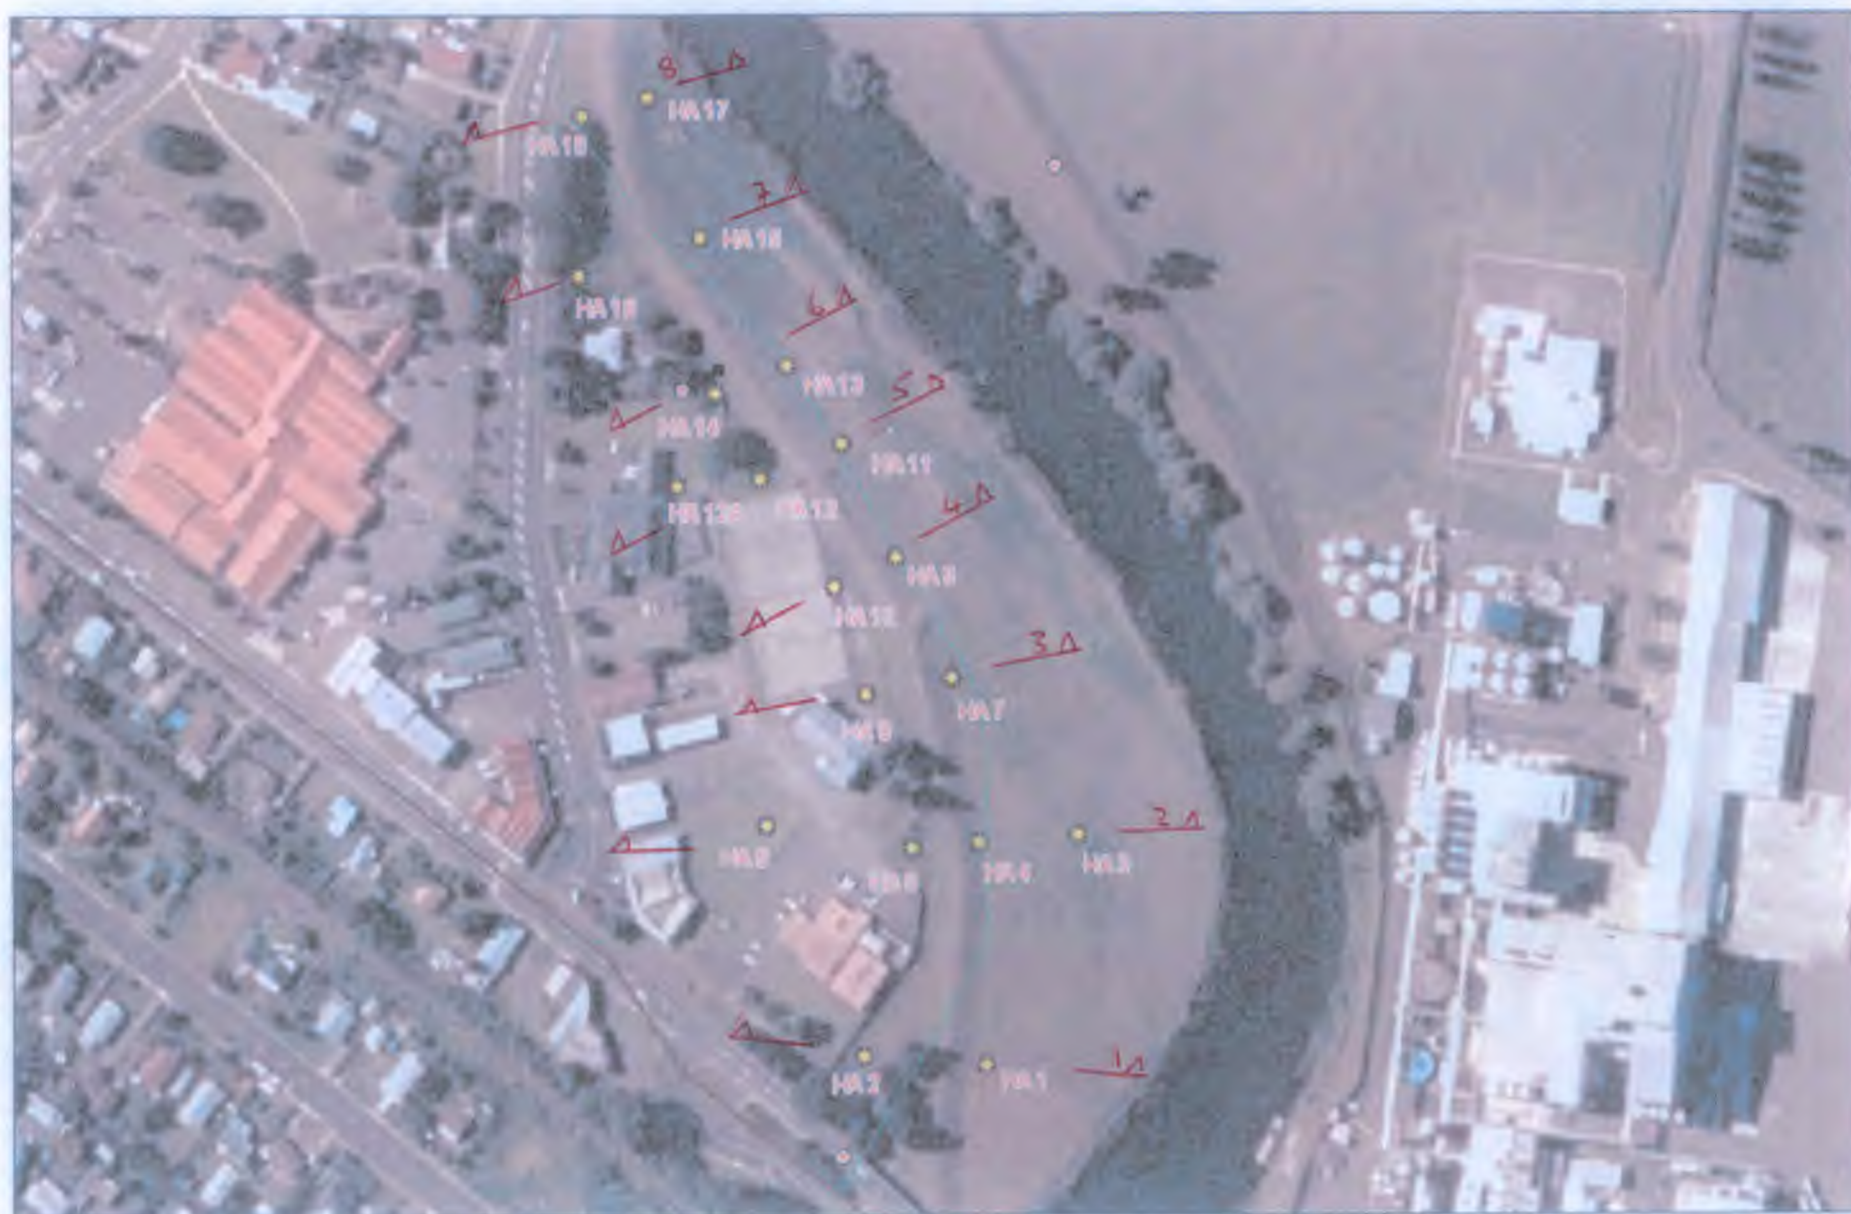
Figure 1

Plan

Rangitaiki River Stopbank
LB 10600 to 11200m

Along the length of the study section the stopbank varies in height from 1.9m to 2.5m. In some areas there is a further small fall away from the stopbank toe. The river berm is typically 40 to 50m wide and is at close to the ground level on the inside of the stopbank. The river berm is narrowest at the downstream end of the study section where it is about 15m wide. There is a bench in the river berm at Cross Section 2 (Figure 1 and 4) where the berm has been used as a borrow area.

The subsurface investigations consisted of 19 hand augers carried out in eight cross sections at roughly 70m intervals along the study length (Figure 1). The location of the hand augers was chosen on the basis of spacing, land owner permission and the presence of underground and overhead services. The hand augers were continued until the holes collapsed below the ground water level or the holes squeezed in. The holes were typically 3.5 to 4.0m deep on the inside of the stopbank and a little shallower on the river berm. The hand auger logs are included in Appendix A.

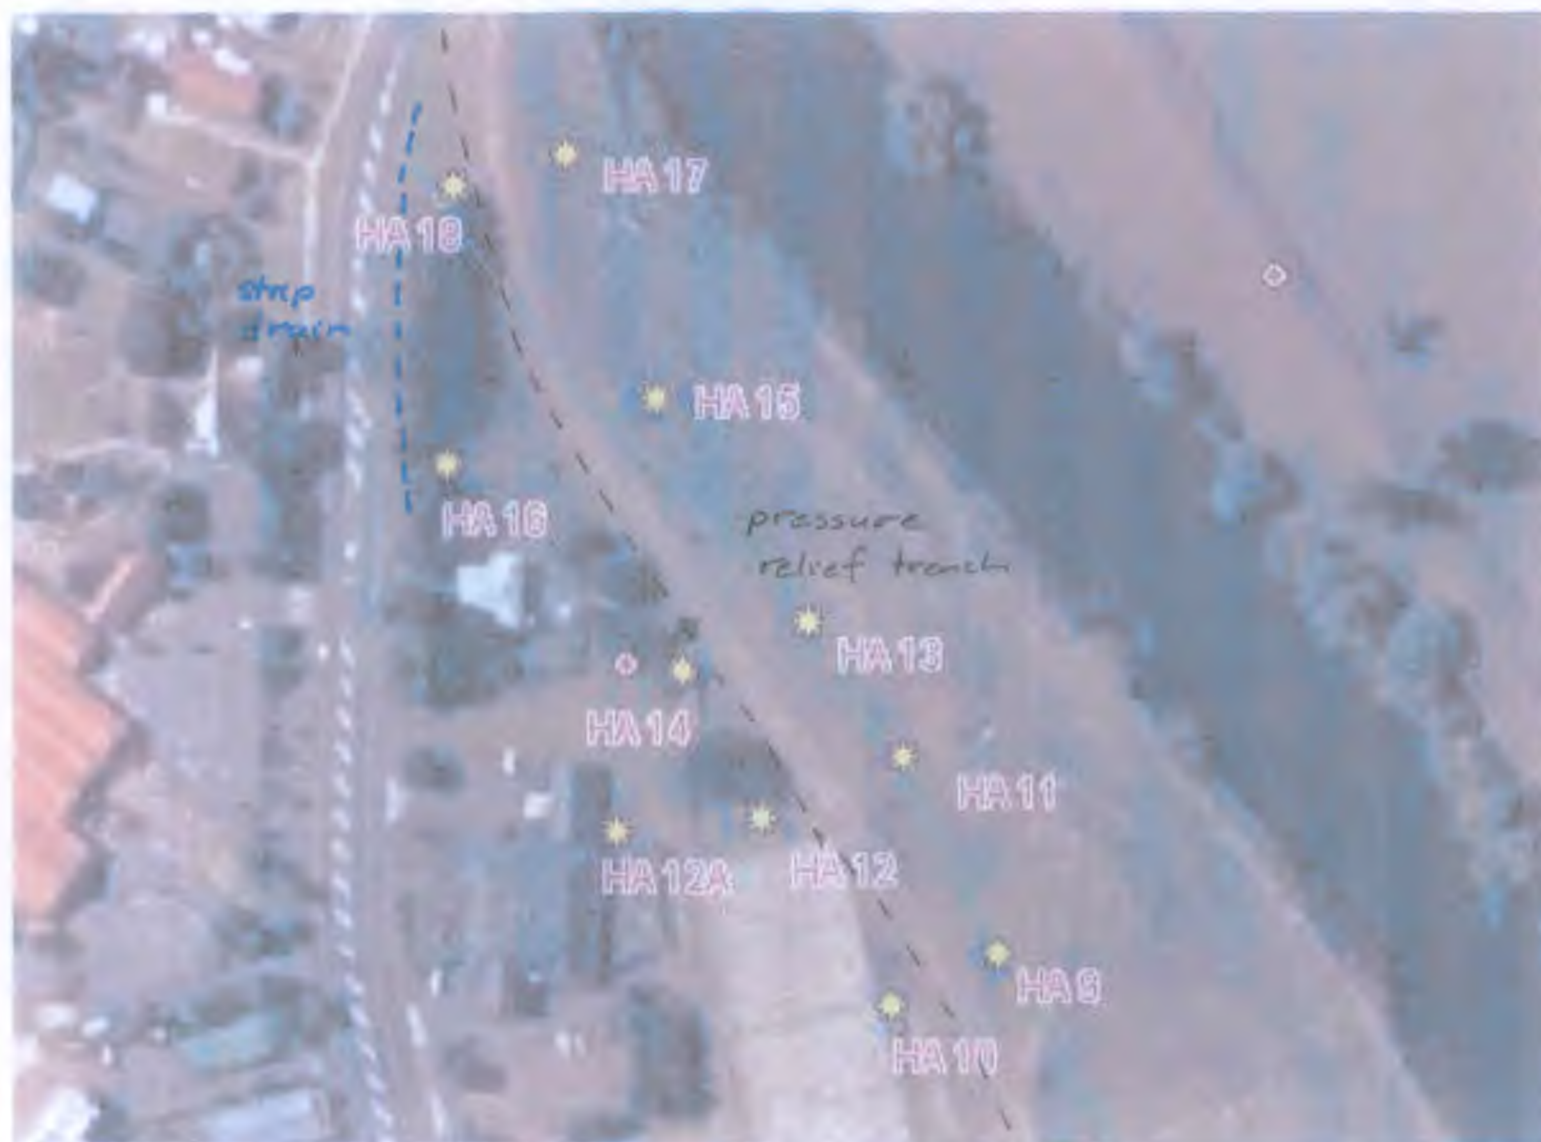
Remedial measures

1. Extensive remedial trenches in the form of pressure relief trenches and / or overlays are required along the whole length of stopbank LB 10600 to 11200m (Figure 11).
2. The freeboard for the design 100 year flood should be checked along the stopbank.
3. The recommended pressure relief trenches could produce large volumes of water over a significant flood. A check should be made to see that the town's stormwater system can take the increased flow.
4. An old rubbish pit was found at Cross Section 6. This should be dug out and replaced with compacted silty soil.
5. The excavation of the pressure relief trenches should be supervised to ensure the highly permeable soil layers are reached.
6. Investigations should be carried out along the edge of the tennis courts and squash club building to see if further pressure relief is required.

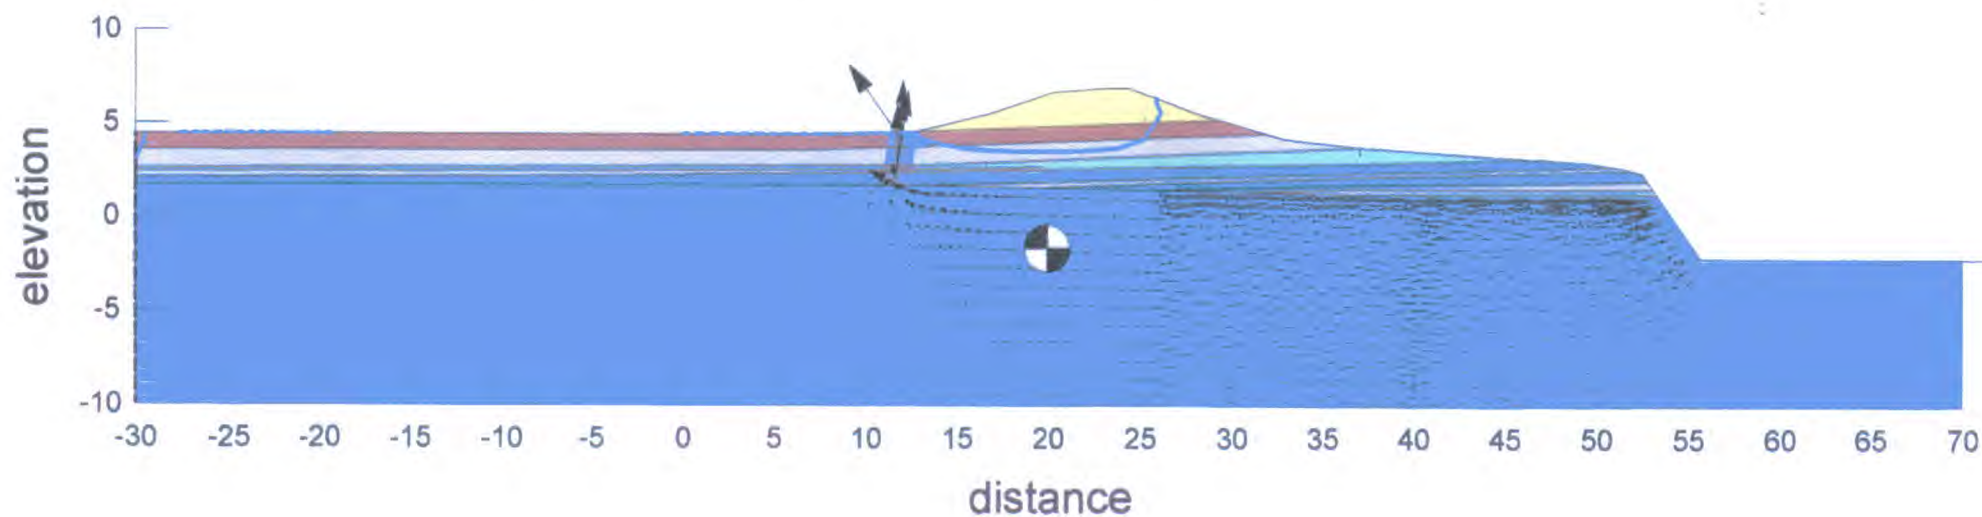
Name: section 8 100 yr.gsz
 Title: Rangitiaki Stopbanks Section 13
 Comments: cross section 8 100 yr flood
 Date: 10/08/2006 Time: 11:03:58 p.m.

time step 40 -80 hours

toe well
