Rangitaiki River Stopbanks Assessment

Section 15

Left Bank 9300 to 9900m

Environment Bay of Plenty

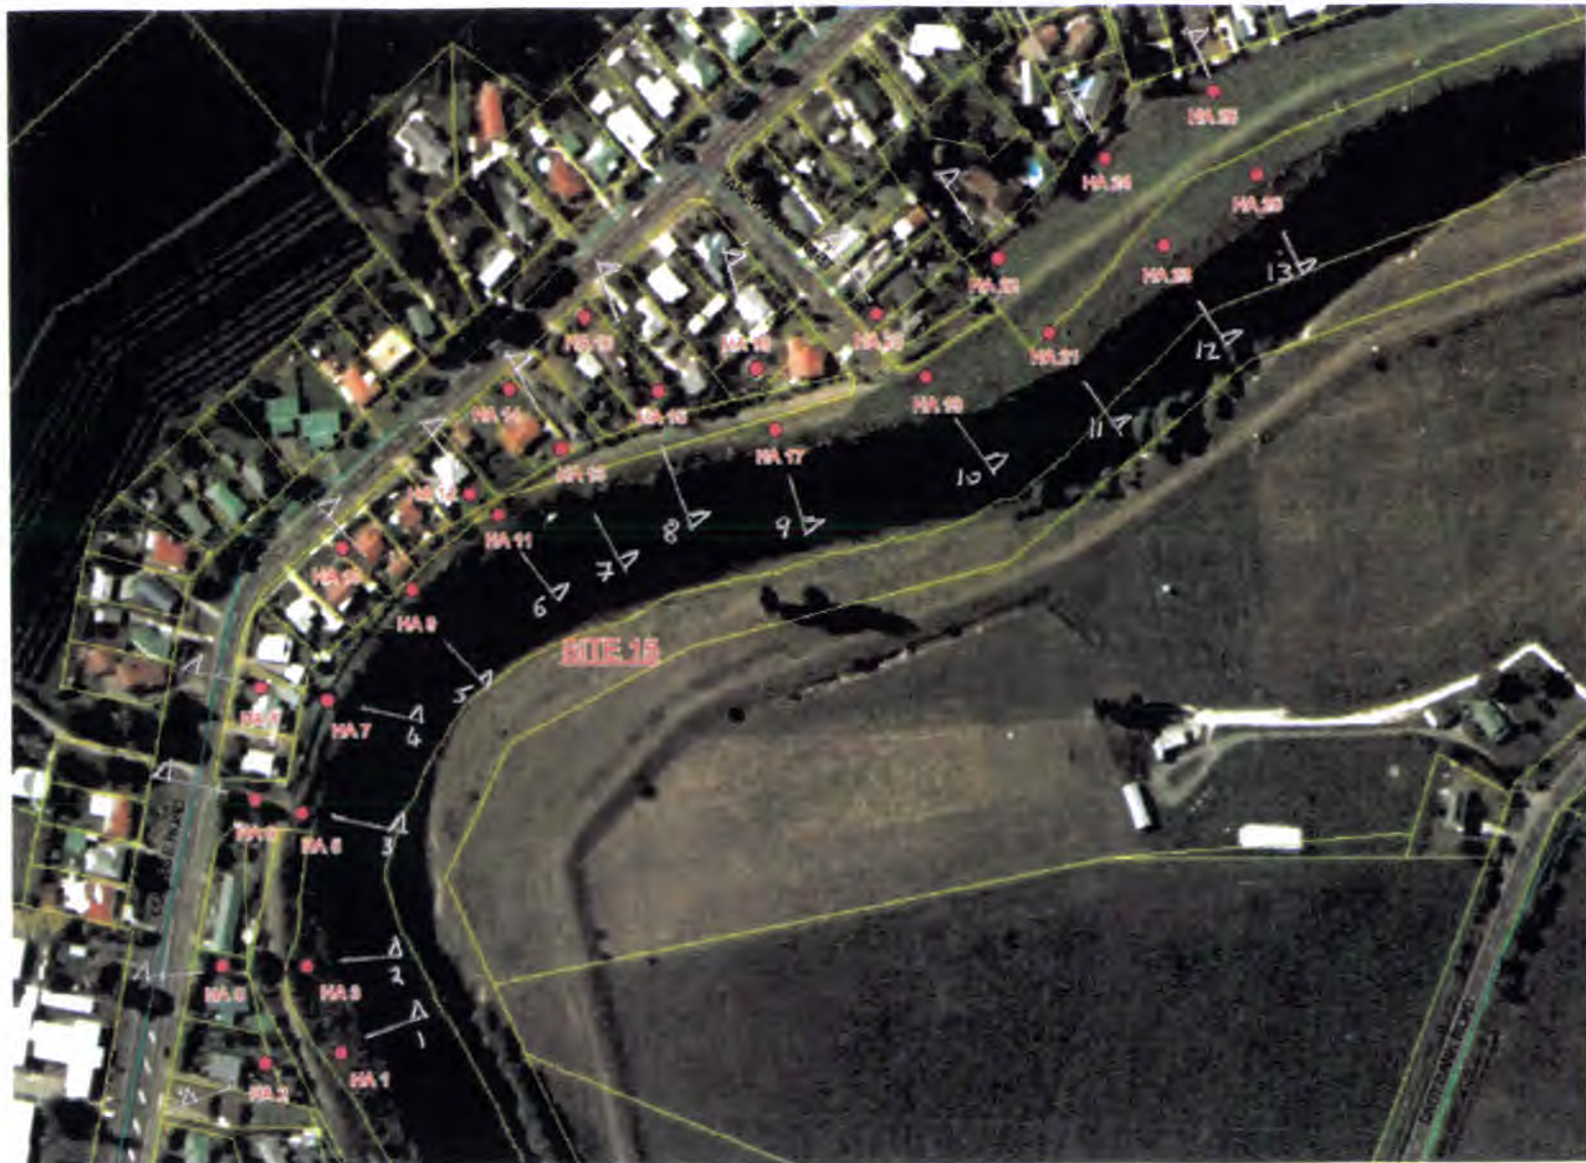
Along this section of stopbank there is a wide variation in stopbank geometry. Over the first 100m the stopbank is about 1.8m above the surrounding land and there is a 5 to 10m wide berm 2 to 3m below the general ground level (Figure 1). (Meterages given are from the upstream end of the study section.)

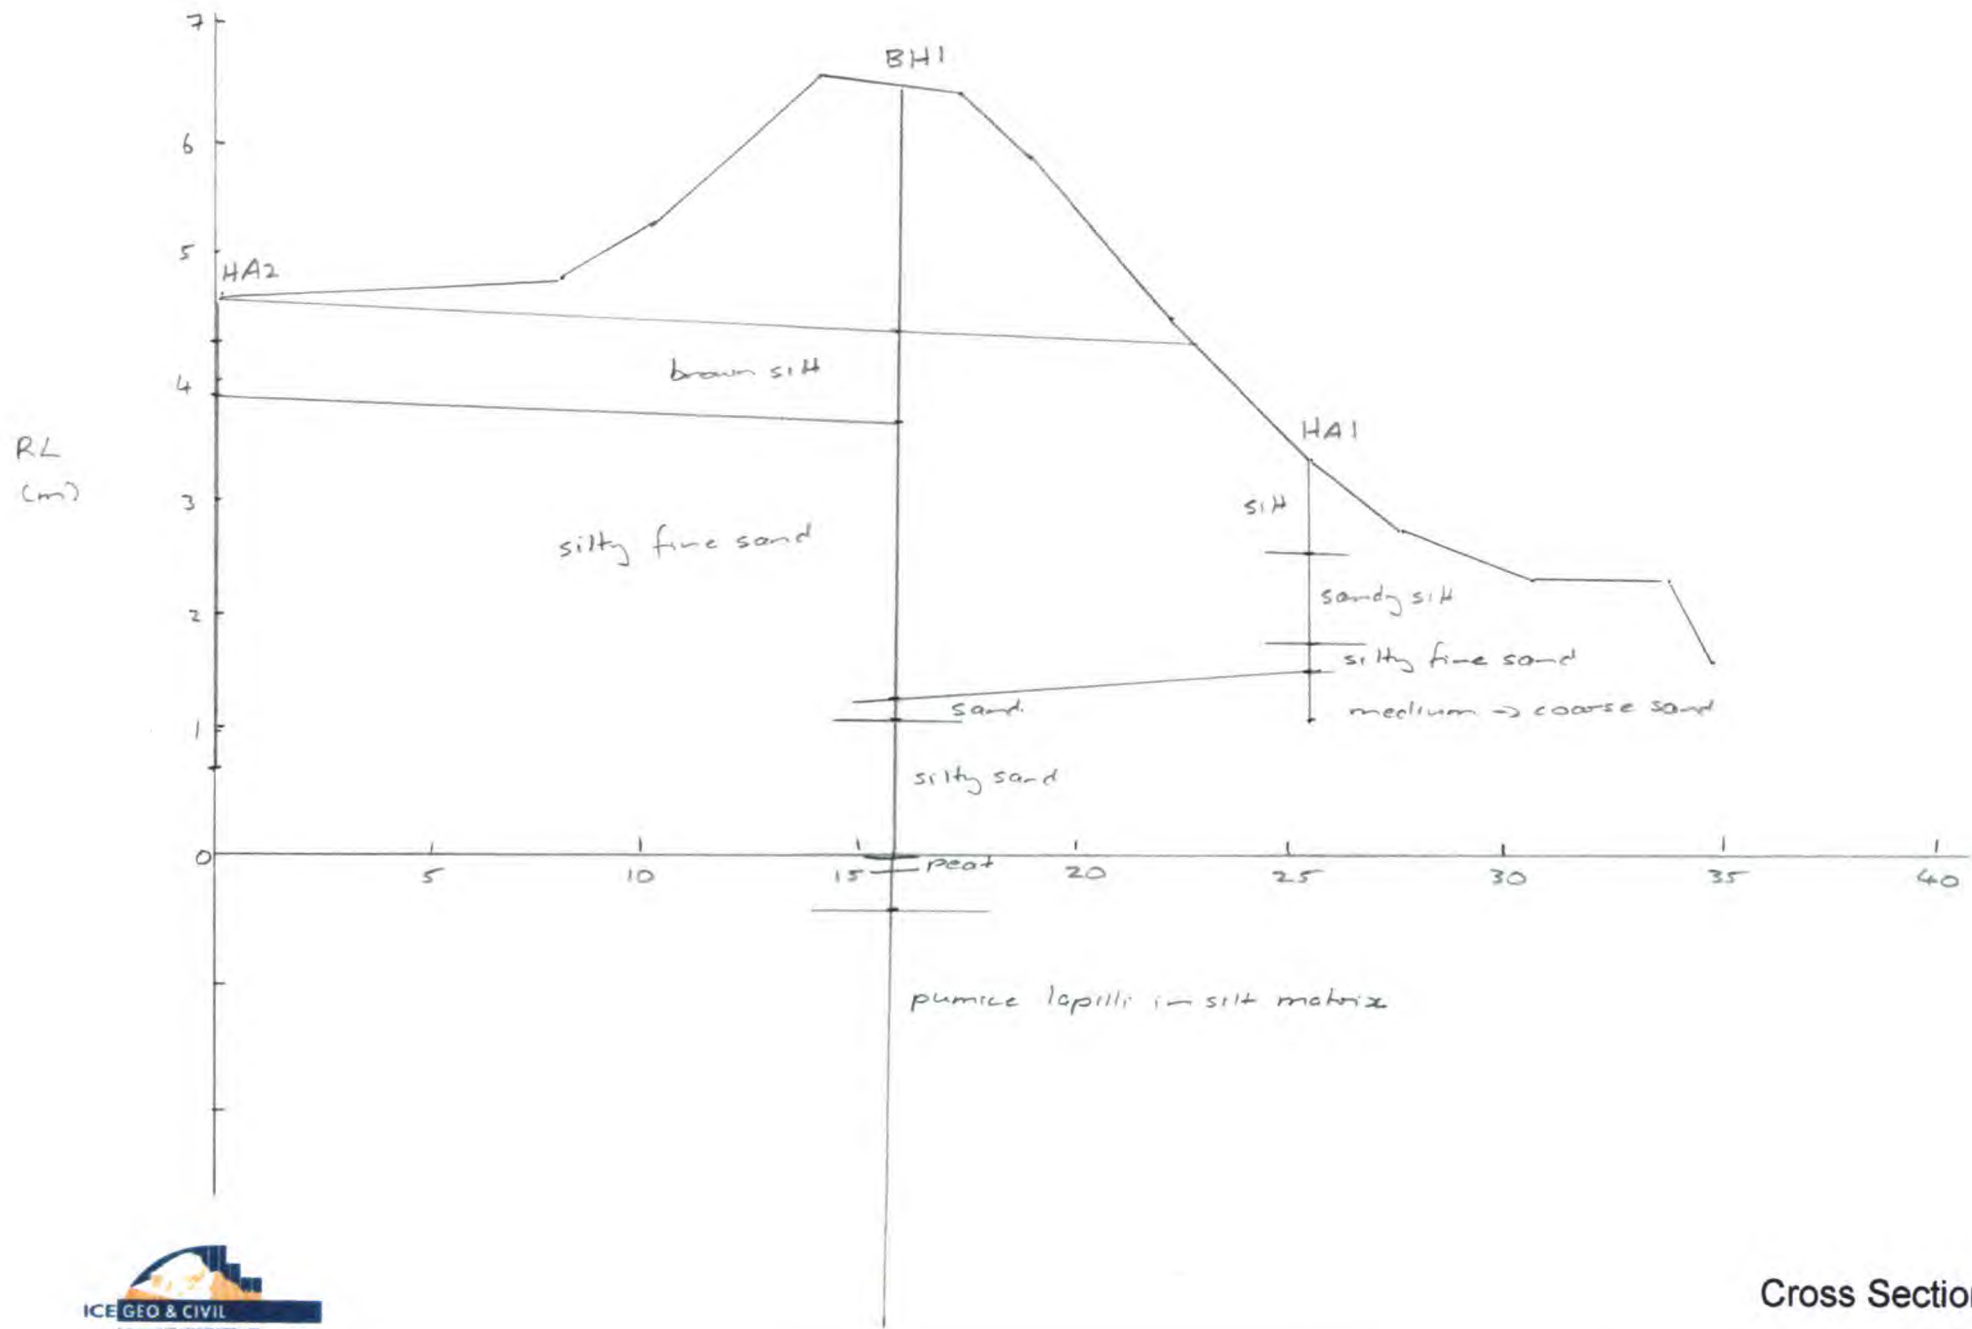
Cross Section 1

Medium to coarse sand was found 1.4m below the ground surface at HA1 on the river berm. Above this level there are layers of silt and silty fine sand. BH1 was drilled through the stopbank to determine the thickness of this sand layer as it has a considerable effect on the seepage pressures on the inside of the stopbank. It was found there is only a 200mm thick layer of coarse sand below the stopbank and there are thin layers of silty sand, fine sand and peat below it. For the purposes of the seepage analysis the basement layer consists of a low permeability layer of pumice lapilli in a silt matrix.

The transient flood analysis carried out assuming the permeabilities given in Table 4 showed that there should not be any seepage or uplift problems with this section of stopbank. As the laboratory test on the silty sand layer showed a permeability of about 3.0×10^{-5} m/s another analysis was carried out assuming this permeability in case the laboratory result was not due to testing problems. It was found that the factors of safety were still acceptable for this permeability. Another analysis was carried out increasing the permeability of the coarse sand to 1×10^{-4} m/s in case the permeability estimated using the Hazen formula is an under-estimate. This analysis also resulted in acceptable factors of safety.

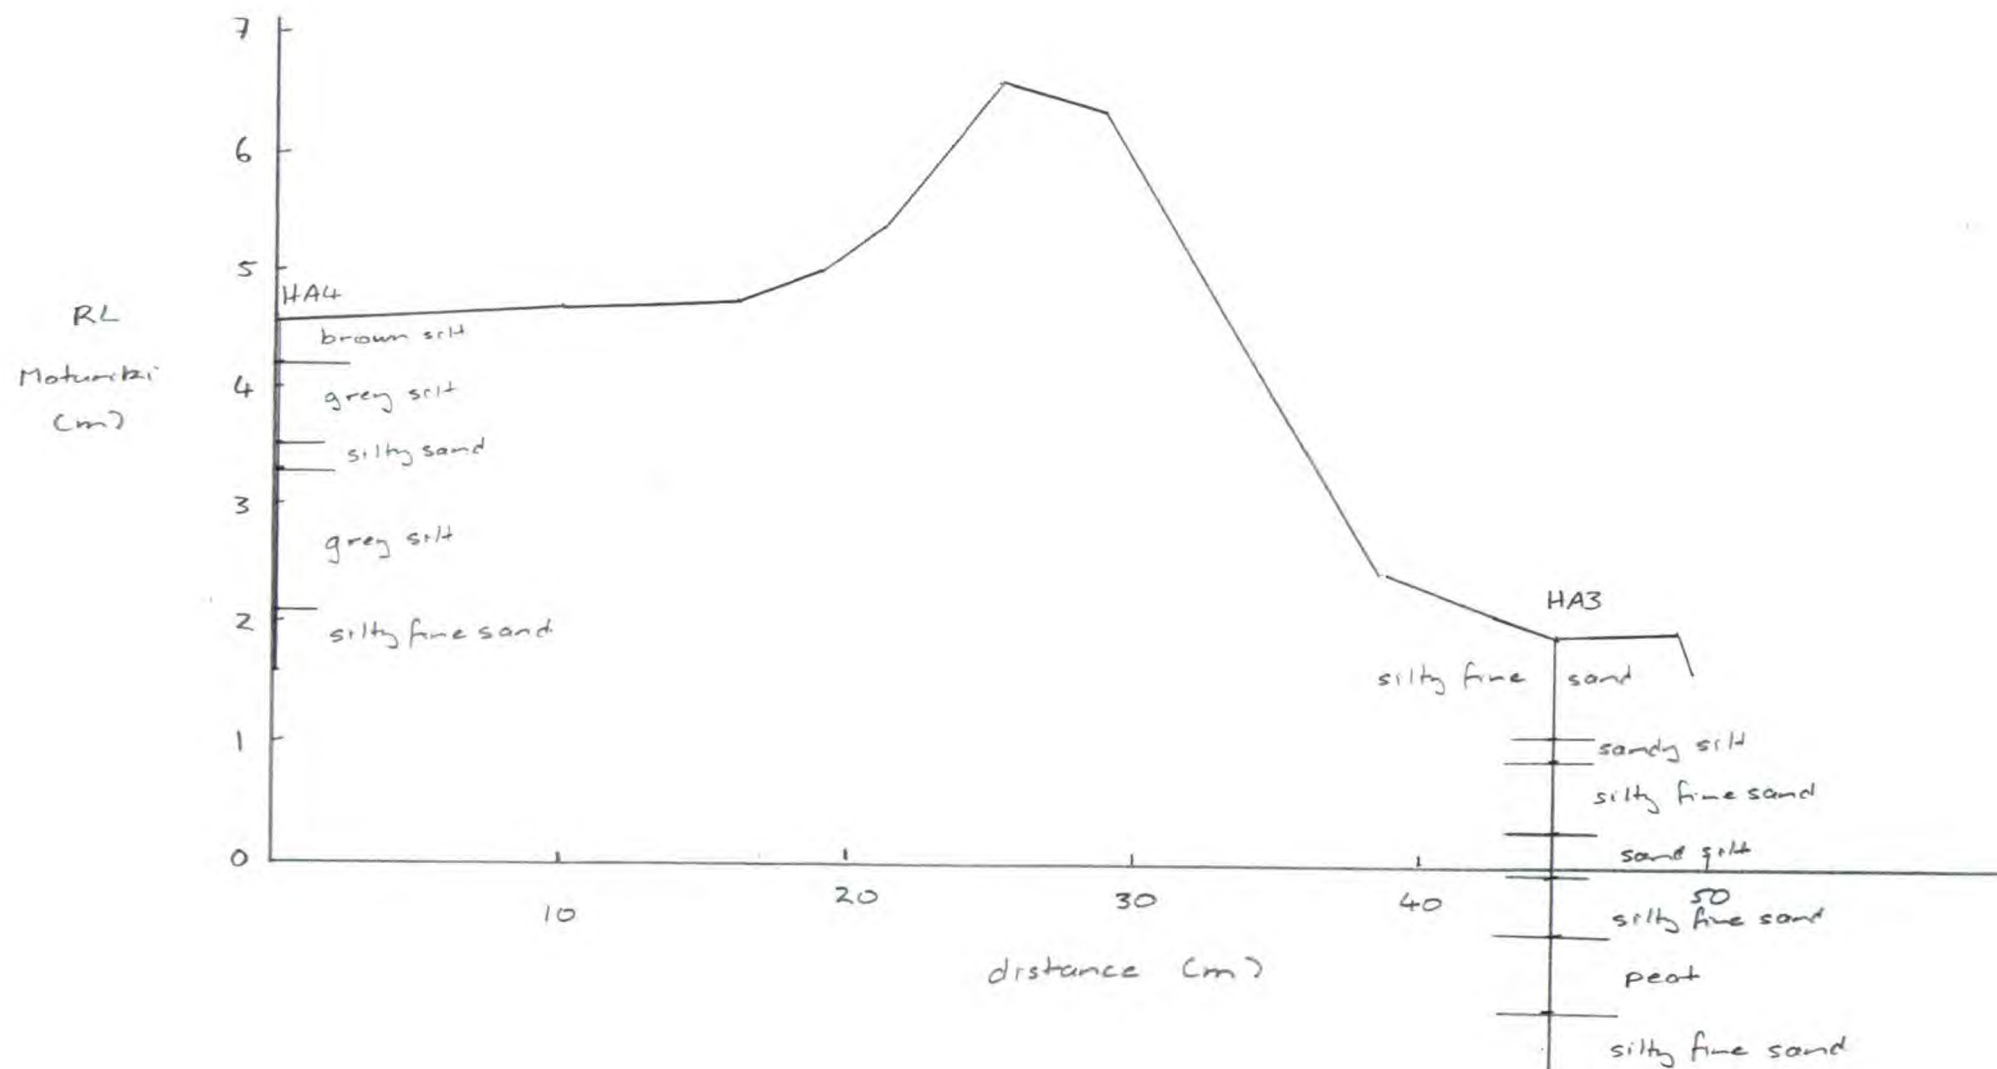
The geometry of the stopbank at Cross Section 2 is similar to that at Cross Section 1 (Figure 4). On the inland side of the stopbank there is a layer of grey silt below the surface brown ashes extending to 1.1m depth. Below this there is silty fine sand. Silty fine sands and sandy silts were found below the river berm in HA4. A 500mm thick layer of peat was found at RL-0.6 and no coarse sands were found above RL-1.4. It was assumed in the analyses that there is silty fine sand extending to RL-4.5 and then the layer of pumice lapilli in a silt matrix found in BH1. This layer was found at RL-0.6 in both BH1 and BH2, and at RL0.0 in a borehole through the stopbank near 35 College Road.

A transient flood flow analysis was carried out as for Cross Section 1. It was found that there should be no seepage problems with this section of stopbank with the assumed soil properties and profile. As for Cross Section 1 a sensitivity analysis was carried out assuming a permeability of 3×10^{-5} m/s for the silty fine sand. A factor of safety against heave of 1.3 was found for this analysis. Only a small reduction in FOS was found when this analysis was repeated with a 1m thick layer of coarse sand just below the depth of HA3.

The slope stability of this section of stopbank was assessed under rapid drawdown conditions when the water level within the stopbank is higher than the river. The soil strength parameters assumed are given in Table 5. A factor of safety against slope failure close to 1.6 was obtained. This is considered acceptable. As Cross Section 1 has a similar geometry it has been assumed that this cross section also has adequate stability.

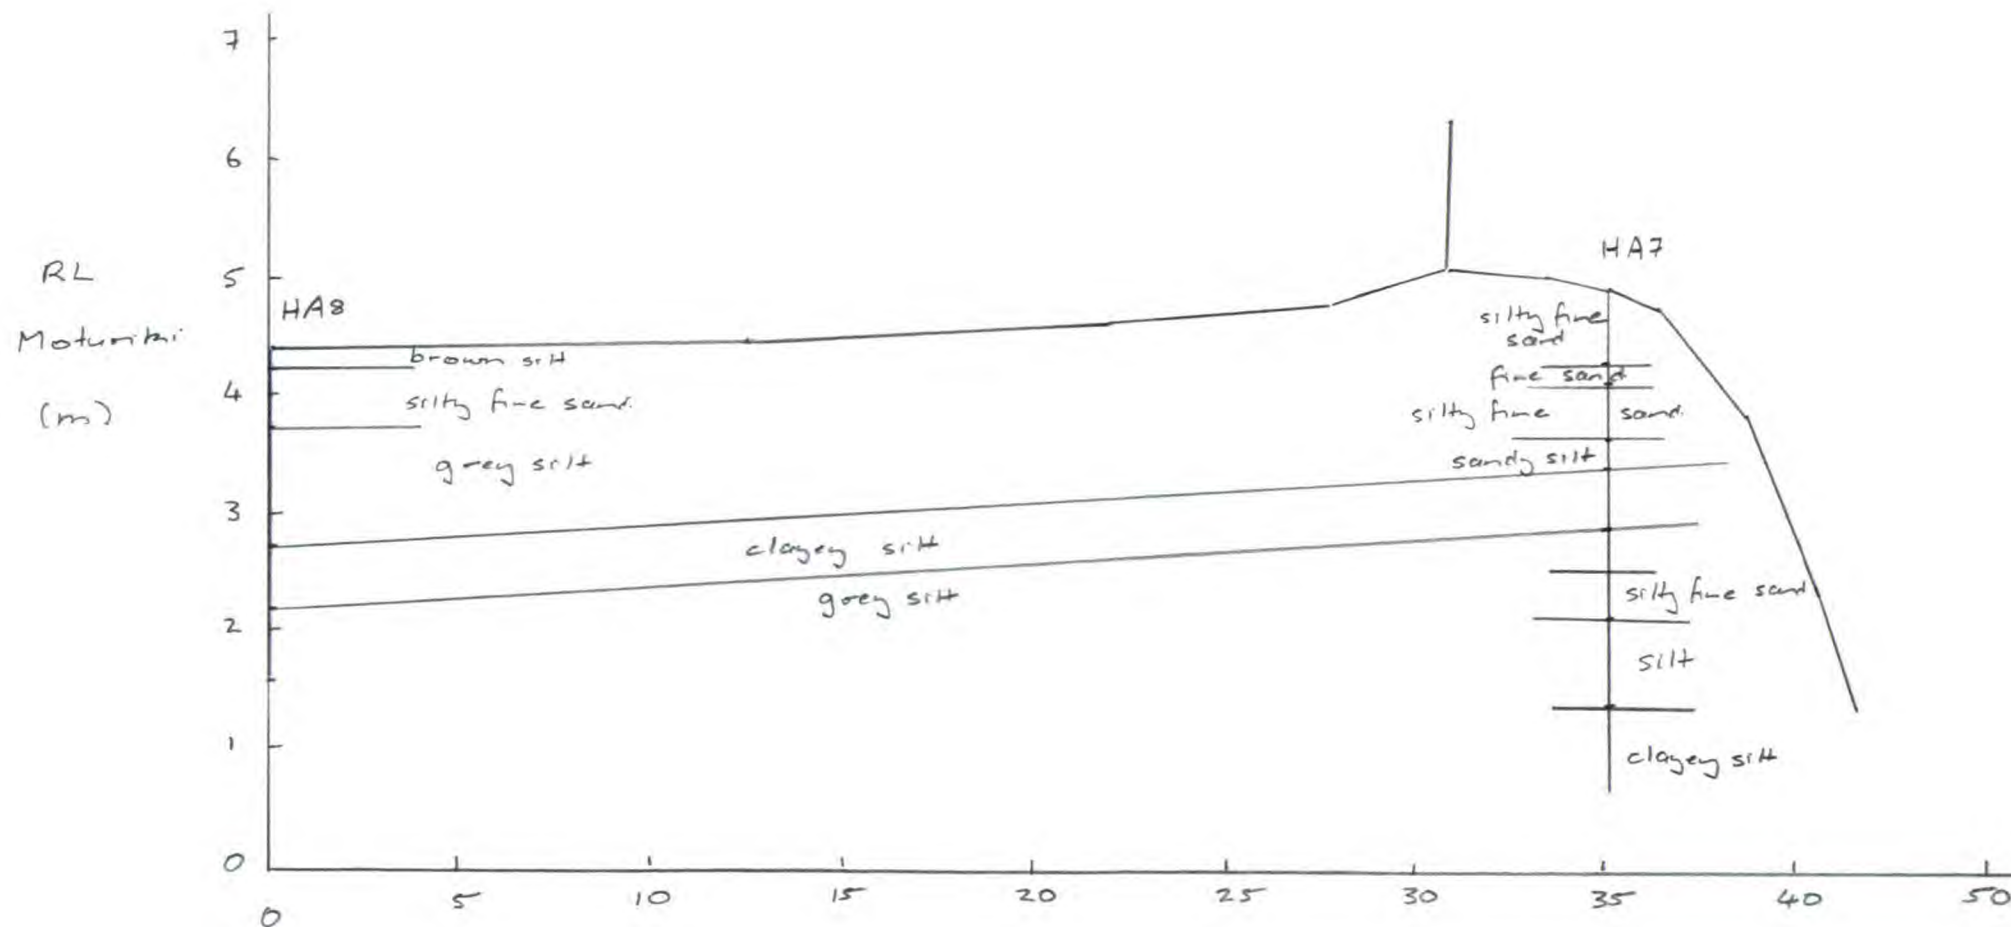
Figure 5

The soils found at cross sections 3, 4, 5 and 6 consist of complex layers of silts, clayey silts and silty fine sands. The flood wall is up to 1.3m high at cross sections 4, 5 and 6 and there is no wall at Cross Section 3. However as the river bank has a similar geometry at all four cross sections it was decided to analyse Cross Section 4 only because it has the thickest layers of silty fine sands and clayey silts at the greatest depth of the four cross sections. Cross Section 4 also has the highest floodwall and hence the narrowest stopbank. The results from the analysis of Cross Section 4 should therefore be conservative when applied to the other cross sections.

A failure of the river bank adjacent to the flood wall was observed in 2004. This may have been due to scour at the toe or very rapid drawdown when the stopbank burst upstream. A stability analysis showed that when the river is high this section of stopbank should have adequate stability, but when the river drops to RL 2.0 the factor of safety against slope failure drops to 1.15. This factor of safety is considered to be unacceptably low for static conditions.

The placement of a 5m wide berm against the river bank up to RL 2.0 should improve the factor of safety against slope failure to more than 1.5 for all conditions in the river.

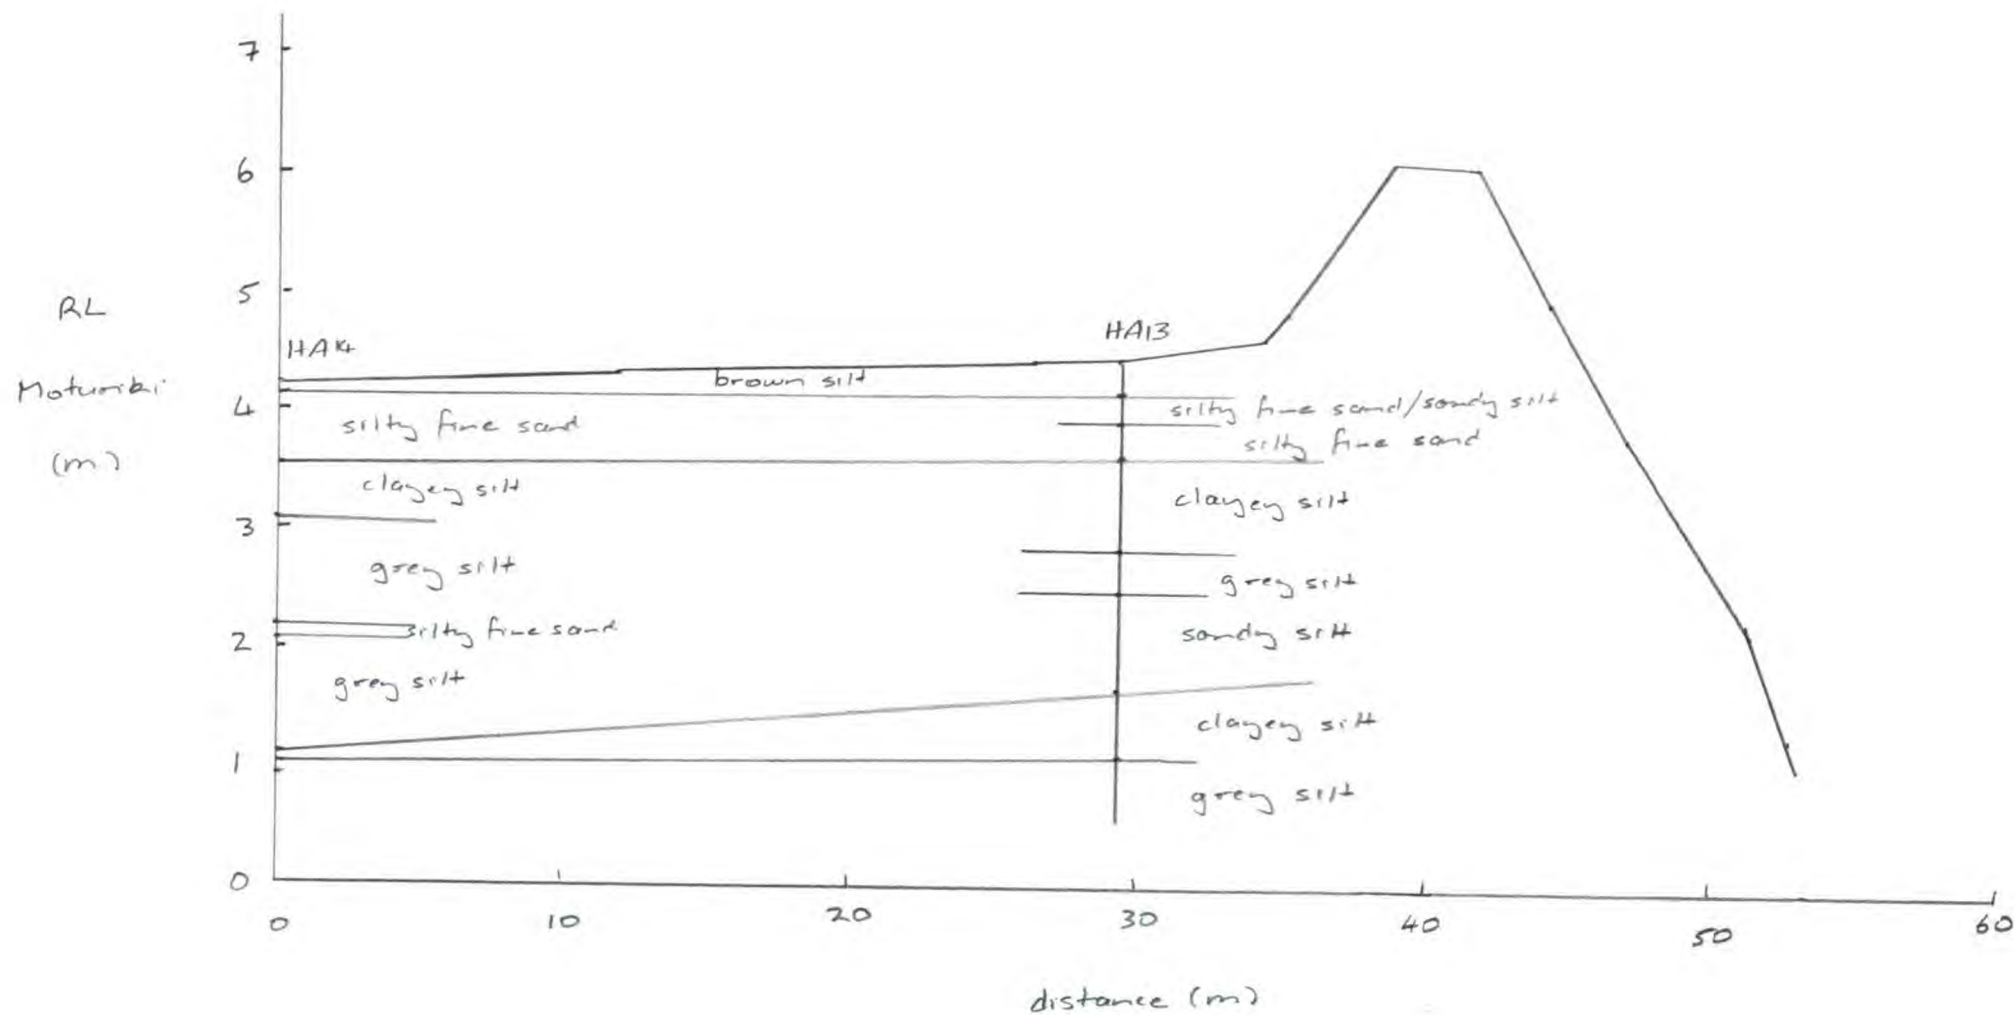
Figure 6

At cross sections 7 and 8 the stopbank is about 1.9m high and there is no river berm. The investigations showed a layer of silty fine sand below a thin layer of brown silt at Cross Section 7 (Figure 6). Below this sand are layers of silt, sandy silt and clayey silt. A 100mm thick layer of fine to medium sand was found at RL 1.1 in HA14 but there did not appear to be a corresponding layer in HA14 closer to the river. Only a thin silty sand layer was found at 2.0m depth in HA15 on Cross Section 8. Therefore the results from the analysis of Cross Section 7 would be conservative when applied to Cross Section 8.

It was assumed in the soil model used in the transient analysis that there was a 1.3m thick layer of sands with a permeability of 1×10^{-4} m/s below the depth of the hand augers and then a layer of pumice lapilli in a silt matrix as found in BH2 down stream. The only seepage problem identified in the analysis was the slight possibility of the heave of the upper brown silt layer. An analysis was carried out assuming a hole in this layer and it was found that the hydraulic exit gradient not high enough to encourage piping of the silty sand below.

The stability analyses of this cross section indicated a factor of safety against slope failure of about 1.2 for both rapid drawdown and low river level conditions. Some stabilising work is therefore required here as for cross sections 3 to 6.

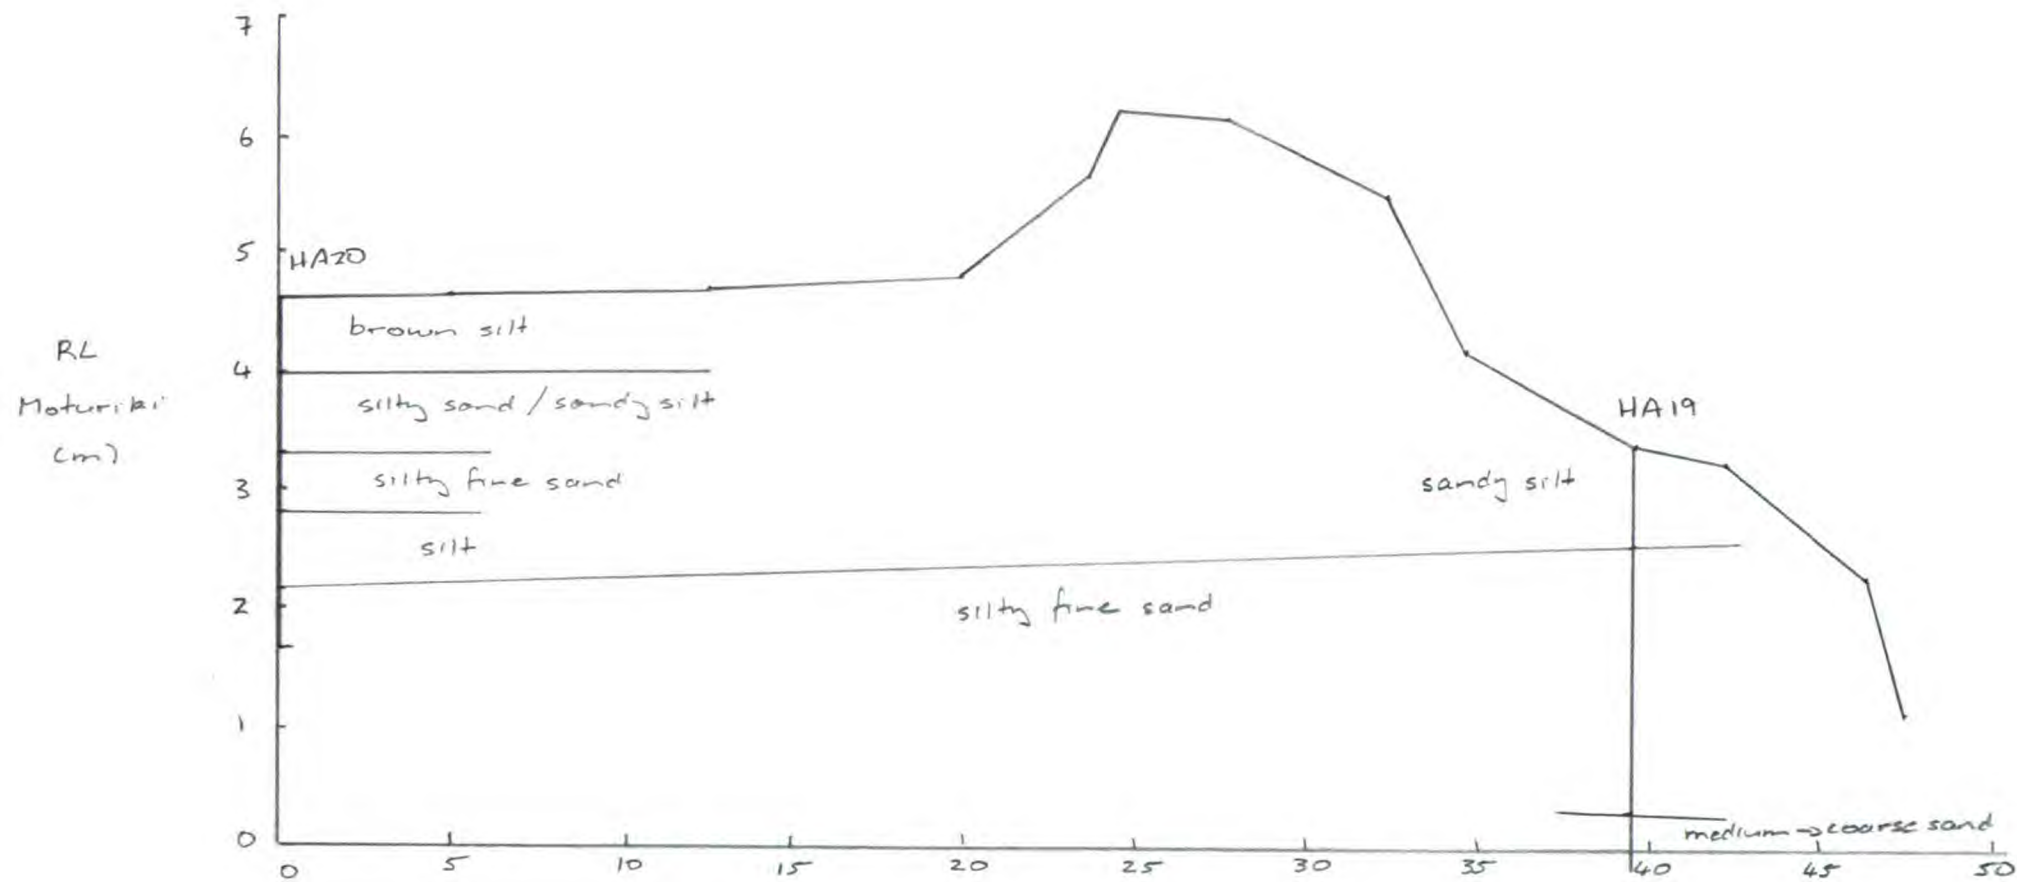
At Cross Section 9 the stopbank is about 1.8m high and there is a narrow river berm (Figure 7). The river bank is lined with rock at this location. The hand augers showed layers of silts, sandy silts and silty fine sands. A clayey silt layer was found at 3.4m depth below the river berm. Initial seepage analyses carried out assuming sands below the depth of the hand augers did not produce conclusive results. BH2 was therefore drilled through the stopbank to confirm the soil types below the depth of the hand augers. It was found that the silty fine sands and silts extend to RL 0.3 and are underlain by about 1m of banded fine to medium sands and then pumice lapilli in a silt matrix.

The factors of safety against slope failure of the stopbank are acceptable for all river levels and drawdown conditions due to the presence of the small river berm at this cross section.

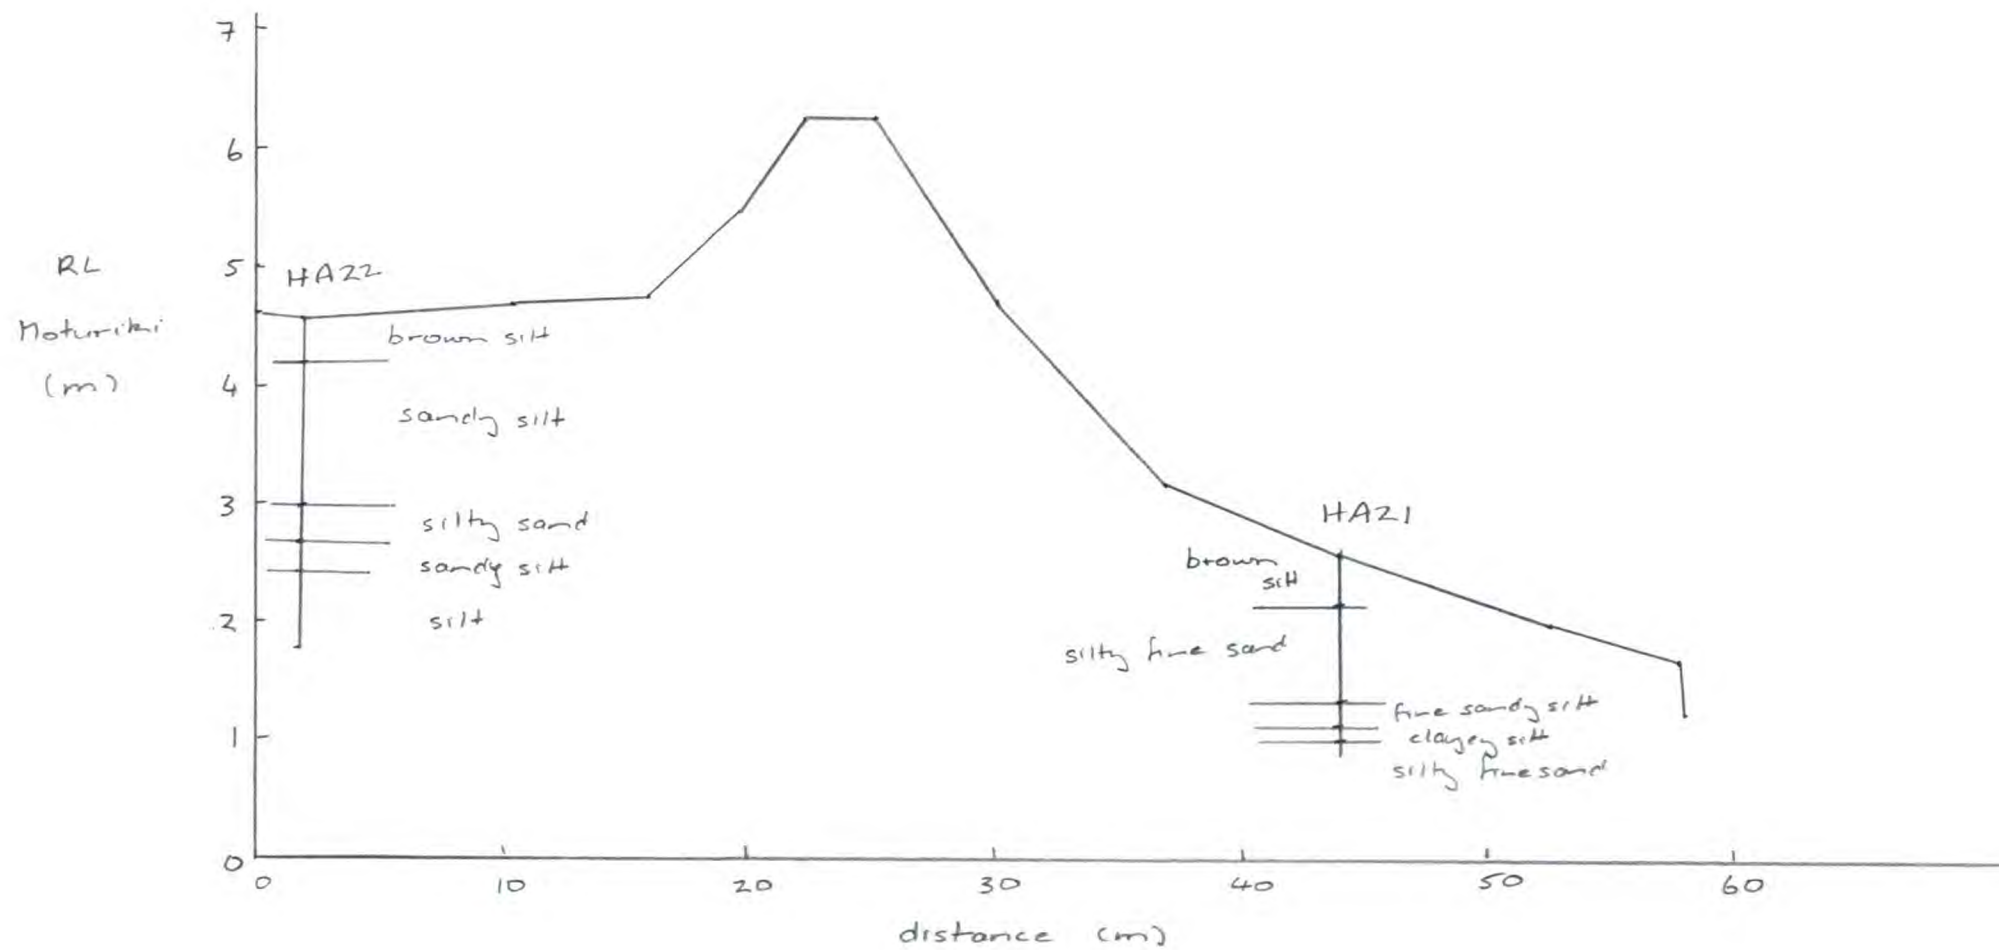
Cross Section 11

Cross sections 11 and 12 have a similar geometry with a low wide river berm (Figure 9). No clean sands were found within the depth of the hand augers and there are no silty fine sands within 2.5m of the ground surface.

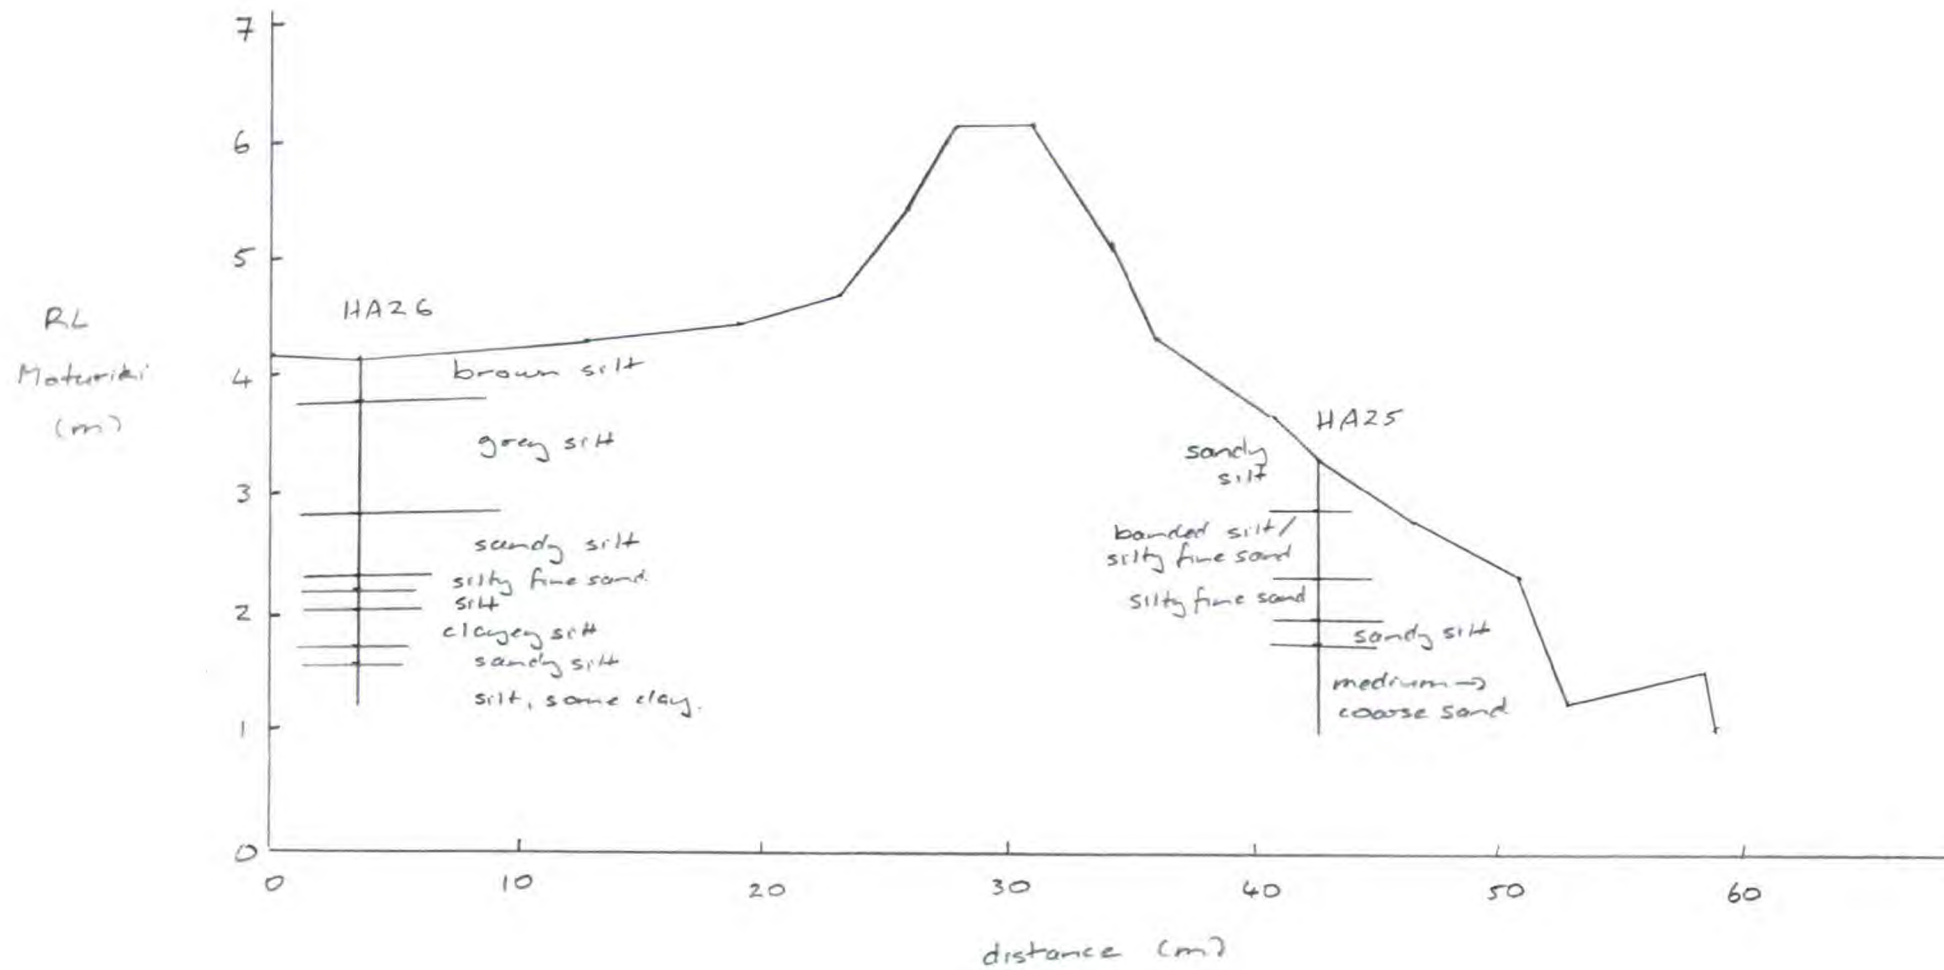
Figure 10

Cross Section 13 slightly over-laps the upstream end of the previously investigated Section 2. The shallowest silty fine sand layer was found at 1.8m below the ground surface (Figure 10). Banded silty fine sands and silts were found below the river berm. The only high permeability layer found is a medium to coarse sand at 1.6m depth below the river berm.

The permeabilities shown in Table 4 were used in the transient seepage analysis. The vertical permeability of the banded sand/silt layer was assumed to be that of a silt and the horizontal that of a silty fine sand. A 3m thick layer of medium to coarse sand with a permeability of 5×10^{-4} m/s was assumed below the depth of the investigations. The lowest factor of safety found against uplift of the surface low permeability layers was greater than 1.2. Therefore it is considered that no work is required at this cross section; which confirms the findings of the Section 2 investigations.

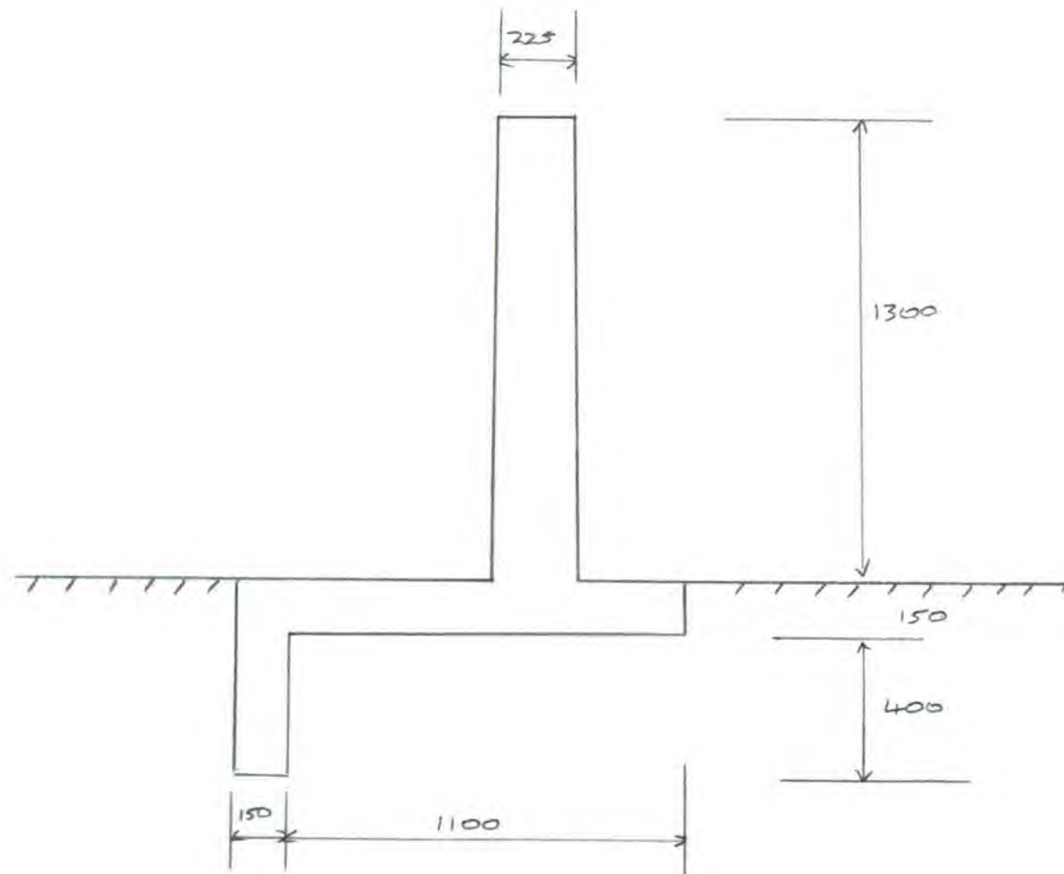
Figure 11 shows a cross section of the floodwall. The original floodwall consisted of a 600mm high upstand on a strip footing and just provided the freeboard above the flood level. After the 1987 earthquake the height of the upstand was raised about 700mm and the key was added to the foundation on the river side.

The stability of the highest section of exposed floodwall has been assessed and found to be acceptable under flood conditions. Seepage beneath the floodwall has also been assessed and it was found that the factor of safety against piping beneath the wall is close to 1.0 at the toe of the wall. The hydraulic exit gradient can be reduced to an acceptable level by installing a 200mm wide by 400mm deep, or a 400mm wide by 200mm deep filter drain along the inland toe of the foundation as shown on Figure 11. This drain should be extended until less than 1100mm of the wall is exposed.
