Rangitaiki River Stopbanks Assessment

Section 2

Left Bank 9100 to 9300m

Environment Bay of Plenty

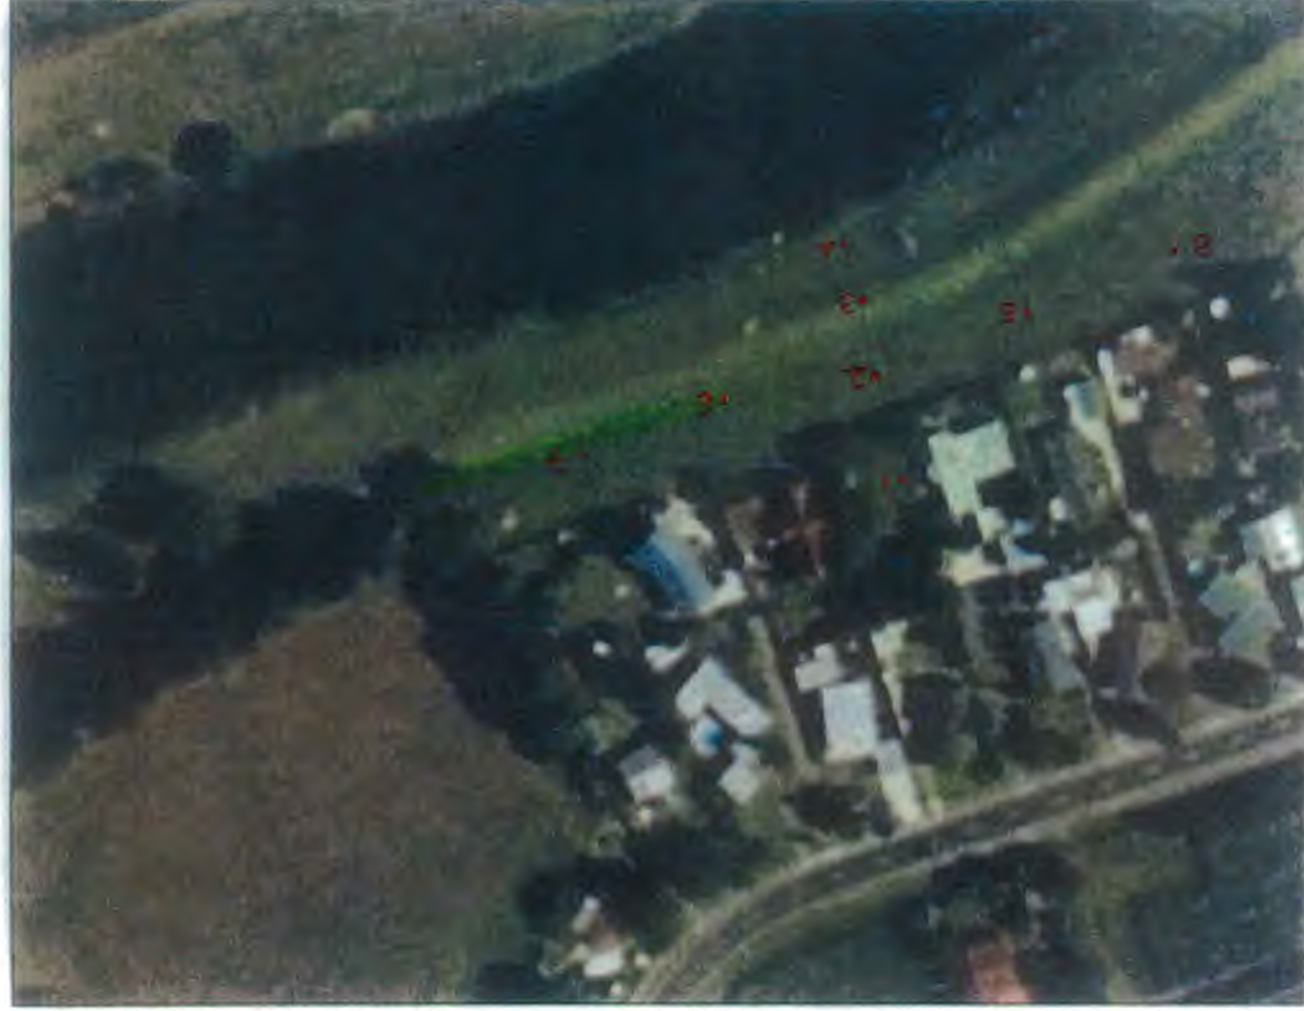
Plan showing hand auger locations

The insitu investigations initially consisted of six hand augers continued to up to 5.4m depth. Two further hand augers were carried out upstream and downstream of the initial augers to check the extent of the required remedial measures. Figure 1 shows the location of the holes and the hand auger logs are included in Appendix A.

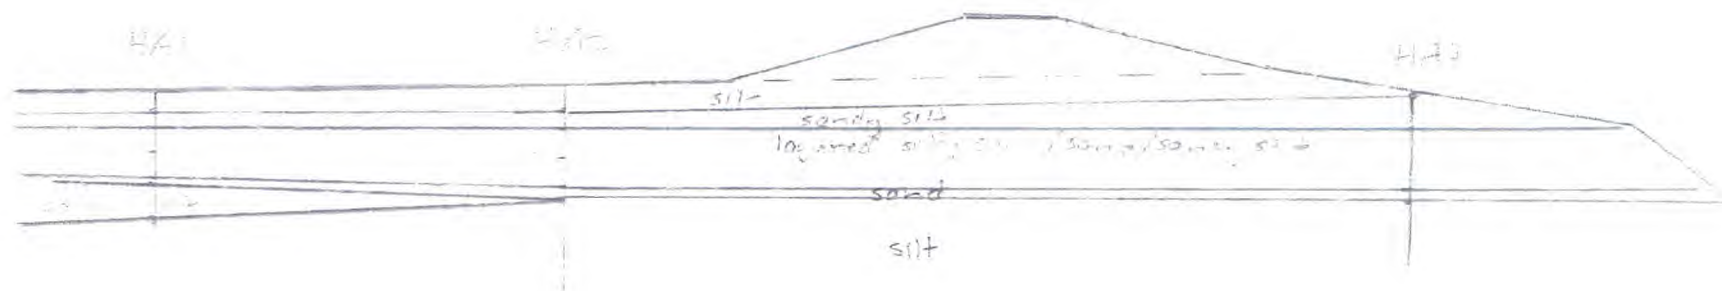
Figure 2

Figures 2 to 4 show the assumed soil profiles of three sections through the stopbank. The sections were surveyed by EBoP staff. Table 1 summarises the soil layers found on an approximate long section behind the stopbank.

Cross section 2
Scale 1:200

Cross Section 2 is in the middle of the area investigated and runs through 163 College Rd. As this was where problems were observed in July 2004 this cross section was analysed first.

An initial static seepage analysis was carried out assuming a ground water level of RL2.1 on the inland side of the model and a river level of RL2.0. A transient seepage analysis was then carried out modelling the full eight days of the 100 year flood. A two hour time step was used.

An allowance was made in the soil model for seepage from the ground surface inland from the stopbank. At about 3.5 days it was found that close to where the paving stones settled the water pressure below the upper silt layer was 8.5 kPa (HA1). The upper silt layer here was found to be 0.7m thick which corresponds to a weight of about 11kPa. If the silt layer is only 0.6m thick as found in some other places the soil weight would be only 9kPa and the factor of safety against heave less than 1.1. This small difference between the weight of the silt and the pressure below it would account for the spongy feel of the ground. Some shallow excavation could have been carried out for the placement of paving stones which would have allowed increased seepage through the silt layer.

The water pressures below the silt layer appear to decrease in both directions away from the location of HA1. The estimated maximum exit gradient from the ground surface is 0.2 which is not considered great enough to cause piping.

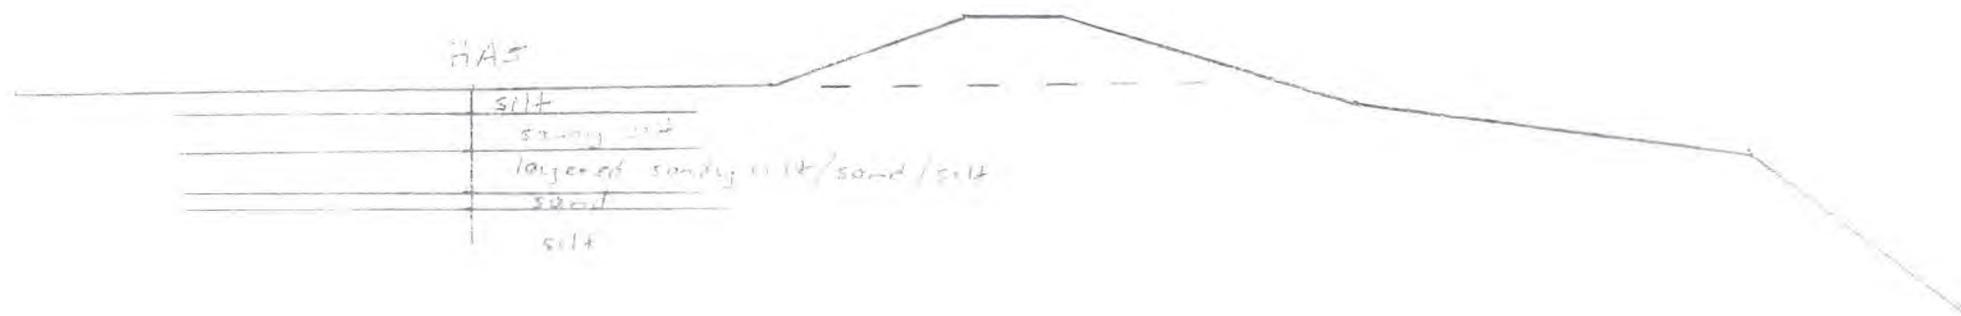
Cross Section 1 is at the HA5 location, 23m upstream from Cross Section 2. The upper two low permeability layers are about 400mm thicker than at Cross Section 2. A seepage analysis was carried out using the same seepage parameters as for Cross Section 2. The maximum pressure found beneath the upper silt layer was 7kPa. If the silt layer is only 600mm thick, as at HA5,

this would give a factor of safety against heave of 1.3, compared to 1.1 at Cross Section 1. The maximum hydraulic exit gradient was estimated at 0.5.

HA8 was augered 35m upstream of Cross Section 1 to check the thickness of the upper low permeability layers. The upper silt was found to be 800mm thick and there were no clean sand layers within the depth of auger hole. It is therefore considered that remedial measures are not required beyond HA5.

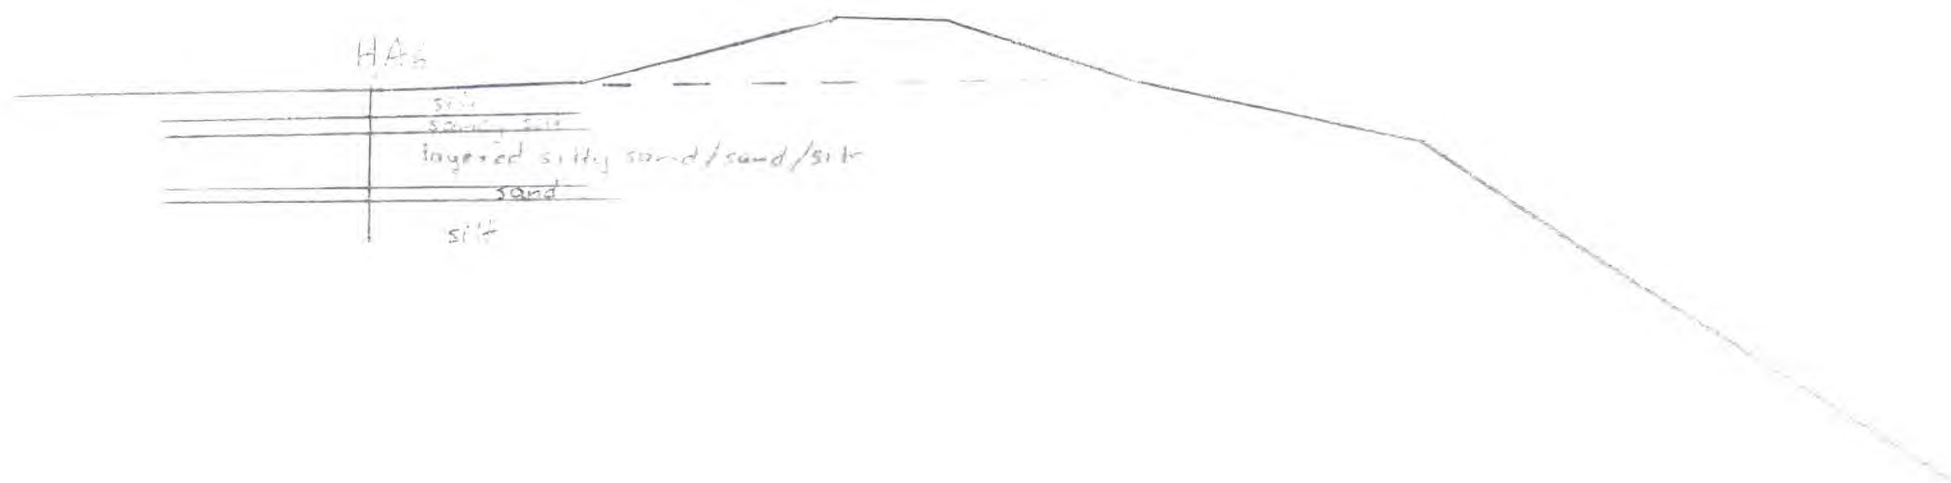
Cross section 3
Scale 1:200

Cross Section 3 is at the HA6 location, 21m downstream from Cross Section 2. The upper two low permeability layers are about 100mm thinner than at Cross Section 2. The seepage analysis estimated a maximum pressure beneath the upper silt layer of 10kPa which gives a factor of safety against heave of about 1.2 if the silt layer is 800mm thick. The introduction of a pressure relief well 10m from the toe of the embankment improves the factor of safety to 1.3.

HA7 was augered 35m downstream of HA6 and it was found that the soils are predominantly silty sands or sandy silts with only thin layers of clean sand and silt. Cross Section 3 was modified to reflect the HA7 soil profile and it was found that pressures up to 9.5kPa could be developed below the upper silt. The upper silt layer at HA7 was 750mm thick which gives a factor of safety against heave of 1.2.

It is therefore considered that a pressure relief trench should extend from the boundary of the sports field upstream to HA5.

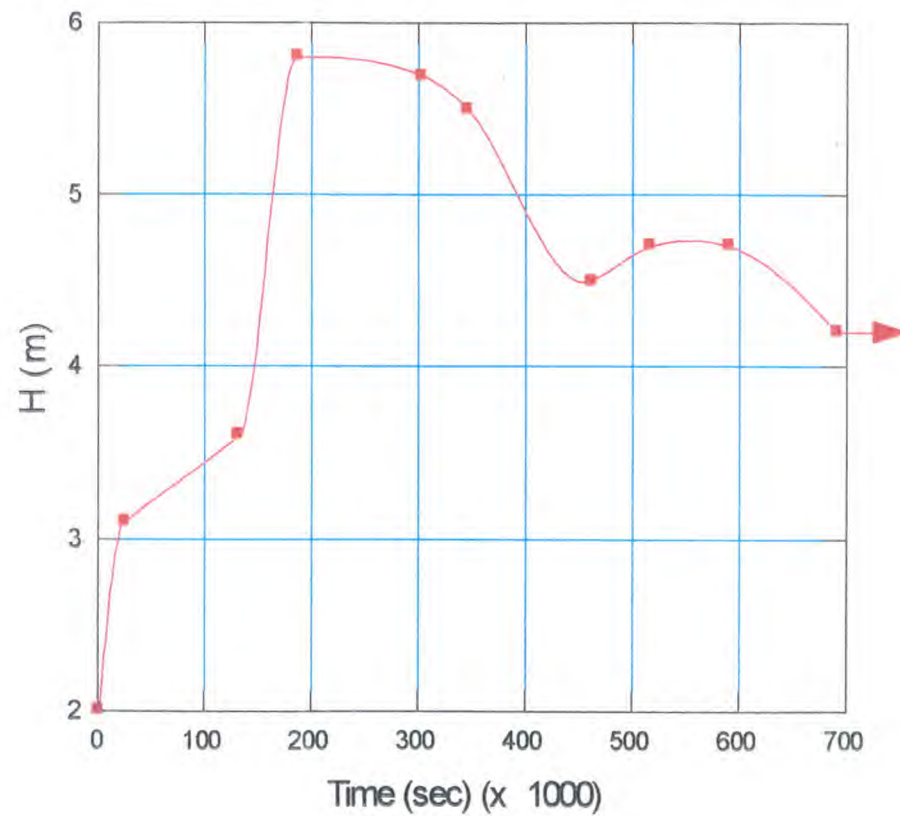
EBoP has provided a 100 year return period flood flow hydrograph for the Rangitaiki River at their benchmark number 22 (Figure 5). This is an eight day hydrograph which rises to a peak of RL5.8 on the third day of the flood. This would allow about 0.4m of freeboard at the site. In the 100 year flood the water level stays close to the peak level for two days before beginning to drop. During the July 2004 the residents say the water was close to the top of the stopbank but the level was high for less than a day with a rapid drop due to the breach upstream of Edgecumbe.

100 year flood flow hydrograph
Scale 1:200

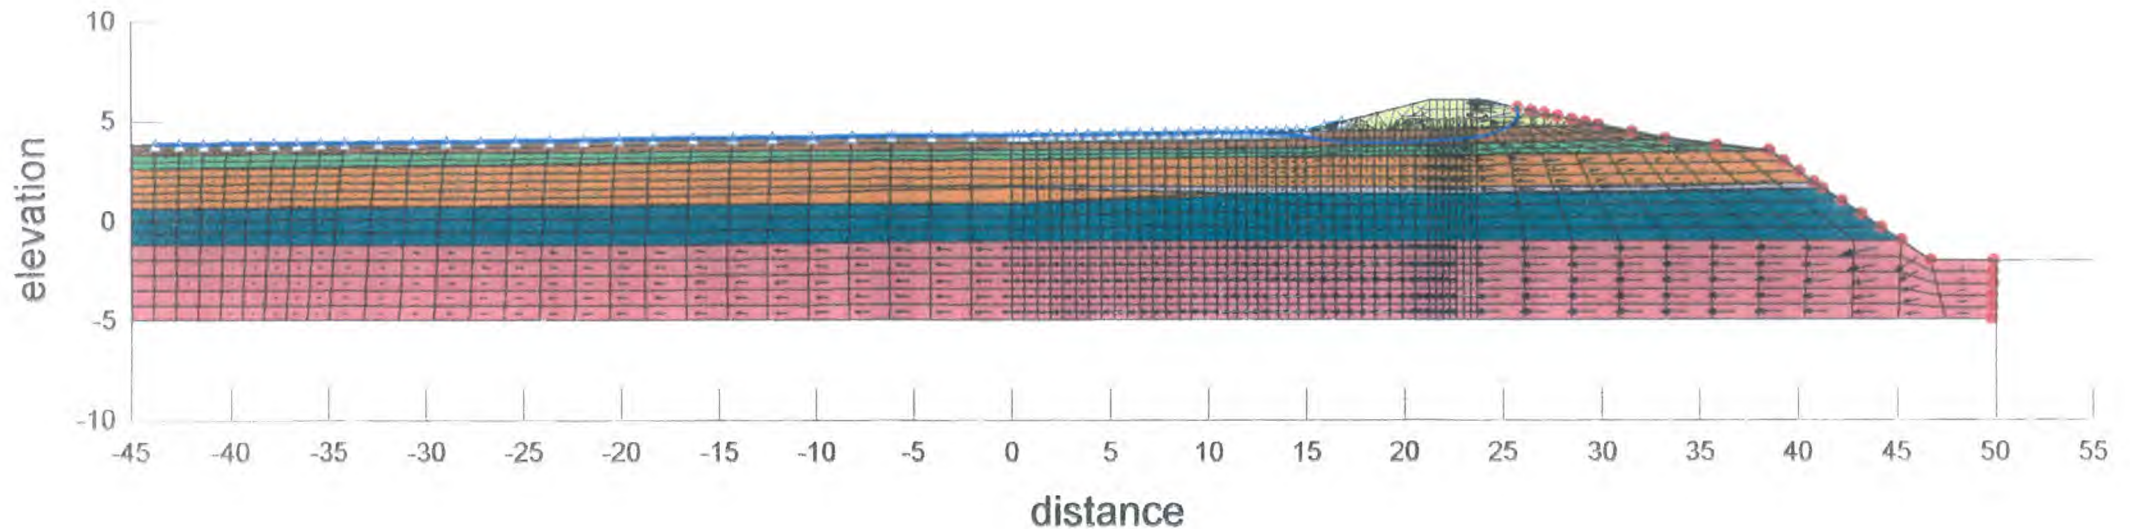
Figure 6: Cross Section 2 Analysis

The soil layers found in the hand augers were simplified in the models used for the seepage and stability analyses (Figure 6). The thin layers of silts, silty sands and sandy silts were modelled as one layer with a representative horizontal permeability but a lower vertical permeability. The various silt layers beneath the fine sand were also combined. Table 3 summarises the saturated soil parameters assumed. Some sensitivity analyses were carried out varying the permeabilities and vertical to horizontal permeability ratios. It was conservatively assumed that there is a layer of pumice lapilli below the depth of investigations.

The Geo-Slope Seep/W (Version 5) computer package used for the seepage analyses contains a library of soil grading curves with corresponding hydraulic conductivity and water content versus water pressure relationships. The particle gradings observed on site were compared to those in the Seep library and the closest fit chosen as the soil model to be used in the seepage analysis.

An analysis was carried out modelling a pressure relief trench about 3m deep reaching into the fine sand layer. The trench was located about 10m away from the toe of the stopbank. It was found that the water pressure below the upper silt at the HA1 location was reduced sufficiently to increase the factor of safety against heave to 1.2 if the silt is only 0.6m thick.

A rough estimate of the amount of seepage from the trench is 1m³ per lineal metre of trench over the eight day duration of the flood.

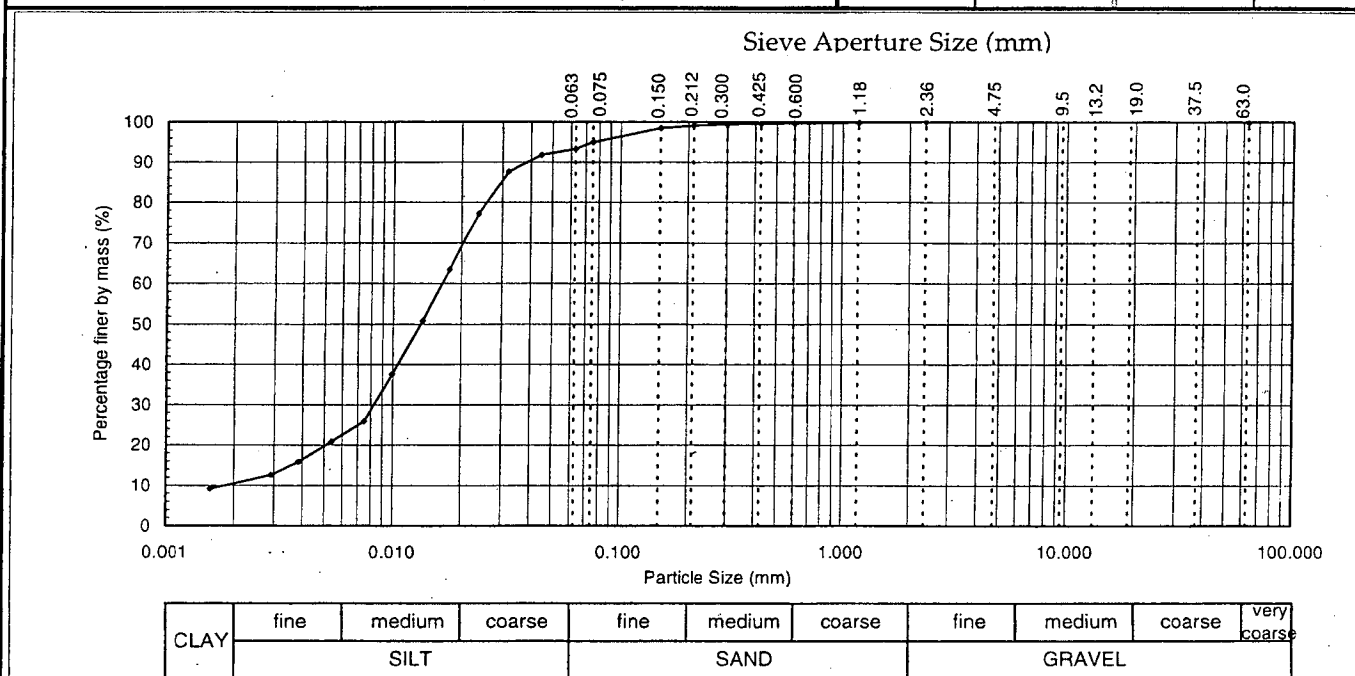
Project : Rangitaiki Stopbanks-Section 2
 Location : Rangitaiki
 Client : Ice Geo & Civil Ltd, Papamoa
 Client/Sample Ref :
 Contractor :
 Hole No: HA1 Depth: 1.90 metres
 Sampled by : Client
 Date received : 5/12/05
 Sampling method : Sample bag
 Sample condition : As received
 Sample description : Brown Silt. Trace clay and fine sand.
 Solid Particle Density (t/m³): 2.44 Assumed
 Water Content (as received): 52.4 %

Test Methods:	Notes:
Particle Size Analysis: NZS 4402:1986: Test 2.8.4 (Hydrometer Method)	
Particle Size Analysis: NZS 4402 1986 Test 2.8.4 (Hydrometer)	pH of suspension : 8.0 Whatmans Full Range pH indicator paper

Hydrometer particle grading tests were carried out on four samples from the hand augers (Appendix B). These were to provide information on the permeability of the soil layers. The grading test results are summarised in Table 2.

Sample	Description	D₁₀ (mm)	D₆₀ (mm)
HA1 1.9m	brown silt, trace clay	0.0018	0.016
HA1 2.6m	brown silty fine sand /sandy silt	0.0085	0.07
HA2 1.6m	brown fine sandy silt	0.006	0.055
HA3	stopbank fill	0.003	0.04

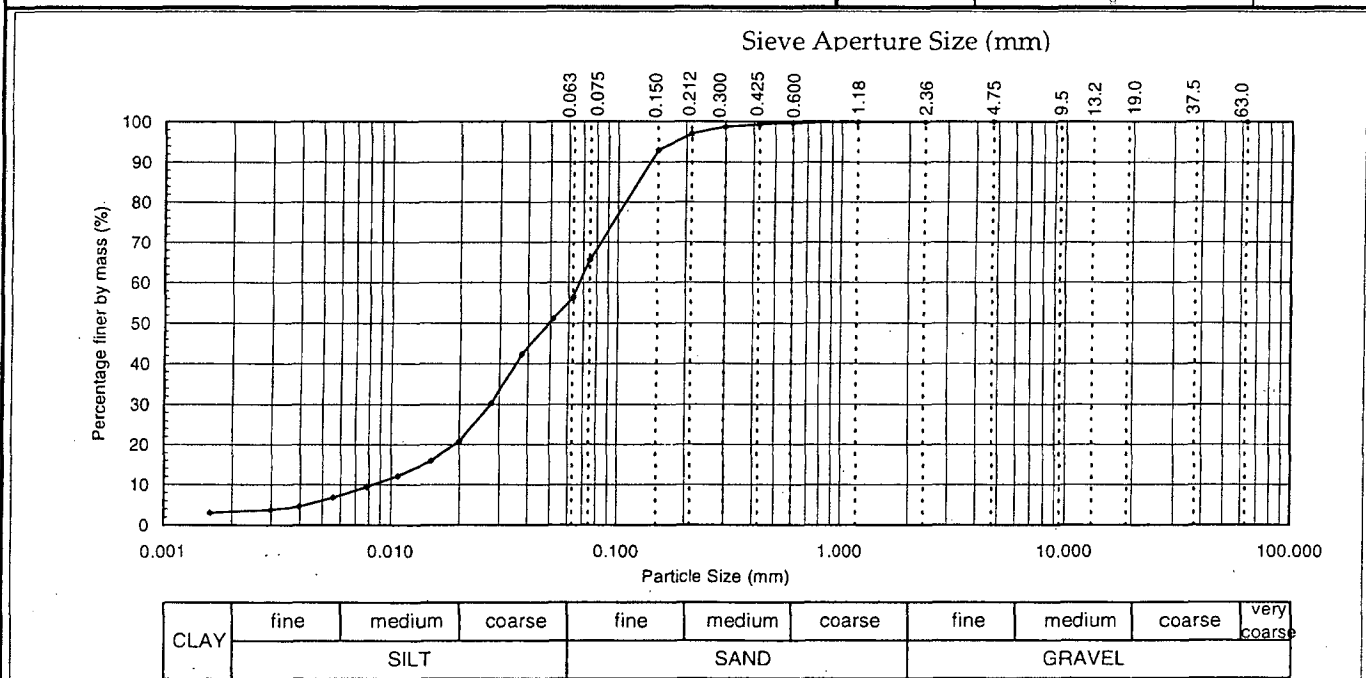
Project : Rangitaiki Stopbanks-Section 2
 Location : Rangitaiki
 Client : Ice Geo & Civil Ltd, Papamoa
 Client/Sample Ref :
 Contractor :
 Hole No: HA1 Depth: 2.60 metres
 Sampled by : Client
 Date received : 5/12/05
 Sampling method : Sample bag
 Sample condition : As received
 Sample description : Dk. Brown fine sandy Silt.
 Solid Particle Density (t/m^3): 2.44 Assumed
 Water Content (as received): 56.5 %

Test Methods	Notes
Particle Size Analysis: NZS 4402:1986: Test 2.8.4 (Hydrometer Method)	
Particle Size Analysis: NZS 4402 1986 Test 2.8.4 (Hydrometer)	pH of suspension : 8.0 Whatmans Full Range pH indicator paper

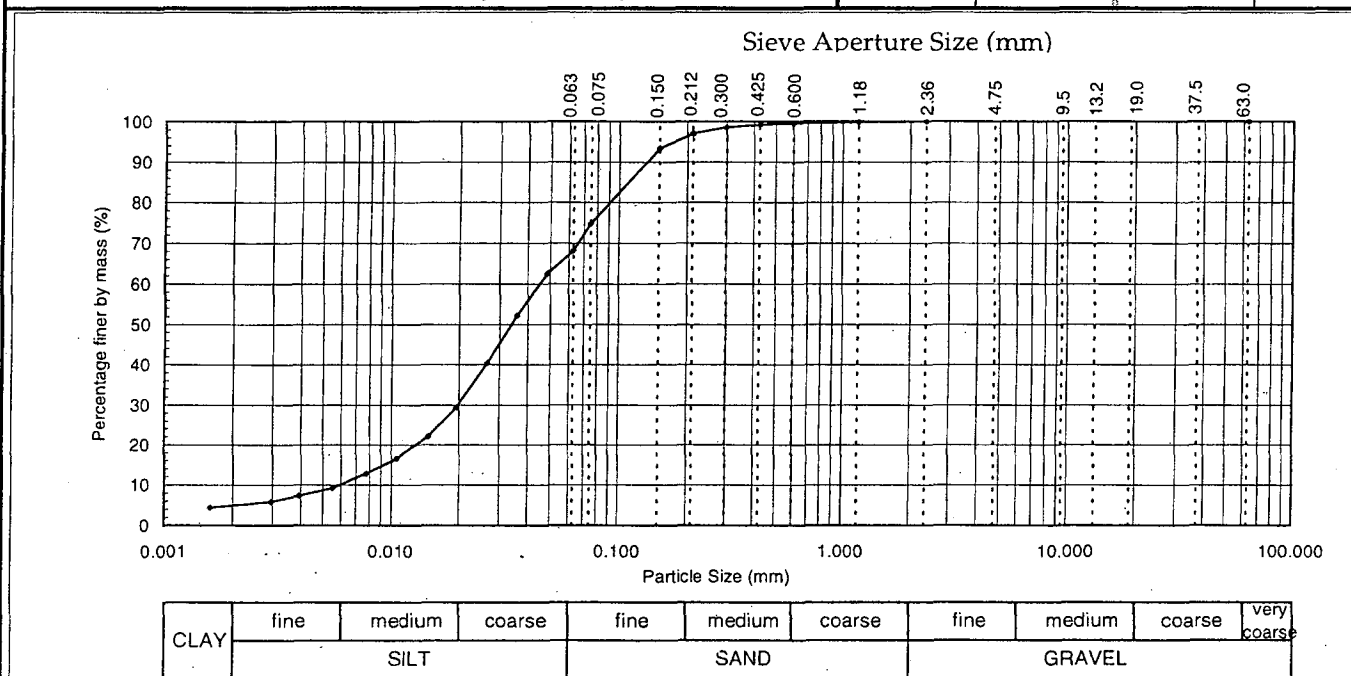
Project : Rangitaiki Stopbanks-Section 2
 Location : Rangitaiki
 Client : Ice Geo & Civil Ltd, Papamoa
 Client/Sample Ref :
 Contractor :
 Hole No: HA2 Depth: 1.60 metres
 Sampled by : Client
 Date received : 5/12/05
 Sampling method : Sample bag
 Sample condition : As received
 Sample description : Brown fine sandy Silt.
 Solid Particle Density (t/m^3): 2.44 Assumed
 Water Content (as received): 46.9 %

Test Methods	Notes
Particle Size Analysis: NZS 4402:1986: Test 2.8.4 (Hydrometer Method)	
Particle Size Analysis: NZS 4402 1986 Test 2.8.4 (Hydrometer)	pH of suspension : 8.0 Whatmans Full Range pH indicator paper

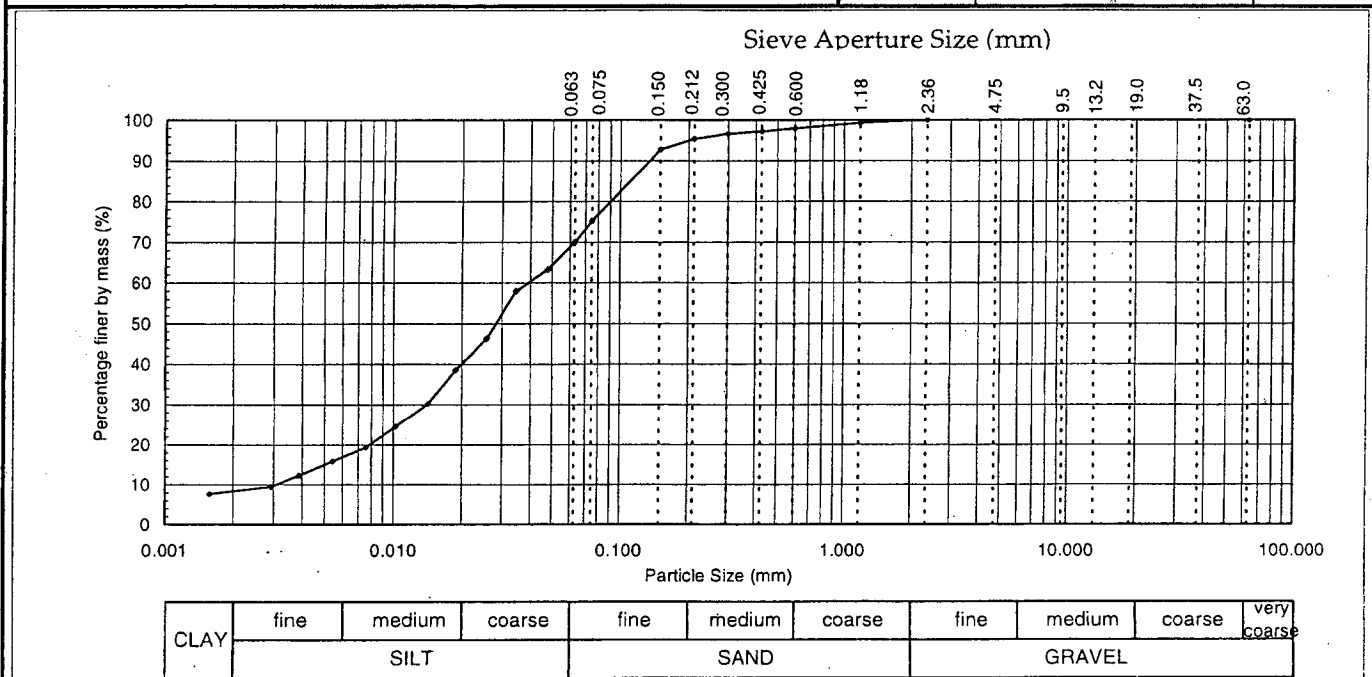
Project : Rangitaiki Stopbanks-Section 2
 Location : Rangitaiki
 Client : Ice Geo & Civil Ltd, Papamoa
 Client/Sample Ref :
 Contractor :
 Hole No: HA3 Depth: 0.30 metres
 Sampled by : Client
 Date received : 5/12/05
 Sampling method : Sample bag
 Sample condition : As received
 Sample description : V. dk. Brown fine sandy Silt.
 Solid Particle Density (t/m^3): 2.44 Assumed
 Water Content (as received): 25.3 %

Test Methods	Notes
Particle Size Analysis: NZS 4402:1986: Test 2.8.4 (Hydrometer Method)	
Particle Size Analysis: NZS 4402 1986 Test 2.8.4 (Hydrometer)	pH of suspension : 8.0 Whatmans Full Range pH indicator paper
