# **Rangitaiki River Stopbanks Assessment**

## **Section 3**

**Left Bank 11500 to 12200m**

**Environment Bay of Plenty**

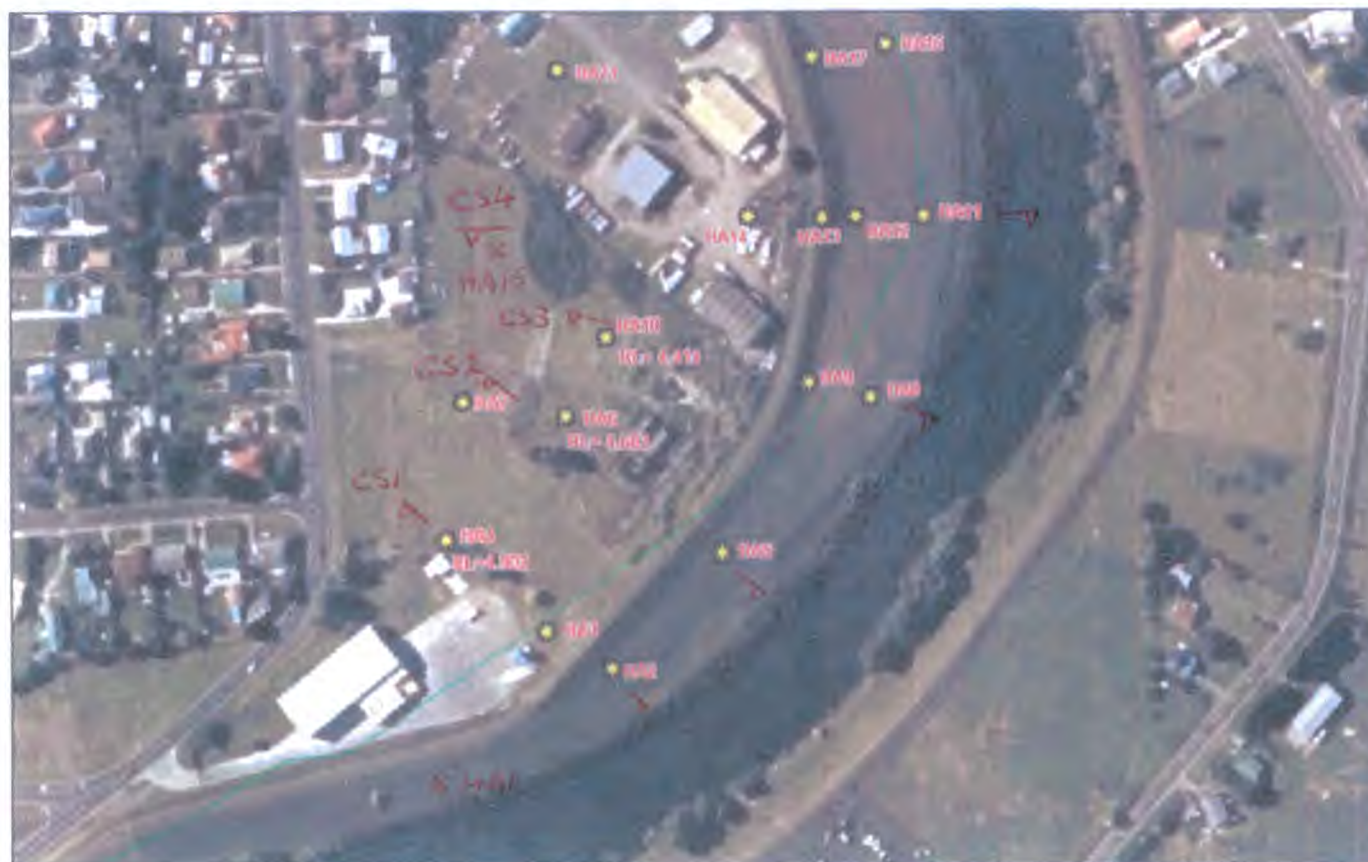
Site plan

Along the length of the study section the stopbank varies in height from 1.7m to 2.8m. There is up to 0.8m of fall away from the stopbank within 60m. The river berm is typically 30m in width but ranges from 60m at about 11,900m to 5m downstream at 12,200m. The river berm is about 1-2m lower than the land inside the stopbank due to excavation for fill material (Figures 1 and 2).

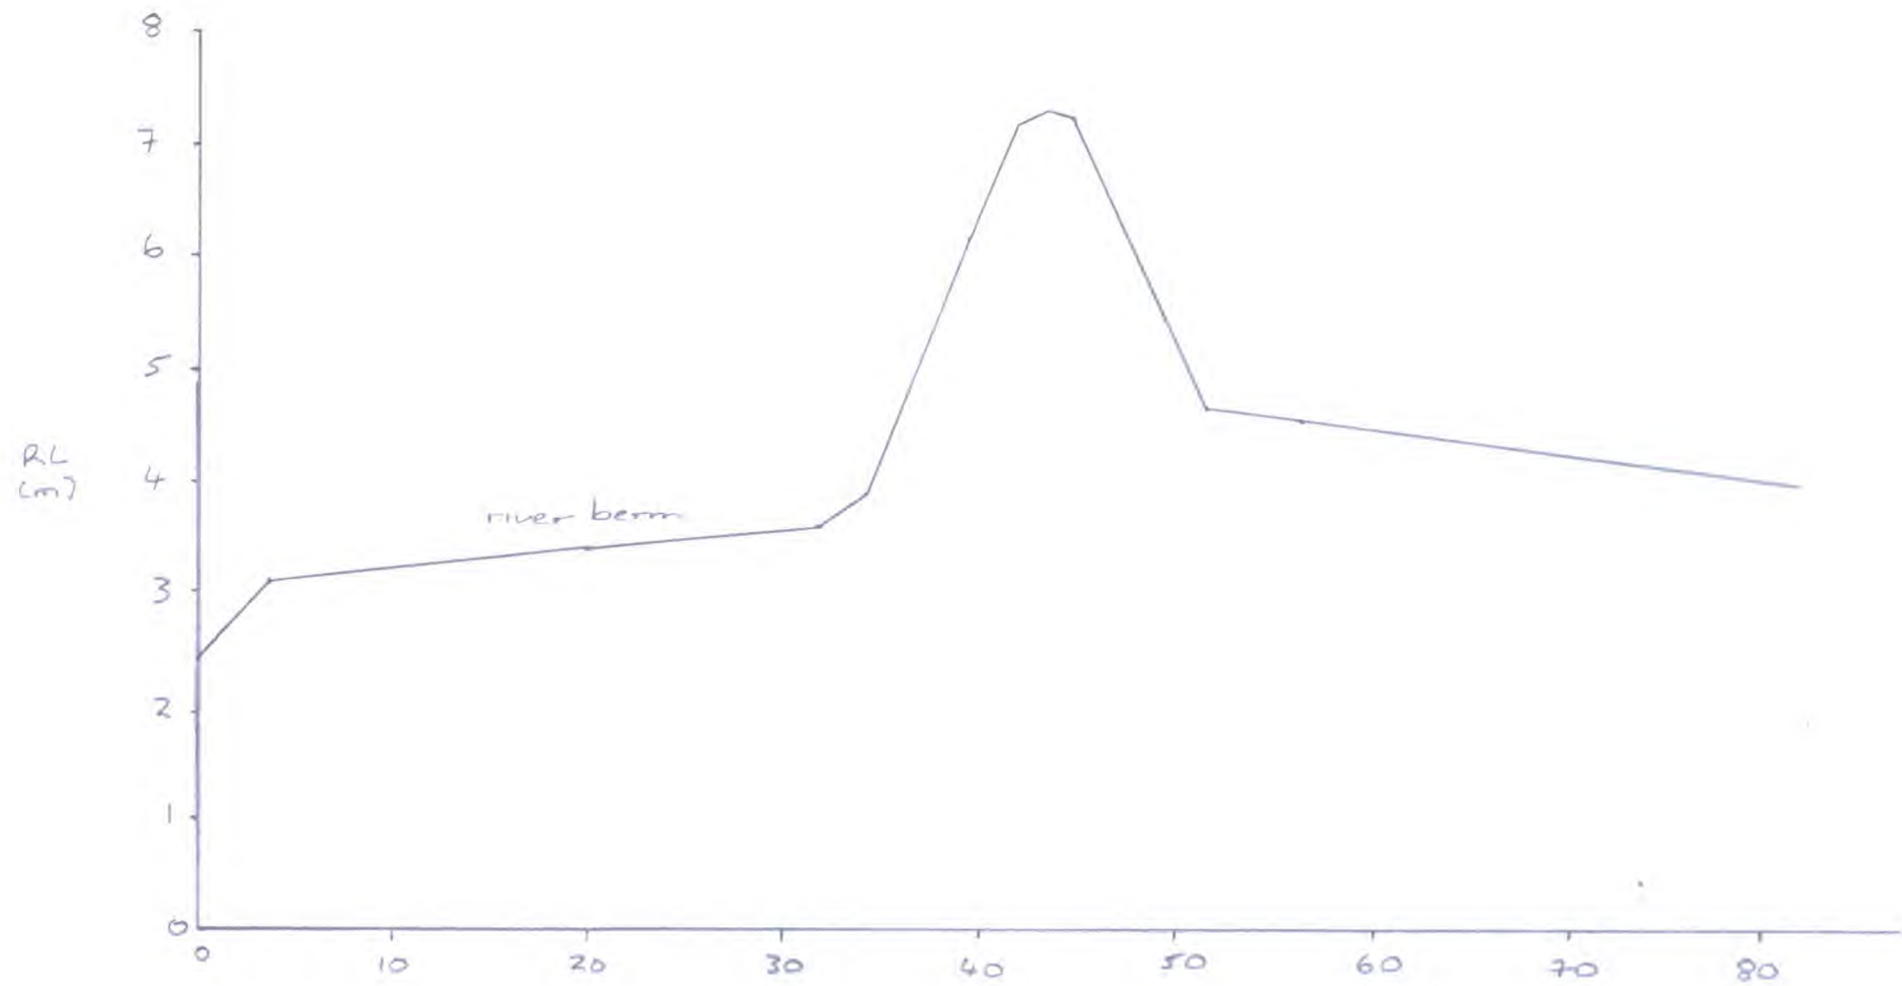
Cross section 7 is close to the EBoP depot. The soil profile used in the analysis was based on hand augers 22 and 23 and Opus' BH8 with coarse sands at 2m depth. It was found that one pressure relief trench at the toe would sufficiently reduce uplift pressures under a 0.5m thick layer of silt to provide a factor of safety of 1.2.

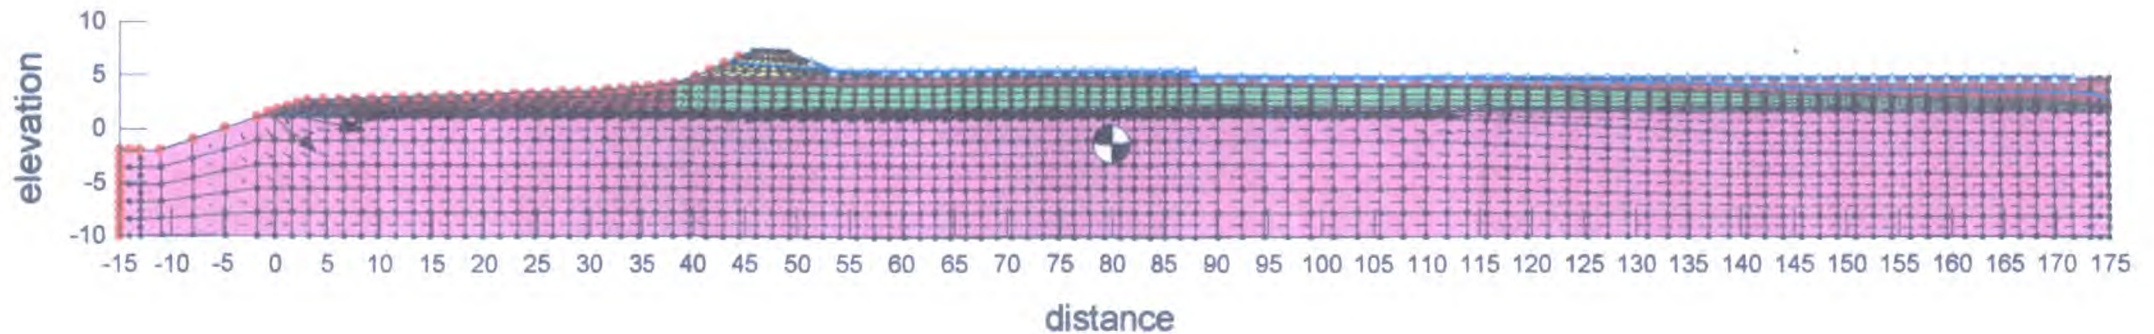
Name: cross section 2 overlay 100yr.gsz  
 Title: Rangitaiki Stopbanks Section 3  
 Comments: Cross Section 2 overlay 100 yr  
 Date: 30/03/2006 Time: 3:45:08 p.m.

Time step 50 - 100 hours

30m wide, 0.5m thick overlay

Cross section 2 lies through Hand augers 5, 6 and 7 in the abandoned timber mill site. HA7 is 90m from the inland toe of the stopbank and 0.2m below it in elevation. The surface silt layer was found to be 0.8m thick in HA6 and 2.3m thick in HA7. It is underlain by silty fine sand, fine sand and fine to medium sand. In HA5, within the broad river berm, coarse sand and lapilli were found at 1.9m depth but are underlain by a thin layer of peat and some medium grain sized sand. It was assumed that the coarse sand layer almost extended inland to HA6.

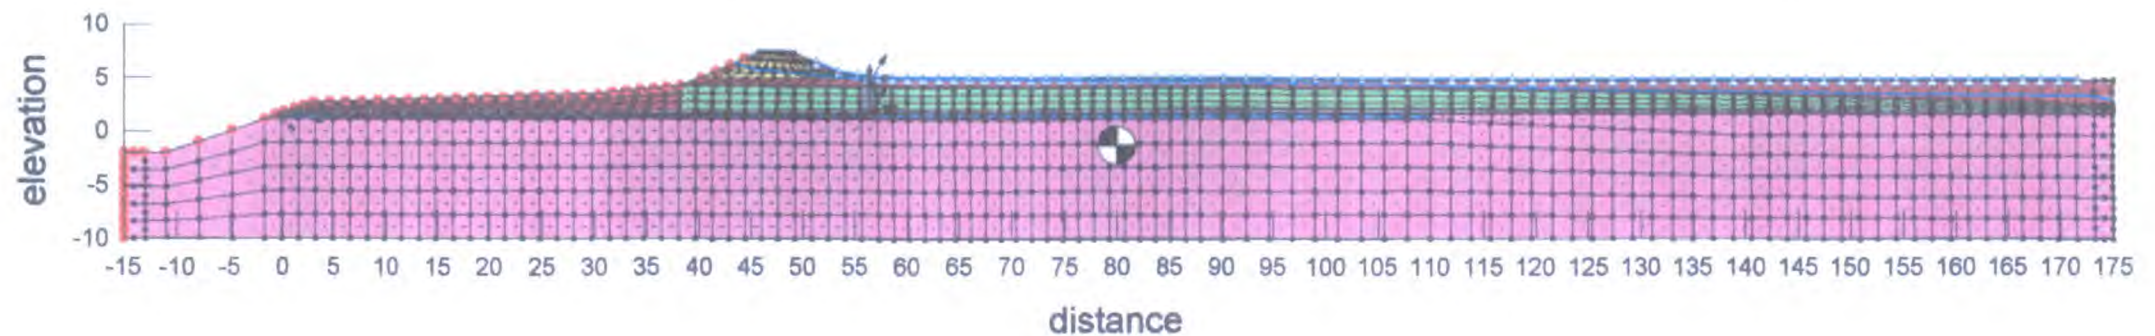
Name: cross section 2 100yr.gsz  
Title: Rangitaiki Stopbanks Section 3  
Comments: Cross Section 2 100 yr flood  
Date: 06/05/2006 Time: 2:28:01 p.m.

pressure relief trench at toe

time step 50 - 100 hours

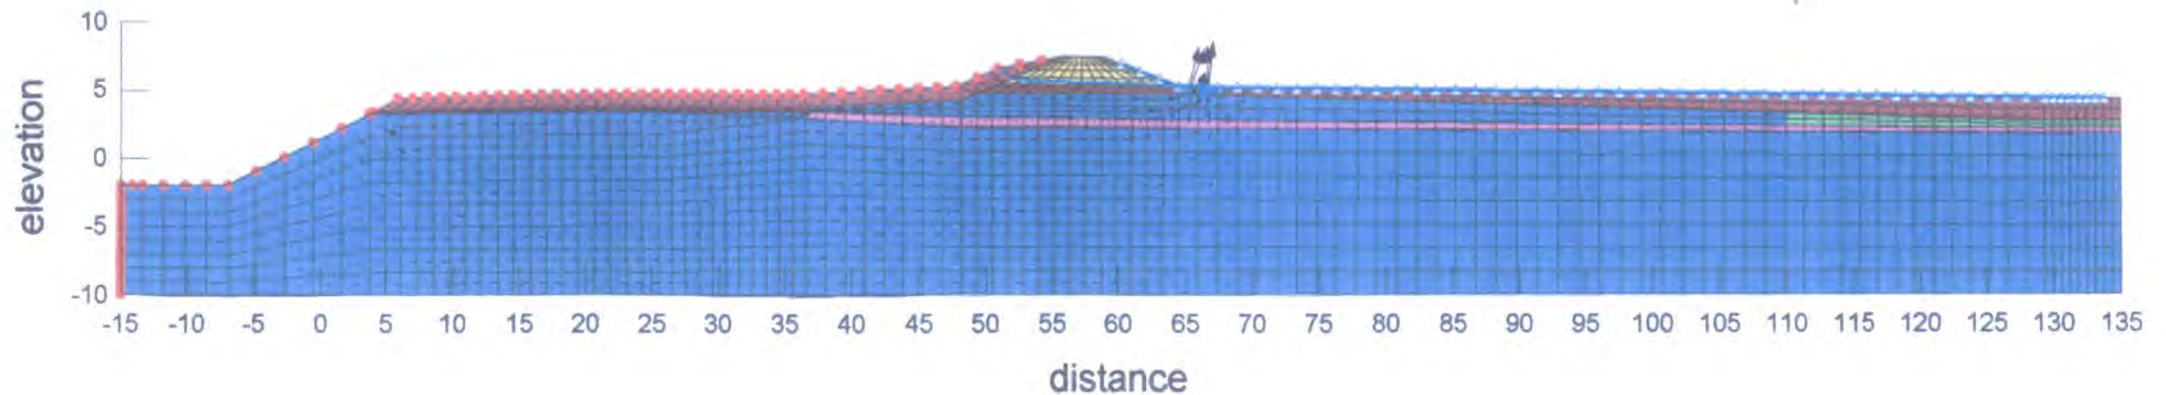
Name: cross section 3 overlay 100yr well.gsz

time step 50 - 100 hours

Coarse sand and lapilli were found exposed in the riverside toe of the stopbank at cross section 3. Some rabbit holes were also found in this area. A medium sand layer was found under the coarse sand and then another coarse sand layer. A medium sand layer was also found in HA10. It was assumed from the hand auger results that the soil layers dip inland away from the river, which is typical of the formation of river plains. The coarse sands and lapilli were therefore assumed to be close to the ground surface at the inland side of the stopbank.

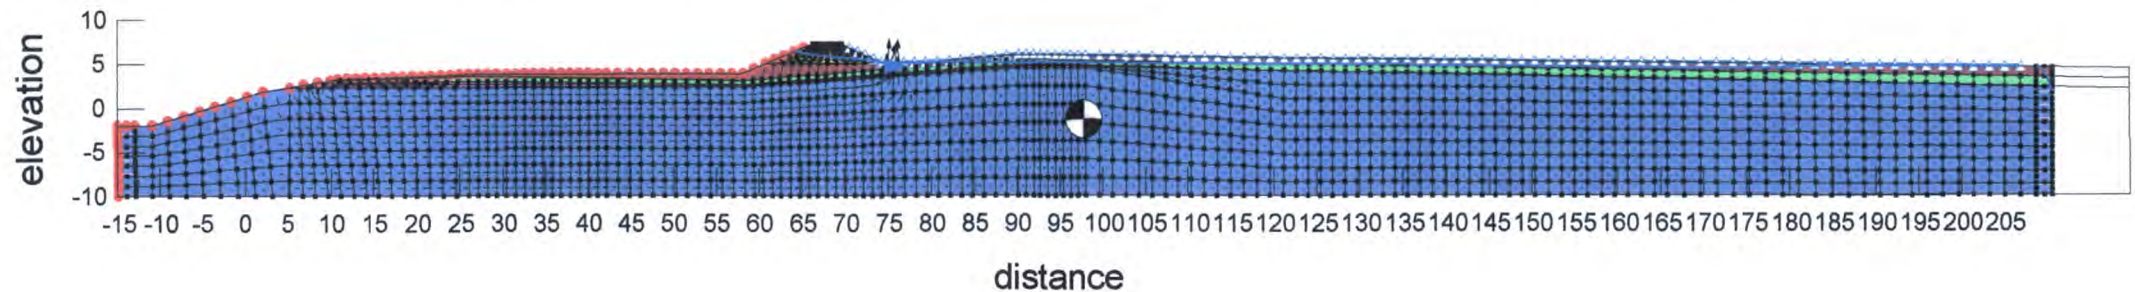
Name: cross section 4 100 yr.gsz  
 Title: Rangitaiki Stopbanks Section 3  
 Comments: Cross Section 4 100 yr  
 Date: 26/09/2006 Time: 12:27:53 p.m.

pressure relief well

time step 50 - 100 hrs

Cross section 4 passes through the industrial area at the end of Ngaio Place. Just inside the stopbank the surface silt layer was found to be only 0.5m thick with coarse sands found at only 1.5m depth (HA14). An auger carried out through the stopbank showed an old road at natural ground level below the stopbank. It is not clear whether the coarse sand layer found inside the stopbank is the same as the layer found 1.5m below the river berm as the river berm is over 1m lower than the land inside the stopbank. The cross section has been conservatively modelled as having one continuous coarse layer.

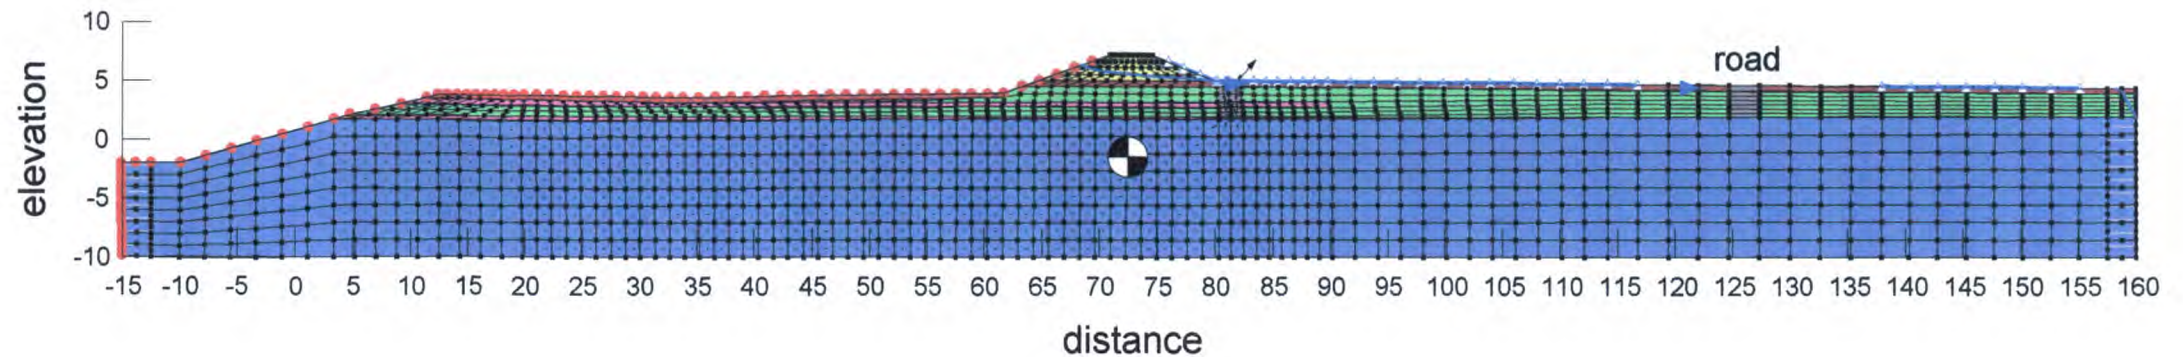
Name: cross section 5 100 yr.gsz  
Title: Rangitaiki Stopbanks Section 3  
Comments: Cross Section 5 100 yr  
Date: 26/09/2006 Time: 12:53:42 p.m.

pressure relief trench at toe and well under road

time step 50 - 100 hours

sand at 2.4m depth. The level of the coarse sand is only 0.2 to 0.4m higher than where it was found below the river berm. It has therefore been assumed to be the same layer in the analysis and that it is very thick. The road was modelled as a 20m wide strip with an impermeable surface.

Analysis of the 100 year flood showed that any areas of the surface silt layer less than 0.8m thick would have a high risk of heave. The uplift pressures under the road were 30% higher than adjacent to the road and the hydraulic exit gradient at the edge of the road also 30% higher than the adjacent ground. It was found that a pressure relief trench at the toe of the stopbank and a well under the road would be needed to bring the factor of safety up to an acceptable level. This amount of pressure relief reduces the uplift pressure under the road by 35%.

A sensitivity analysis was carried out assuming the coarse sand layer was 3m thick, as found in Opus BH8. This analysis showed that two pressure relief locations would still be advisable.

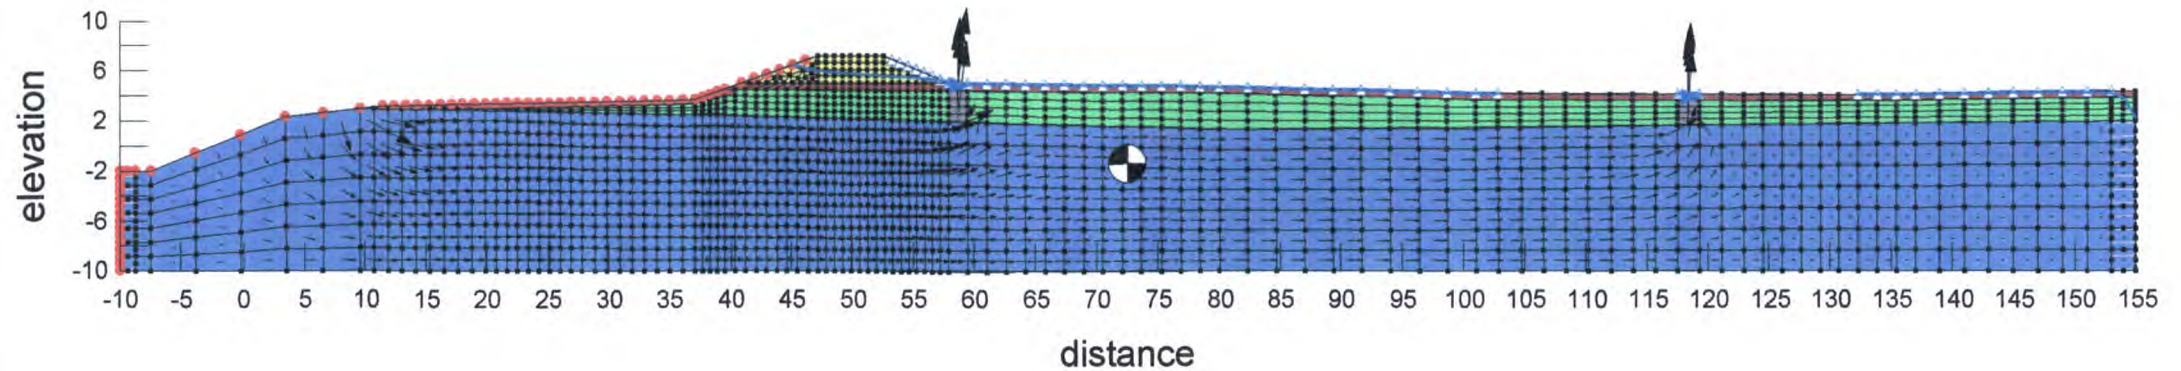
Name: cross section 6 100 yr.gsz  
Title: Rangitaiki Stopbanks Section 3  
Comments: Cross section 6 100 yr  
Date: 26/09/2006 Time: 1:27:49 p.m.

Time step 50 - 100 hours

two pressure relief trenches

The road was also modelled in cross section 6. The coarse sand was found at 3.4m depth 20m from the inland toe of the stopbank; but if the hand auger adjacent to Ngaio Place is included in the model a single pressure relief trench at the stopbank toe does not produce an adequate factor of safety against uplift. Another pressure relief well under the road is therefore recommended.

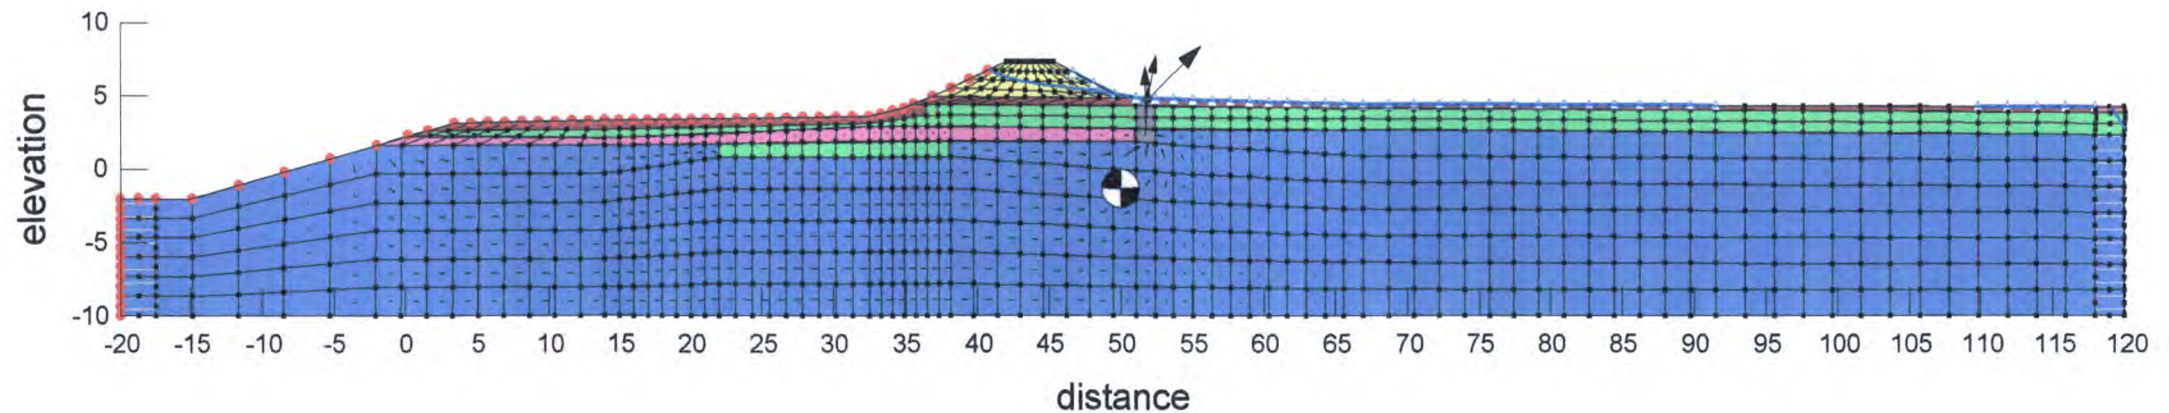
Name: cross section 7 100yr.gsz  
Title: Rangitaiki Stopbanks Section 3  
Comments: Cross Section 7 100 yr  
Date: 26/09/2006 Time: 1:40:48 p.m.

One pressure relief trench at toe

time step 40

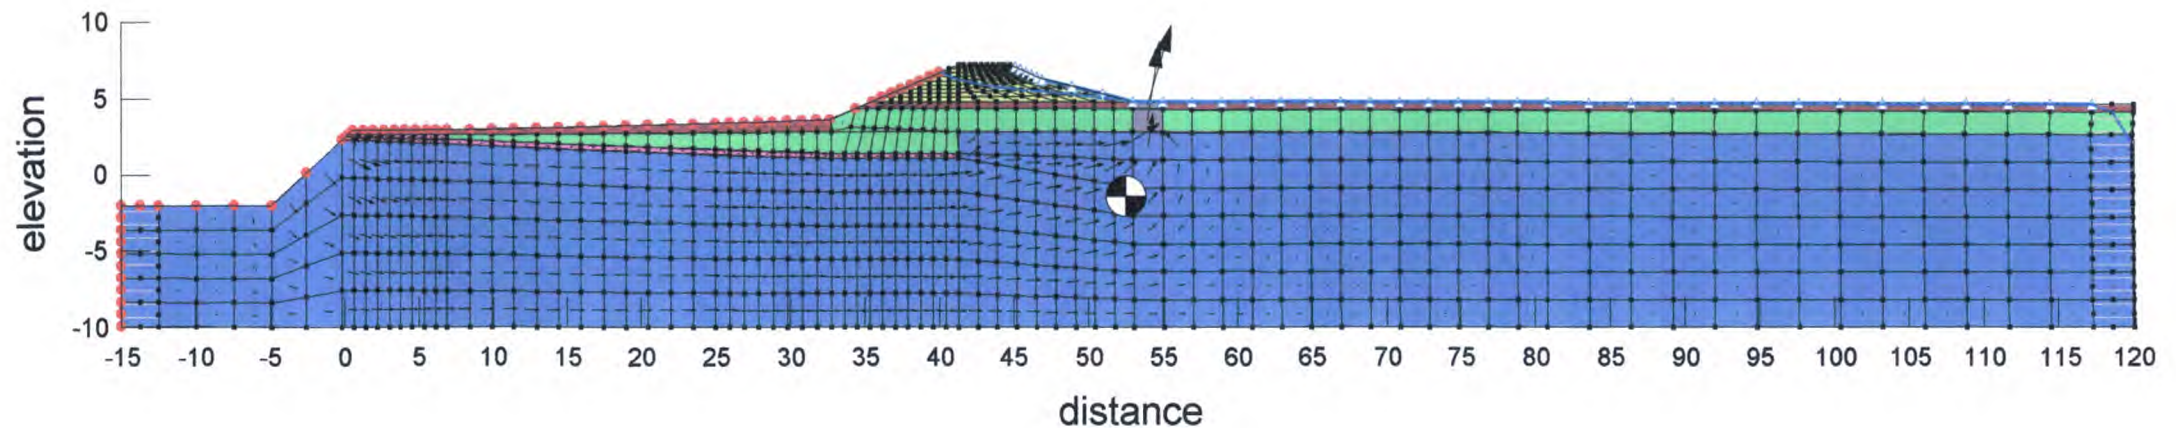
Name: cross section 8 100 yr.gsz  
Title: Rangitaiki Stopbanks Section 3  
Comments: Cross Section 8 100 yr flood  
Date: 26/09/2006 Time: 4:29:45 p.m.

One pressure relief trench

time step 40

The soil profile found in hand augers 24 and 25 is similar to that found in hand augers 22 and 23 and one pressure relief trench is required.

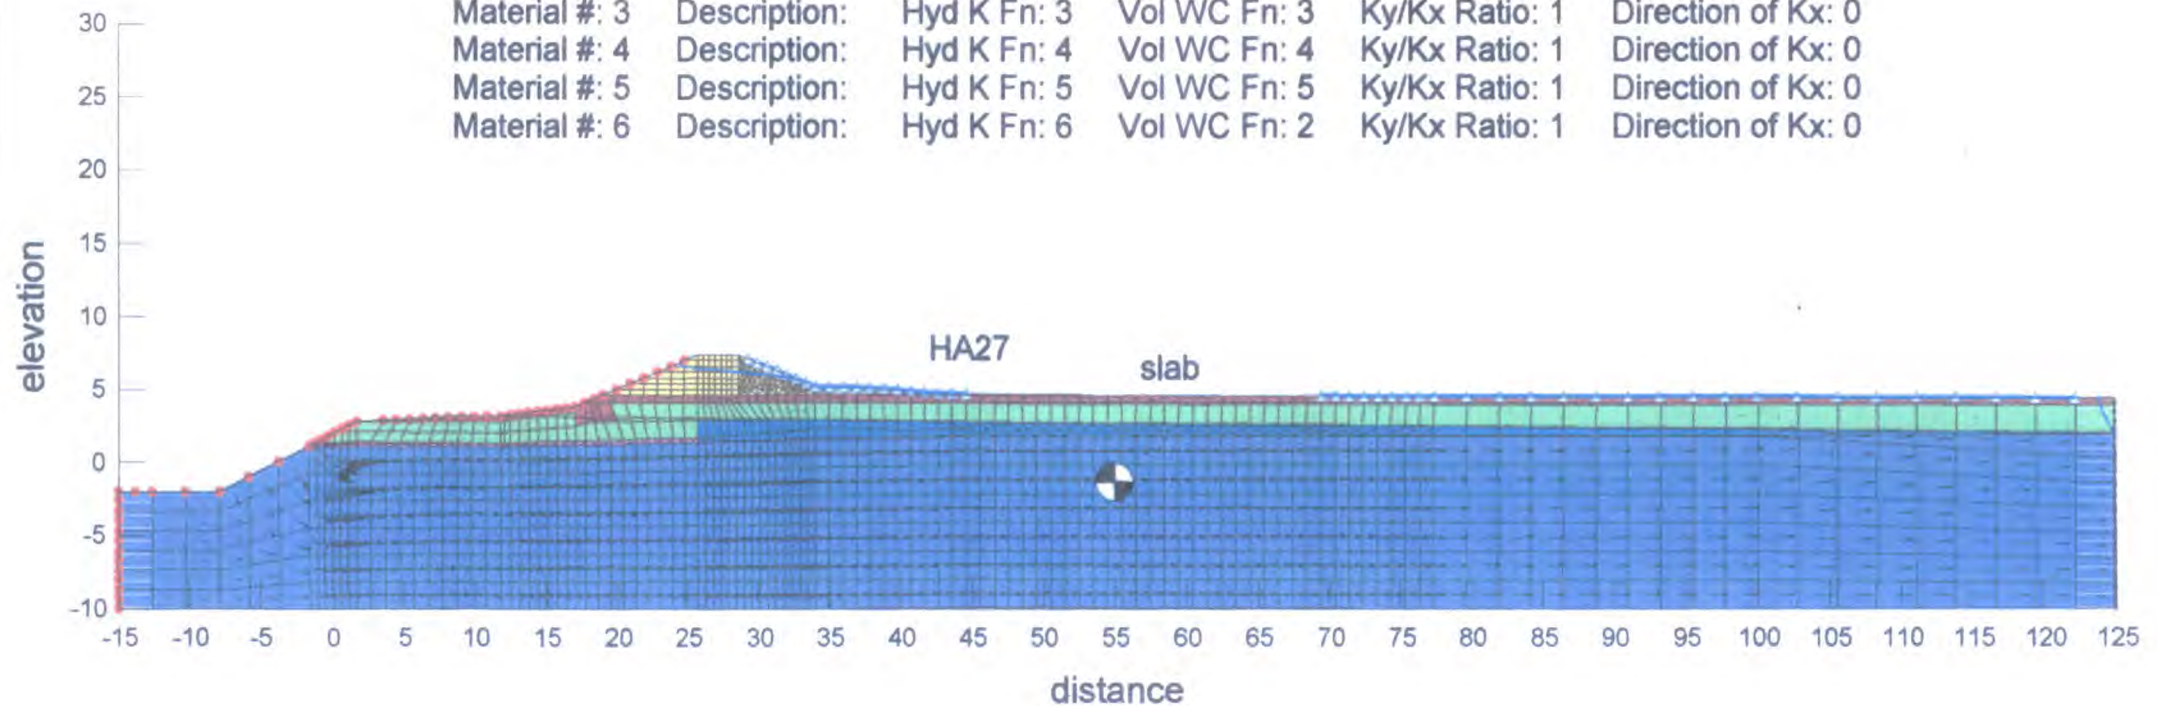
Name: cross section 9 100 yr flood mod silt.gsz

time step 40 - 80 hours

Cross section 9 passes through a property where some self storage units have just been built. The stopbank is 2.8m high and there is a narrow river berm. At the inland toe of the stopbank (HA27) silt was found at 1.8m depth below the surface silt and a silty fine sand layer. Clayey silt was found at 2.6m depth and the auger was stopped at 2.8m due to the hole squeezing in. The clayey silt was assumed to have a permeability of  $1 \times 10^{-7}$  m/s.

In the seepage analysis a coarse sand layer was conservatively assumed below the depth of HA27 as coarse sand was found below the river berm. If seepage is allowed at the ground surface there appears to be an adequate factor of safety against heave, however if the concrete slab of the self storage units is modelled higher uplift pressures develop. These pressures are not considered to be high enough to cause uplift problems but concentrations of flow around the edges of the slab could be created. It is therefore recommended that subsoil drainage be installed around the edge of the slab to allow water to escape without the loss of soil particles.

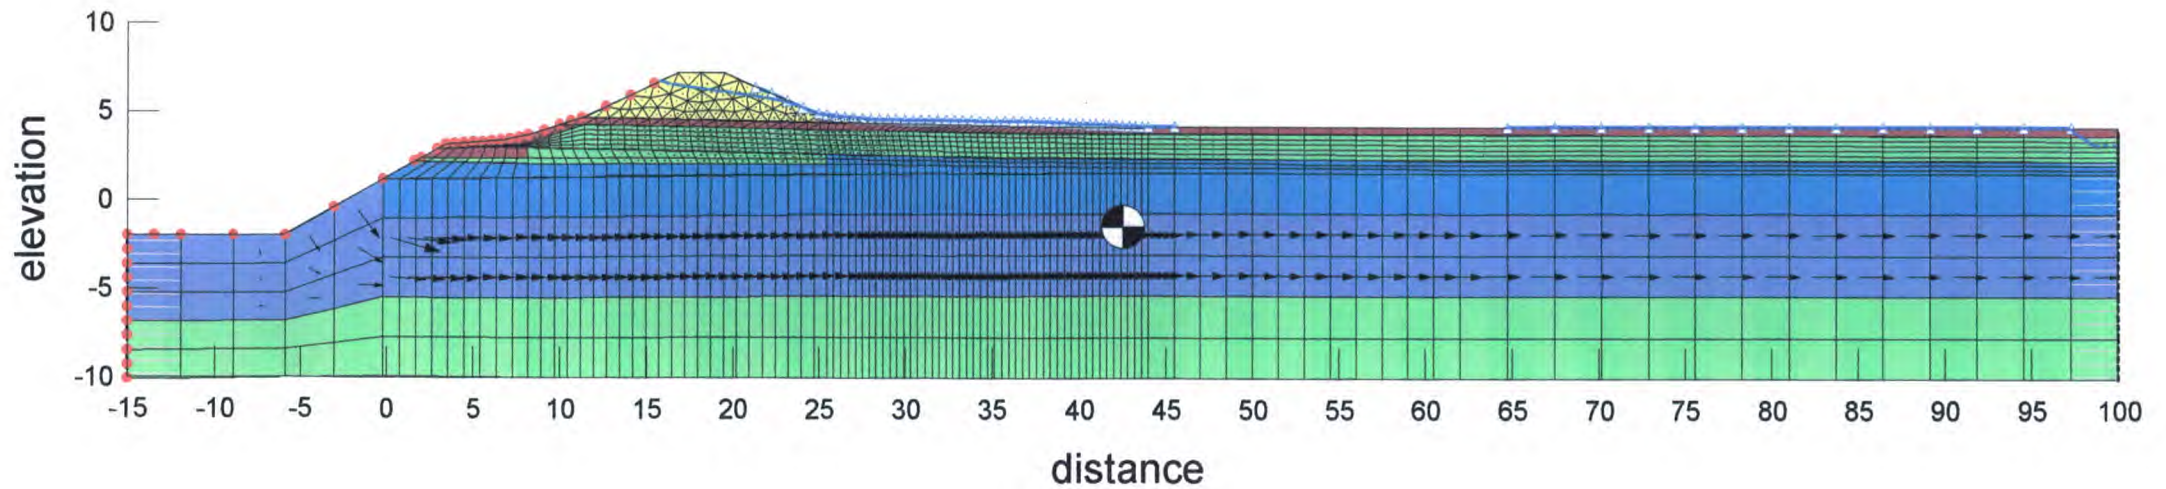
Name: cross section 10 100 yr flood mod.gsz  
Title: Rangitaiki Stopbanks Section 3  
Comments: Cross Section 10 - 100 yr flood  
Date: 07/05/2006 Time: 11:03:05 a.m.

time step 40 - 80 hours

In the seepage analysis it was assumed that there was a 4m thick layer of coarse sands below the depth of the hand augers. The road was modelled as an impermeable surface. It was found that there is a factor of safety of about 1.2 against uplift of the silt layer without any remedial measures. The maximum hydraulic exit gradient at the toe of the stopbank was found to be 0.4 which is the maximum considered acceptable in these soils.
