Rangitaiki River Stopbanks Assessment

Section 5

Left Bank 11200 to 11500m

Environment Bay of Plenty

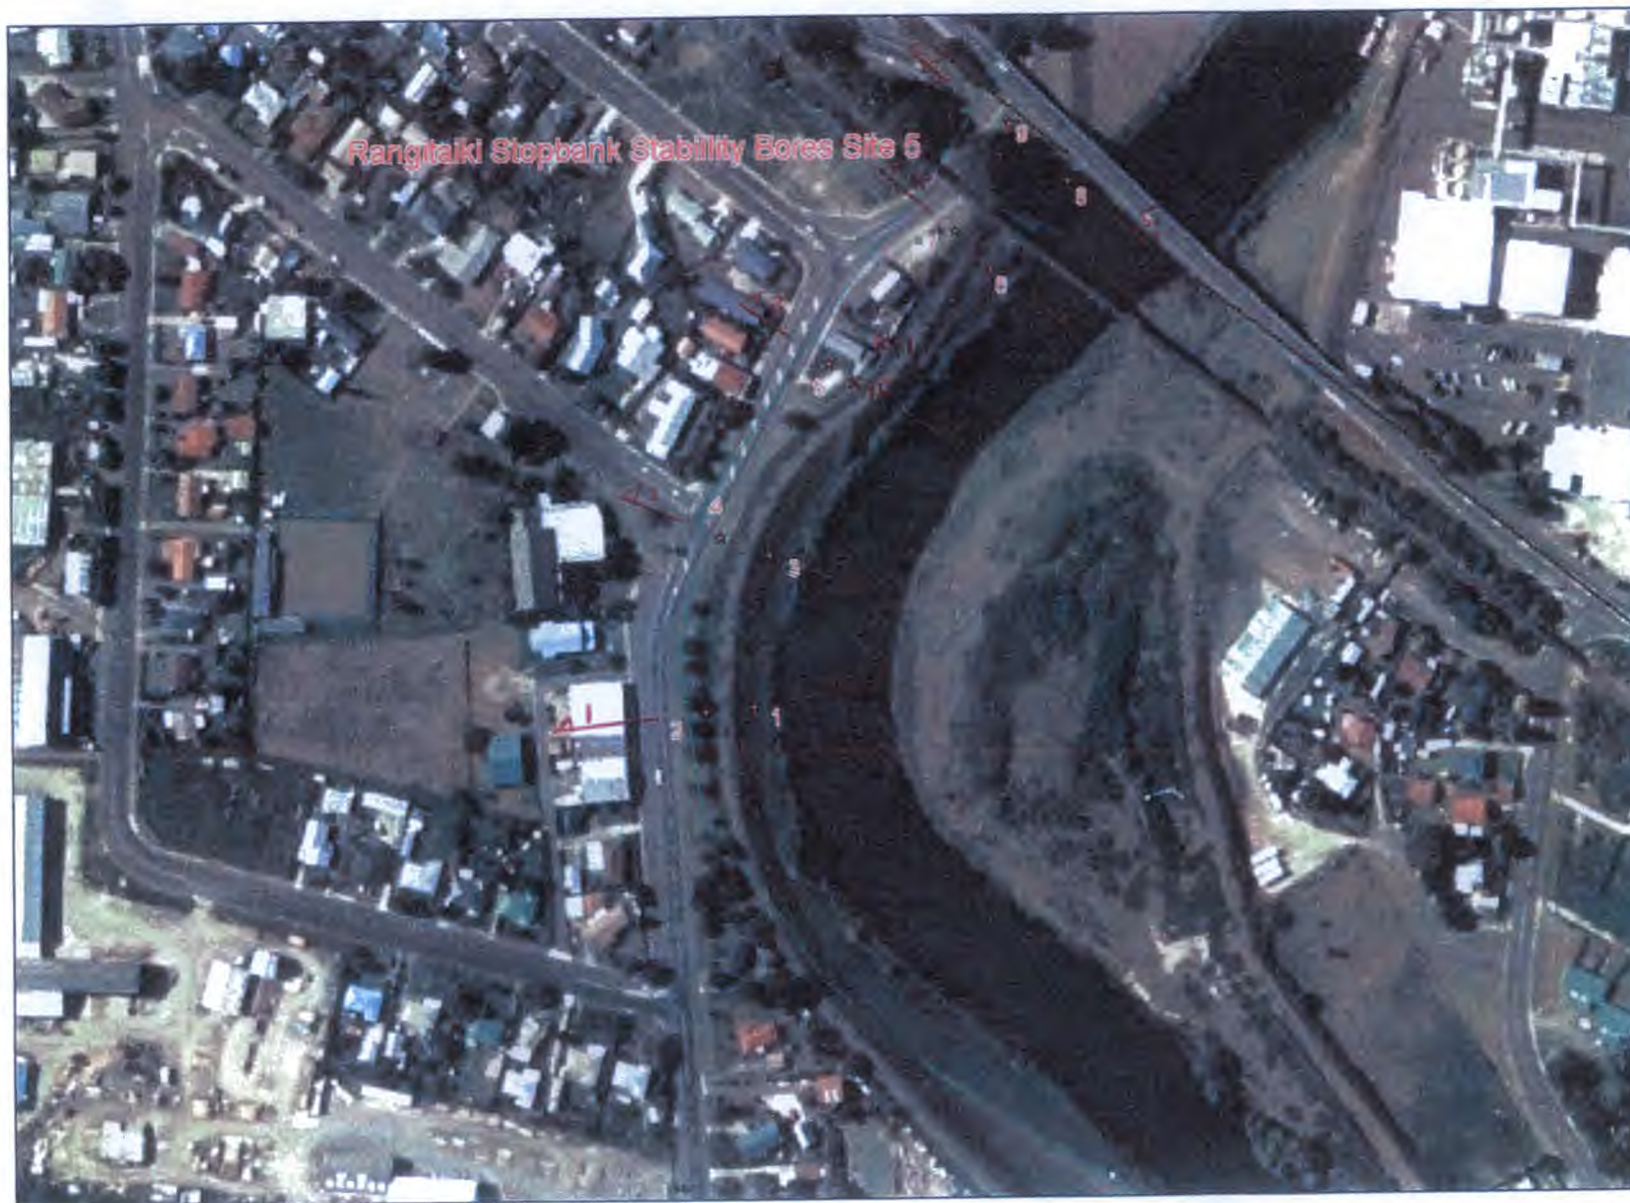
The initial subsurface investigations consisted of nine hand augers arranged in five cross sections along the river. A further two augers were carried out near Cross Section 3 to help refine the analysis. The augers were between 2.3 and 4.2m deep. Some augers were stopped because clayey silts were causing the hole to squeeze in. Figure 1 shows the location of the hand auger holes and the logs are included in Appendix A.

A study of the information available on the stopbanks along the Rangitaiki River identified some areas where there may be potential problems in major floods (Ice Geo & Civil, September 2005). The section of stopbank on the left bank from 11,200 to 11,500m was identified as a possible problem area due to the relatively high head across the stopbank, damage experienced in the Edgecumbe earthquake and the narrow river berm (Figure 1). This study section is immediately downstream of Section 3 (Ice Geo & Civil, April 2006).

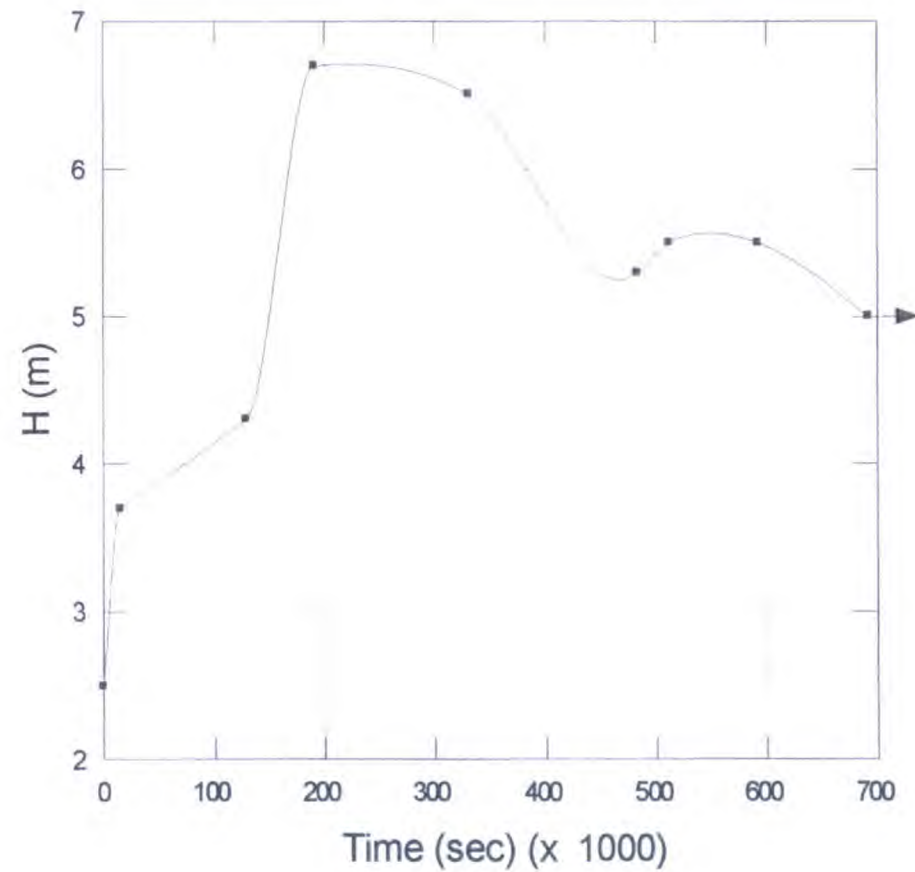
Design 100 year flood flow hydrograph

EBoP has provided a design 100 year return period flood flow hydrograph for the Rangitaiki River at their benchmark number 28 (Figure 2). This is an eight day hydrograph which rises to a peak of RL6.7 on the third day of the flood. The top of the stopbank ranges from RL6.9 to 7.2, therefore it appears that the stopbank should be topped up in places to achieve the required freeboard in an urban area. In the 100 year flood the water level stays close to the peak level for two days before beginning to drop. This is almost long enough for steady state conditions to develop with high permeability soils.

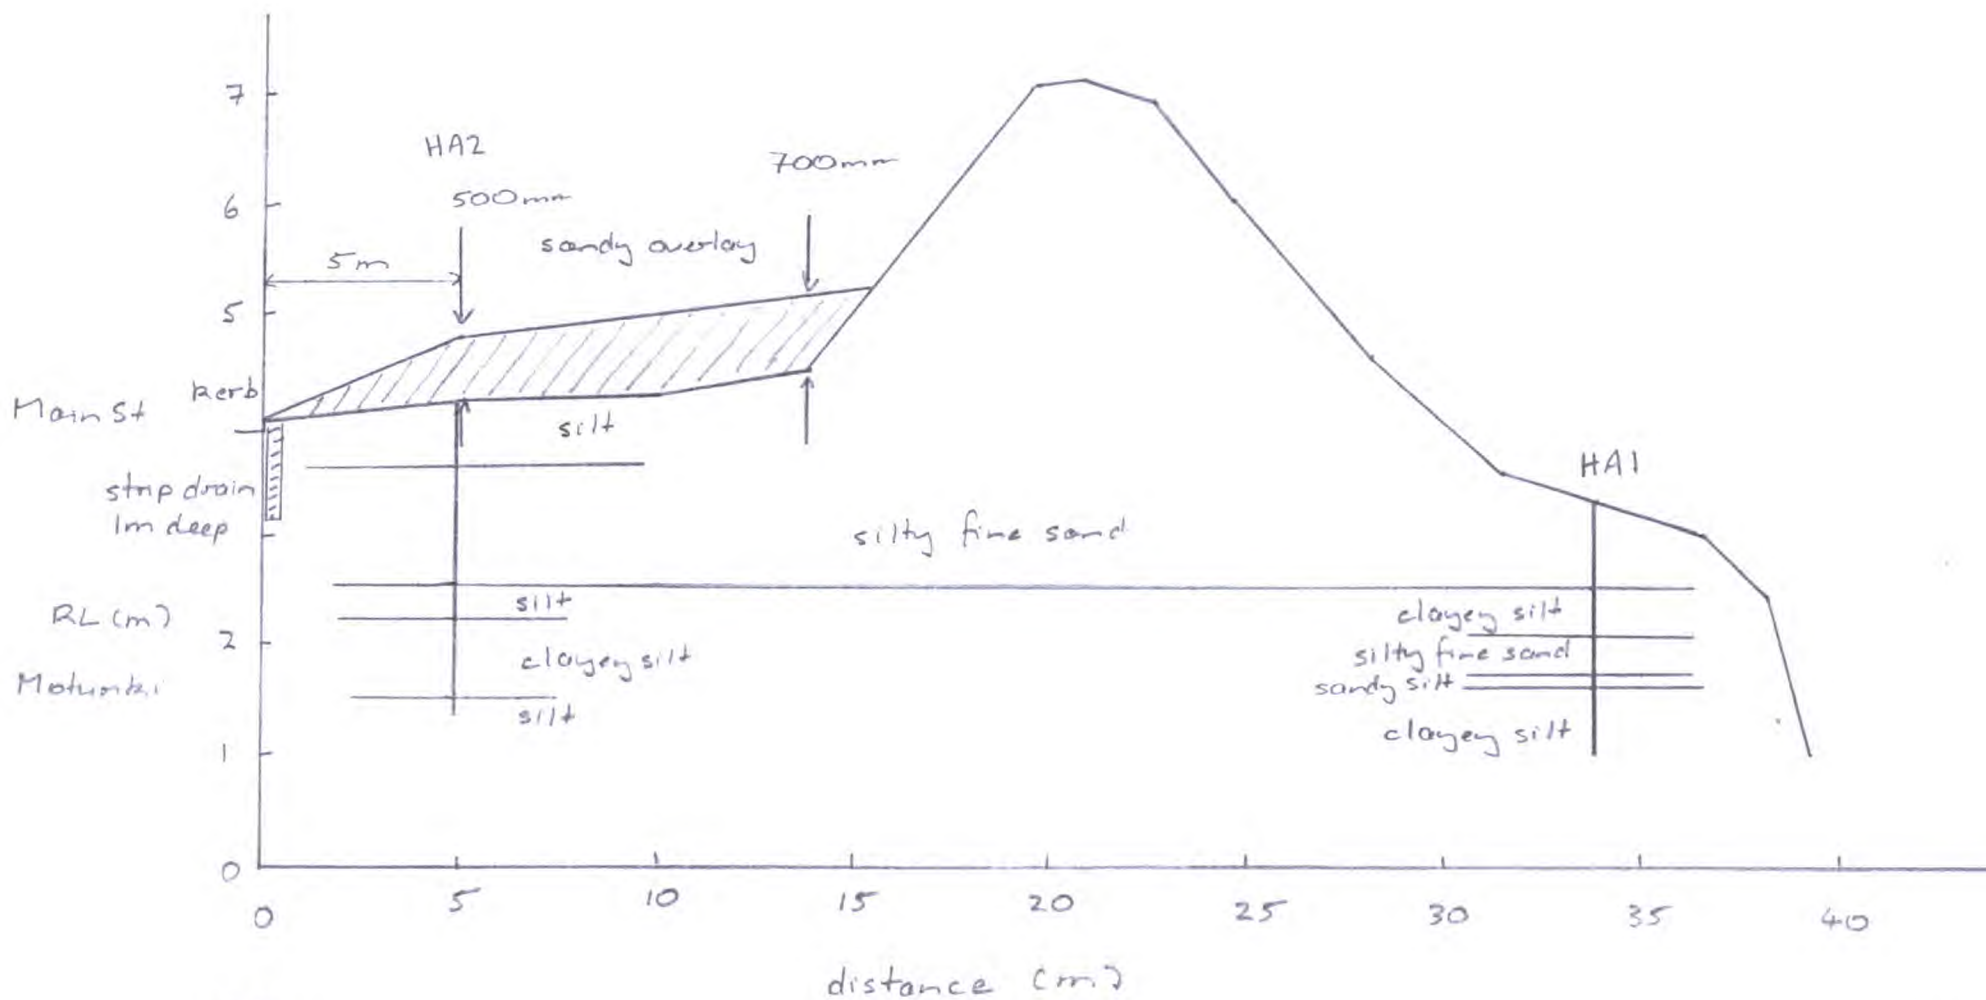
Cross section 1

Cross Section 1 is at the upstream end of the study section. The stopbank is 2.5m high and there is a 10m wide river berm. On the inland side of the stopbank the upper silt layer is 0.5m thick and is underlain by silty sands, sandy silts and clayey silt at 2.0m depth.

An initial static seepage analysis was carried out assuming a ground water level of RL2.7 on the inland side of the model and a river level of RL2.5. A transient seepage analysis was then carried out modelling the full eight days of the 100 year flood. A two hour time step was used.

An allowance was made in the soil model for seepage from the ground surface between the stopbank toe and the road. The soils below the depth of investigation were assumed to be coarse sands and lapilli.

The transient flood analysis showed that there could be a problem with heave of the upper silt layer and high pressures could develop under the road. The hydraulic exit gradient at the toe of the stopbank was found to be about 0.4. This is considered to be the highest acceptable hydraulic gradient in these silty soils.

An overlay 700mm thick at the stopbank toe, tapering to 500mm thick 5m from the kerb then down to the kerb was modelled. This was combined with a 1m deep strip drain along the back of the kerb. The overlay and drainage improved the factor of safety against heave of the silt to 1.2. The maximum exit gradient was reduced to 0.3.

The soil layers found in the hand augers were simplified in the models used for the seepage analyses (Figures 3, 4 and 5). The surface layers of silt and sandy silt were modelled with the same low permeability. Below this the layers were divided into clayey silt, silty fine sand/ sandy silt, silty fine sand, fine sand, fine to medium sand and coarse sand and lapilli. The permeabilities assumed were conservatively based on the grading test results for near-by

The overlay should ideally consist of a silty sand of similar or higher permeability than the surface brown silts. A density of 15kN/m^3 has been assumed. It is considered that the overlay can be shaped down around the existing large trees as the tree roots will prevent heave in these localised areas. The overlay should be extended upstream to the edge of the Council land as shown on Figure 6.

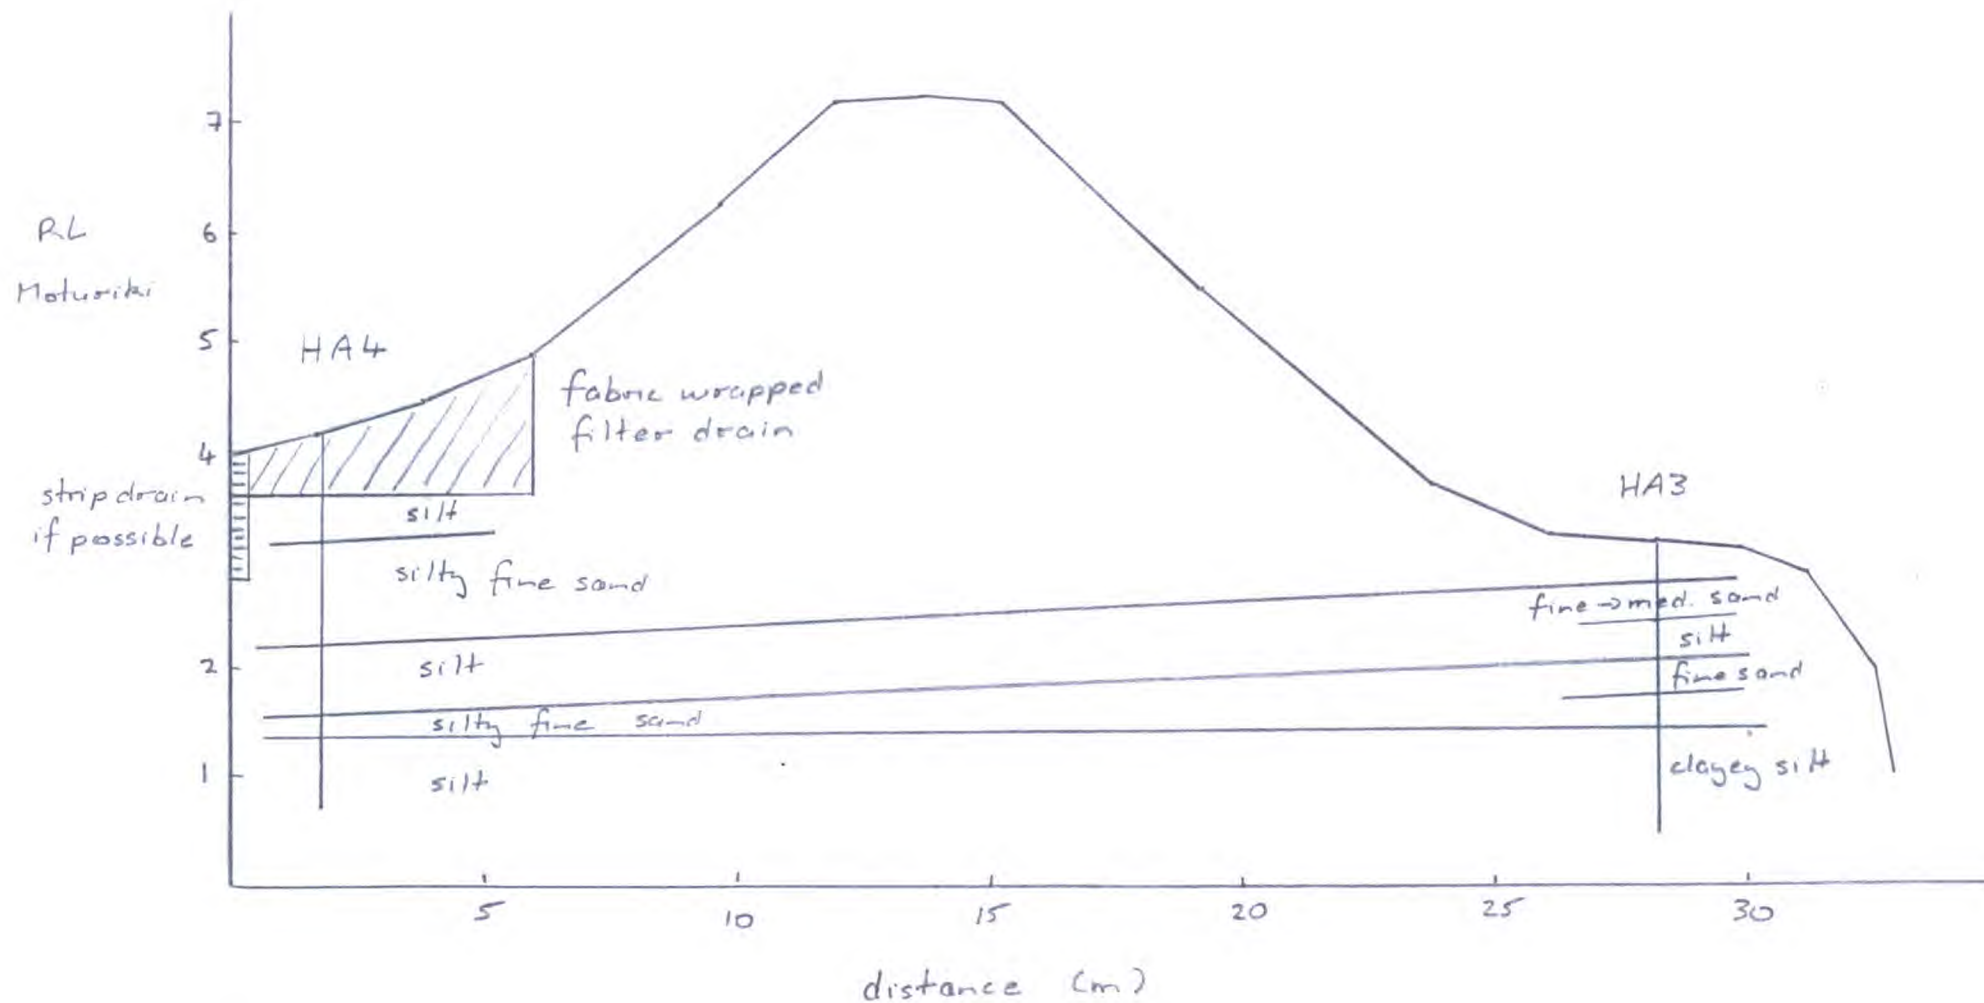
Cross section 2

At Cross Section 2 the inland stopbank toe is almost against the kerb of Main Street and there is a gas main under it. The stopbank rises 3.3m above the kerb. The soils found in HA4 on the inland side of the stopbank are silts and silty fine sands. A clayey silt was found at 1.6m depth in HA3 on the narrow river berm.

The transient flood analysis showed high hydraulic exit gradients at the toe of the stopbank. The installation of a wide toe drain should lower the hydraulic gradient to a safe level. The drain should be installed as deep as possible to reduce pressures under the road but the presence of the services is likely to prevent excavation of more than a few hundred millimetres. If possible the strip drain from Cross Section 1 should be extended around this narrow section.

The drainage work will have to be carried out with the supervision of the service providers. The water from the drain could spill onto the road or into the existing stormwater system.

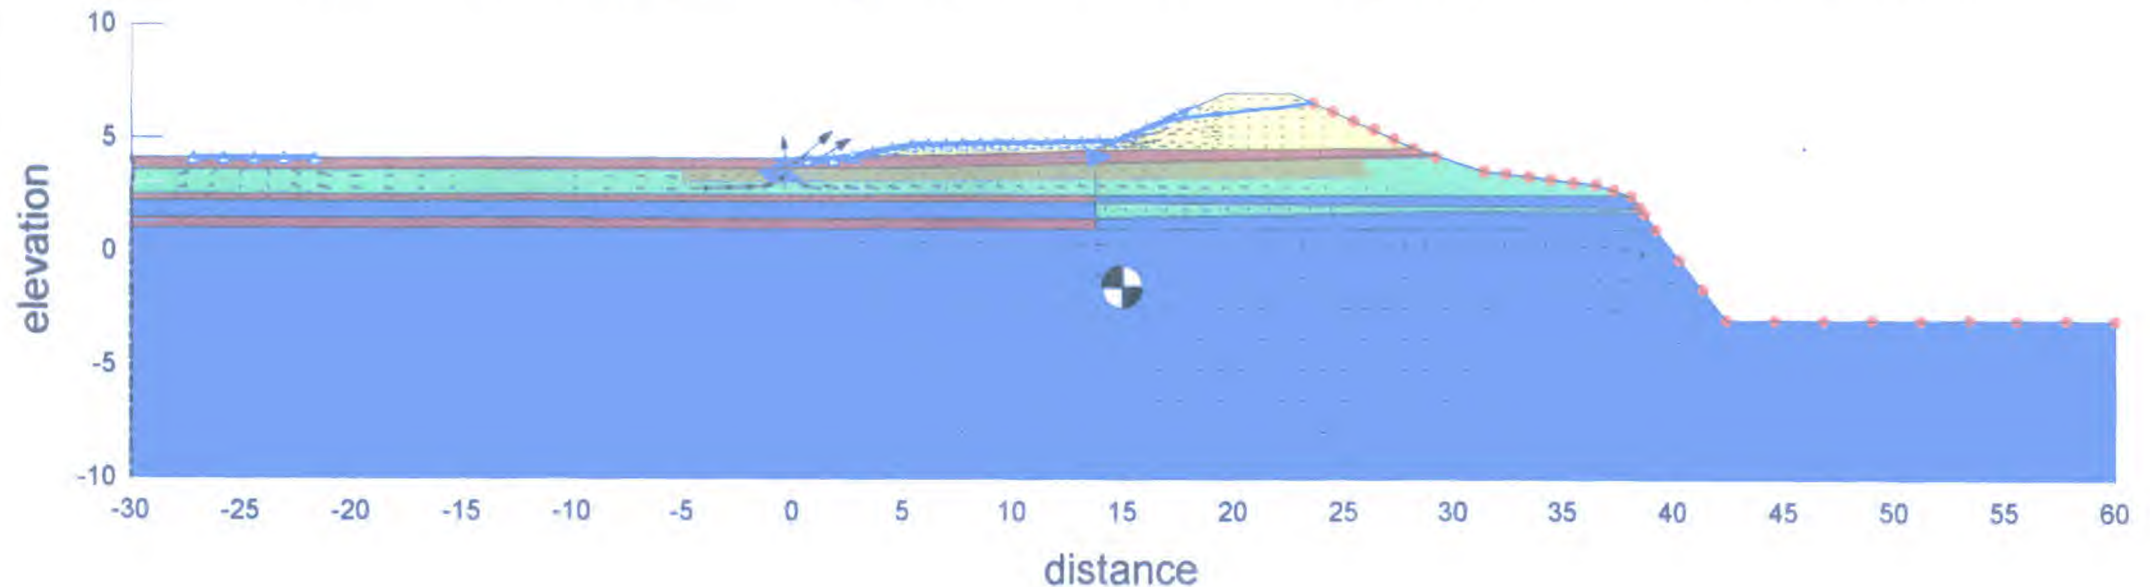
Name: cross section 1 overlay 100yr.gsz
 Title: Rangitaiki Stopbanks Section 5
 Comments: Cross Section 1 overlay 100 year
 Date: 03/08/2006 Time: 10:53:35 a.m.

0.5m overlay and strip drain at kerb

Time step 40 80 hours
