Rangitaiki River Stopbanks Assessment

Section 6 Addendum

Right Bank 11850 to 12300m

Environment Bay of Plenty

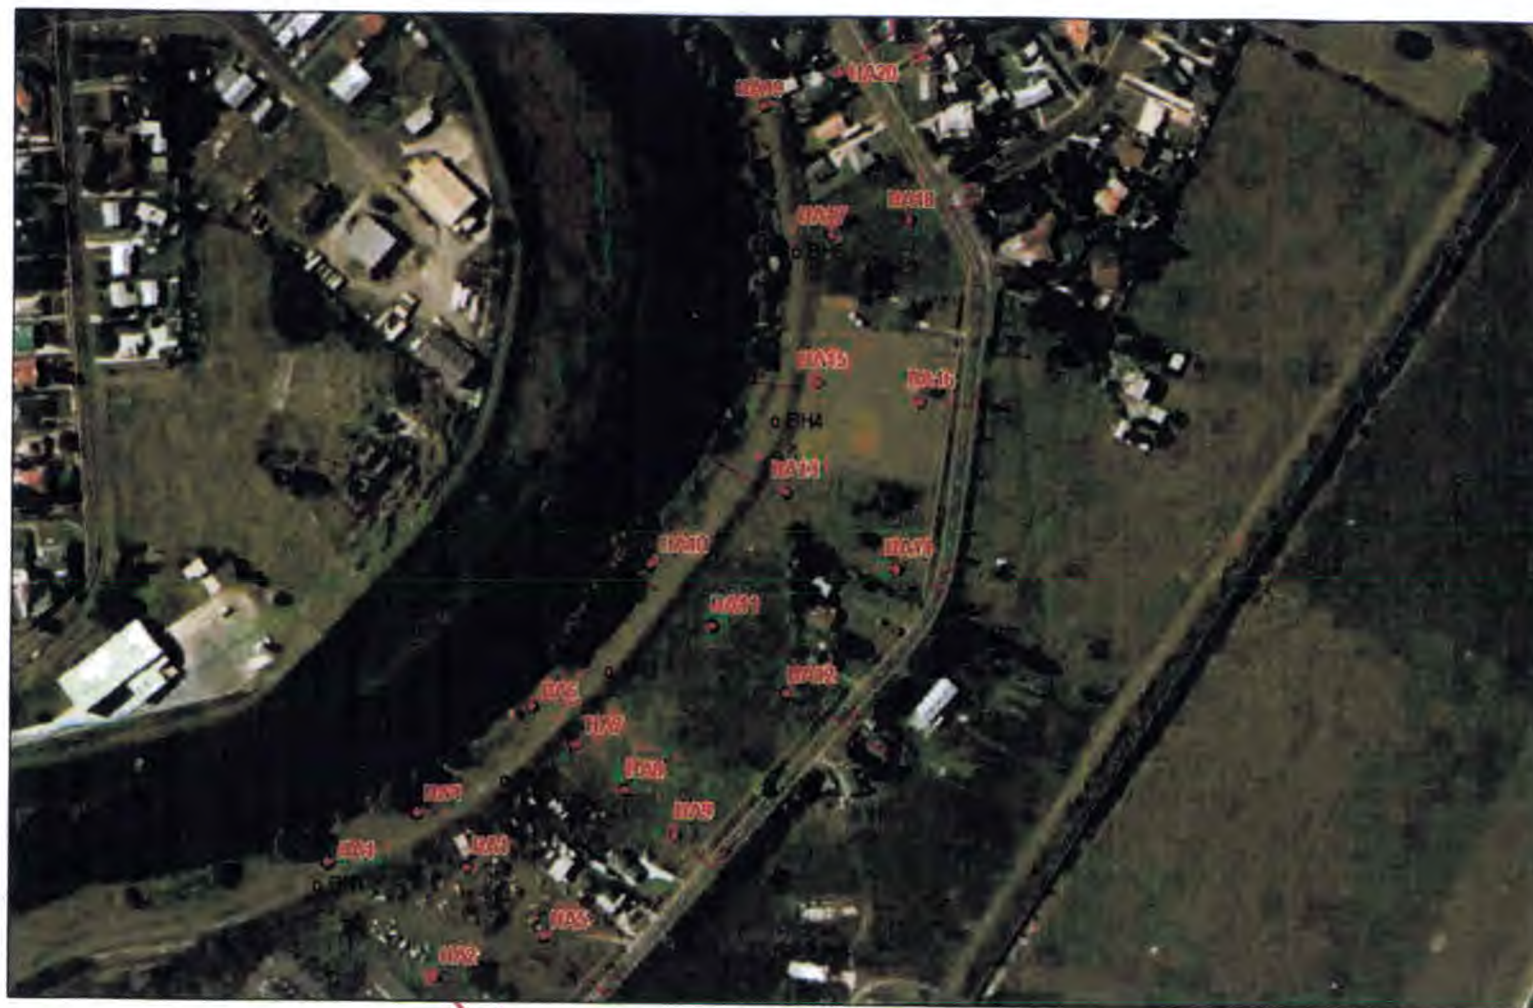
Seepage assessment of the 300 year flood based on the information from 22 hand augers showed the influence of the thickness of various layers with high permeability on uplift pressures. It was therefore considered that deeper investigations were required to define the layer thicknesses and refine the analyses. The subsurface investigations carried out consisted of five boreholes through the crest of the stopbank (see attached Long Section). The target depth of the boreholes was 15m but BH3 appeared to hit some timber at 14.3m depth and was stopped. BH2 was extended to 16.5m as the borehole was still in a layer of coarse pumice lapilli at 15.0m. The boreholes were located to provide information at the most problematic cross sections previously analysed. BH2 was moved downstream from the previous Cross Section 2 due to a 33kV cable being under the stopbank at the cross section. BH3 was moved to be opposite a power pole which had water coming up around it in the 2004 flood. Figure 1 shows the locations of the in situ investigations.

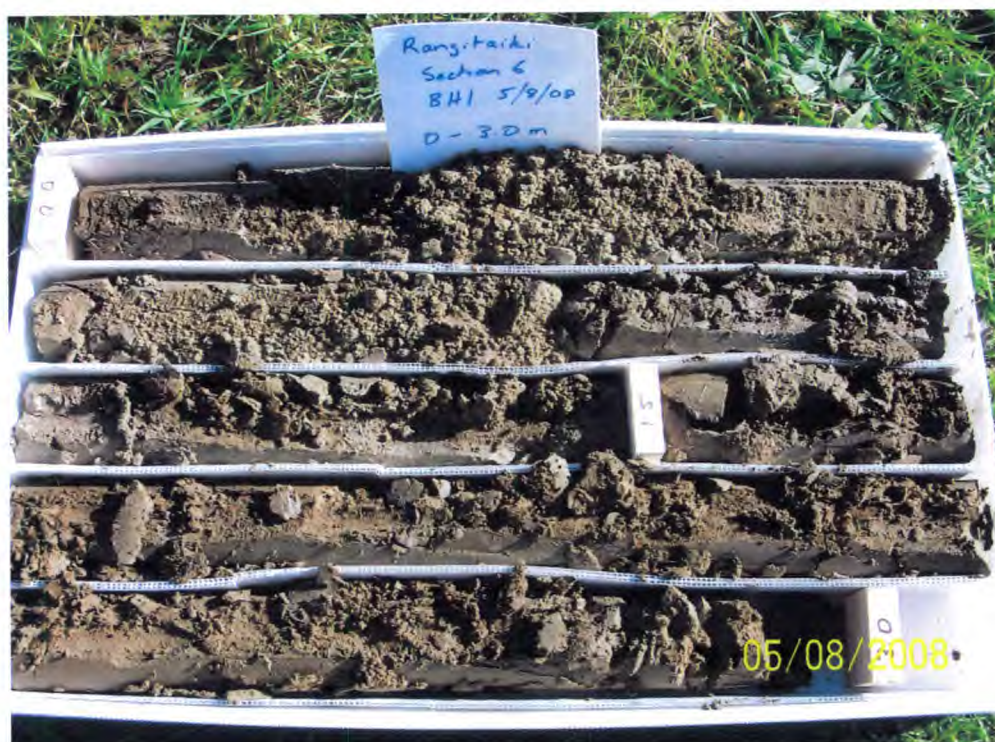
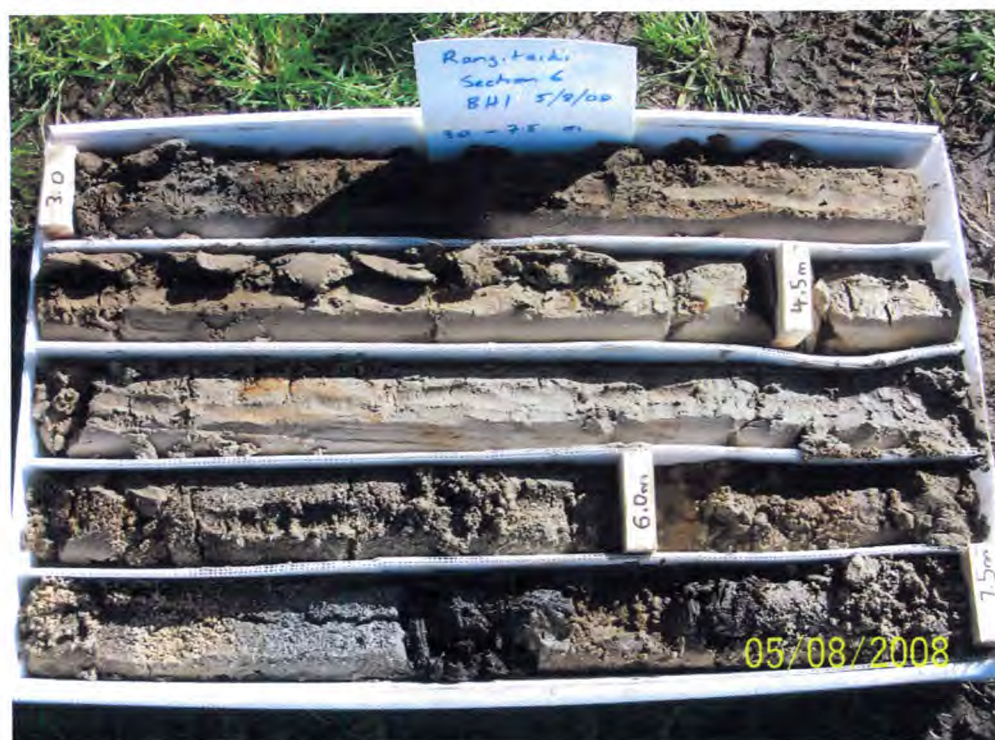
Borehole 1

The bore logs and photographs are included in Appendix A. 14 falling head tests were carried out through the base of the bore holes to gain a feel for the in situ permeabilities of the soils.
