**AC CONSULTING GROUP LIMITED**

**RANGITAIKI RIVER HYDROLOGICAL MODELLING  
PEER REVIEW**

Report No. W1522 01 Rev 0  
17 October 2000

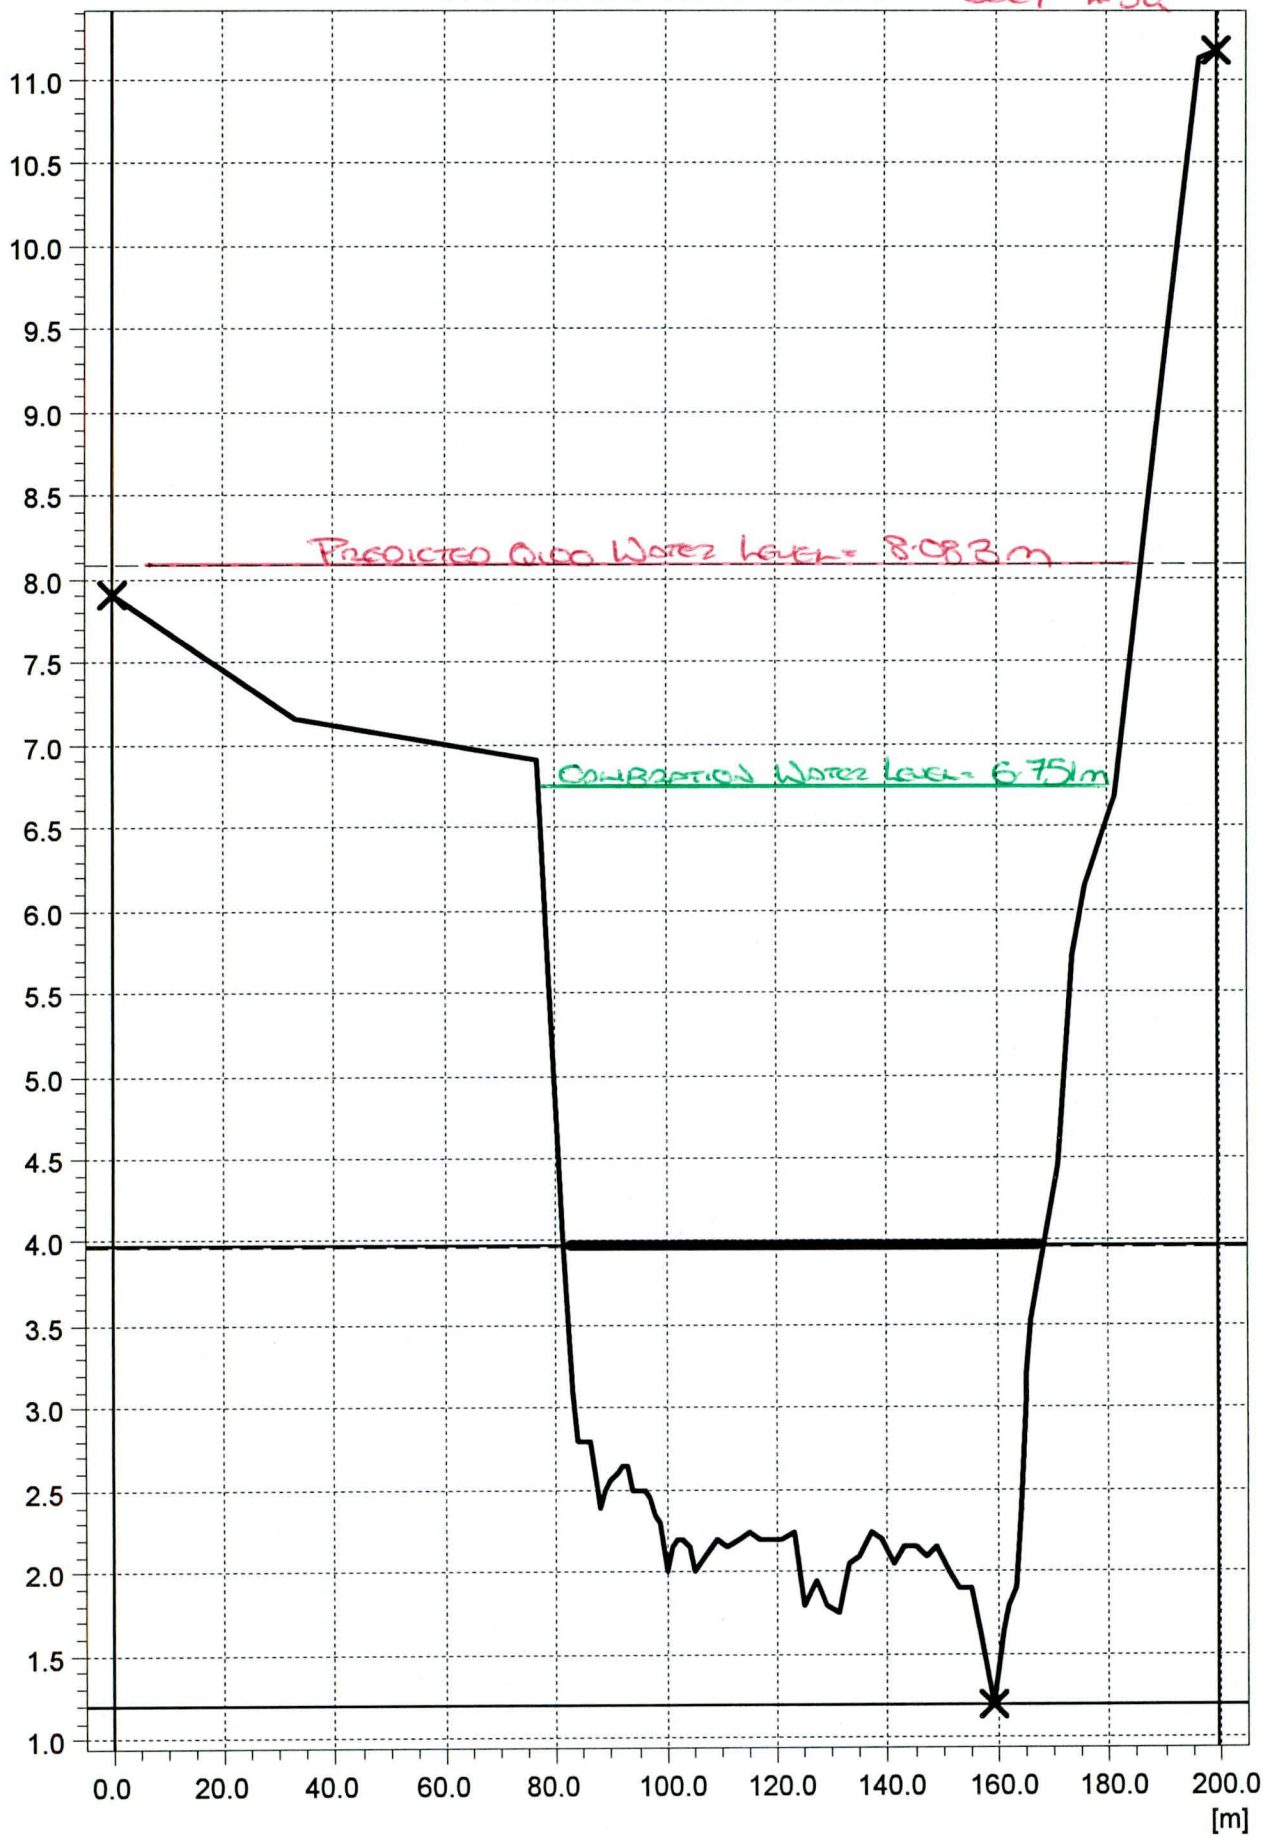
Sec 7<sup>n</sup> 43a

Cross Section No	Mike 11 Chainage (km)	Comment
43a	7.58	Appear to be OK for the calibration event, may have to be adjusted for the 100 year event. Skewed to calib flow?
42	8.01	Appears OK
41a	8.39	Cross section data insufficient for calibration event.
41	8.59	May not take into account the super elevation.
40	8.78	Appear OK, potentially other XS information required DS to define the channel around the bend.
39	9.09	Appears OK for the calibration event.
38	9.44	Observed results mirrored? More survey data required around the bend. Channel skewed to calib flow.

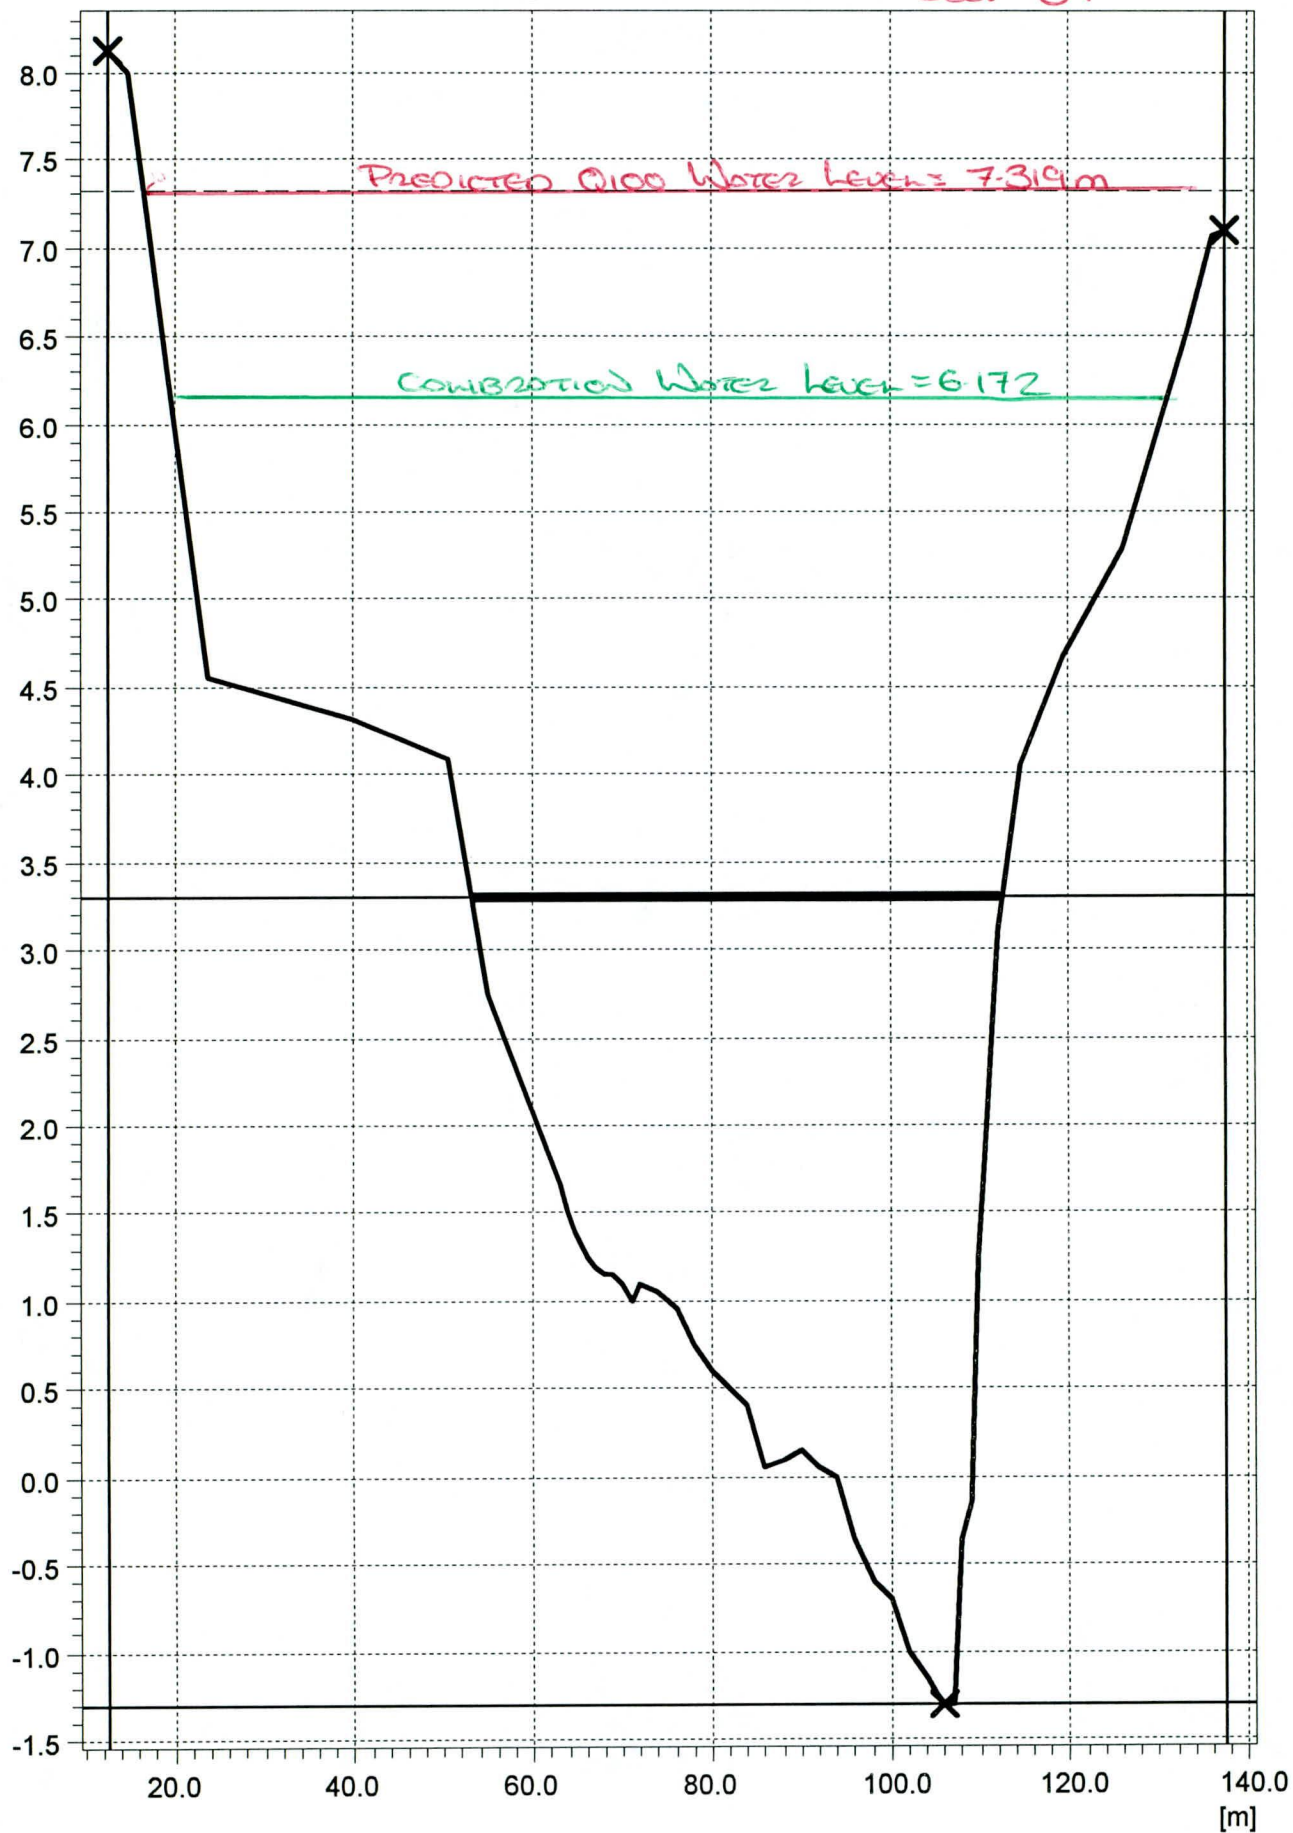
RANGITAIKI 9.690 1/01/90 Sect<sup>n</sup> 37

Cross Section No	Mike 11 Chainage (km)	Comment
37	9.69	Appears OK for calibration event. Additional information possibly required for 100 yr event.
36	10.06	Appears to be OK. Additional XS required around the bend. However, channel width appears to be consistent with d/s XS.
35	10.47	Appear to be OK for calibration event for this section of channel.
34	10.87	XS appears to be indicative of this section of channel. Unsure why such a variance in calibration vs. observed.
33	11.32	Appear to be OK for calibration event for this section of channel.
32	11.69	Sizeable variance in observed vs calibration. Does not appear to take into account super elevation.
31	12.04	Cross section appears OK.

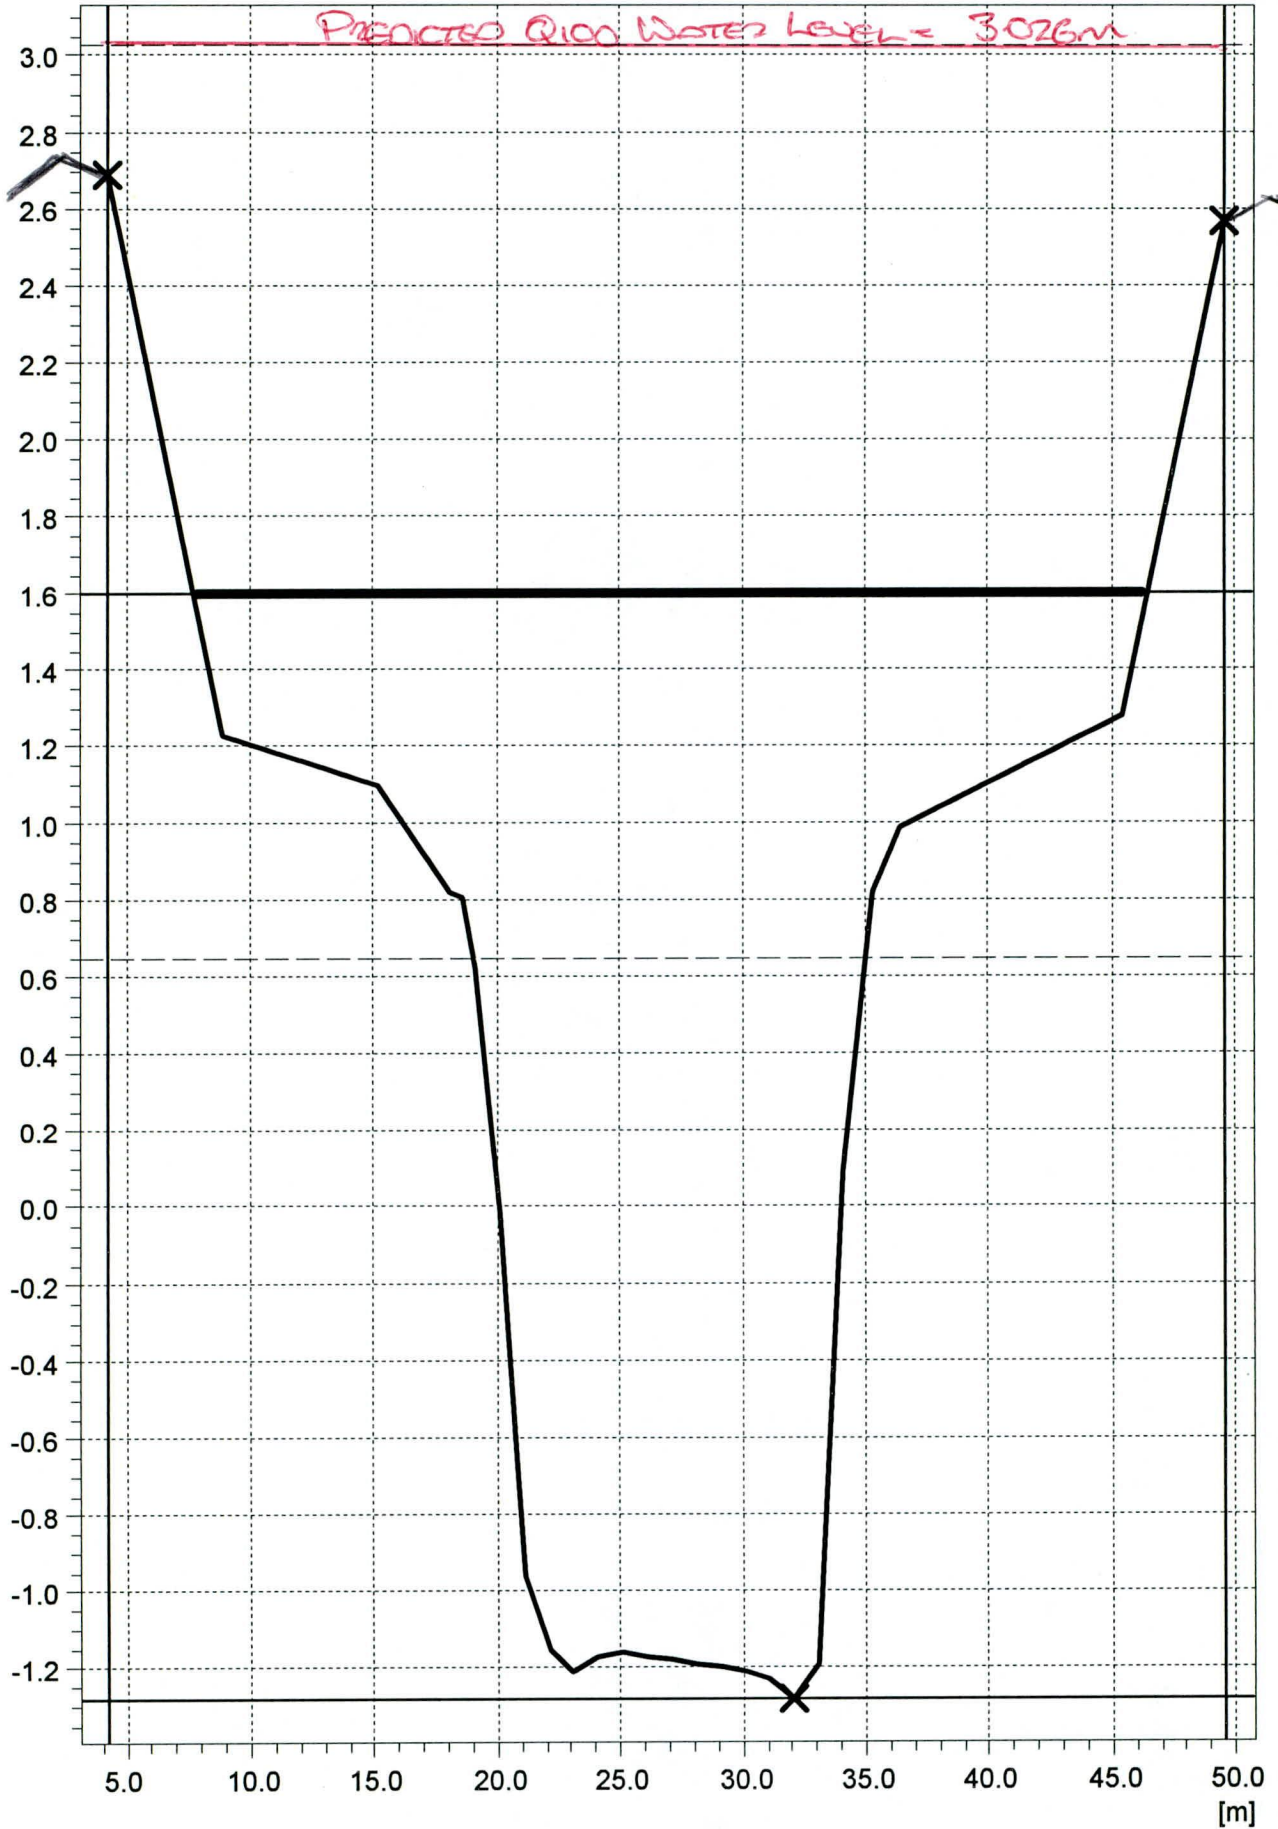
REIDS CENTRAL 18.994 1/01/90

Predicted Q100 Water Level = 3.026m
