Reids Canal Floodway Upgrading

Stage 3

Geotechnical Assessment

Bay of Plenty Regional Council

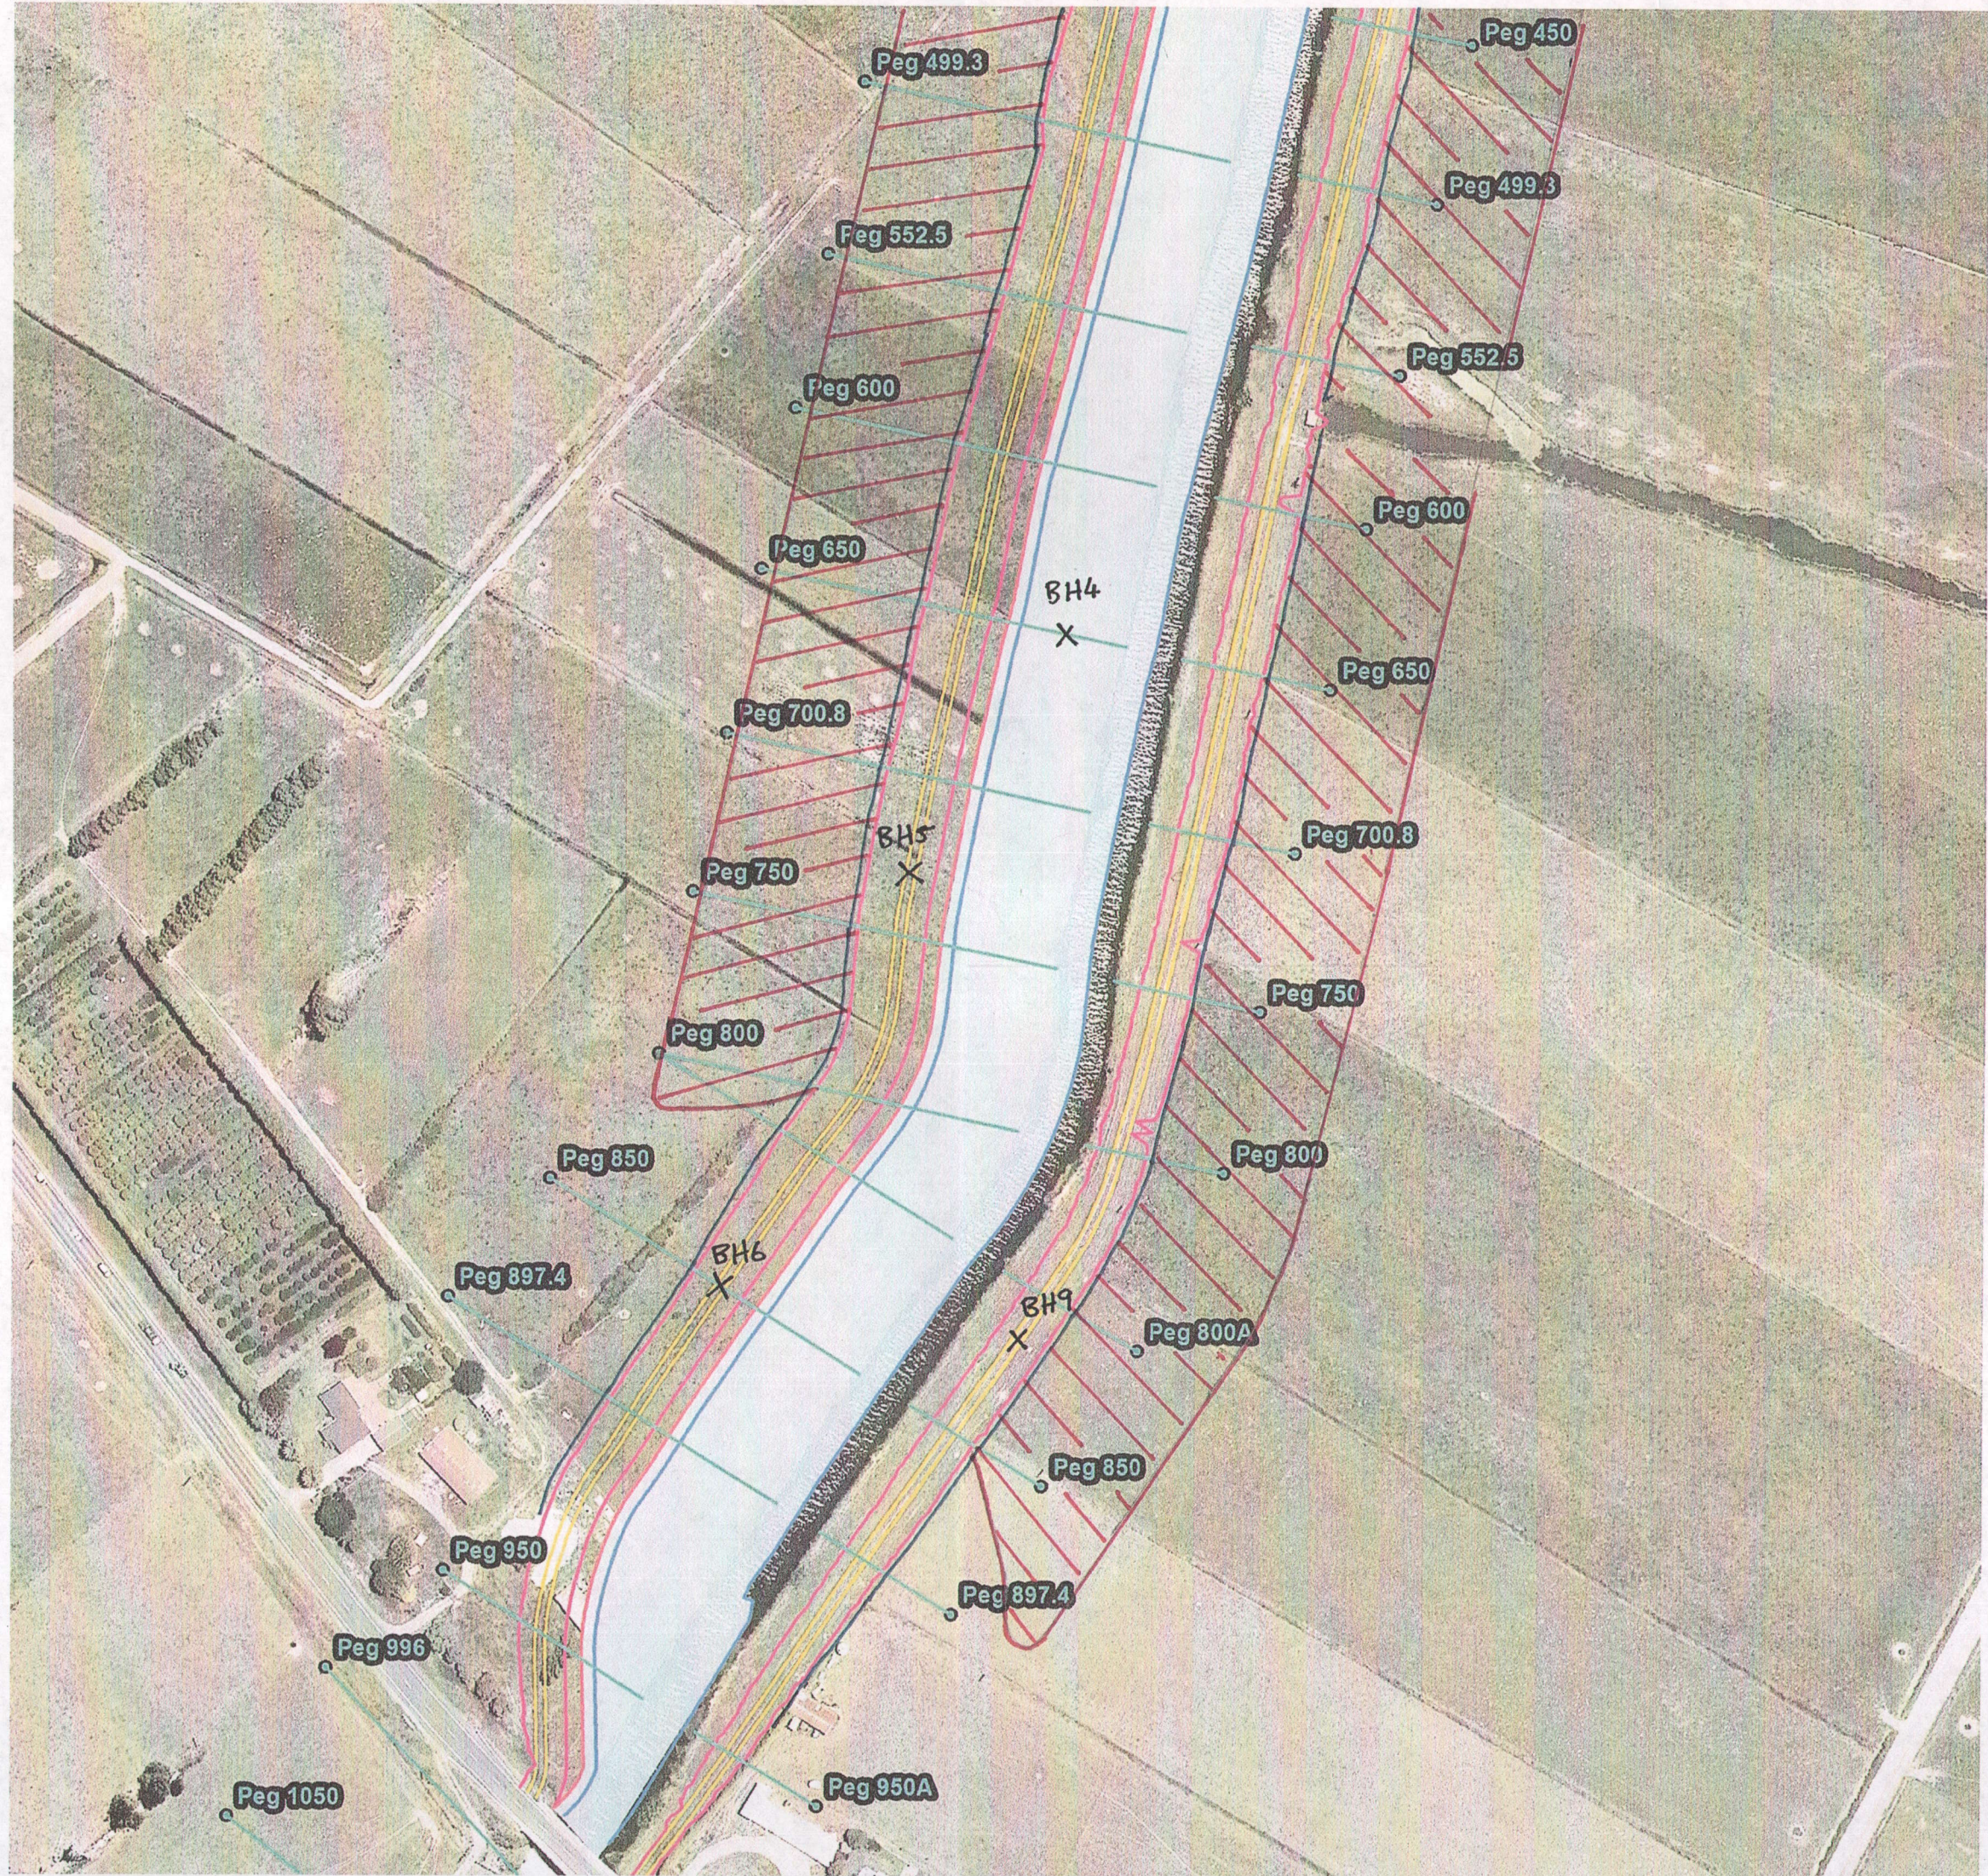
Figure 1b

Figure 1a
X borehole
/// overlay
— wick drains

Figure 1 show the extent of the canal covered by this report and the LIDAR plot in Figure 2 shows the ground contours. The stopbank meterages referred to throughout the report are shown on Figure 1.

Seepage analyses have been carried out on six cross sections at the test locations along the left stopbank and three cross sections along the right stopbank. Table 5, in Section 5.10, summarises the measures recommended to achieve a level of protection against stopbank failure due to heave and piping. The recommended remedial measures are also shown marked up on Figure 1.

Table 5 summarises the recommended remedial measures along each stopbank. These are also shown marked up on Figure 1. It is considered that drainage wicks are required wherever the ground level is below RL1.9. Wherever the ground level is below RL0.6 and the depth to the sand is less than 1.2m, a 50m wide overlay to RL0.6 is required.

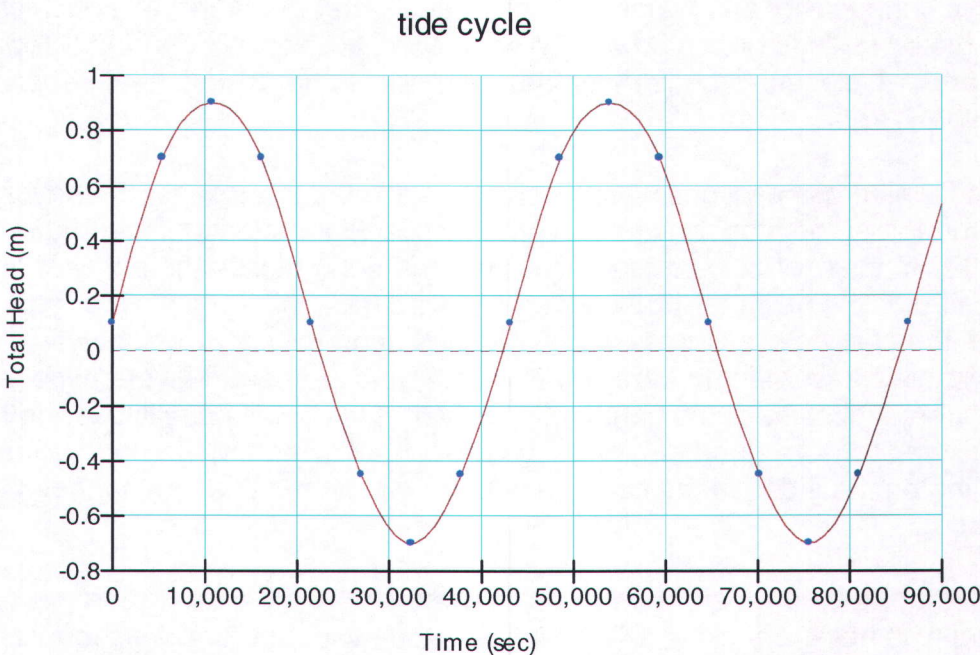
Figure 5: Average tide cycle

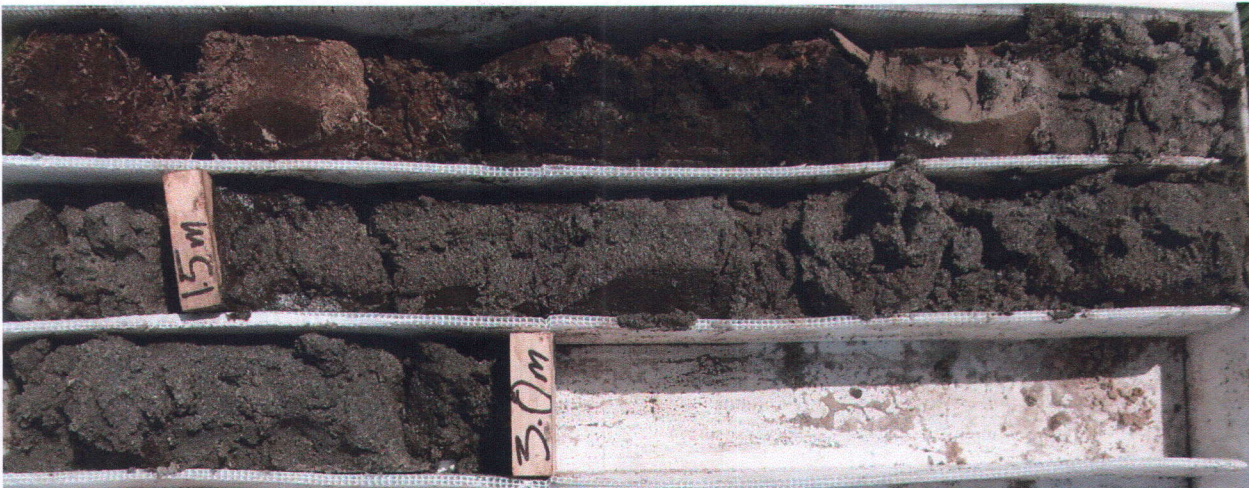
Borehole 3

The borehole at 500m (BH3) was in an old stream path evident as depression about 500mm deep. The basement sand was found at RL-0.4, only 0.6m below the ground surface and 0.6 to 1.6m above the basement sand level found in other boreholes in this part of the basin. The possibility of there being preferential seepage paths under stopbanks along old stream paths was therefore confirmed.

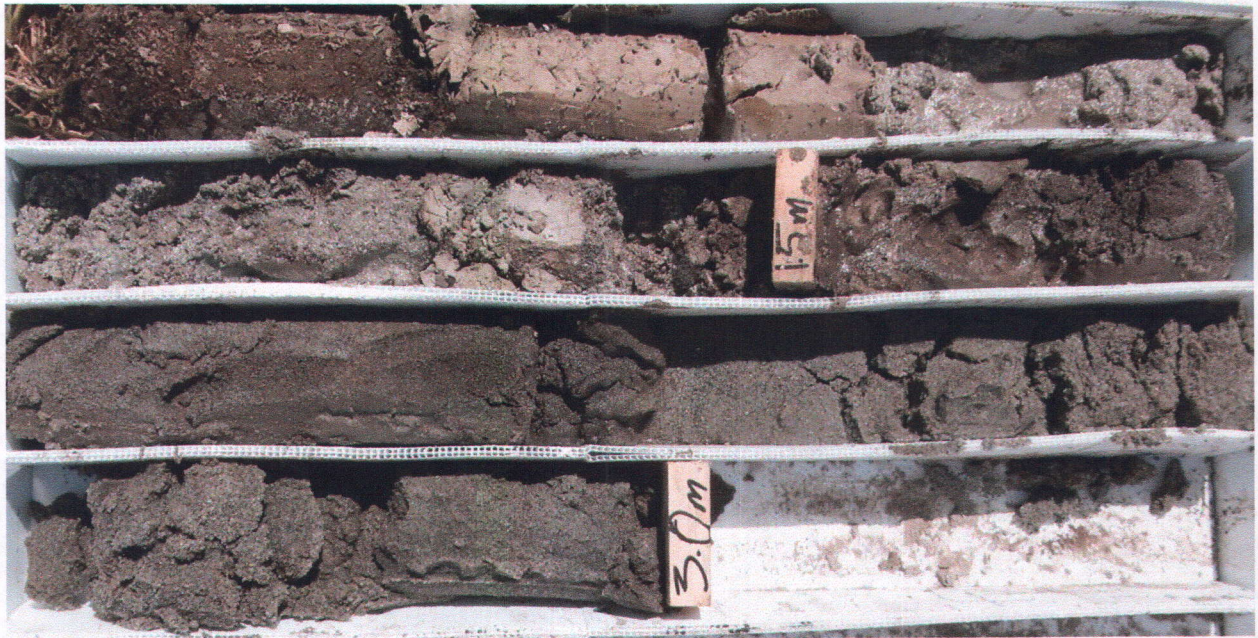
Borehole 5

BH5 at 720m was in the lowest part of the basin at RL0.2. The same layers of organic and pumiceous silt were found at the ground surface as at BH3 but they are only 0.4m thick, compared to 0.6m in the old stream channel. The surface silts are underlain by 1m of medium to coarse sand and then another 0.2m thick silt sequence above the basement sands.

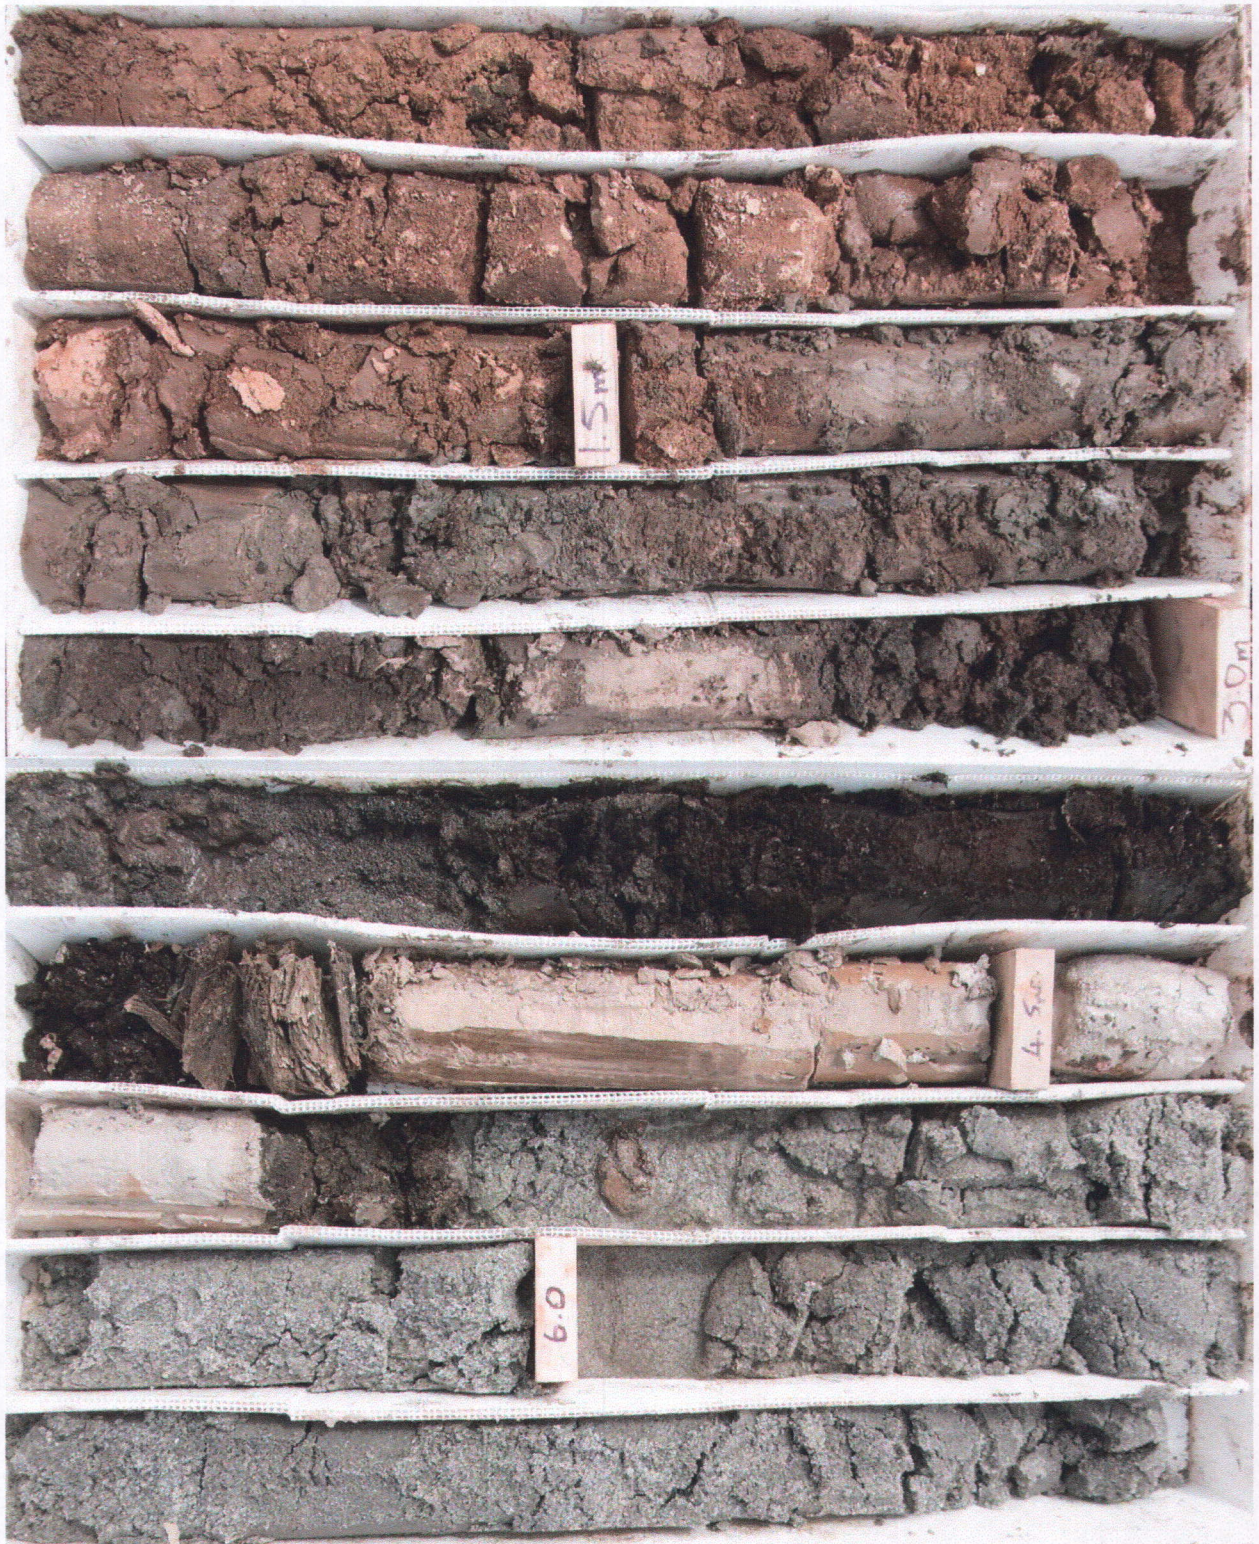
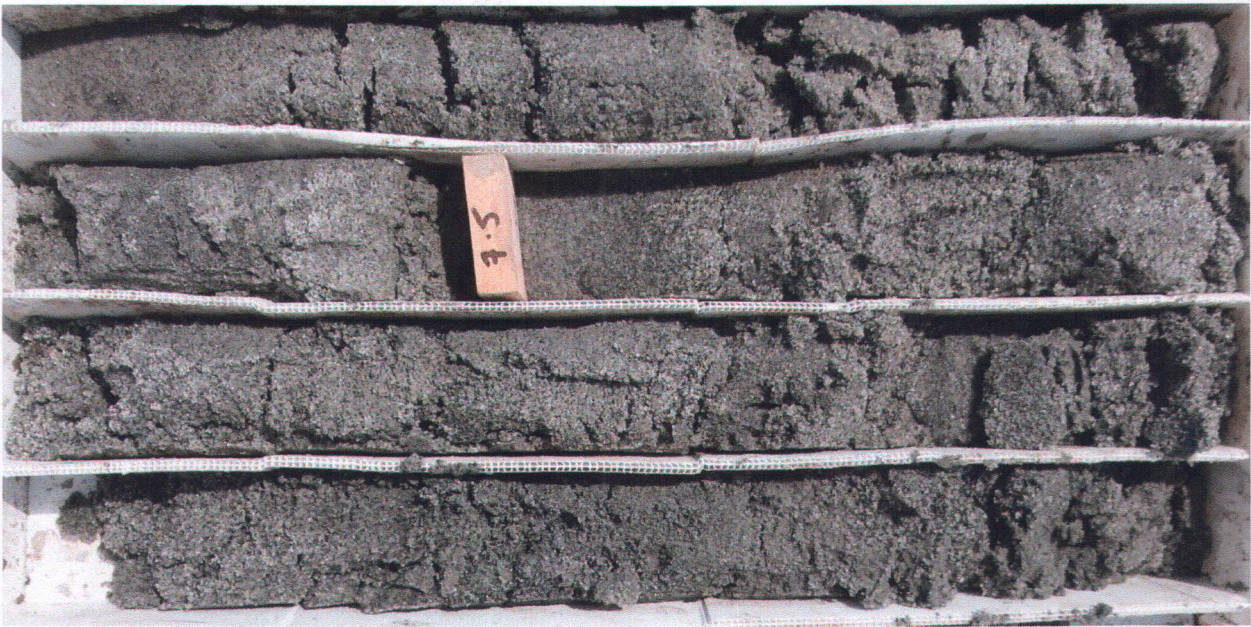
Borehole 8

The thick silt layers found in BH8 could be due to the removal of sand in the old stream channel and the deposition of silt when stream flow was slowed or stopped.

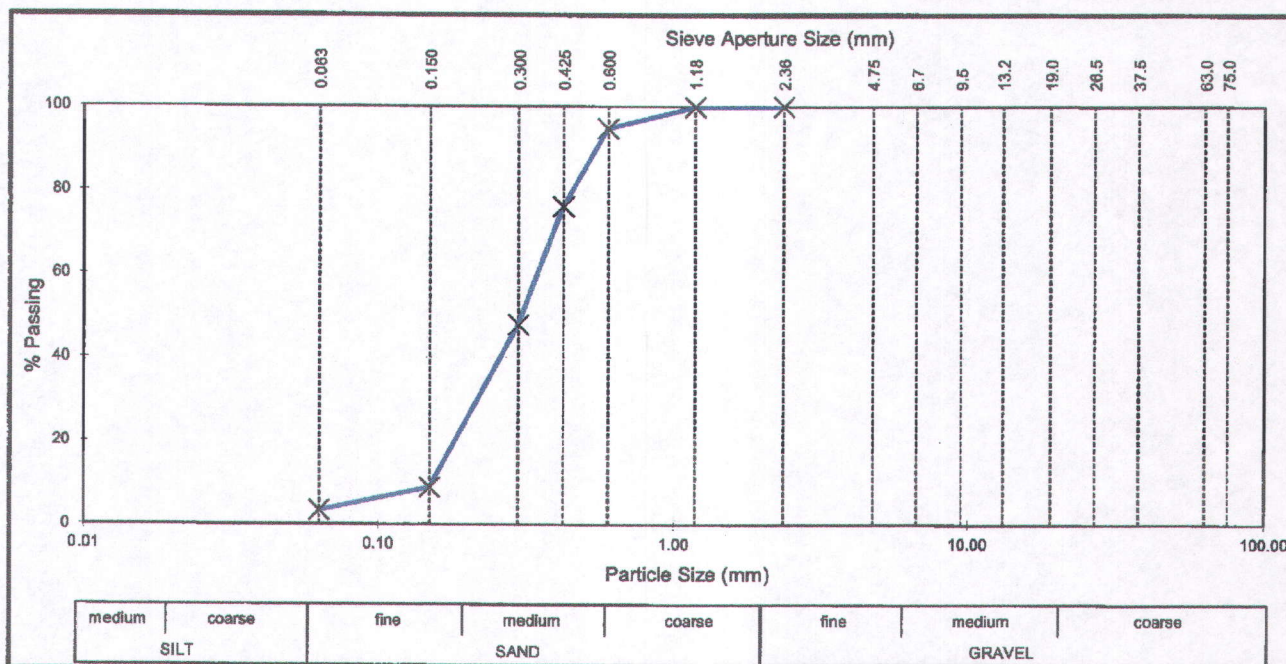
Project : Reids Canal Stage 3
 Location : Thornton
 Client : Ice Geo & Civil
 Contractor : N/A
 Sampled by : Marriane O'Halloran (Ice Geo & Civil)
 Date sampled : April 2013
 Sampling method : Borehole
 Sample description : Fine - coarse SAND with a trace of Silt
 Sample condition : Natural State (as received)
 Bore hole no : 1
 Depth : 4.2 Metres

Sieve Analysis							
Size (mm)	% Passing	Size (mm)	% Passing	Size (mm)	% Passing	Size (mm)	% Passing
75.00	-	19.00	-	4.75	-	0.425	76
63.00	-	13.20	-	2.36	100	0.300	48
37.50	-	9.50	-	1.18	100	0.150	9
26.50	-	6.70	-	0.600	95	0.063	3

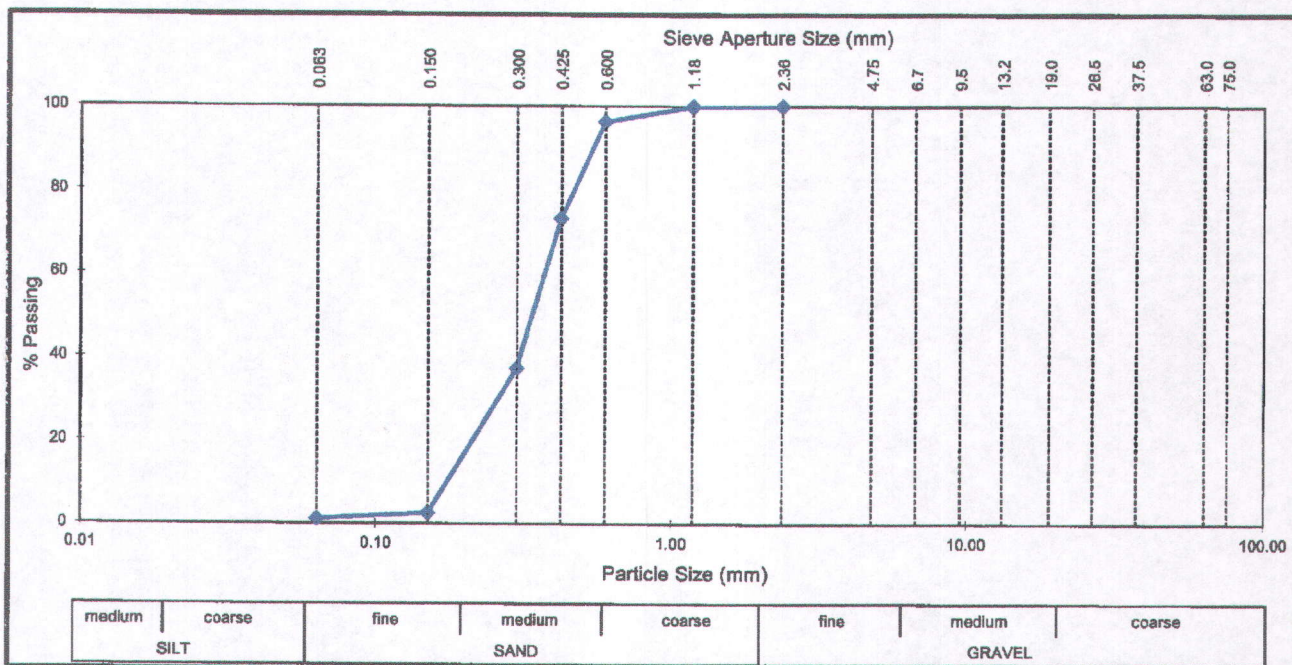
Project : Reids Canal Stage 3
 Location : Thornton
 Client : Ice Geo & Civil
 Contractor : N/A
 Sampled by : Marriane O'Halloran (Ice Geo & Civil)
 Date sampled : April 2013
 Sampling method : Borehole
 Sample description : Fine - coarse SAND
 Sample condition : Natural State (as received)
 Bore hole no : 1
 Depth : 5.0 Metres

Sieve Analysis							
Size (mm)	% Passing	Size (mm)	% Passing	Size (mm)	% Passing	Size (mm)	% Passing
75.00	-	19.00	-	4.75	-	0.425	73
63.00	-	13.20	-	2.36	100	0.300	37
37.50	-	9.50	-	1.18	100	0.150	3
26.50	-	6.70	-	0.600	96	0.063	1

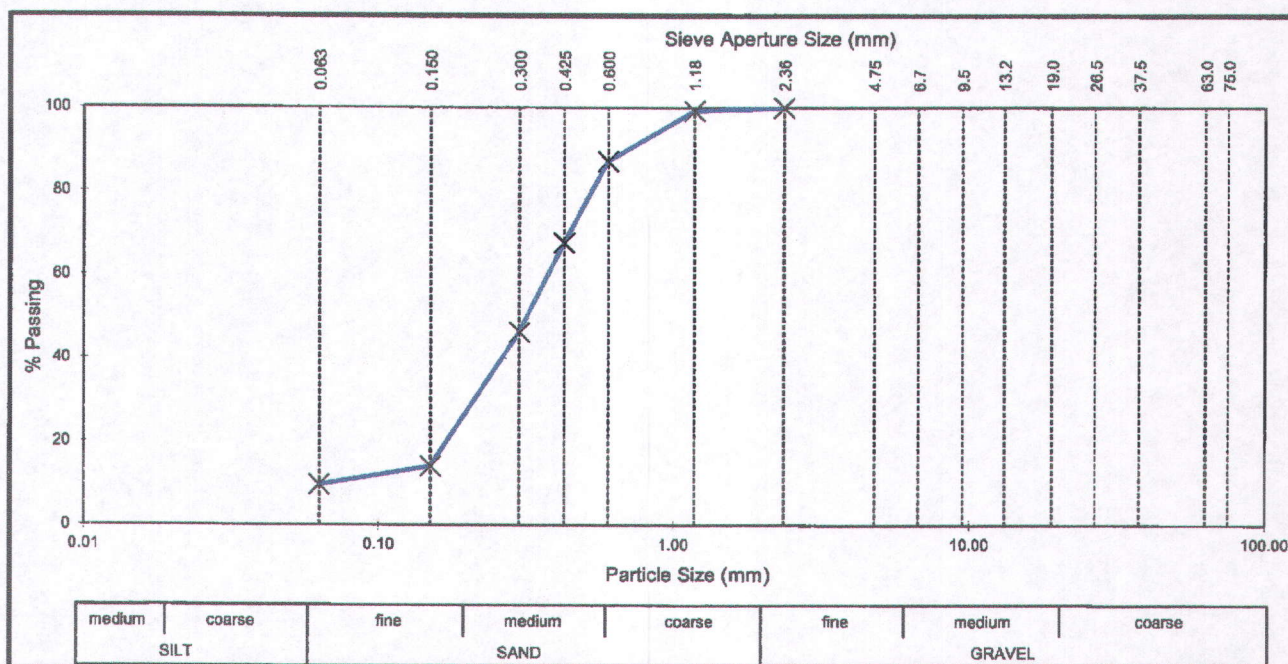
Sieve Analysis							
Size (mm)	% Passing	Size (mm)	% Passing	Size (mm)	% Passing	Size (mm)	% Passing
75.00	-	19.00	-	4.75	-	0.425	68
63.00	-	13.20	-	2.36	100	0.300	46
37.50	-	9.50	-	1.18	99	0.150	14
26.50	-	6.70	-	0.600	87	0.063	10

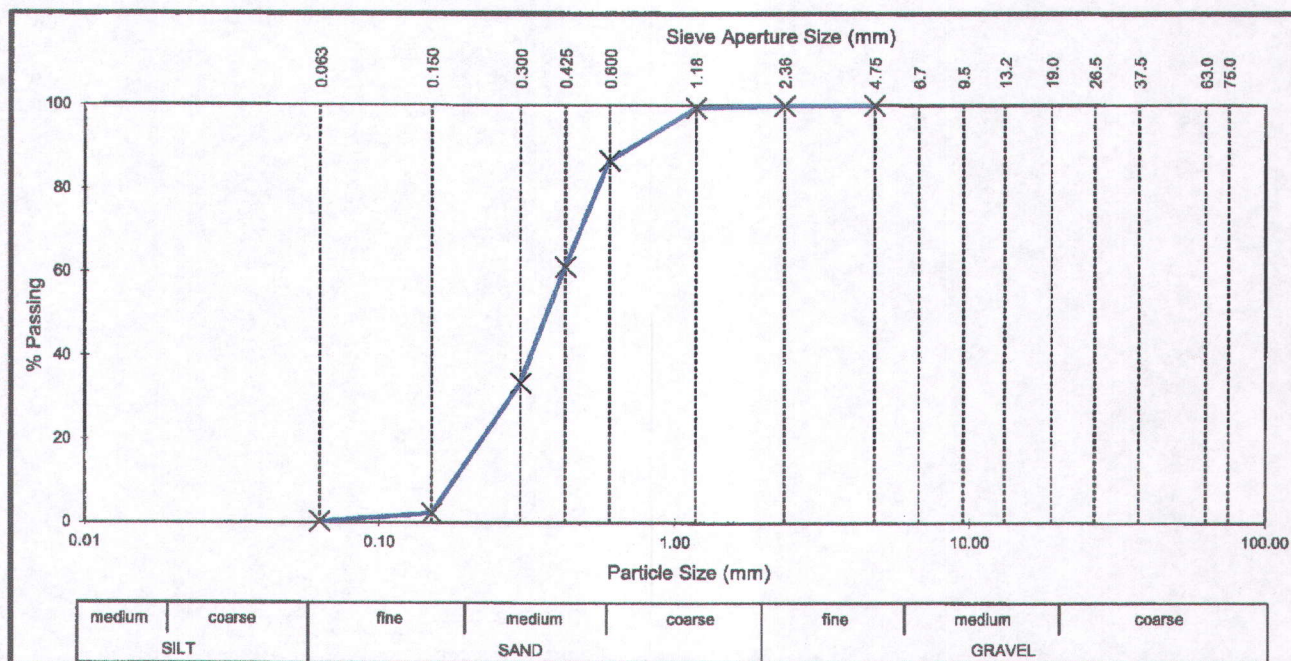
Project : Reids Canal Stage 3
 Location : Thornton
 Client : Ice Geo & Civil
 Contractor : Unknown
 Sampled by : Marriane O'Halloran
 Date sampled : April 2013
 Sampling method : N/A
 Sample description : Fine - coarse SAND
 Sample condition : Natural State (as received)
 Bore hole no : 8
 Depth : 5.5 Metres

Sieve Analysis							
Size (mm)	% Passing	Size (mm)	% Passing	Size (mm)	% Passing	Size (mm)	% Passing
75.00	-	19.00	-	4.75	100	0.425	61
63.00	-	13.20	-	2.36	100	0.300	34
37.50	-	9.50	-	1.18	99	0.150	2
26.50	-	6.70	-	0.600	87	0.063	0

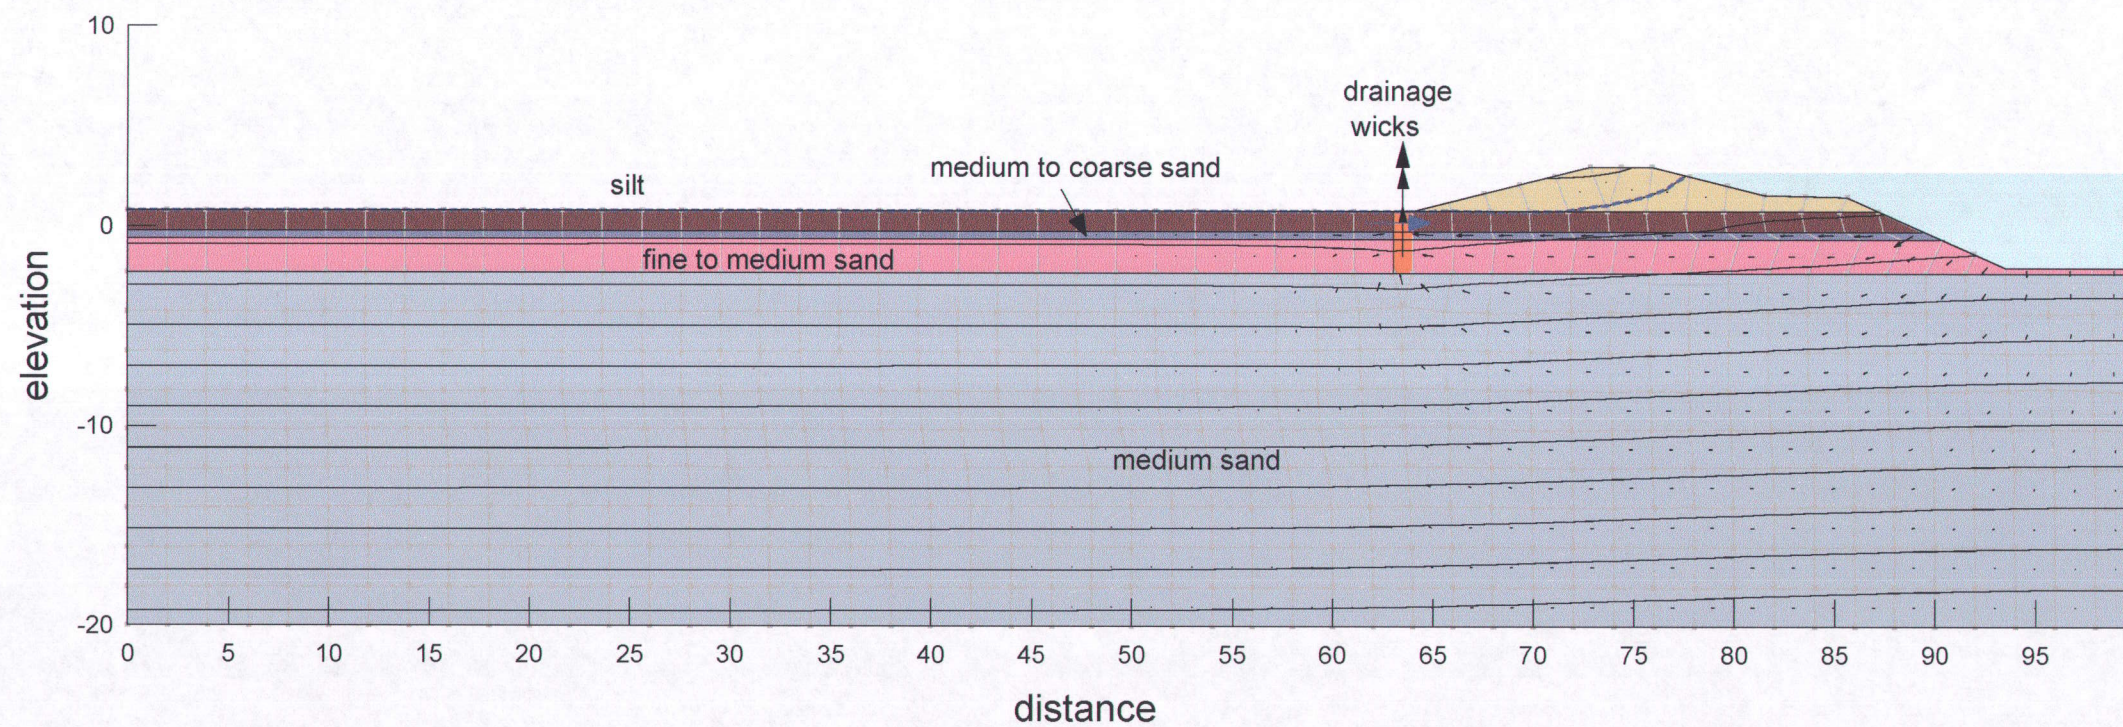
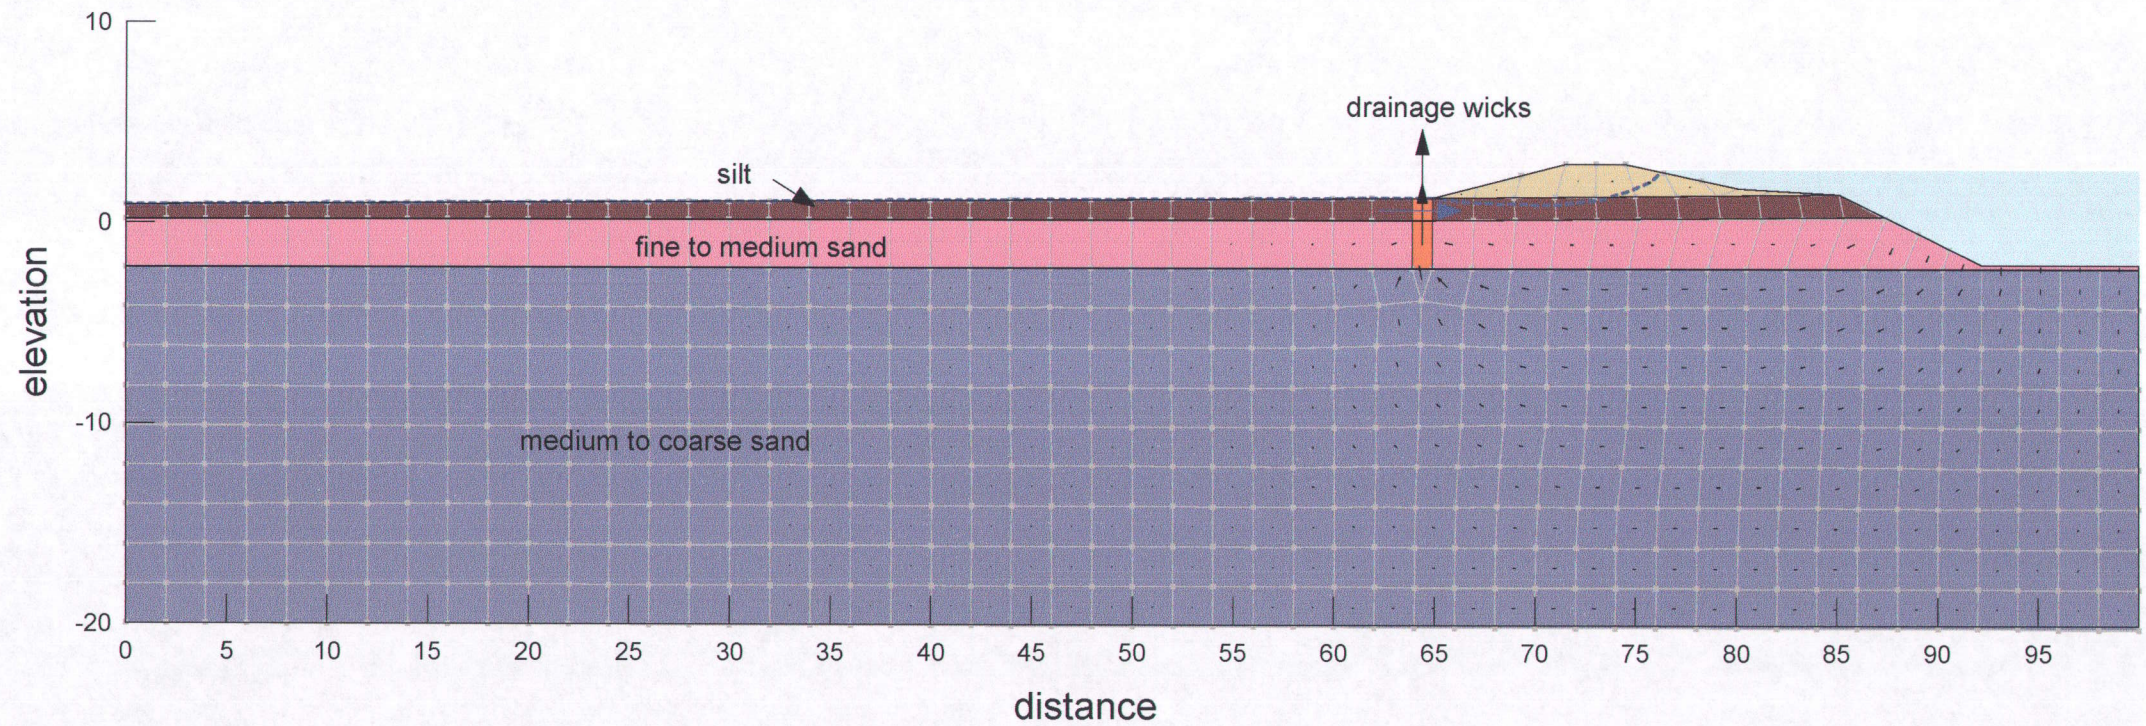
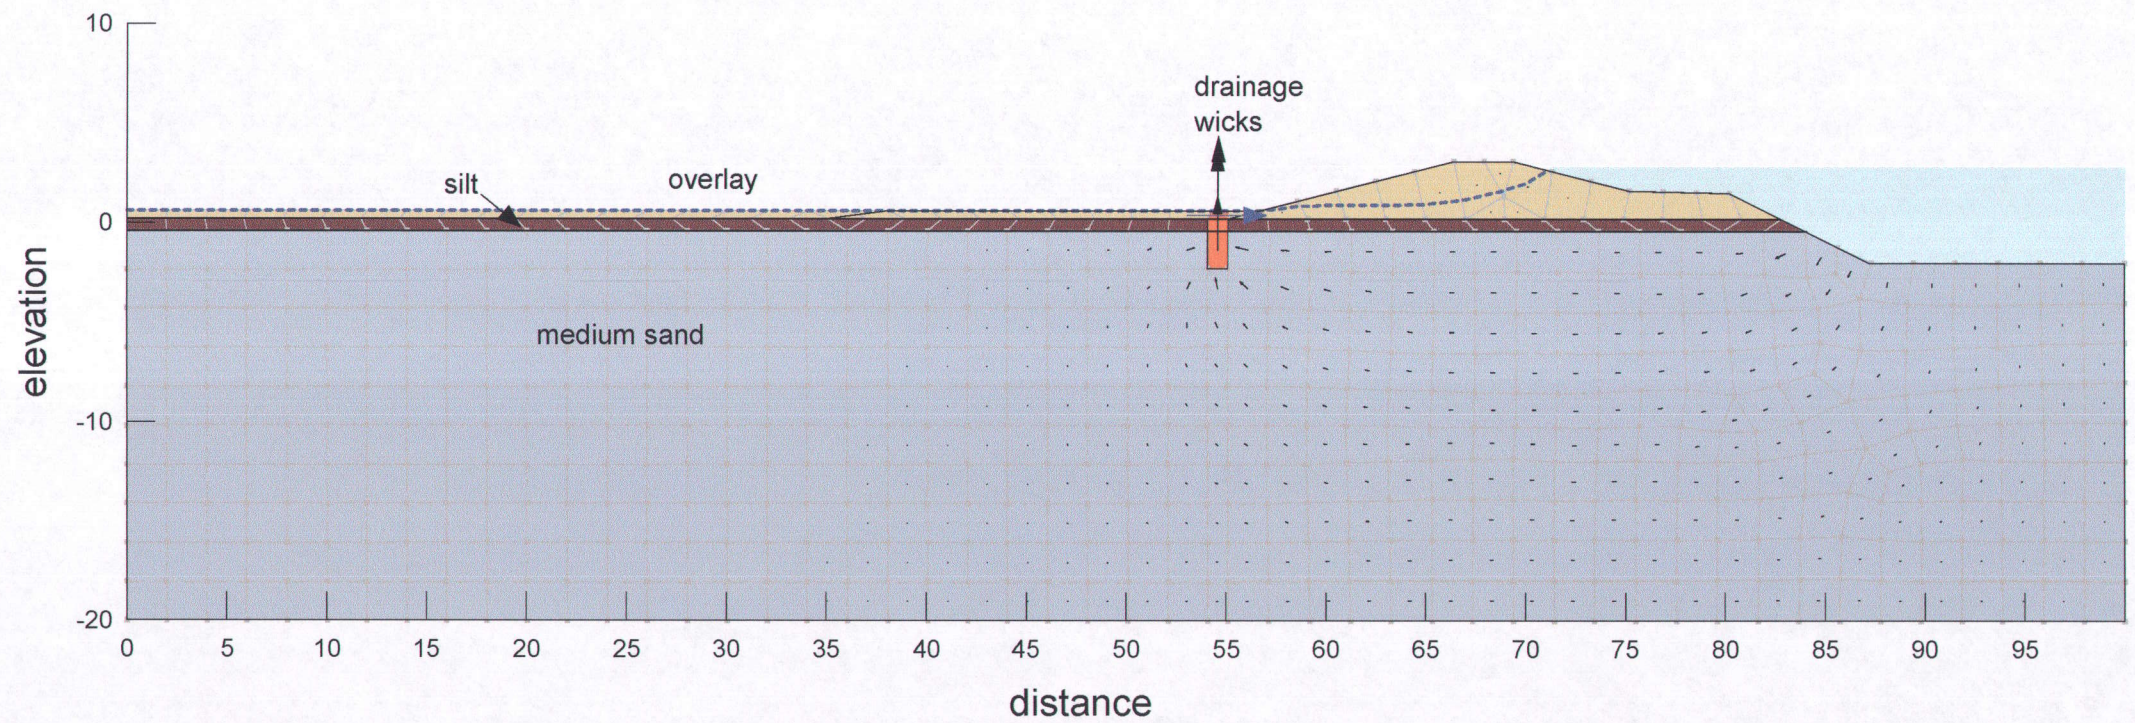
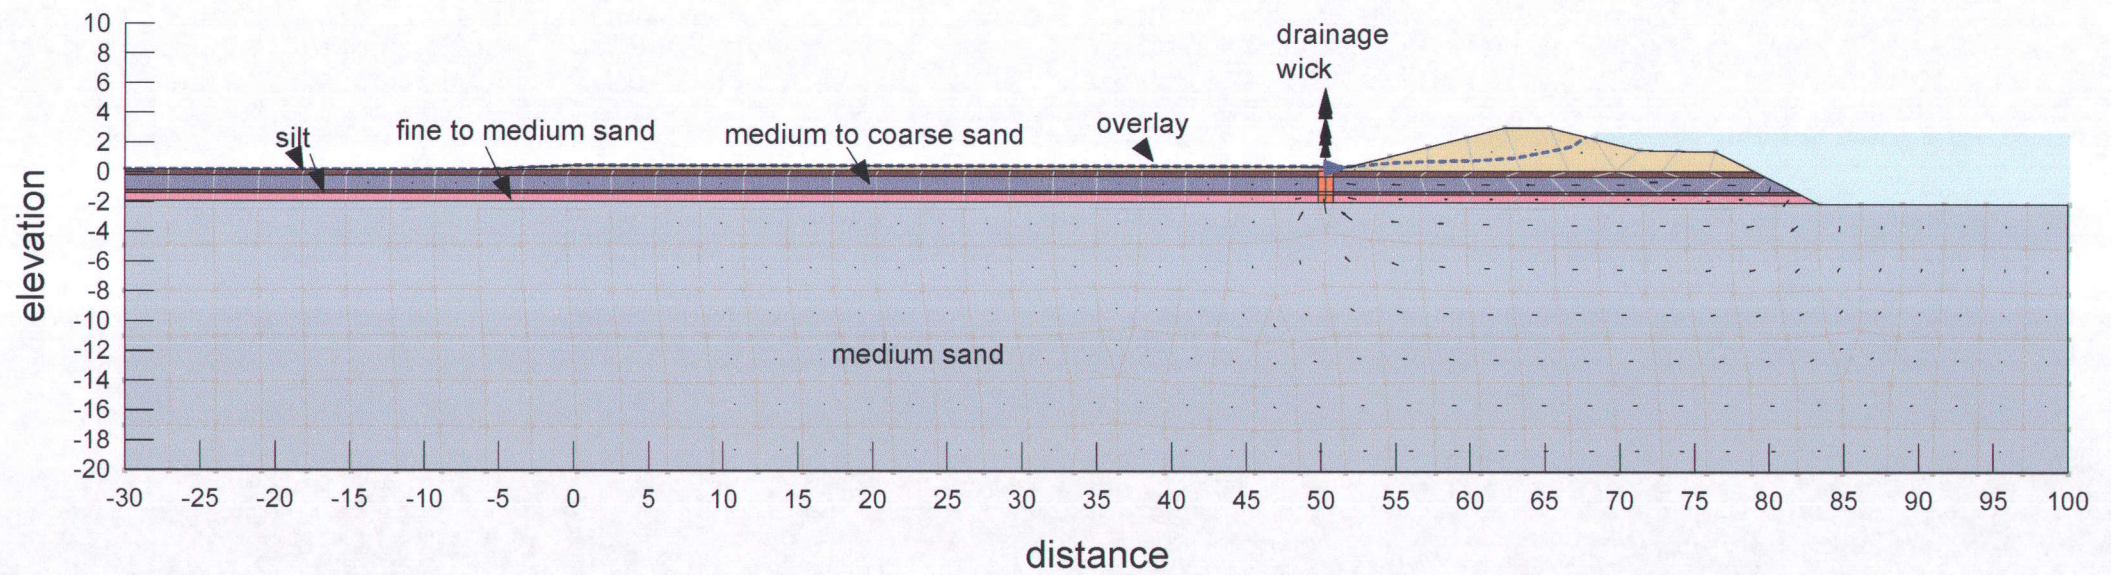
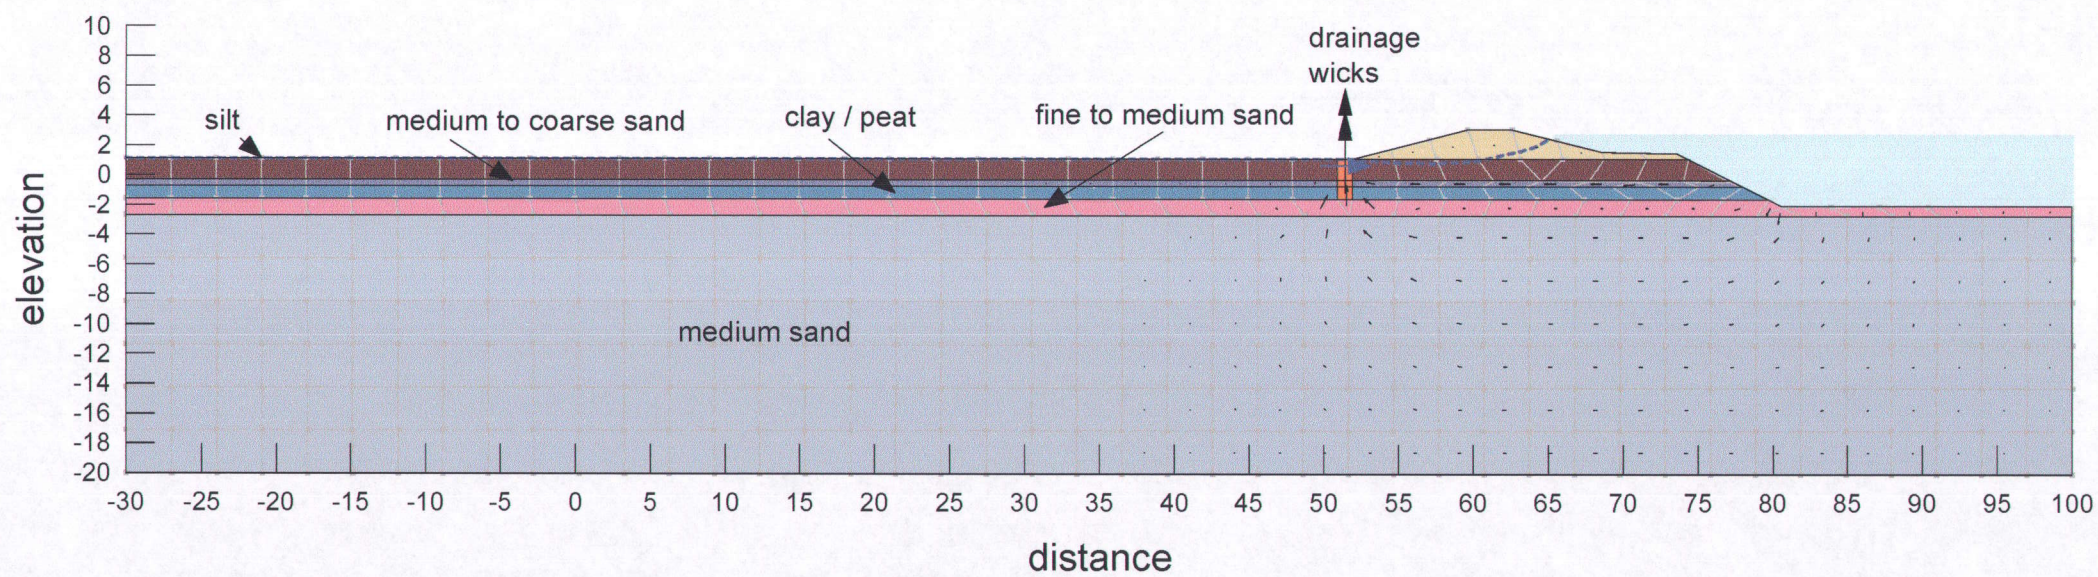
The soil layers found in the in situ investigations were simplified to form seepage analysis models for each of the stopbank cross sections. These are discussed in following sections and are shown in Appendix C.

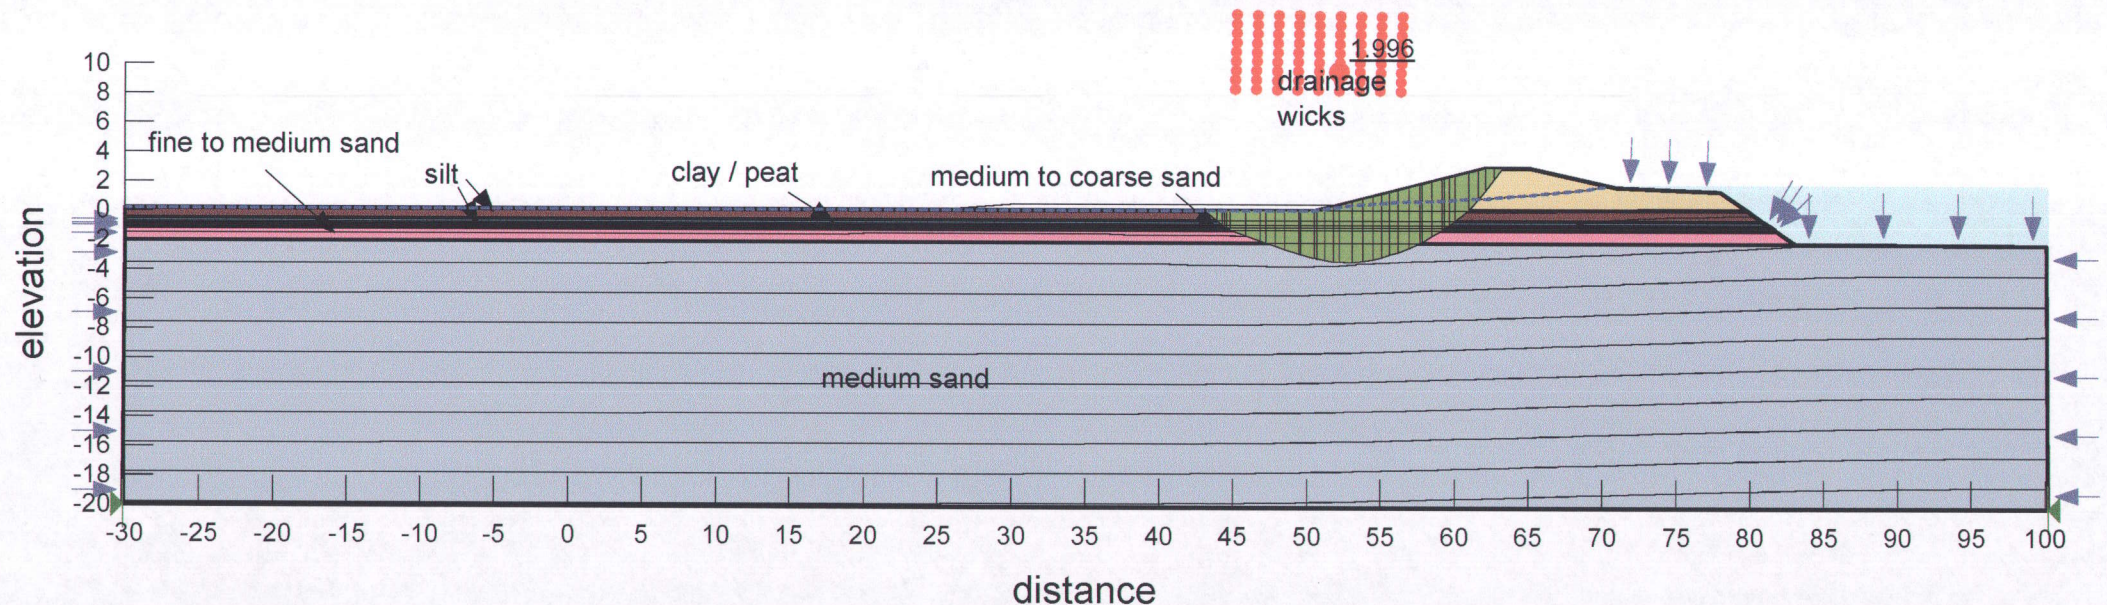
File Name: Cross Section LB650 stopbank trans.gsz
 Date: 16/06/2013 Time: 4:37:25 p.m.

Name: Material 1 fill Unit Weight: 17 kN/m³ Cohesion': 2 kPa Phi': 33 °
 Name: Material 2 silt Unit Weight: 15 kN/m³ Cohesion': 2 kPa Phi': 24 °
 Name: Material 3 fine to medium sand Unit Weight: 13 kN/m³ Cohesion': 0 kPa Phi': 35 °
 Name: Material 4 medium to coarse sand Unit Weight: 13 kN/m³ Cohesion': 0 kPa Phi': 35 °
 Name: Material 5 medium sand Unit Weight: 13 kN/m³ Cohesion': 0 kPa Phi': 35 °
 Name: Material 6 clay / peat Unit Weight: 10.5 kN/m³ Cohesion': 30 kPa
 Name: Material 8 wick drains Unit Weight: 13 kN/m³ Cohesion': 0 kPa Phi': 35 °

The lowest stopbank factor of safety found was on the inland face 6 days into the flood when seepage has progressed through the stopbank. At LB650m the factor of safety was 2.0 and at RB450, 1.7. These factors of safety are all considered acceptable.

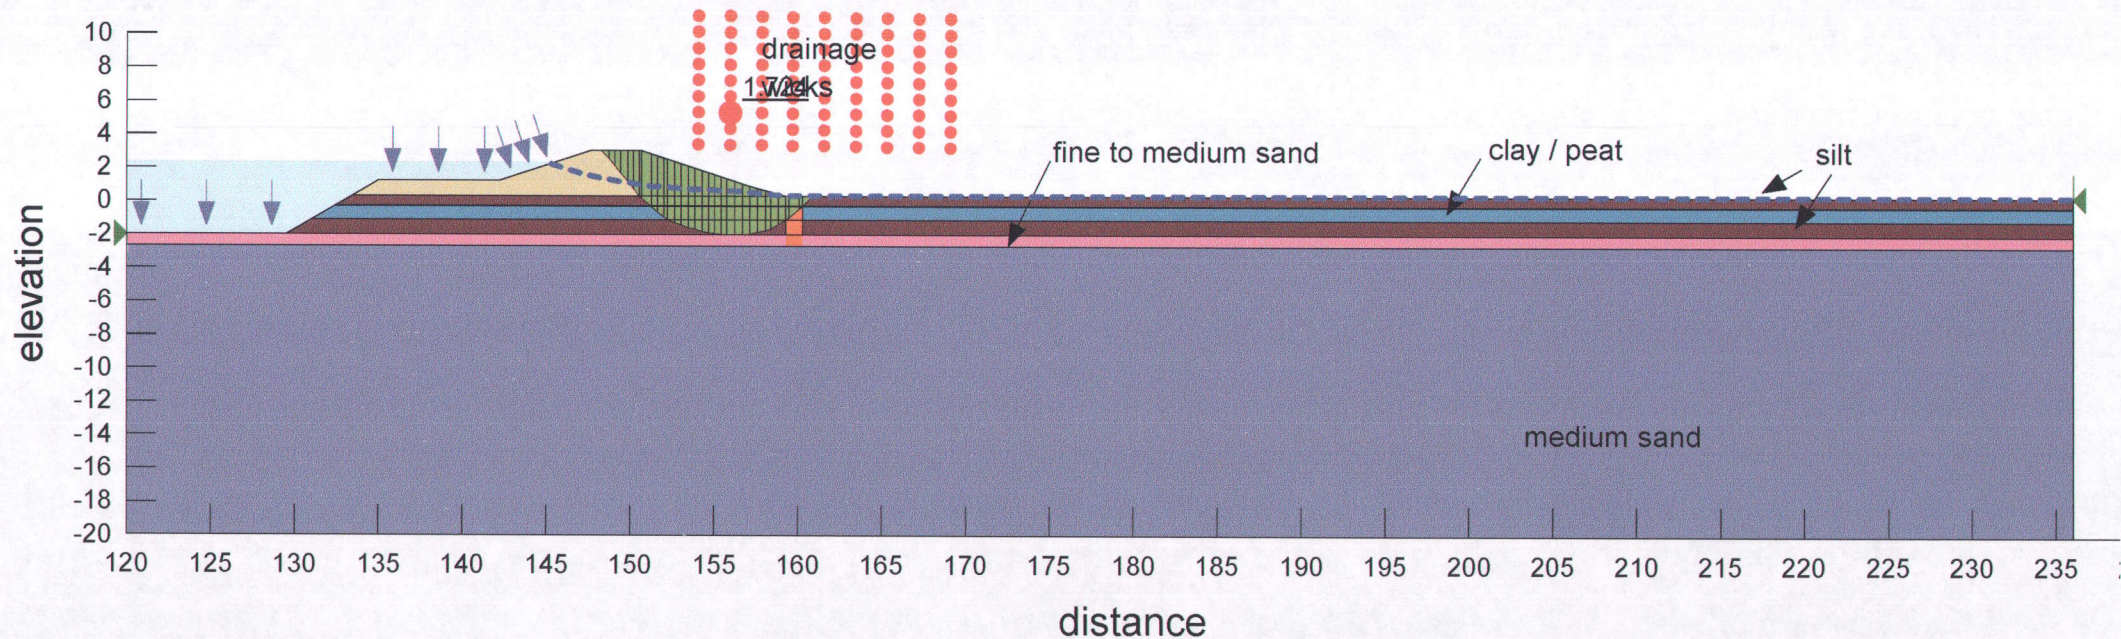
File Name: Cross Section RB450 stopbank trans.gsz
 Date: 16/06/2013 Time: 5:11:12 p.m.

Name: Material 1 till Unit weight: 17 kN/m³ Cohesion': 2 kPa Phi': 33 °
 Name: Material 2 silt Unit Weight: 15 kN/m³ Cohesion': 2 kPa Phi': 24 °
 Name: Material 3 fine to medium sand Unit Weight: 13 kN/m³ Cohesion': 0 kPa Phi': 35 °
 Name: Material 4 medium to coarse sand Unit Weight: 13 kN/m³ Cohesion': 0 kPa Phi': 35 °
 Name: Material 6 clay / peat Unit Weight: 10.5 kN/m³ Cohesion': 30 kPa
 Name: Material 8 wick drains Unit Weight: 13 kN/m³ Cohesion': 0 kPa Phi': 35 °
