Transpower Edgecumbe Substation

33kV Indoor Conversion

Assessment of Effects on Security of the Rangitaiki River Stopbank

August 2014

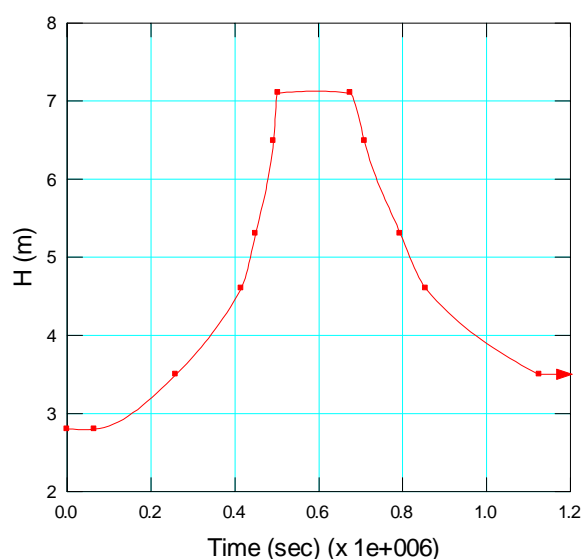
Figure 2: Truncated 300 year return period hydrograph

As the substation is a critical structure the design standard for the stopbank adjacent to it has been taken as a 300 year return period flood. Due to the nature of the soils in the Rangitaiki Plains steady state bank full analyses of the stopbanks lead to unacceptable piping and uplift pressures in many places; therefore transient analyses are necessary. The Regional Council has provided an estimate of a 300 year return period flood flow hydrograph for the Rangitaiki River at their benchmark number 31. This is a 13 day hydrograph which rises to a peak well above the top of the stopbank. It has been assumed in the analyses that the river will over-top the stopbank away from the substation and will be lapping at the top of the stopbank for two days. The truncated hydrograph used in the analyses is shown in Figure 3. A four hour time step was used in the analyses.

The initial ground water levels were taken as RL2.7 in the river and RL3.0 inland. The water level measured at the time of the hand augers was about RL1.3. This was after a relatively dry period; the ground water level during a 300 year return period flood is likely to be considerably higher.

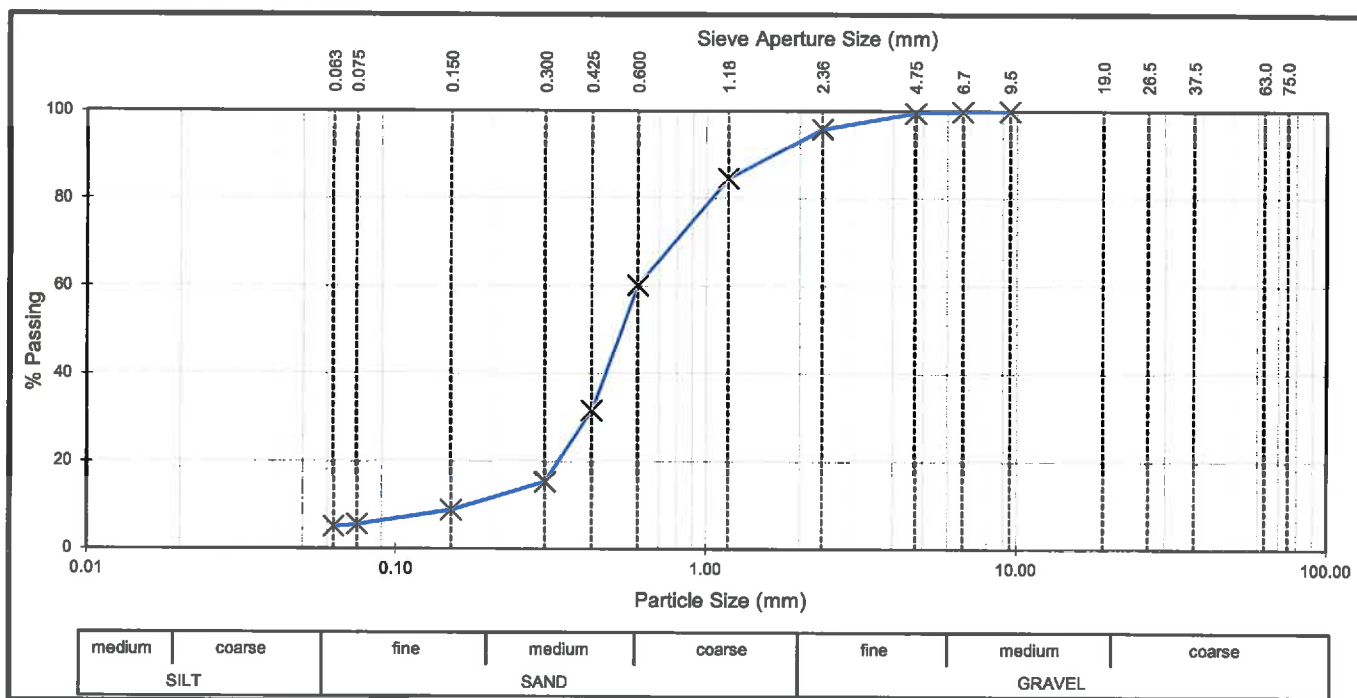
Project No : **255549.00/0TL**
 Lab Ref No : **14/534A**
 Client Ref No : **--**

Project : **Edgecumbe Substation**
 Location : **Edgecumbe**
 Client : **Ice Geo & Civil**
 Contractor : **N/A**
 Sampled by : **Marianne O'Halloran (Ice Geo & Civil)**
 Date sampled : **Unknown**
 Sampling method : **Borehole**
 Sample description : **Fine - coarse SAND with traces of Gravel & fine Silt**
 Sample condition : **Natural State (as received)**
 Bore hole no : **HA 2**
 Depth : **2.0 Metres**

Sieve Analysis							
Size (mm)	% Passing	Size (mm)	% Passing	Size (mm)	% Passing	Size (mm)	% Passing
75.00	-	19.00	-	2.36	96	0.300	15
63.00	-	9.50	100	1.18	84	0.150	9
37.50	-	6.70	100	0.60	60	0.075	6
26.50	-	4.75	100	0.425	32	0.063	5

The particle grading information from the tests discussed above and other grading tests from the previous stopbank investigations have been used to assess whether soil particles from one layer can wash into a coarser layer. Standard filter grading criteria have been used³. It appears from the analyses that the upper silt and silty fine sand should not wash into the medium to coarse sand found beneath it. Although no grading curve is available for the coarse pumice sand / fine lapilli layer, observations of the soil on site suggest that movement of fines through this layer is possible.

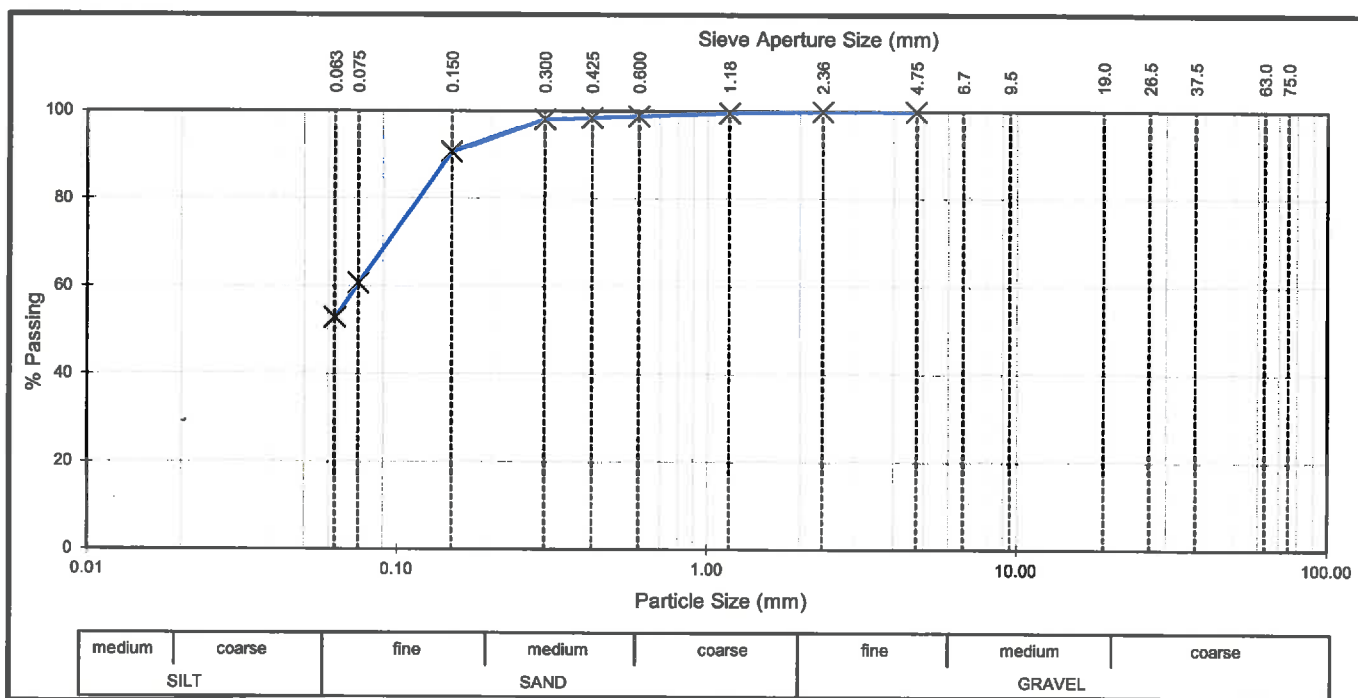
Project No : **255549.00/0TL**
 Lab Ref No : **14/534B**
 Client Ref No : **--**

Project : **Edgumbe Substation**
 Location : **Edgumbe**
 Client : **Ice Geo & Civil**
 Contractor : **N/A**
 Sampled by : **Marianne O'Halloran (Ice Geo & Civil)**
 Date sampled : **Unknown**
 Sampling method : **Borehole**
 Sample description : **Fine - medium Sandy SILT**
 Sample condition : **Natural State (as received)**
 Bore hole no : **HA 3**
 Depth : **0.9 Metres**

Sieve Analysis							
Size (mm)	% Passing	Size (mm)	% Passing	Size (mm)	% Passing	Size (mm)	% Passing
75.00	-	19.00	-	2.36	100	0.300	98
63.00	-	9.50	-	1.18	100	0.150	91
37.50	-	6.70	-	0.60	99	0.075	61
26.50	-	4.75	100	0.425	99	0.063	53

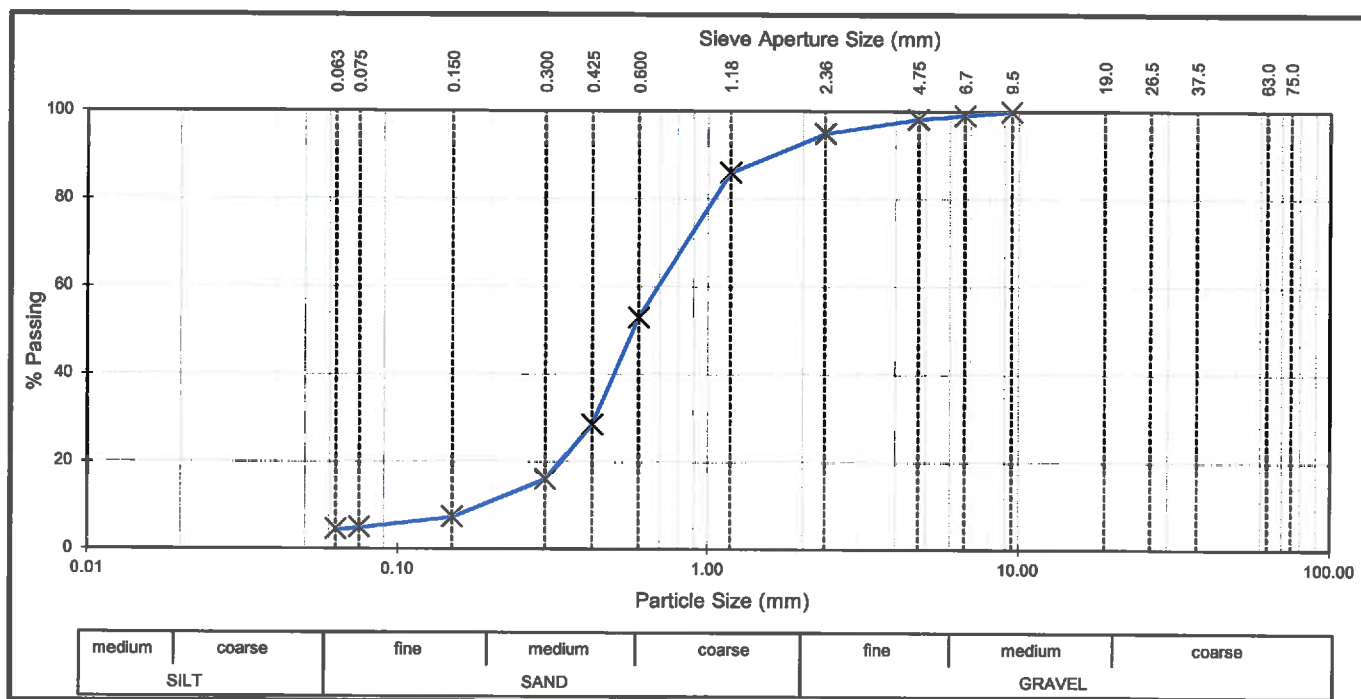
Project No : **255549.00/0TL**
 Lab Ref No : **14/534C**
 Client Ref No : **--**

Project : **Edgumbe Substation**
 Location : **Edgumbe**
 Client : **Ice Geo & Civil**
 Contractor : **N/A**
 Sampled by : **Marianne O'Halloran (Ice Geo & Civil)**
 Date sampled : **Unknown**
 Sampling method : **Borehole**
 Sample description : **Fine - Coarse SAND with traces of Gravel & fine Silt**
 Sample condition : **Natural State (as received)**
 Bore hole no : **HA 3**
 Depth : **2.5 Metres**

Sieve Analysis							
Size (mm)	% Passing	Size (mm)	% Passing	Size (mm)	% Passing	Size (mm)	% Passing
75.00	-	19.00	-	2.36	95	0.300	16
63.00	-	9.50	100	1.18	86	0.150	7
37.50	-	6.70	99	0.60	53	0.075	5
26.50	-	4.75	98	0.425	29	0.063	5

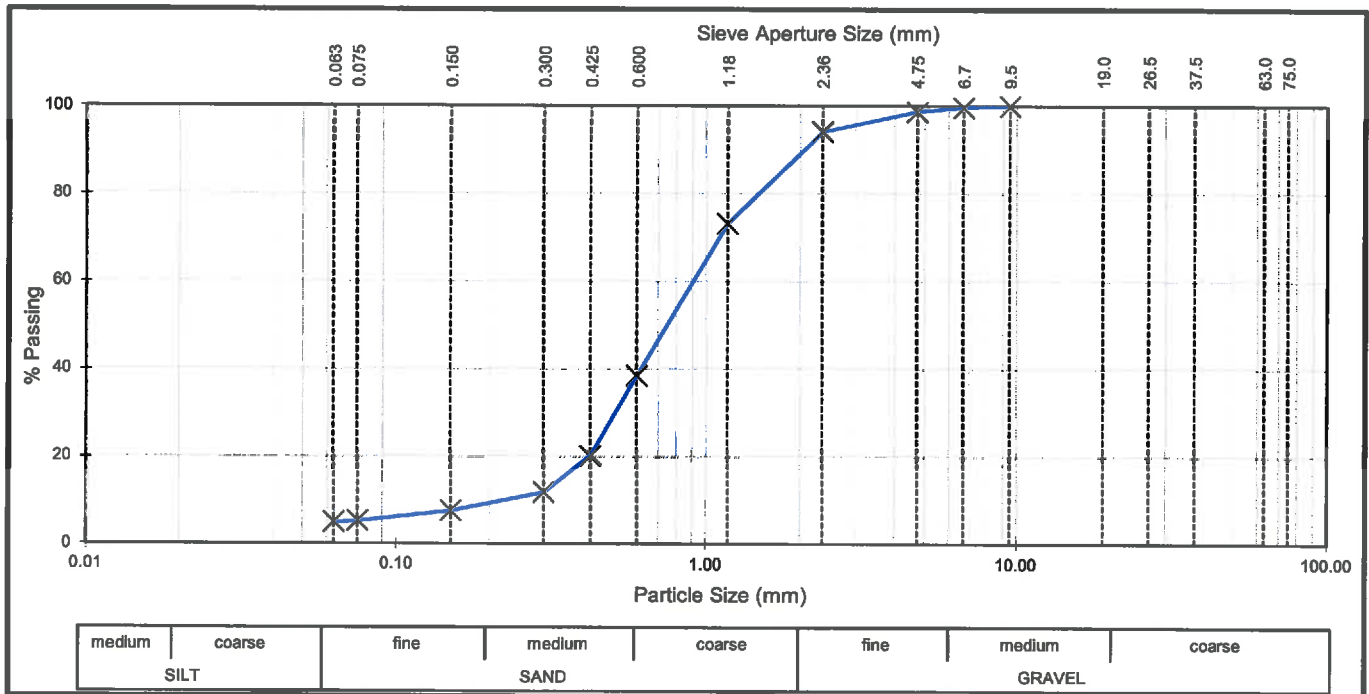
Project No : 255549.00/0TL
 Lab Ref No : 14/534D
 Client Ref No : --

Project : Edgumbe Substation
 Location : Edgumbe
 Client : Ice Geo & Civil
 Contractor : N/A
 Sampled by : Marianne O'Halloran (Ice Geo & Civil)
 Date sampled : Unknown
 Sampling method : Borehole
 Sample description : Fine - coarse SAND, minor fine Gravel, trace of Silt
 Sample condition : Natural State (as received)
 Bore hole no : HA 9
 Depth : 0.9 Metres

Sieve Analysis							
Size (mm)	% Passing	Size (mm)	% Passing	Size (mm)	% Passing	Size (mm)	% Passing
75.00	-	19.00	-	2.36	94	0.300	12
63.00	-	9.50	100	1.18	73	0.150	8
37.50	-	6.70	100	0.60	39	0.075	5
26.50	-	4.75	99	0.425	20	0.063	5

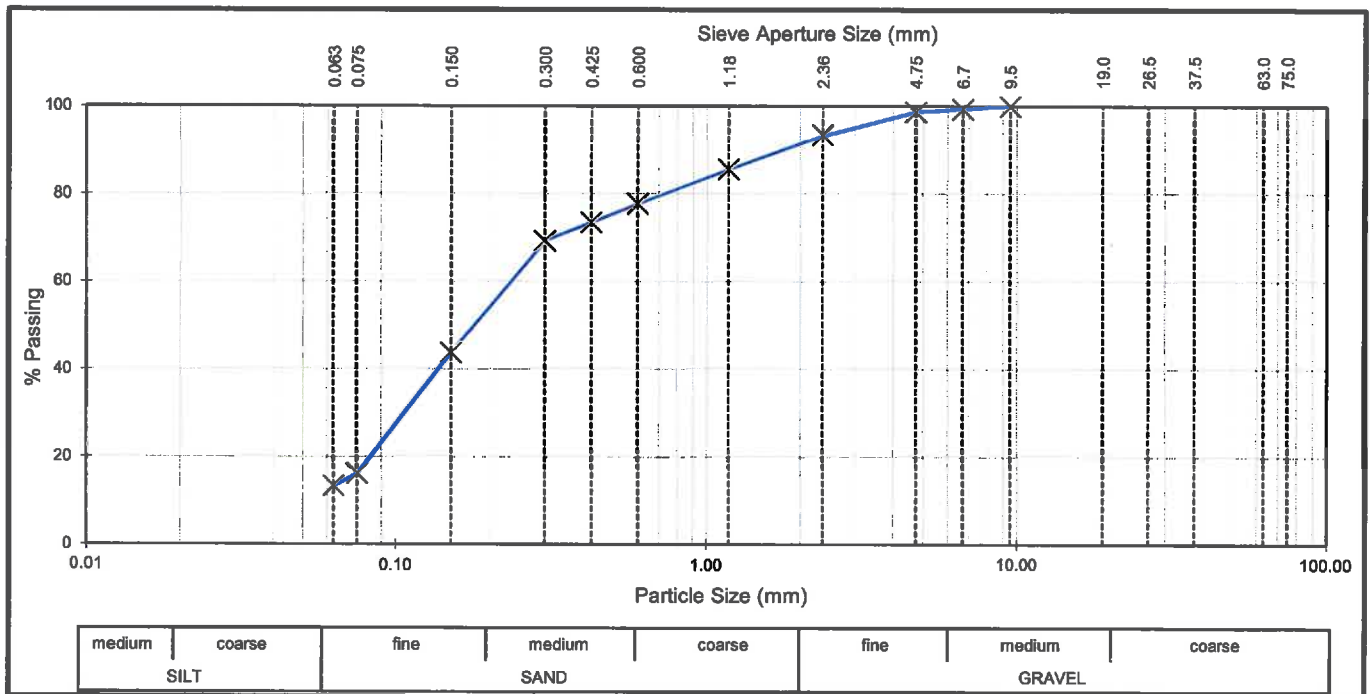
Project No : **255549.00/0TL**
 Lab Ref No : **14/534E**
 Client Ref No : **--**

Sieve Analysis							
Size (mm)	% Passing	Size (mm)	% Passing	Size (mm)	% Passing	Size (mm)	% Passing
75.00	-	19.00	-	2.36	93	0.300	69
63.00	-	9.50	100	1.18	86	0.150	44
37.50	-	6.70	99	0.60	78	0.075	16
26.50	-	4.75	99	0.425	73	0.063	13

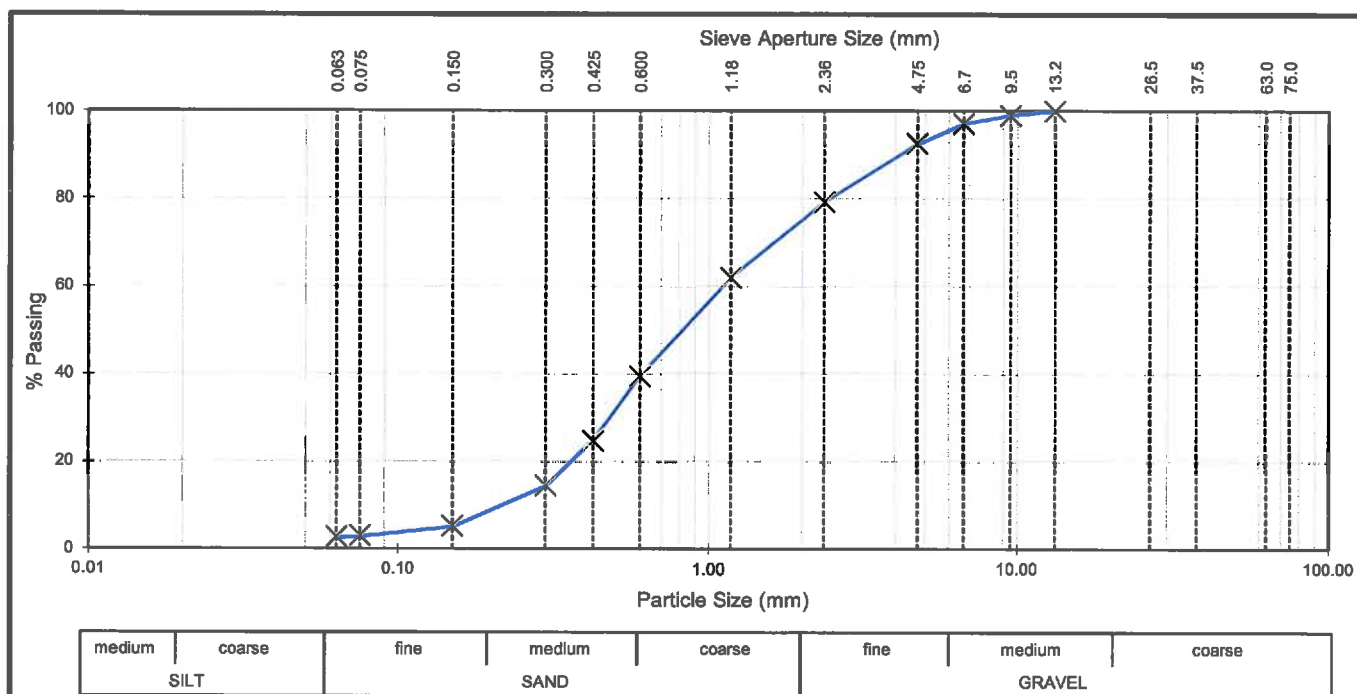
Project No : **255549.00/0TL**
 Lab Ref No : **14/534F**
 Client Ref No : **—**

Sieve Analysis							
Size (mm)	% Passing	Size (mm)	% Passing	Size (mm)	% Passing	Size (mm)	% Passing
75.00	-	13.20	100	2.36	79	0.300	14
63.00	-	9.50	99	1.18	62	0.150	5
37.50	-	6.70	97	0.60	40	0.075	3
26.50	-	4.75	92	0.425	25	0.063	3

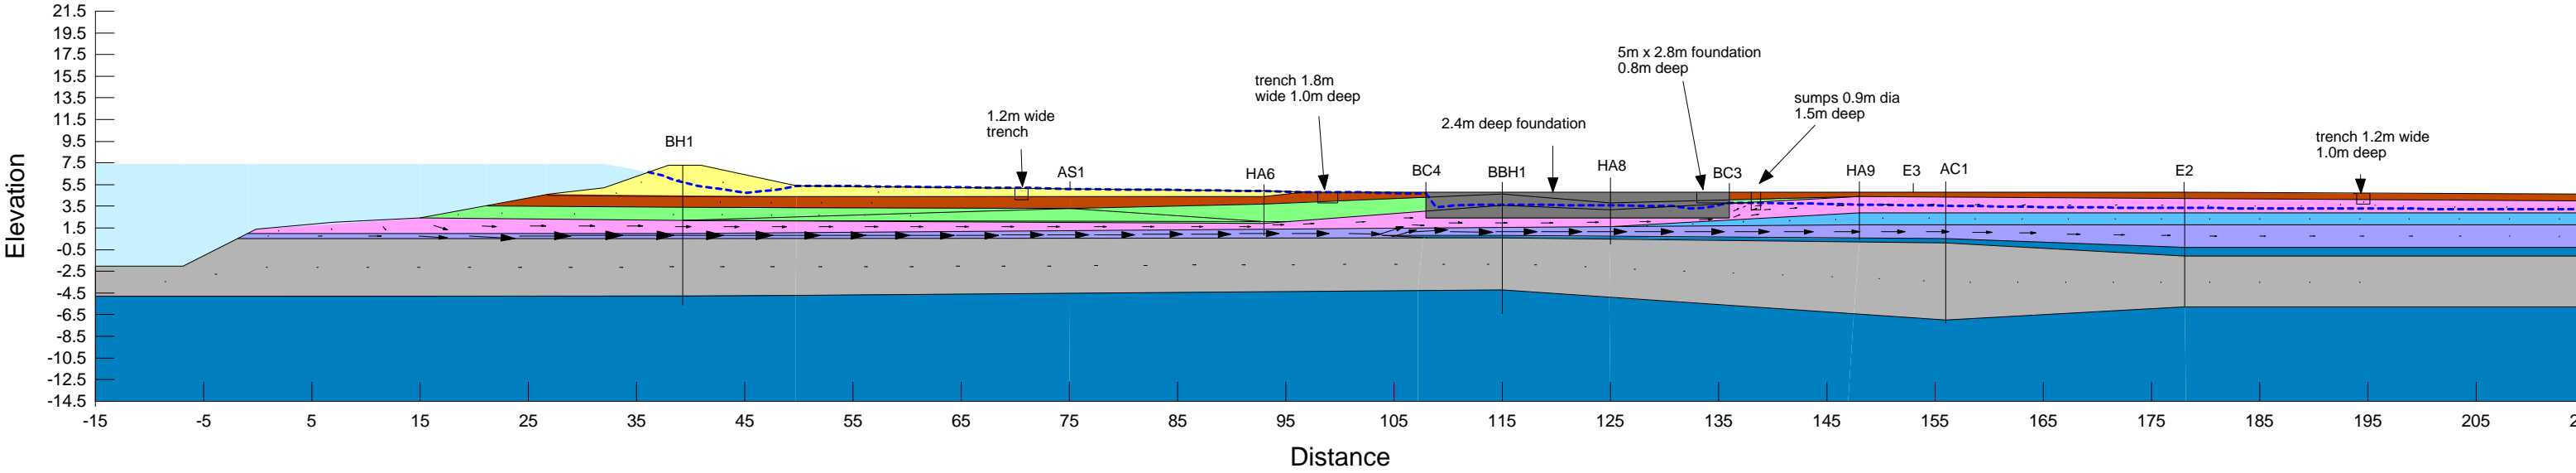
File Name: Cross Section 2 found a.gsz
Date: 21/08/2014Time: 2:04:14 p.m.

Foundation E - concrete

An analysis carried out with Foundation E excavated showed that water could rise into the base of the excavation when the river level approaches the toe of the stopbank (RL5.0). At this level the factor of safety against heave of the base of the foundation is about 1.2; therefore care should be taken if the river rises in the excavation phase. Excavation should not be carried out if there is heavy rain in the long range forecast. In the worst case if the excavation is open and the river rises before concrete is poured the hole may need to be temporarily backfilled. Once the concrete foundation is in place the uplift pressures beneath it and the flow gradients up the side of the foundation should not be high enough to cause problems. It has been assumed that there will be no problems with the adjacent shallower foundation H. Similarly no problems are expected with the manholes.

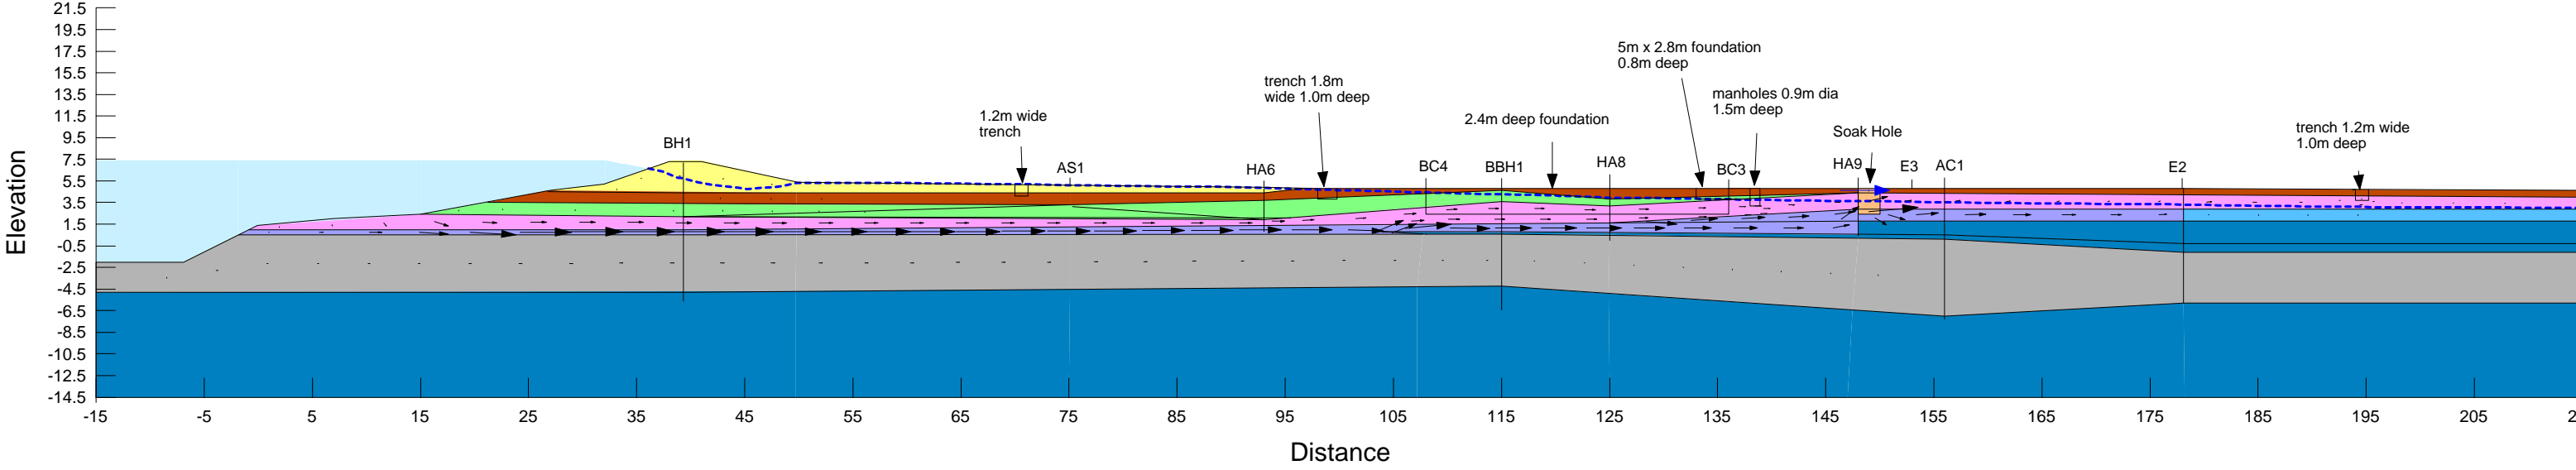
File Name: Cross Section 2 soak hole.gsz
Date: 25/08/2014Time: 8:35:23 a.m.

Soak Hole

This cross section passes through several section of trench, the main 33kV conversion structure and the soak pit. It was also used to assess excavation H and a representative manhole. The cross section passes close to the AS1 tomo but it has been assumed that the subsurface profile is governed by BH1 and HA6, which do not show the peat found in AS1. It can be seen from the LIDAR plot that the cross section is through ground that was slightly lower than at the AS1 location prior to the placement of the overlay.
