**Rangitāiki-Tarawera Rivers Scheme Liaison Group Meeting
to be held in Committee Meeting Room 1, Bay of Plenty Regional
Council's Whakatāne Office on Wednesday, 4 December 2014
commencing at 11.00 am**

River Scheme Flood Damage Project Completion Report

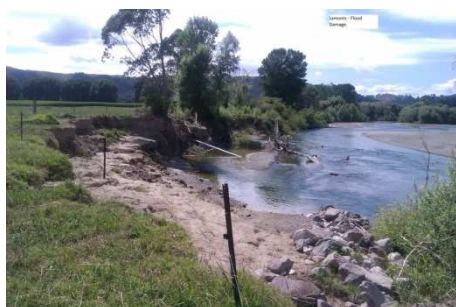
Before – Flood damaged section of the Rangitāiki River

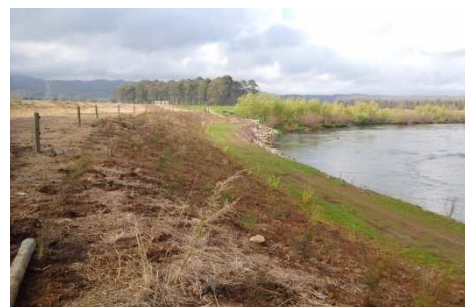
After – reformed, rock lined and restoration planting including mānuka and toetoe

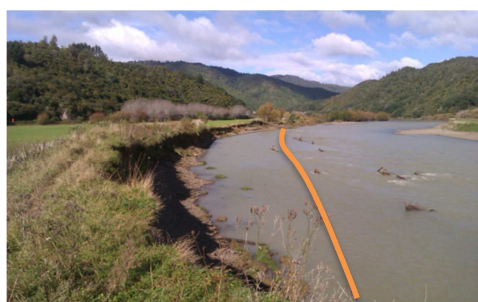
Before – Flood damaged section of the Waioeka River (Lanauze site)

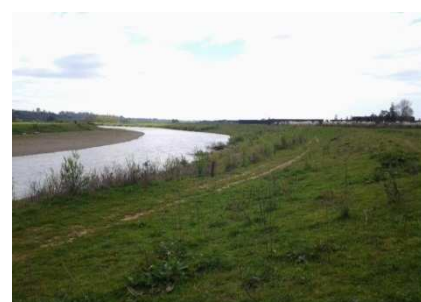
After – restored stopbank, and restoration planting

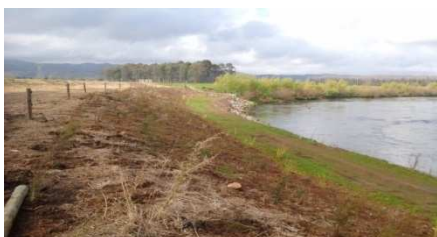
1. Main stopbank strengthening. This involved rock work, geotechnical work, drains, overlays and several other large and small scale activities. These works were successfully completed during 2004-2013.

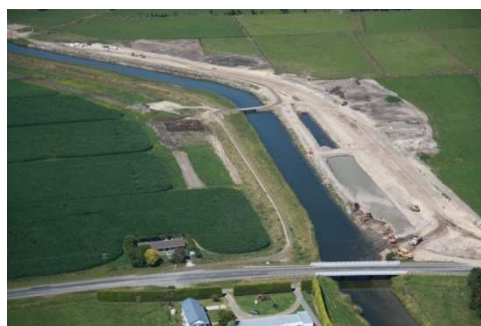
2. Floodway widening and spillway– these are the large scale works near Thornton Road. The major works to date have involved widening the lower reaches of the Rangitāiki Floodway. Stage 1 and Stage 2A, consisting of approximately 2,500 lineal metres of Floodway widening that have been completed within the agreed budget. Stage 2B is currently under construction. The last report to Council on this project was the detailed issues and options report presented to the 13 February 2013 Operations, Monitoring and Regulations Committee. Agreed budget is \$10.4million for the Floodway works and \$2.2million for the Spillway.
