Rangitaiki River Stopbanks Assessment

Reynold's Bend

Right Bank 3040 to 4700m

June 2014

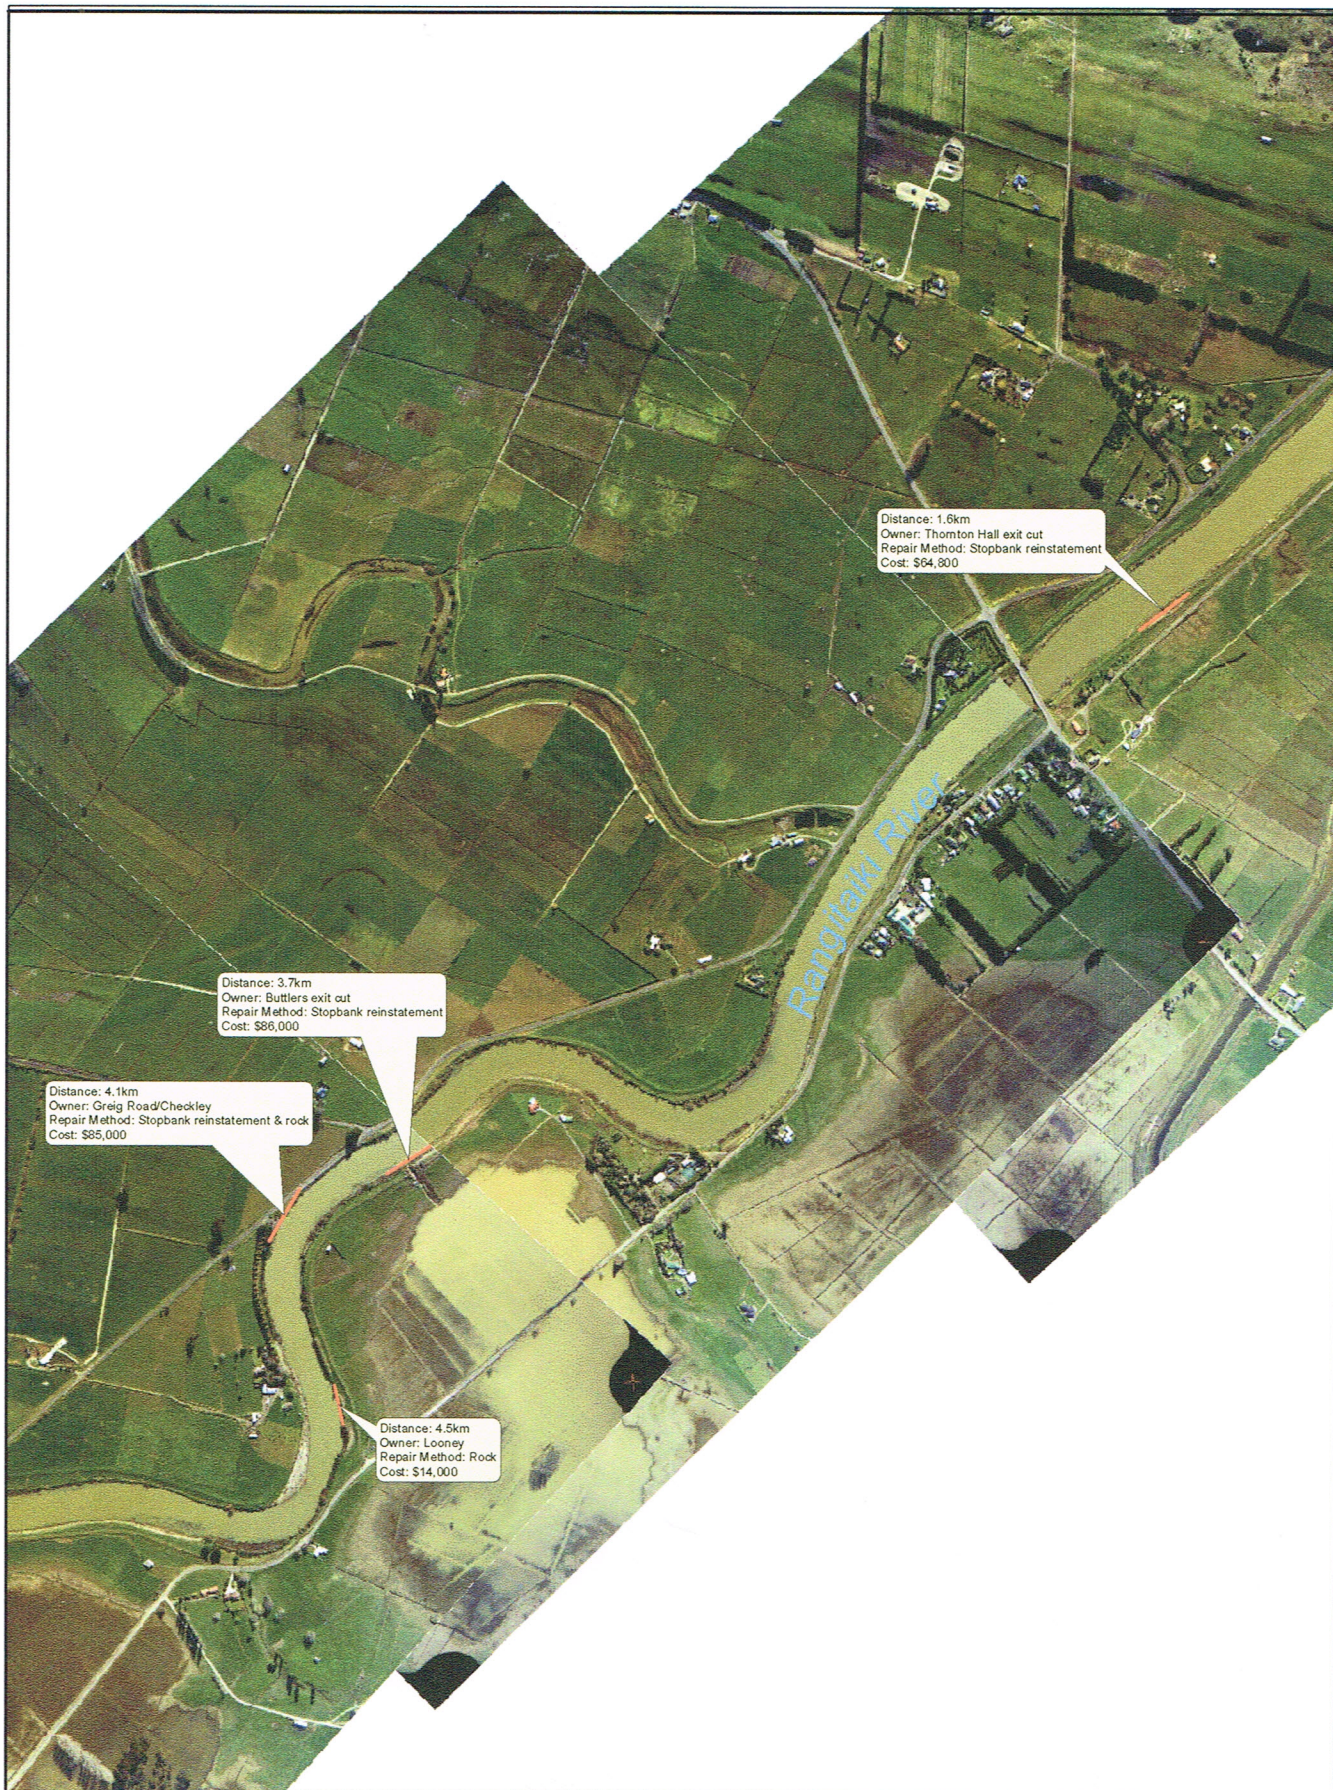
Appendix 6

July 2004 Flood Damage Locality Plan

and a piping failure progressed back to the river bank. Farmers had previously observed springs in the paddocks and heaving when the river was high¹. The breach was repaired with greywacke rock fill and some rip rap was placed along the river bank. The Catchment Commission carried out investigations and installed 11 piezometers in the area in 1966 and 67. The information gained was used to design an overlay typically 3 to 4ft thick, but up to 5ft thick in the area of the breach. A second overlay was placed in a low area near the top of the bend as shown on drawing R450/11/2 Sheet 1 attached.

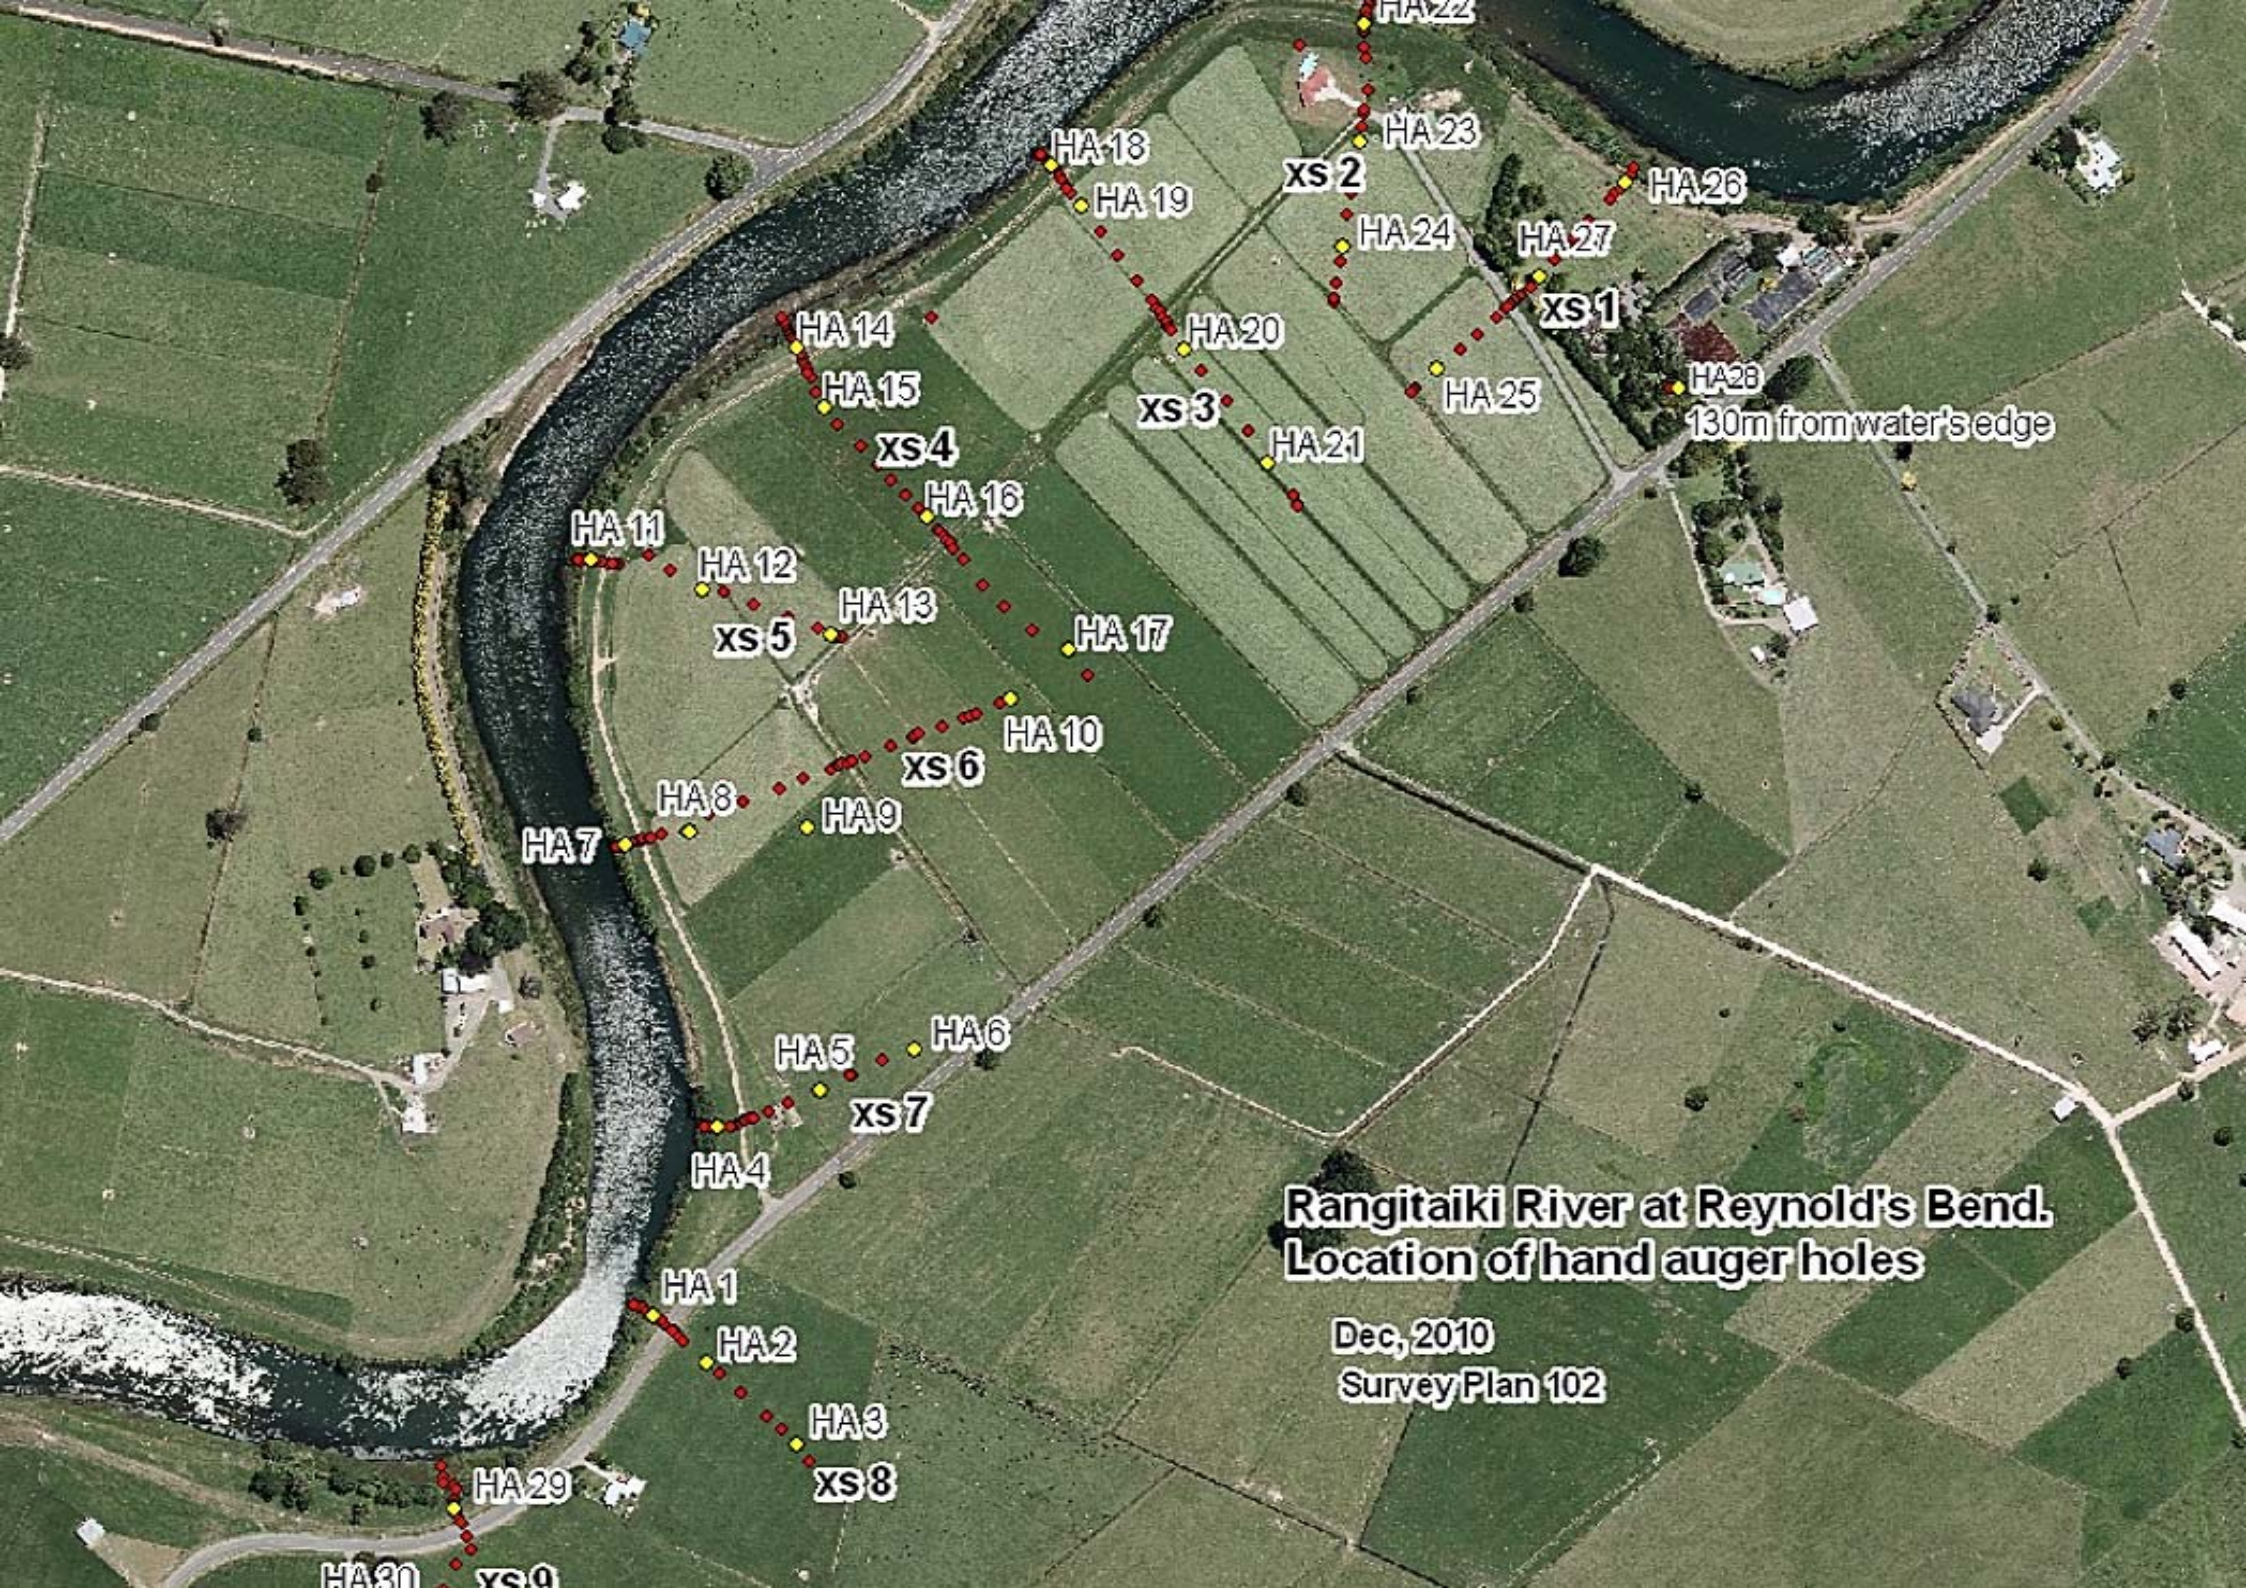
Dec, 2010
Survey Plan 102

**Rangitaiki River at Reynold's Bend.
Location of hand auger holes**

Hand augers 1, 22 and 26 were carried out through the top of the stopbank. These showed that the stopbank is made predominantly of dense sandy silt and silty fine sand. Some hard gravel was found in HA26 and a thin silty fine to coarse sand layer was found overlying the natural soil at the base of the stopbank foundation in HA22.

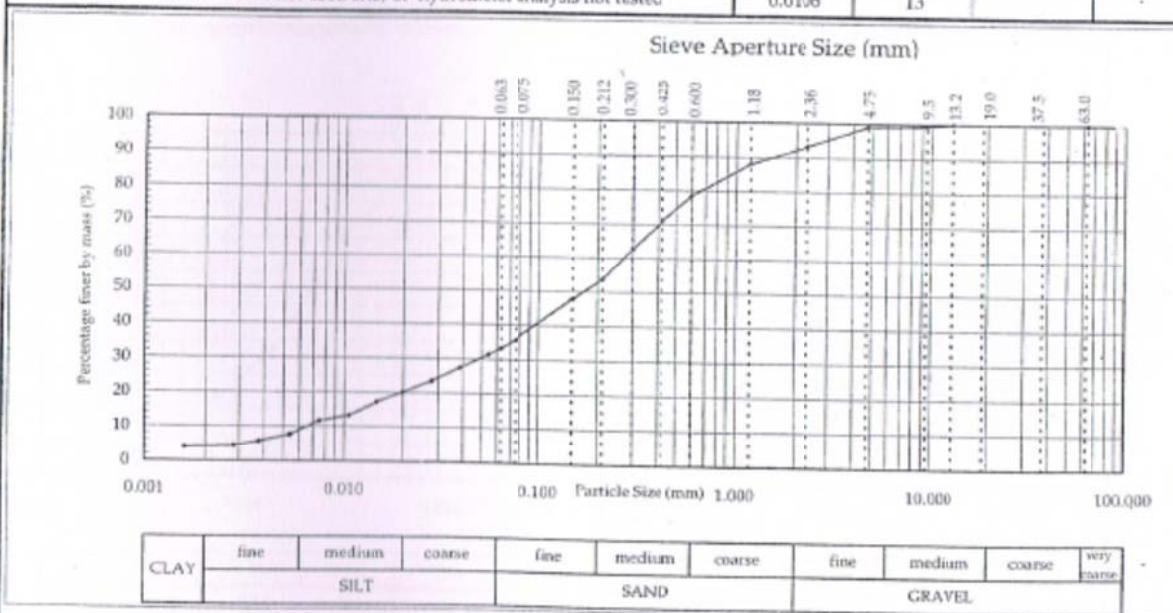
Project : Rangitaiki Stopbanks
 Location: Unknown
 Client : Beca Carter Hollings and Ferner Ltd
 Client/Sample Ref : -
 Contractor : -
 Bore/Test Pit No: BH1 Depth: 0.30 metres 2850m
 Sampled by : Unknown 4840
 Date received : 03/04/02
 Sampling method : Unknown
 Sample condition : As received
 Sample description : Light brown silty fine SAND
 Solid Particle Density (t/m^3): 2.65 assumed
 Water Content (as received): 8.3 %

Sieve Analysis						Hydrometer Analysis			
Sieve Size (mm)	Passing (%)	Sieve Size (mm)	Passing (%)	Sieve Size (mm)	Passing (%)	Particle Size (mm)	Passing (%)	Particle Size (mm)	Passing (%)
63.0	--	4.75	99	0.300	63	0.0541	31	0.0075	12
37.5	--	2.36	93	0.212	54	0.0389	27	0.0054	8
19.0	--	1.18	88	0.150	48	0.0279	23	0.0038	6
13.2	100	0.600	79	0.075	36	0.0199	20	0.0028	4
9.5	99	0.425	71	0.063	33	0.0147	17	0.0016	4
Note: "--" denotes sieve not used and/or hydrometer analysis not tested						0.0106	13

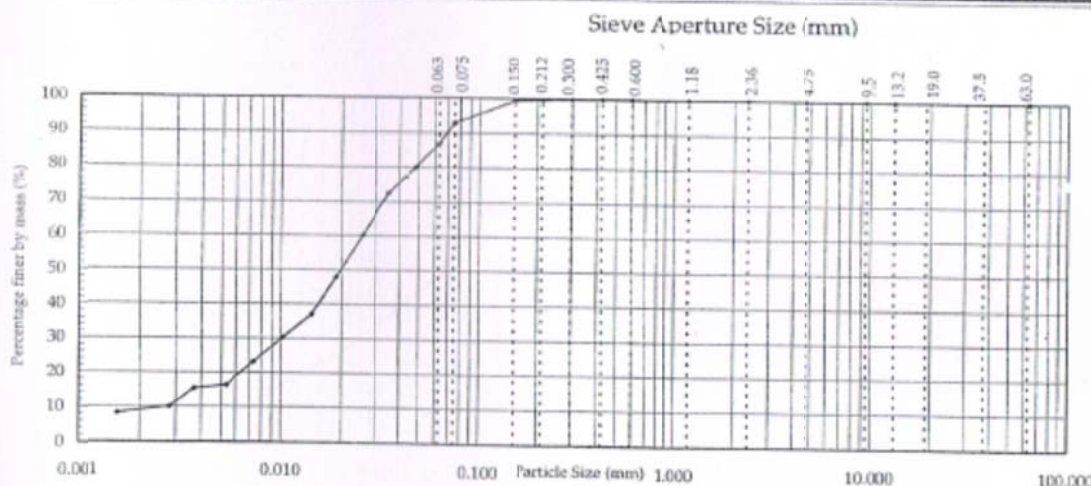
Project : Rangitaiki Stopbanks
 Location: Unknown
 Client : Beca Carter Hollings and Ferner Ltd
 Client/Sample Ref : -
 Contractor : -
 Bore/Test Pit No: BH1 Depth: 1.20 metres 2850 mm
 Sampled by : Unknown 4840
 Date received : 03/04/02
 Sampling method : Unknown
 Sample condition : As received
 Sample description : Light brown sandy SILT
 Solid Particle Density (t/m^3): 2.65 assumed
 Water Content (as received): 38.8 %

Sieve Analysis						Hydrometer Analysis			
Sieve Size (mm)	Passing (%)	Sieve Size (mm)	Passing (%)	Sieve Size (mm)	Passing (%)	Particle Size (mm)	Passing (%)	Particle Size (mm)	Passing (%)
63.0	--	4.75	100	0.300	100	0.0482	80	0.0074	23
37.5	--	2.36	100	0.212	100	0.0350	72	0.0053	16
19.0	--	1.18	100	0.150	99	0.0257	60	0.0037	15
13.2	100	0.600	100	0.075	93	0.0189	48	0.0028	10
9.5	100	0.425	100	0.063	87	0.0142	37	0.0016	8
Note: "--" denotes sieve not used and/or hydrometer analysis not tested						0.0102	30

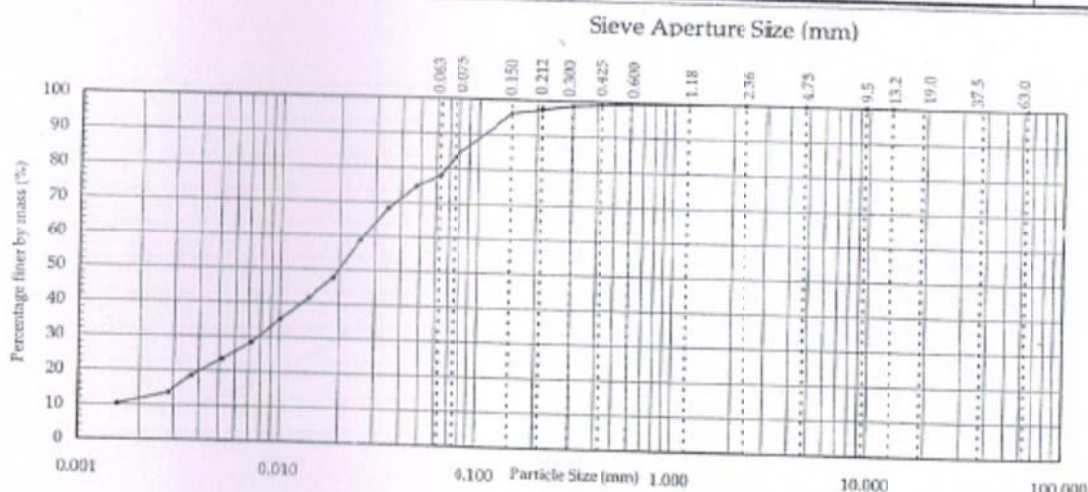
Project : Rangitaiki Stopbanks
 Location: Unknown
 Client : Beca Carter Hollings and Ferner Ltd
 Client/Sample Ref : -
 Contractor : -
 Bore/Test Pit No: BH2 Depth: 0.30 metres 2.850m
 Sampled by : Unknown 3.9.0.0.0
 Date received : 03/04/02
 Sampling method : Unknown
 Sample condition : As received
 Sample description : Light brown sandy SILT
 Solid Particle Density (t/m^3): 2.65 assumed
 Water Content (as received): 14.9 %

Sieve Analysis						Hydrometer Analysis			
Sieve Size (mm)	Passing (%)	Sieve Size (mm)	Passing (%)	Sieve Size (mm)	Passing (%)	Particle Size (mm)	Passing (%)	Particle Size (mm)	Passing (%)
63.0	--	4.75	100	0.300	99	0.0475	75	0.0072	28
37.5	--	2.36	100	0.212	97	0.0347	68	0.0052	23
19.0	--	1.18	100	0.150	96	0.0254	59	0.0037	18
13.2	100	0.600	100	0.075	83	0.0186	48	0.0028	14
9.5	100	0.425	99	0.063	78	0.0139	41	0.0016	10
						0.0100	35

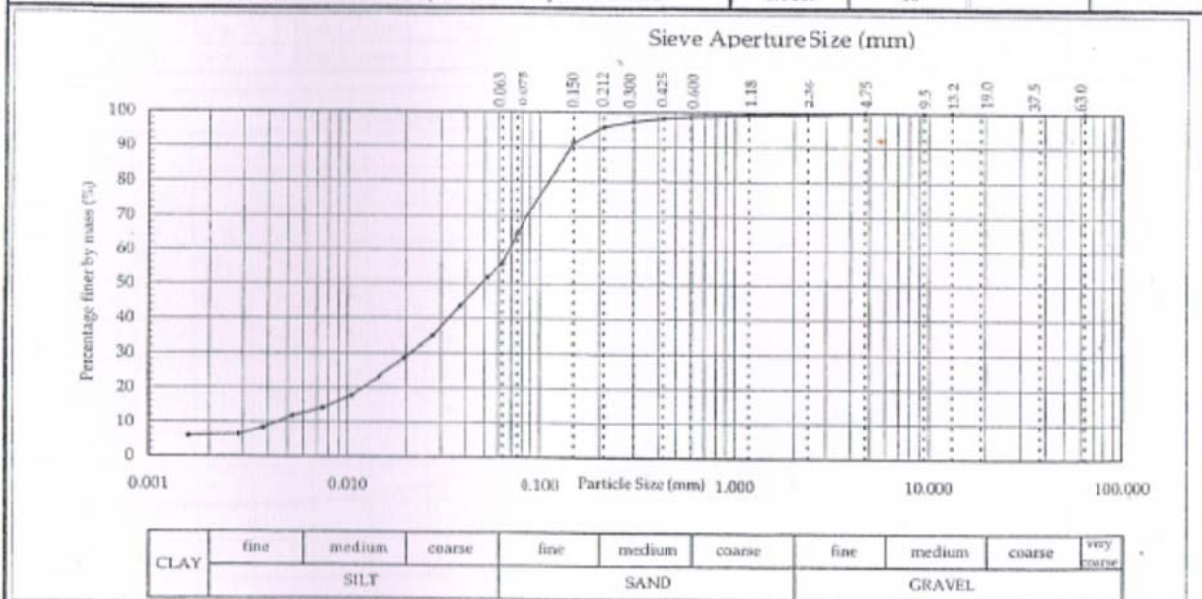
Project : Rangitaiki Stopbanks
 Location : Unknown
 Client : Beca Carter Hollings and Ferner Ltd
 Client/Sample Ref : -
 Contractor : -
 Bore/Test Pit No : BH3 Depth: 0.50 metres 2900-4000
 Sampled by : Unknown
 Date received : 03/04/02
 Sampling method : Unknown
 Sample condition : As received
 Sample description : Light brown sandy SILT
 Solid Particle Density (t/m^3): 2.65 assumed
 Water Content (as received): 10.4 %

Sieve Analysis						Hydrometer Analysis			
Sieve Size (mm)	Passing (%)	Sieve Size (mm)	Passing (%)	Sieve Size (mm)	Passing (%)	Particle Size (mm)	Passing (%)	Particle Size (mm)	Passing (%)
63.0	--	4.75	100	0.300	97	0.0515	52	0.0075	14
37.5	--	2.36	100	0.212	96	0.0375	44	0.0053	12
19.0	--	1.18	99	0.150	91	0.0273	35	0.0038	8
13.2	100	0.600	99	0.075	65	0.0197	29	0.0028	6
9.5	100	0.425	98	0.063	56	0.0145	23	0.0016	6
Note: "--" denotes sieve not used and/or hydrometer analysis not tested						0.0105	18

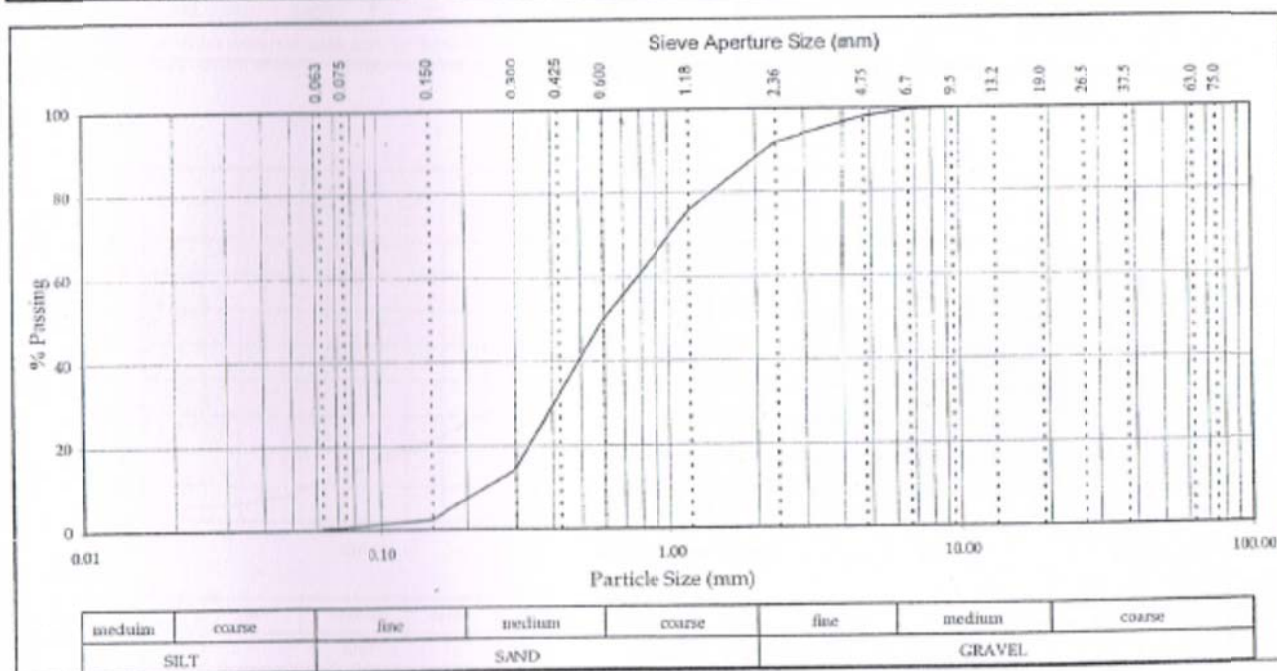
Project : Rangitaiki Stopbanks
Location : Unknown
Client : Beca Carter Hollings and Ferner
Contractor : N/A
Sampled by : Beca Carter Hollings and Ferner
Date sampled : Unknown
Sampling method : Unknown
Sample description : Gravelly SAND
Sample condition : Natural State
Bore hole no : 14 2000-
Depth (m) : 3.4m 3990

Particle Size Distribution					
Size (mm)	% Passing	Size (mm)	% Passing	Size (mm)	% Passing
75.00	-	13.20	-	2.36	92
63.00	-	9.50	100	1.18	76
37.50	-	6.70	100	0.600	50
19.00	-	4.75	98	0.425	33
				0.300	15
				0.150	2
				0.075	1
				0.063	0
