PRELIMINARY INVESTIGATION OF THE
INFLUENCE OF MATAHINA POWER STATION ON
**RIVER BANK STABILITY ALONG THE
RANGITAIKI RIVER**

Prepared for
Electricity Corporation of New Zealand Ltd
Hamilton

Prepared by
J Dahm
M R Edwards
D N Jennings
WORKS Consultancy Services
Hamilton

May 1988

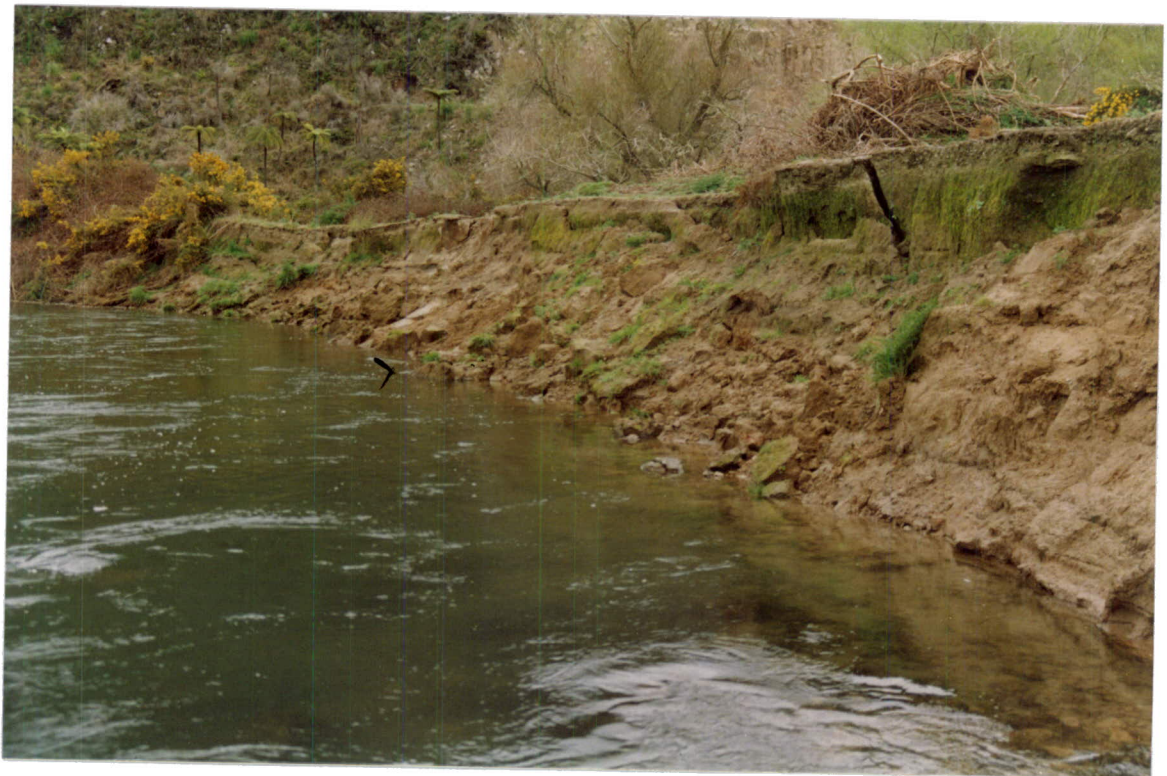
Figure C5. Site 5.

The location of the site on the outside of a meander bend, the evidence of basal erosion in the depth profile and the erodible basal material all suggest that undermining by erosion is the primary reason for the bank instability. As most of the subaerial materials are of relatively low permeability (Figure C5) water level fluctuations could possibly aggravate the erosion by draw-down effects.

However, the sharp increase in depths adjacent to the bank and the absence of a bench suggest that the rate of bank retreat is controlled by basal erosion (see chapter 4) and thus, that draw-down effects do not accentuate the rate of erosion.

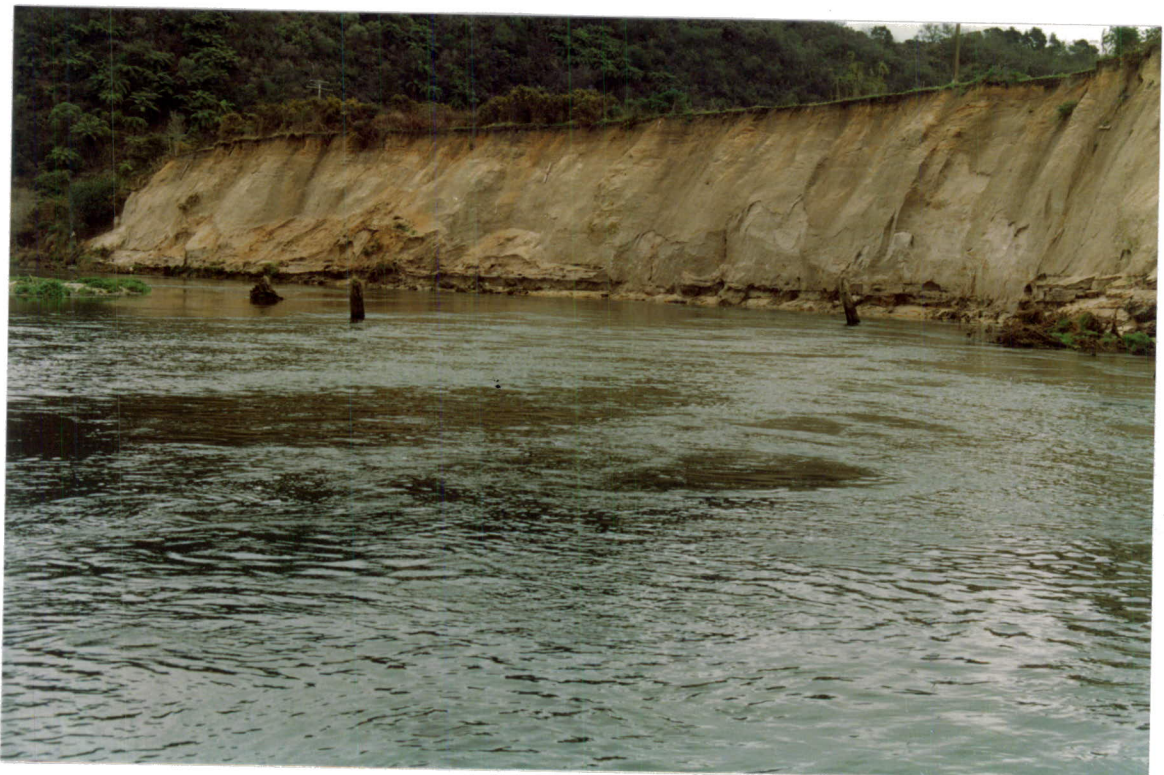
Figure C6. Site 6

The location of the site on the outside of a bend, the presence of readily erodible cohesionless materials at, or near, river level, and the moderate depths adjacent to the bank all suggest that bank retreat is controlled by basal erosion. Water level fluctuations could induce high seepage pressures immediately above the relatively impermeable paleosol layer accentuating bank instability. However, the absence of a bench above the paleosol suggests that such effects do not increase bank retreat above that rate occurring due to basal erosion.

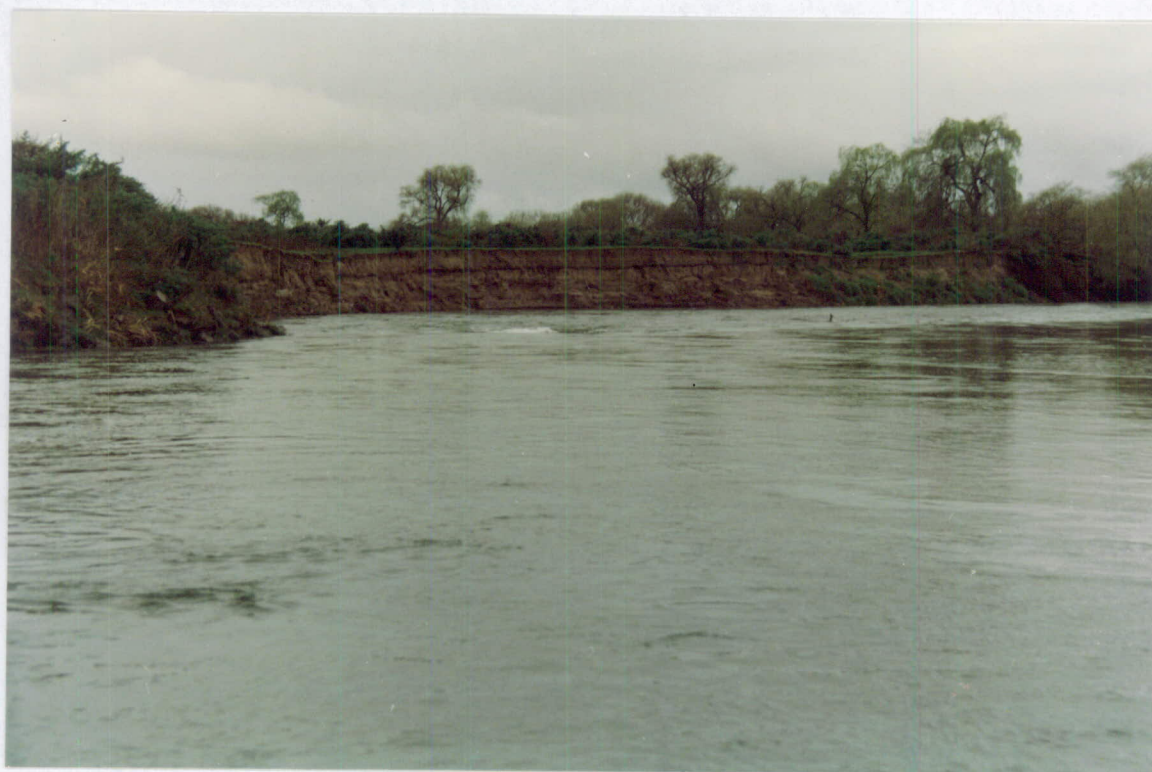
Figure C10. Site 9

The setting of the bank, located on the outer edge of a meander bend, suggests the bank instability was initiated by basal scour. The basal scour now appears to have been restricted by the willow protection - though it is possible that this protection may be undermined, renewing the erosion, during a major flood. As the bank stratigraphy was not able to be established the influence of water level fluctuations on any future bank erosion cannot be commented on.

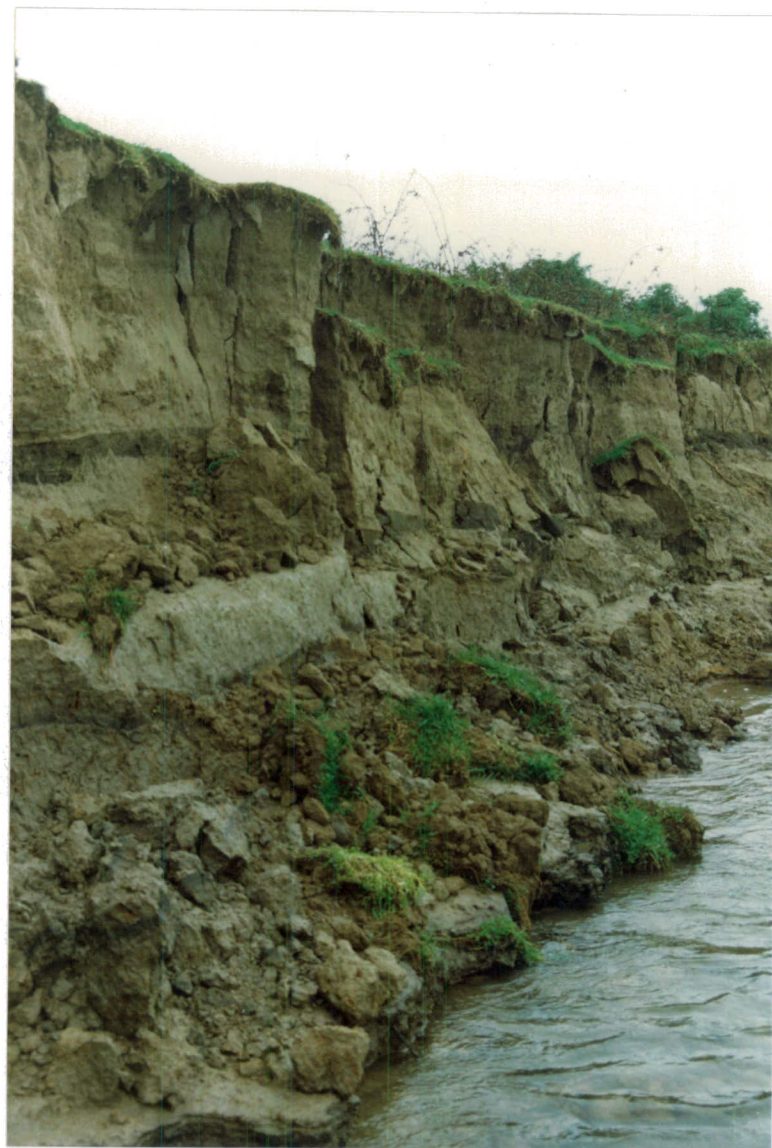
FIGURE C11 : SITE 10

Flow impinges on the base of the bank and thus basal scour appears the most likely reason for the bank instability. However, as most material above water level at the time of visit (about 1-1.1m RL at Te Teko) was relatively cohesive (either silts or silty sands), it is possible that draw-down effects associated with water level fluctuations above this level could aggravate bank retreat at the site.

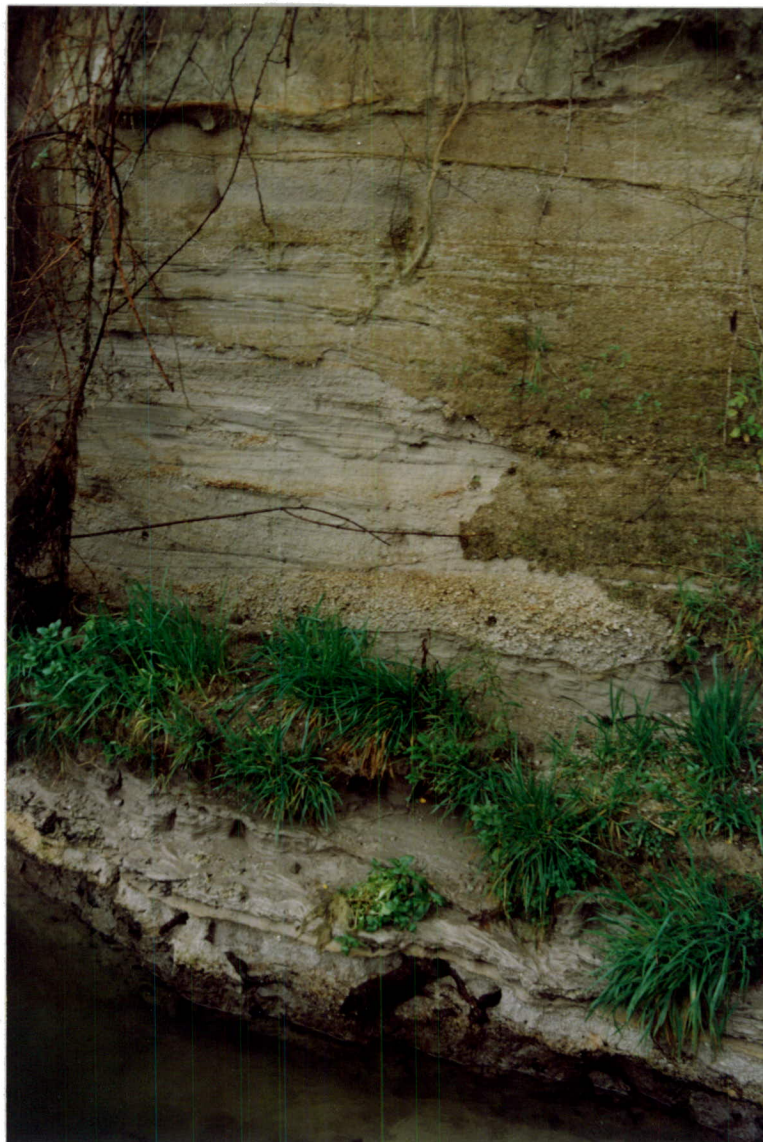
FIGURE C13 : SITE 11

The location of the bank on the outer edge of meander bend, the swift velocities adjacent to the bank, the readily erodible cohesionless materials at the base of the areas of more active erosion and sharply increasing depths adjacent to the bank all suggest that basal scour is the primary mechanism responsible for bank instability. The presence of free draining gravels throughout most of the lower region of the area of most active erosion (ie, the downstream end of the site) suggests that drawdown effects associated with water level fluctuations are unlikely to play a significant role. The absence of any notable bench further confirms this. Thus, it appears that the rate of bank retreat is controlled by the rate of erosive removal of the basal sediments.

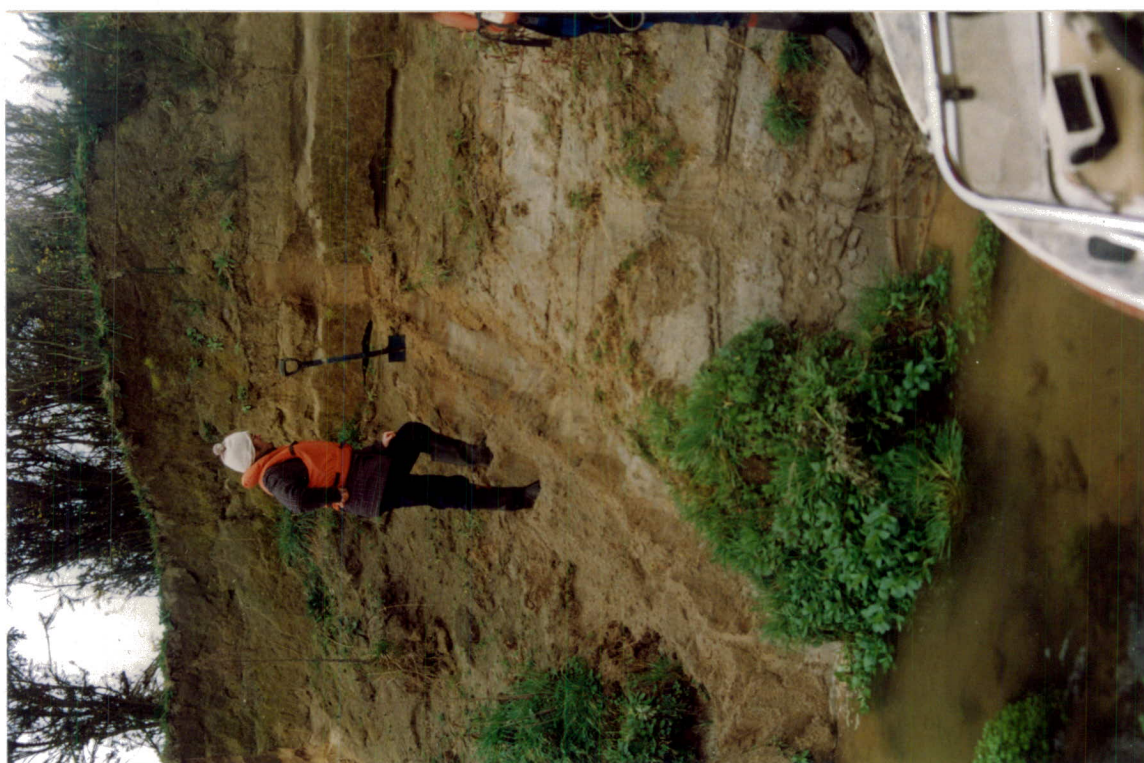
Figure C17. Site 13.

The location of the bank on the outside of a bend with readily erodible materials at and above water level suggests basal erosion is the primary mechanism responsible for bank instability. The bench observed just below water level indicates less readily erodible (and probably less permeable) materials. The sharp increase in depth beyond the narrow bench suggests this material is in turn being removed by undermining due to scour of more readily erodible materials lower in the bank. Water level fluctuations extending below the bench may induce removal of material by piping at the interface between the less permeable bench layer and the overlying sands. Thus, it is possible that draw-down effects could slightly aggravate bank instability at this site. However, more probably, the rate of bank retreat is controlled predominantly by the removal of loose sediments, above the bench, by lateral corrasion.

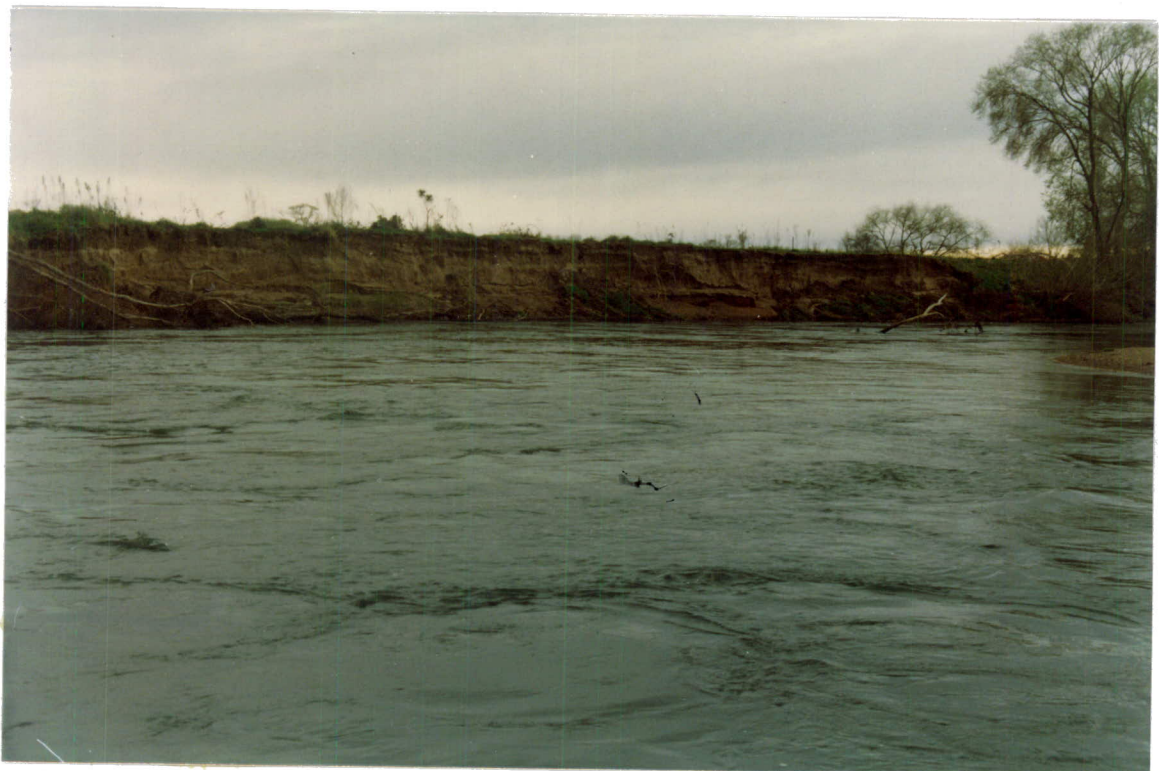
Figure C18. Site 14.

The location of the eroding area together with the field evidence of medium swift velocities impinging on the erodible base of the bank all suggest that basal erosion is the primary mechanism responsible for both initiating, and controlling the rate of, bank retreat. Clear evidence of undermining of the upper bank by erosive removal of lower bank materials is evident in figure C19.

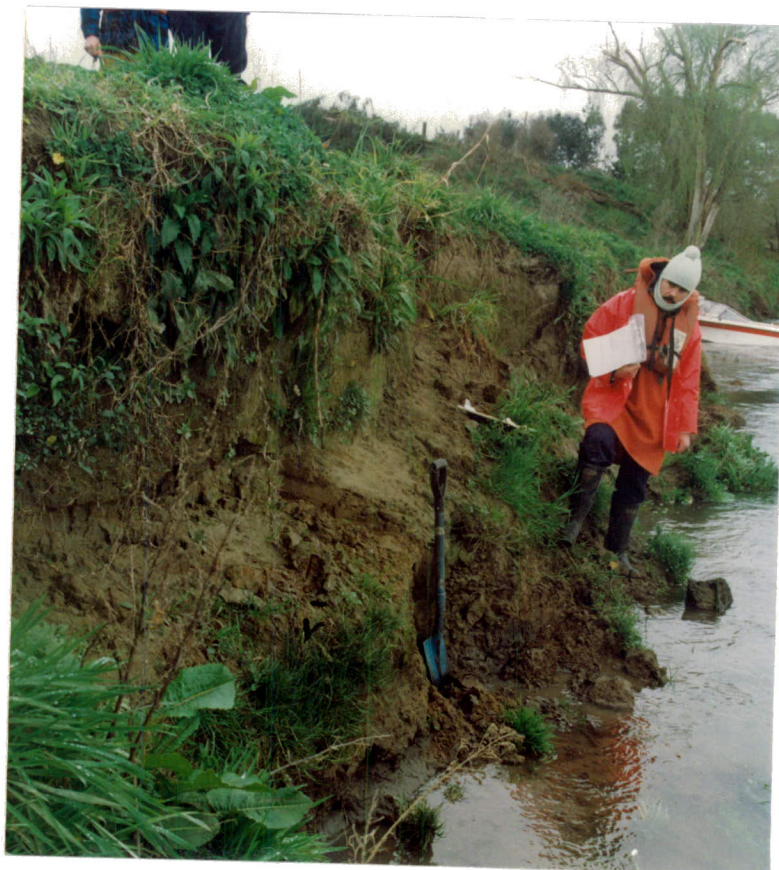
Figure C21. Site 16.

Left hand bank on outside of approach to a minor bend. The bank is failing over a distance of 80m. Bank height ranges from 1.5-2m (Figure C21).

Benches are evident at the site immediately above the cohesive silt layer (figure C21). This suggests that bank instability is induced by removal of the cohesionless sands undermining the silts. The sand may be removed by either erosion or piping. The location of the site and the relatively swift nearshore velocities suggests that erosion is probably the predominant mechanism. However, draw-down related mechanisms may play a contributory role.

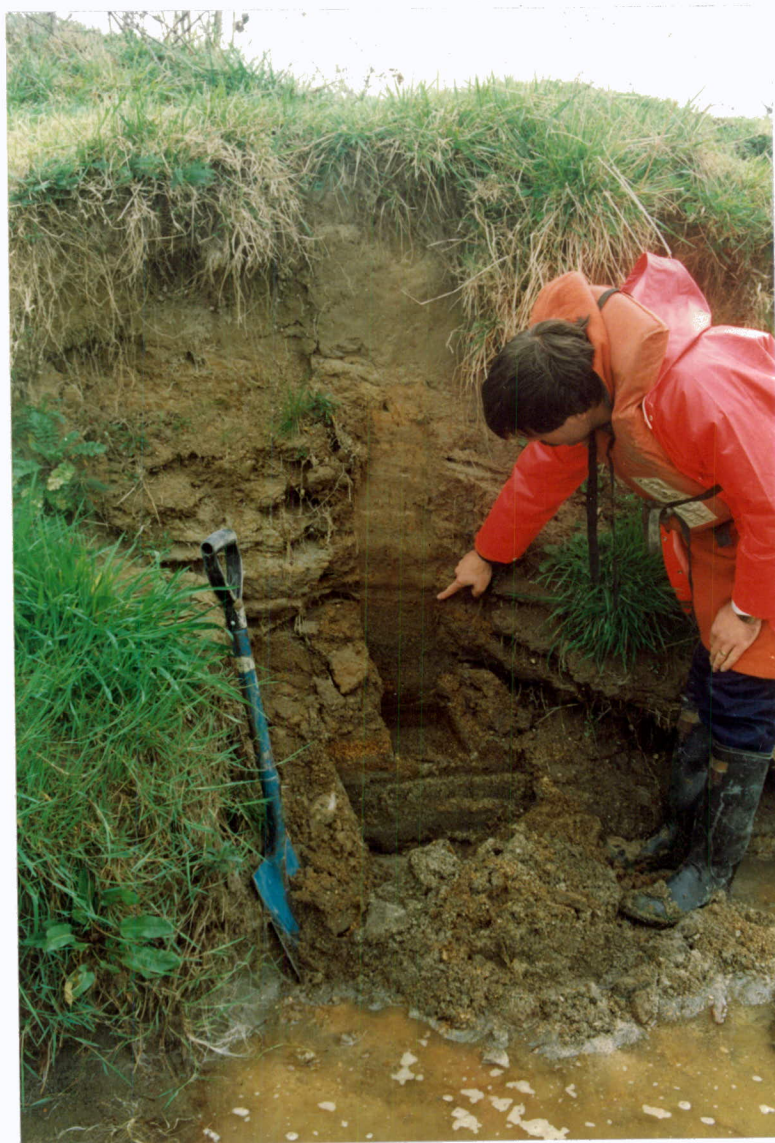
FIGURE C25 : BANK STRATIGRAPHY AT SITE 18

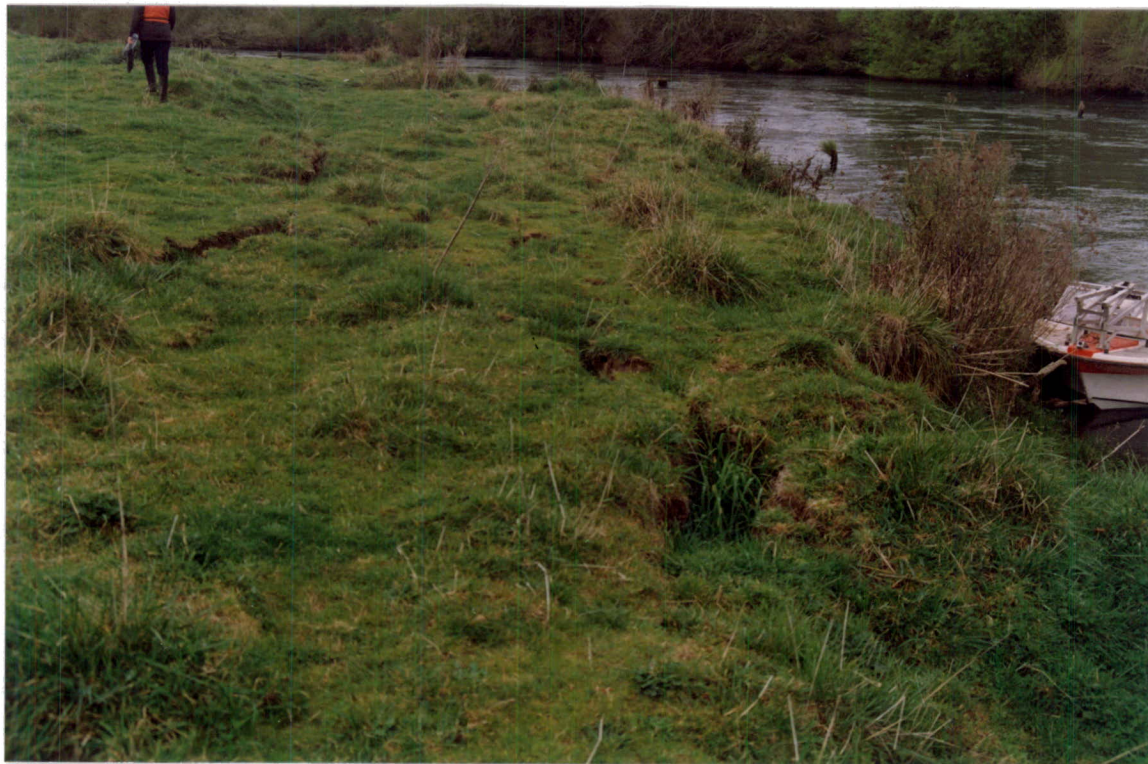
FIGURE C26 : SITE 18

Several factors appear to play a role at this site. Over much of the upstream region the damage appears to be primarily related to the recent earthquake with numerous tension cracks evident in this area (Figure C26). However the more notable erosion scarp at the downstream end (Figure C24) appears also to be related to basal erosion. Flow velocities are swift in this region and the cohesionless materials in the lower bank (Figure C25) are readily erodible. In addition a tendency for flow to be deflected across the channel towards the left bank is evident in aerial photographs taken on 3.7.87. Turbulence in the lee of the numerous tree stumps in this region may also act to aggravate bank stability. These stumps also divert flow towards the banks.

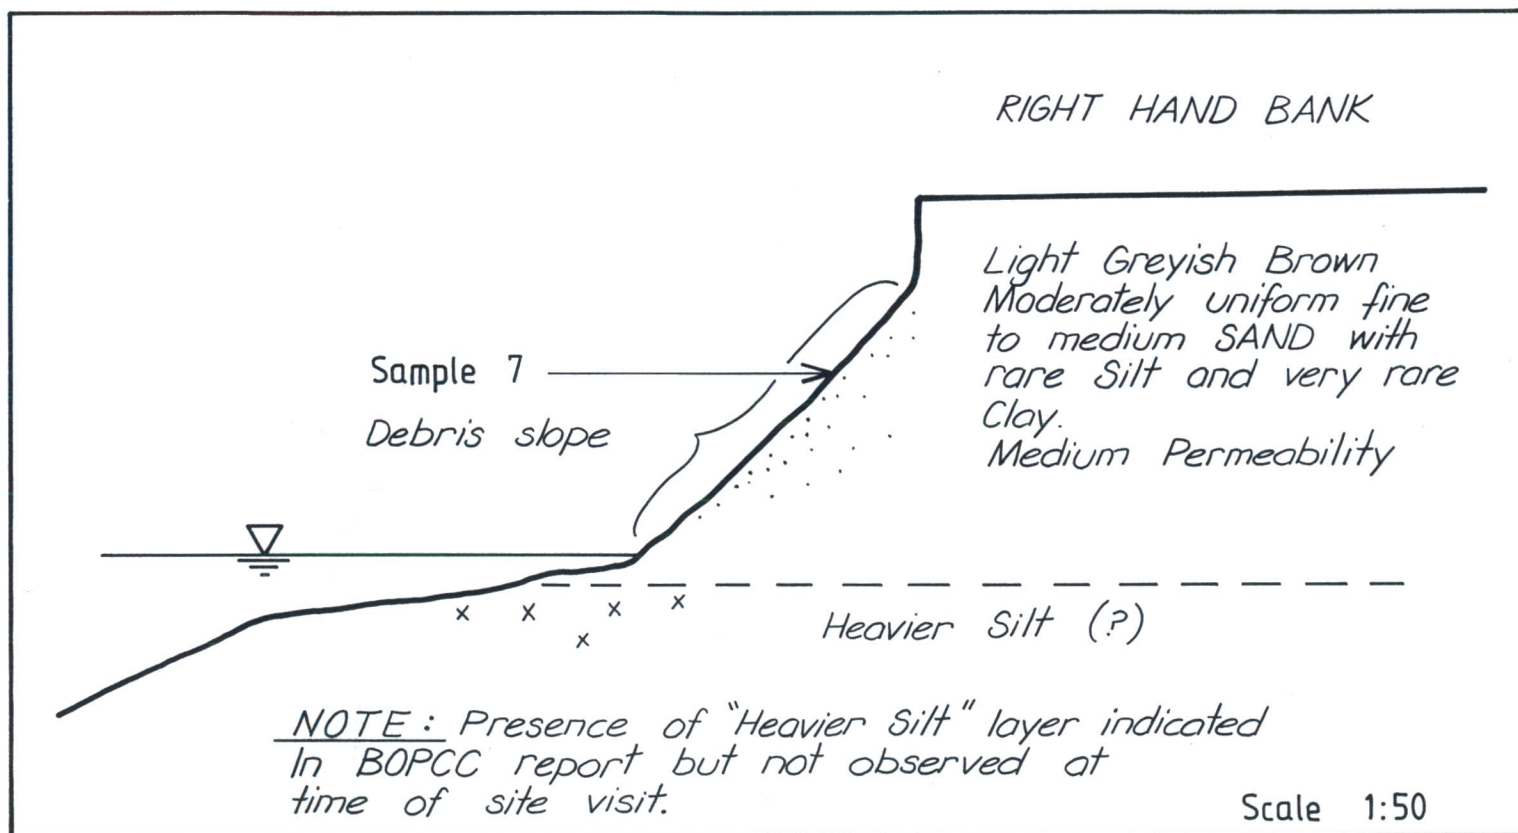
FIGURE C29

Right hand bank on inside of bend. The instability extends over a distance of 100m. The bank is composed of sands containing some silt in the upper regions (Figure C29). Lower bank materials were unable to be ascertained due to the presence of recent slump debris. However the BOPCC report of 1980 noted a "heavier silt" at the toe. Bank heights range from 2-2.5m with a platform, up to 5m width, evident just below water level (Figure C30). Water velocities through the reach are slow and have almost certainly been decreased by the lowering of this region in the recent earthquake.

Site 20 Bank Stratigraphy

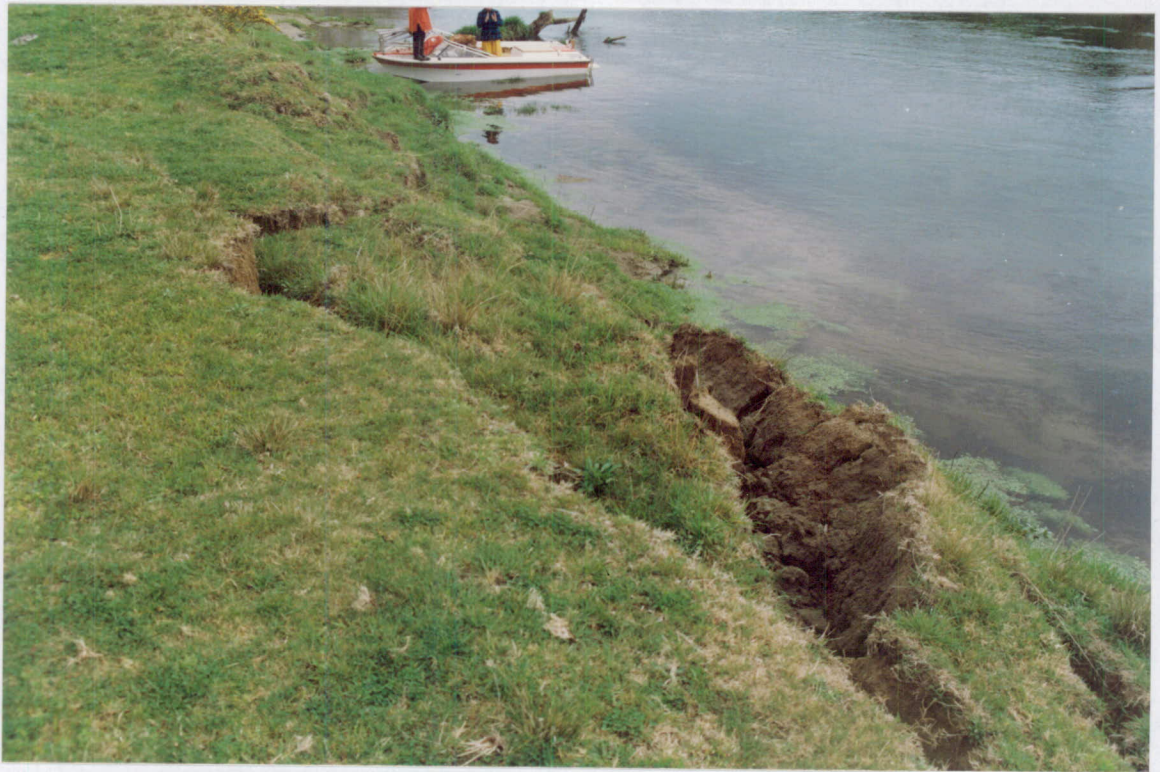
Figure C30. Site 20.

Erosion has occurred at this site for some time - being reported in the 1980 BOPCC report. In addition both old and new scarps are evident at the site (Figure C31). However the presence of numerous recent tension cracks along the top of the erosion scarps (Figure C30) suggests that the extensive recent scarps could be the result of seismic damage. The presence of large slump deposits, remaining at the foot of even old erosion scarps (Figure C31), suggests that basal erosion is relatively insignificant at the site. This is consistent with the location on the inside of the bend and the presence of a wide shallow platform at the base of the bank. As available evidence indicates that the bank is largely composed of relatively impermeable materials, particularly near the base, it is probable that the original erosion was largely initiated by weakening processes - possibly draw-down effects. However as the slump deposits are not rapidly removed, hence providing some toe support, it is unlikely that bank retreat was ever rapid. Photographic evidence contained in the BOPCC report of 1981 provides some confirmation for this view indicating almost complete vegetation (grasses) cover of the bank.

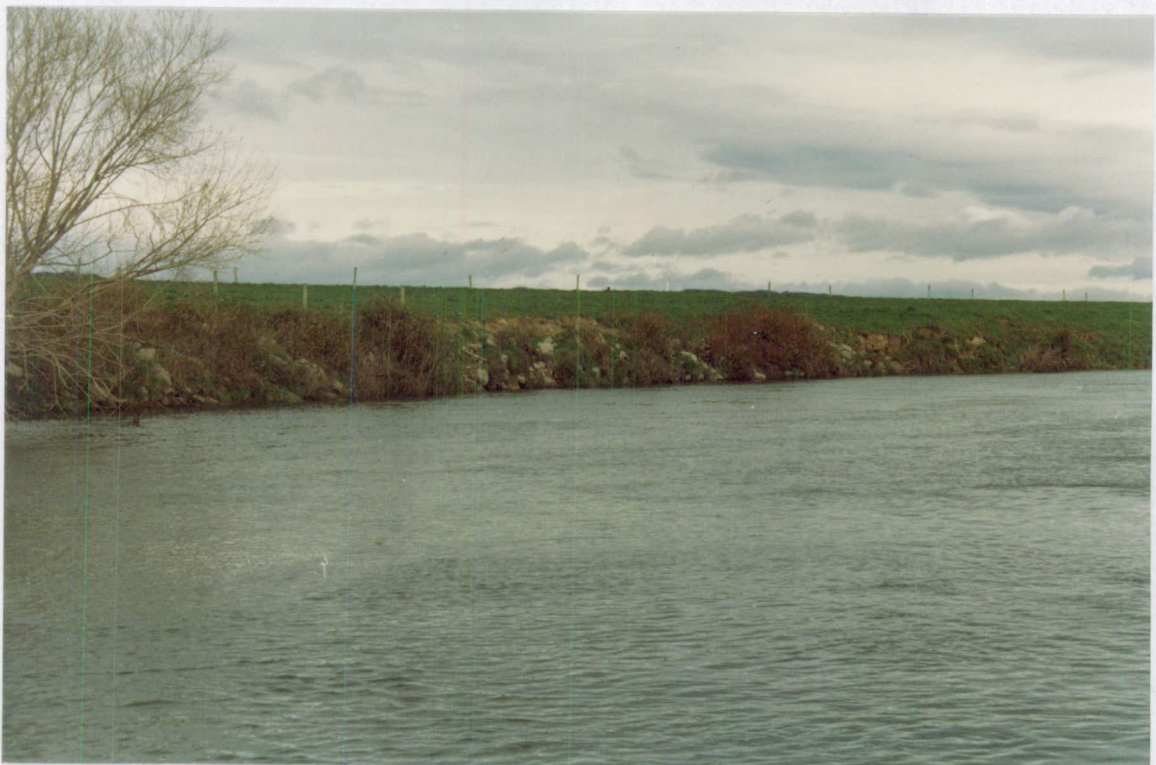
Figure C34. Site 22.

The BOPCC report of 1980 speculated that some recent breaks observed at that time were attributable to the operating regime of September/October 1980. However, they also noted that aggravation of the erosion by stock appeared to be severe. Hence at least three mechanisms - basal scour, stock damage and possible draw down effects - have been implicated at this site. As the rate of erosion has never been severe it is difficult to isolate the relative contribution of each mechanism historically. However, as noted above, any effect of basal erosion could be significantly reduced in the future. Hence water level fluctuations (due to tidal effects or power generation) could be the more significant factors in any future erosion. However there is presently no evidence to suggest that significant erosion can be expected.

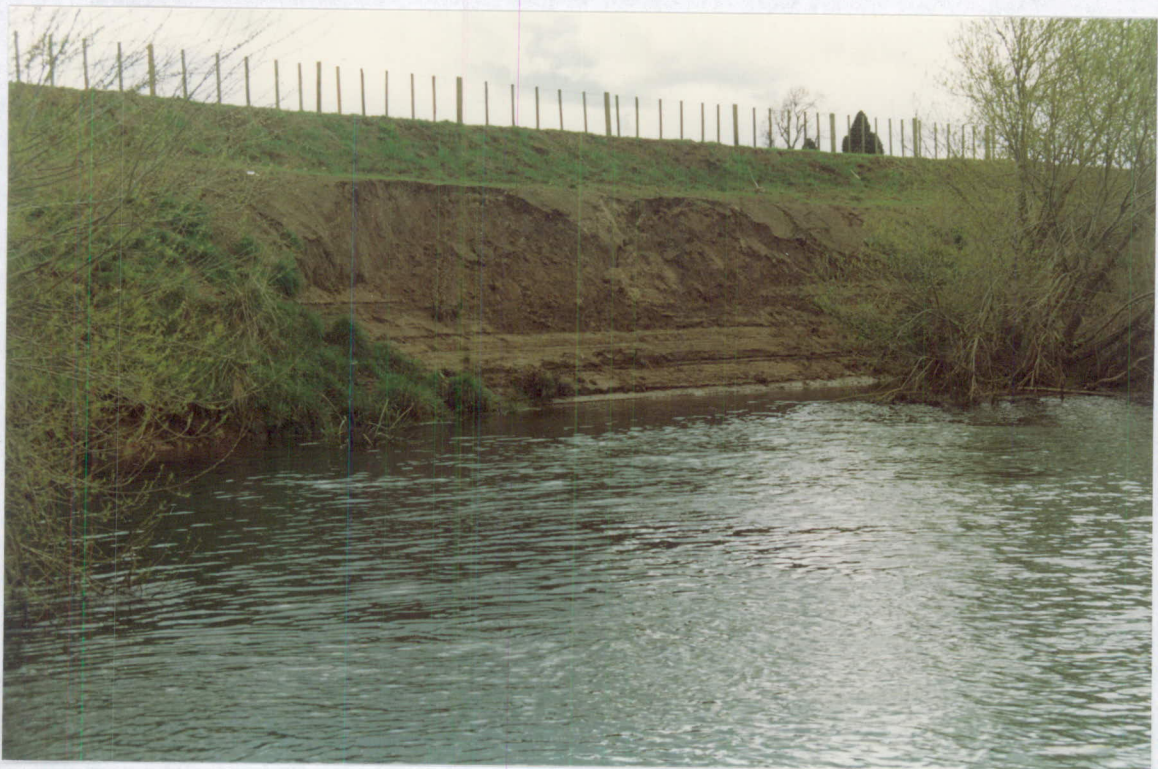
Figure C36. Site 23.

Left bank on the outside of a relatively sharp bend. Instability occurs over a length of 150m (Figure C35), much of the damage directly affecting the stopbank (Figure C36). This area has been significantly affected by the March 1987 earthquake, with water level now apparently about 1.0m higher relative to the banks (Mr D Roberts, BOPCC, pers. comm). Consequently some areas of previous rock protection are partially, and in some cases completely, submerged. Bank materials were not logged but appear to be relatively cohesive silty materials, though cohesionless materials may exist lower in the bank (ie, now submerged). Water level measurements surveyed by the BOPCC in June 1987 indicate a very low water level gradient in this region - 1:27157 between 1.505km and 15.74km (BOPCC plan R595). Consequently velocities in the reach are now relatively low.

A midstream island previously existing at the site, but removed subsequent to 1980, may also have contributed by directing flow into the bank. The recent change in regime is likely to significantly reduce the importance of basal erosion in the future - though some uncompacted fill (reinstated earthquake damage) was removed in a recent small fresh (Figure C36).

The BOPCC report of 1980 noted that the operating regime of September/October 1980 resulted in active block slumping at this site. Photos taken at that time indicate banks of relatively less permeable silty materials (possibly silty sands), which could have been susceptible to drawdown effects. The failure types evident in these photos also suggest, not conclusively, that draw down effects may have aggravated erosion at the site.

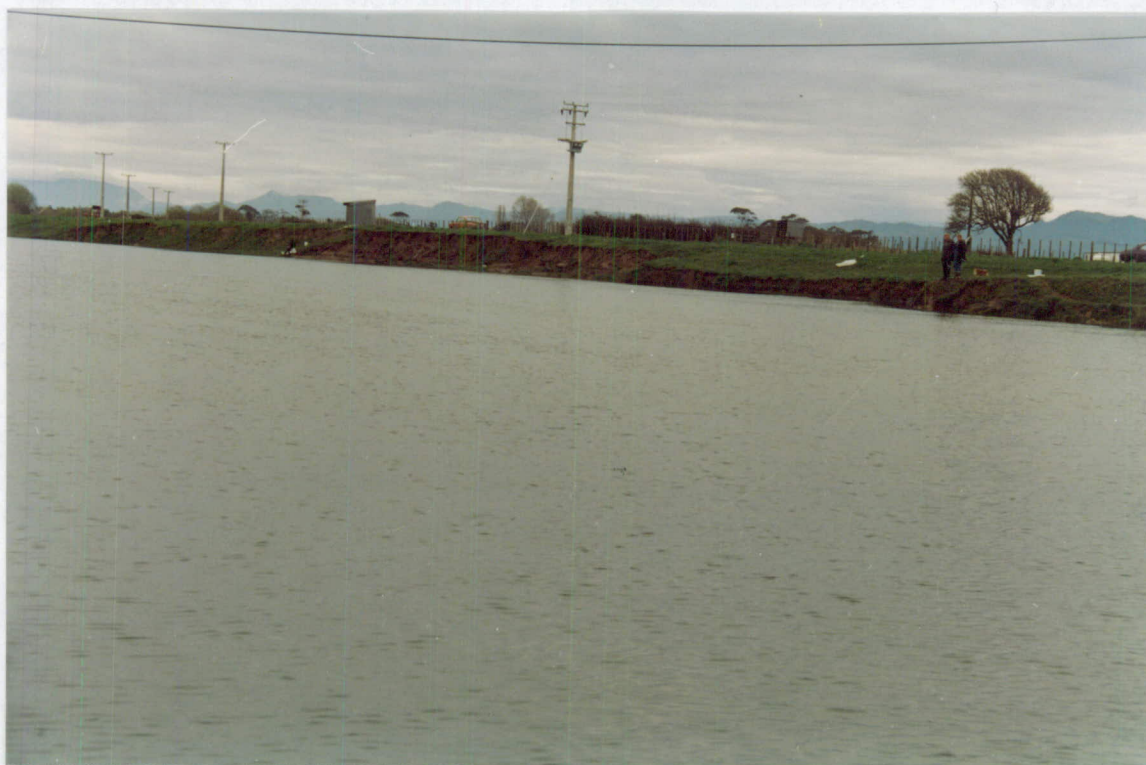
Figure C42. Site 28.

Left hand bank on outside of curve in the river. Damage extends over a distance of about 400m. The bank ranges in height from 0.5-2m, in some places being cut into the stopbank and in other places the low terrace fronting the stopbank (Figure C42). The low terrace is composed of fine cohesive materials (Figures C43 and C44) while the stopbank is composed of coarser and more friable materials (Figure C45). The reach is tidal and velocities are generally low at normal flows.

The location of the site on the outside of a bend suggests basal erosion at high flows could be an important mechanism. However, velocities are such that basal erosion is not likely to be significant at normal flows. The low terrace could also be influenced by draw-down related effects given the relatively puggy and impermeable materials composing this feature. It would be expected that this bank is regularly saturated over its full height by water level fluctuations, as tidal fluctuations alone generally exceed 1.0m at this site (BOPCC Plan R595). Moreover the materials of this bank appear to be relatively resistant to erosion. Clearly, however, unless the slump deposits were removed by erosion the bank would probably soon stabilise.

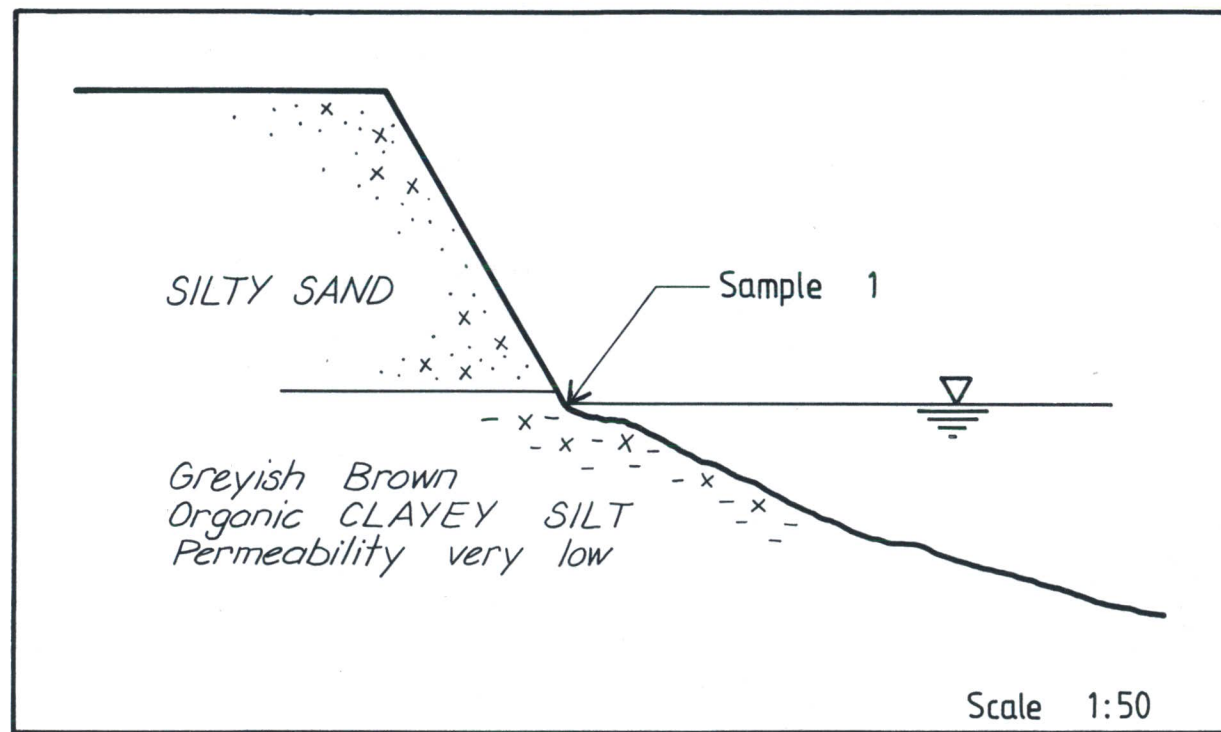
FIGURE 43

Bank Stratigraphy

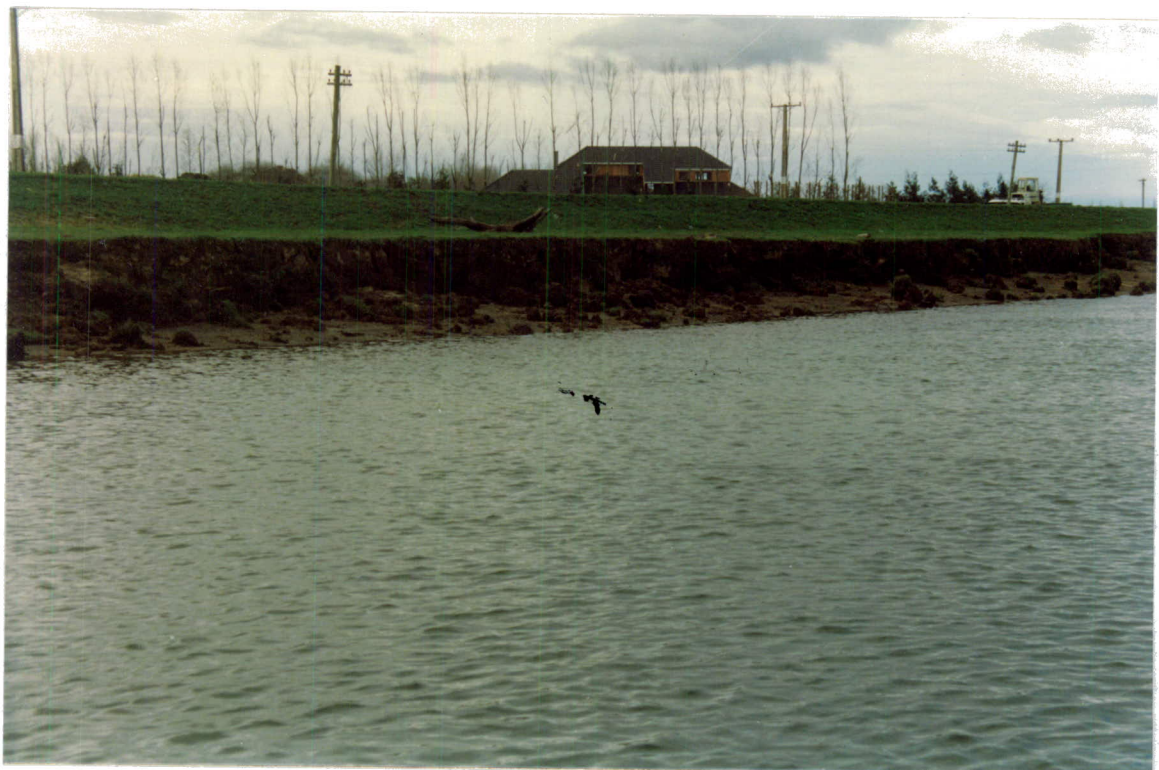
Figure C46. Site 29.

A variety of mechanisms could be active in this reach. As the bank is regularly saturated by tidal fluctuations, which are of similar scale to the bank height, draw-down effects could conceivably play an important role. To some extent this is supported by the fact that erosion is common along both banks throughout this region. Wave lap erosion could also be important, particularly with winds from a northeast or southwest direction which would blow directly along the 2km reach. Such small wind generated waves lapping against the bank could be expected to be particularly effective in regions where the bank is underlain by cohesionless sands. Current erosion could also play a role during freshes and/or floods. The fact that debris does not simply accumulate at the base of the bank, stabilising the region, suggests removal of this material by river flows. Nonetheless, the clumps of slump debris over the platform fronting the banks (Figure C46) does suggest that current erosion is minimal at normal flows.
