Sullivan's Breach, Rangitaiki River Stopbank

18 July 2004

A Review of the Causes of the Breach

Environment Bay of Plenty

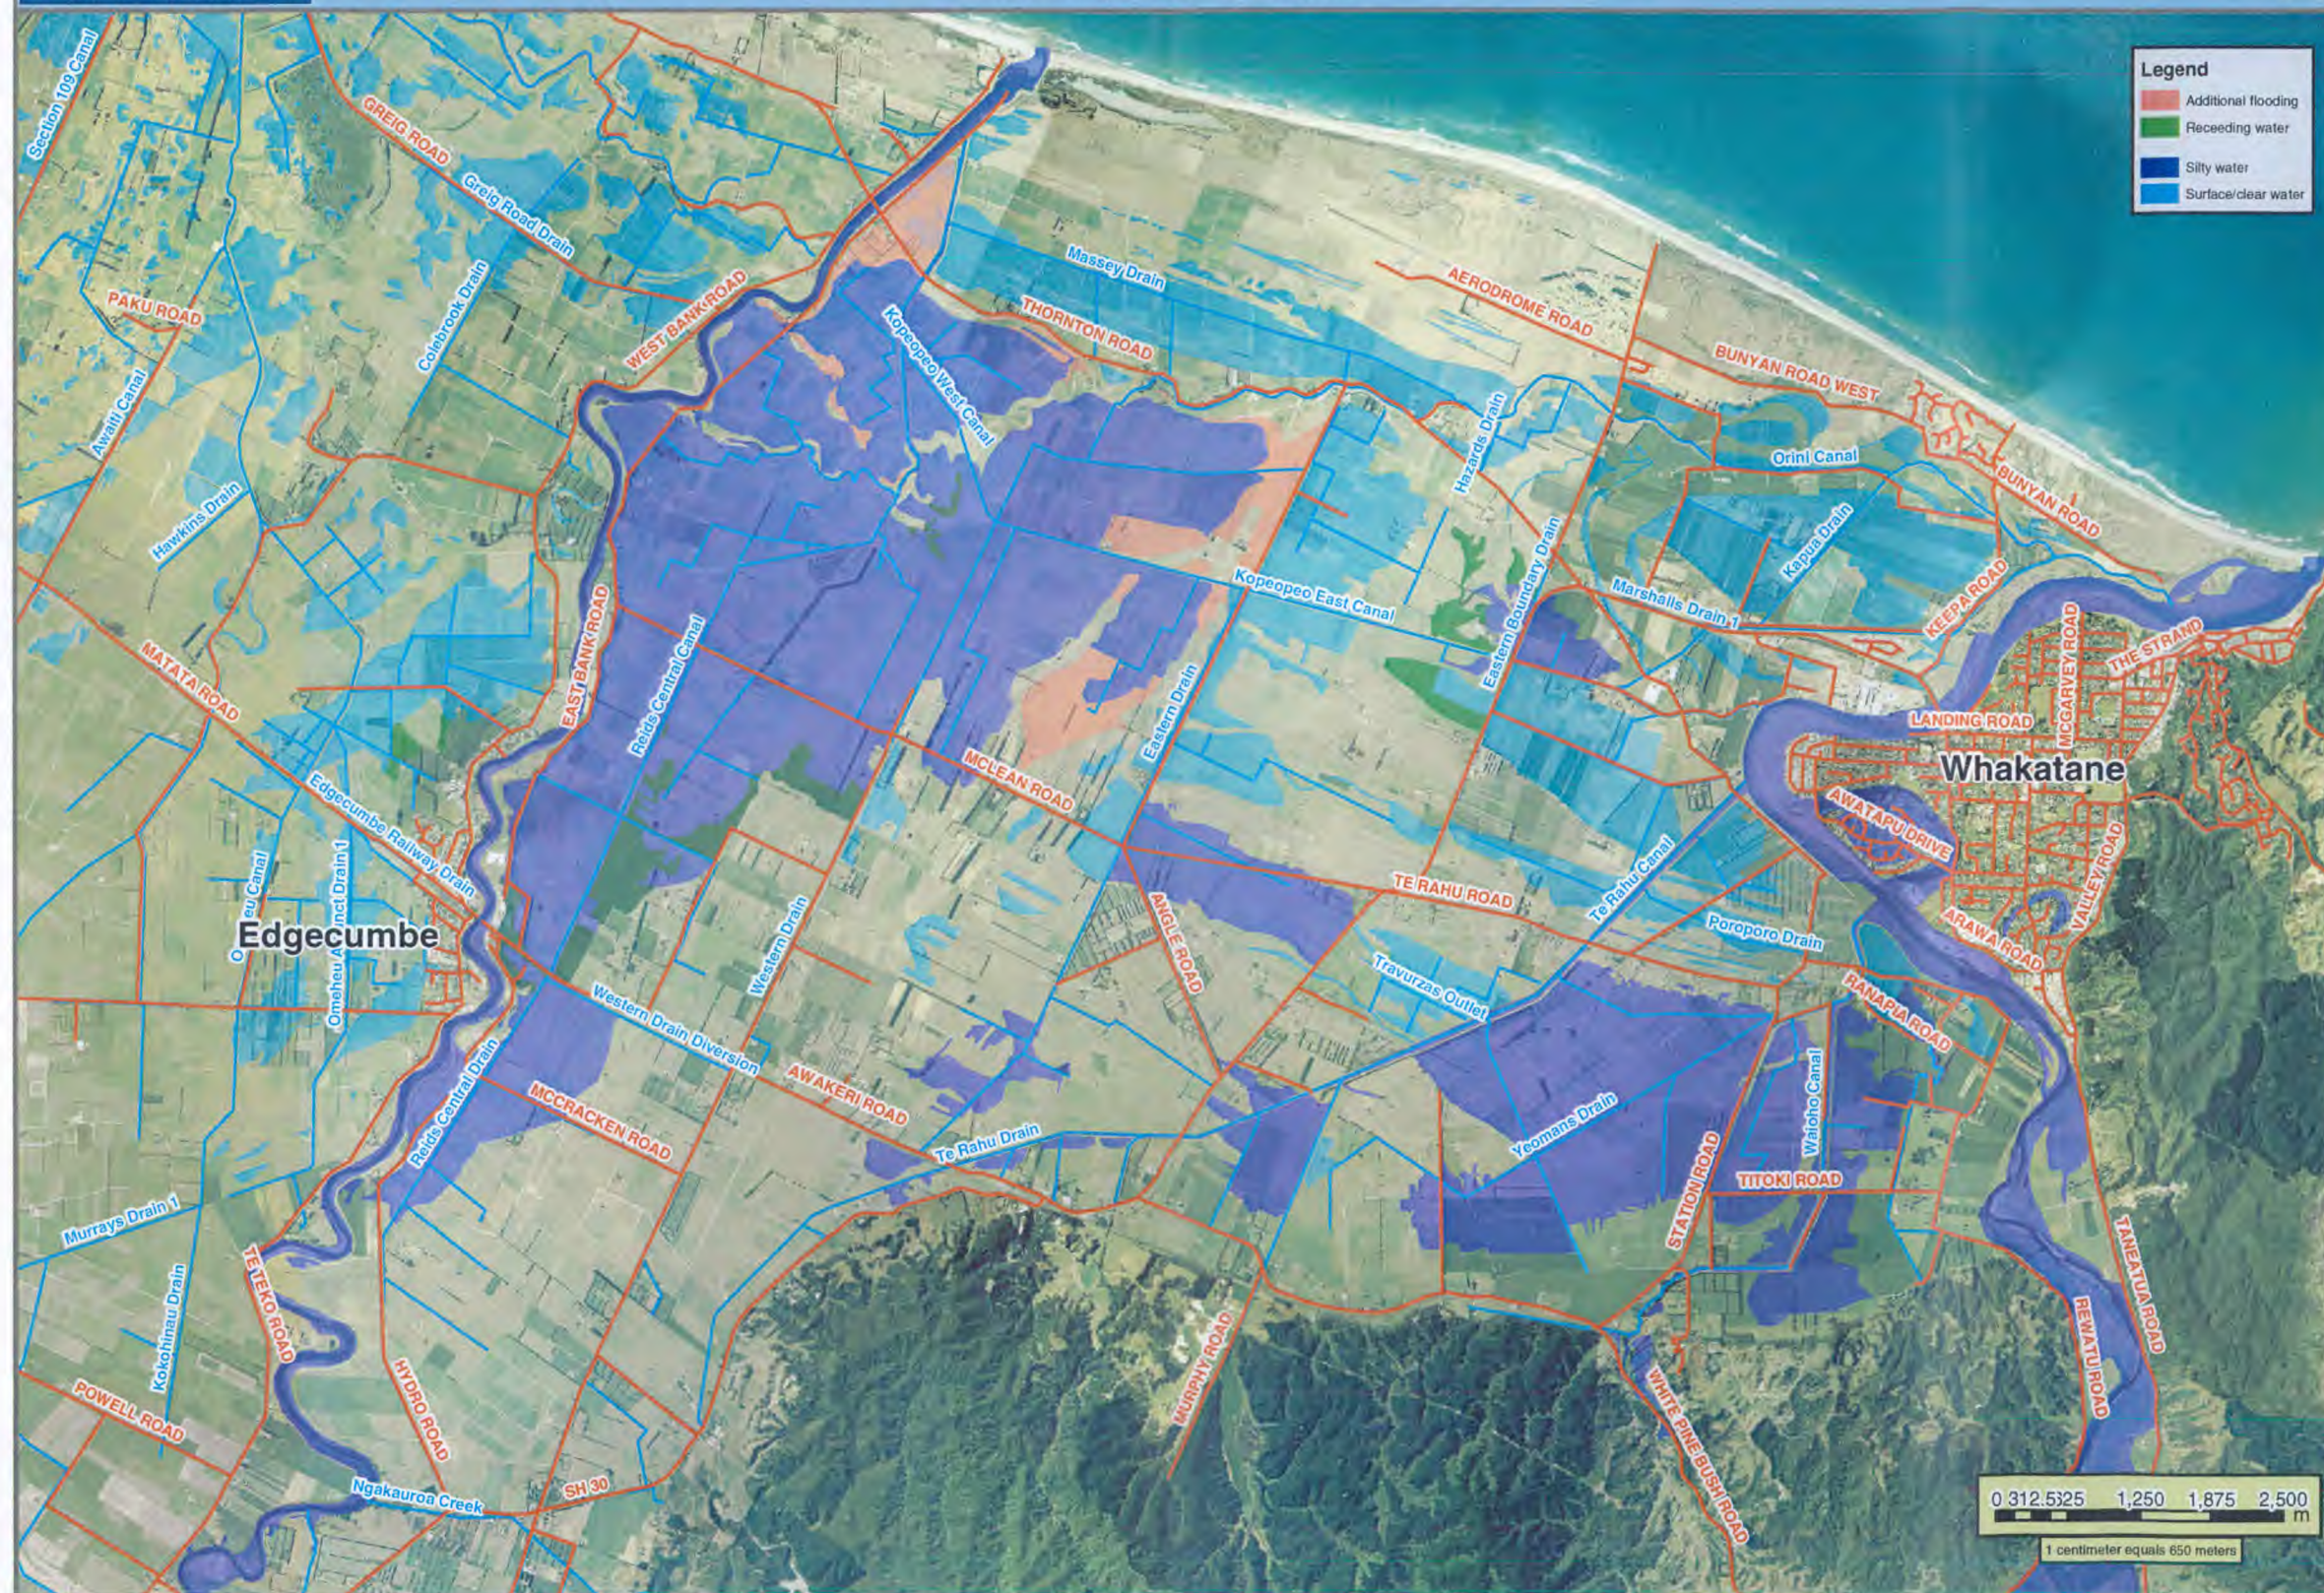
Rangitaiki/Whakatane

Flooding as of approximately 2pm - 19 July 2004,
additional information from 20th July 2004

Some parts of the Bay of Plenty experienced over 300mm of rain. Surface flooding occurred in many areas as drainage systems and pumps could not cope with the volume of water. The surface flooding in some areas made it difficult to detect leakage from stopbanks.

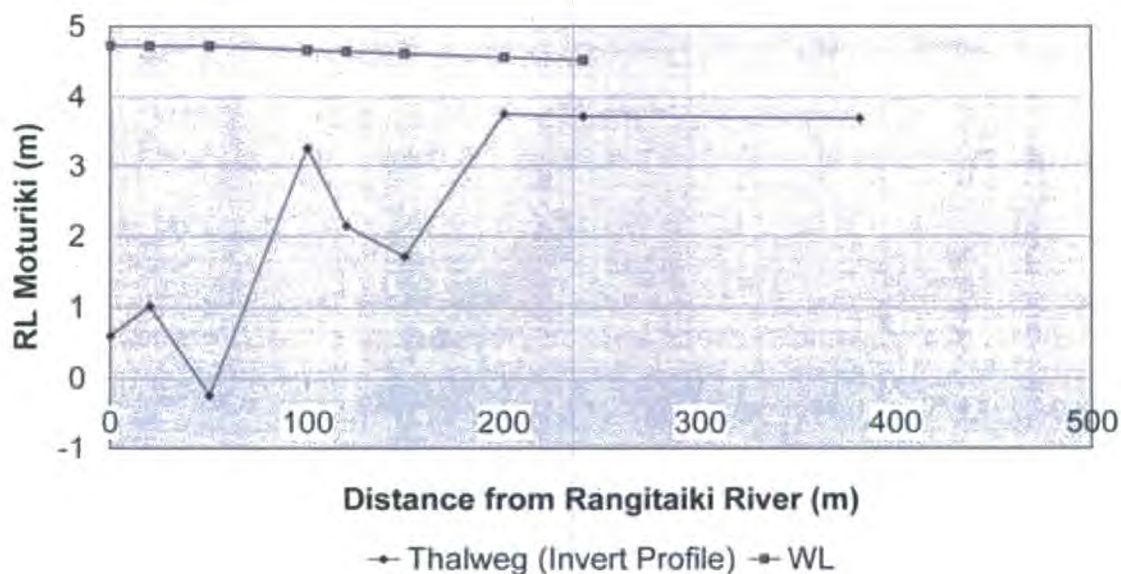
Figure 4: Long section along scour hole from river to Hydro Road (EBOP)

The large volume of water which flowed through the breach scoured out a hole nearly 5m deep where the stopbank had been (Figure 3). The scour hole extended inland about 150m from the stopbank centreline, typically reducing in depth with increasing distance from the stopbank (Figure 4, Photograph 3). About 5m beyond the end of the scour hole was a shallow depression which was later found to be an old abandoned stream channel.

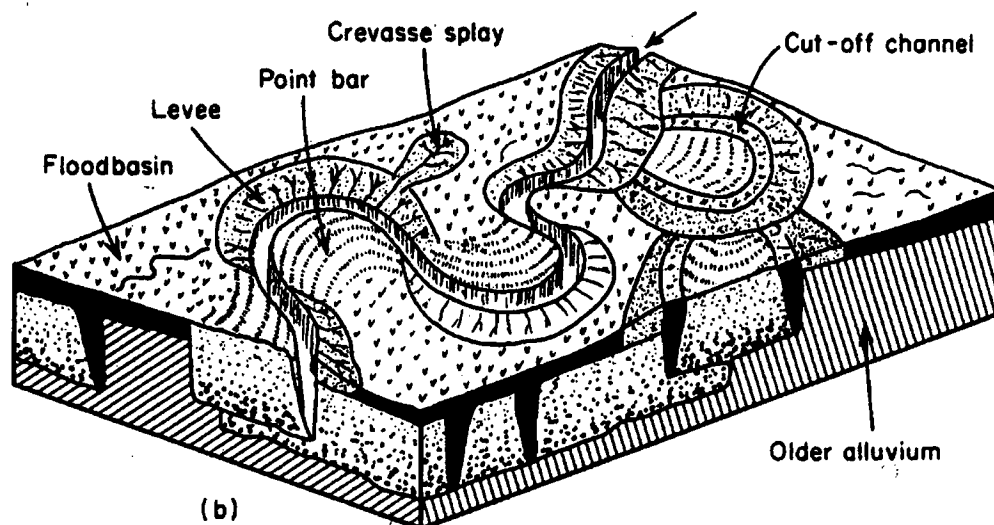
Figure 5: The floodplain environment of meandering rivers
(Figure 4.2 Freeze & Cherry (1979) Reference 5)

The plains have been built up by over-bank alluvial deposits from meandering rivers in flood, wind blown sand, airfall ash deposits and peat formation in depressions. The active volcanism of the upper Rangitaiki River catchment and the high erodibility of the volcanic tephra result in a large source of sediment which can be deposited on the plains. The outcome of the plain formation processes is a wide and unpredictable variety of soil types and grain sizes within small horizontal and vertical distances. Figure 5 (Reference 5) illustrates the floodplain environment of a meandering river with bank erosion and cut-off channels.

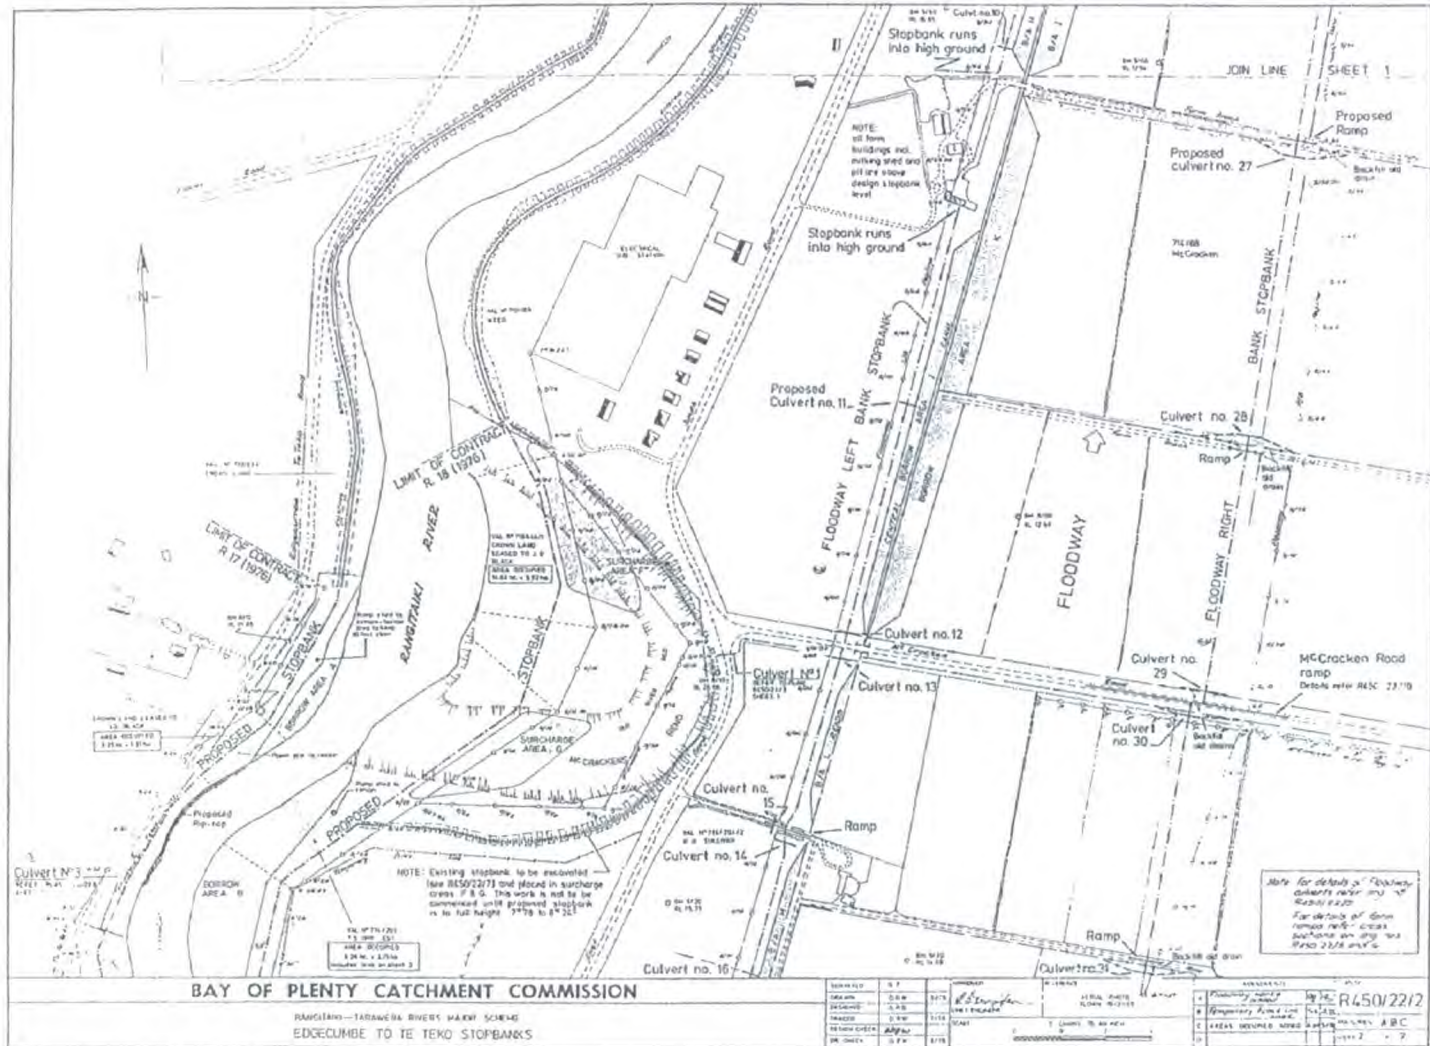
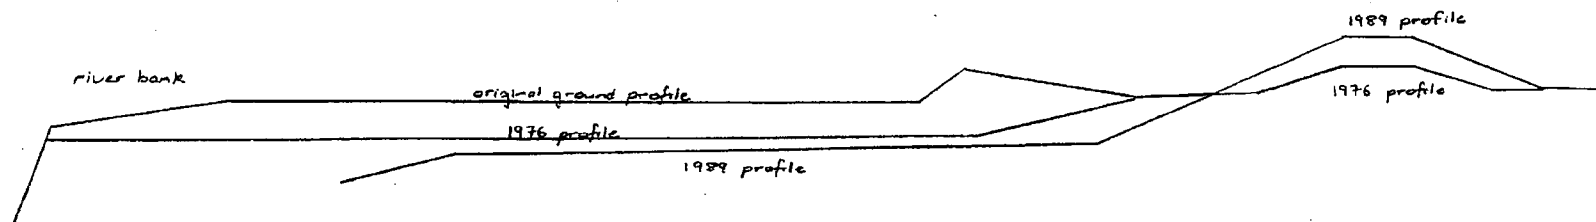
The stopbank was typically 1.5m above the general ground level, with 3H:1V side batters (Reference 6). Most of the soils used in stopbank construction were sandy silts and silty sands removed from the river side of the stopbank. Figure 6 shows the approximate original surface, the stopbank and the depth of excavation from the berm (approximately 1.4m). A small bench was left in front of the stopbank.

Type I damage consists of river bank slumping. As shown in Figure 6 there is about a 15m difference in the location of the river bank between the time the stopbank was originally built and when it was repaired after the earthquake. This difference may be due to the river bank slumping and subsequent erosion.

Before the repair work to the stopbank was carried out it was realised that the depression created by ground subsidence in the Edgumbe area meant that the stopbanks were no longer high enough to retain a 100 year return period flood. The stopbank at the breach site had to be raised 1.2m to re-instate adequate flood protection. The work was carried out in 1989 mainly using local silty sand/ sandy silt soils. The re-instated profile is shown in Figure 6 (Reference 9).

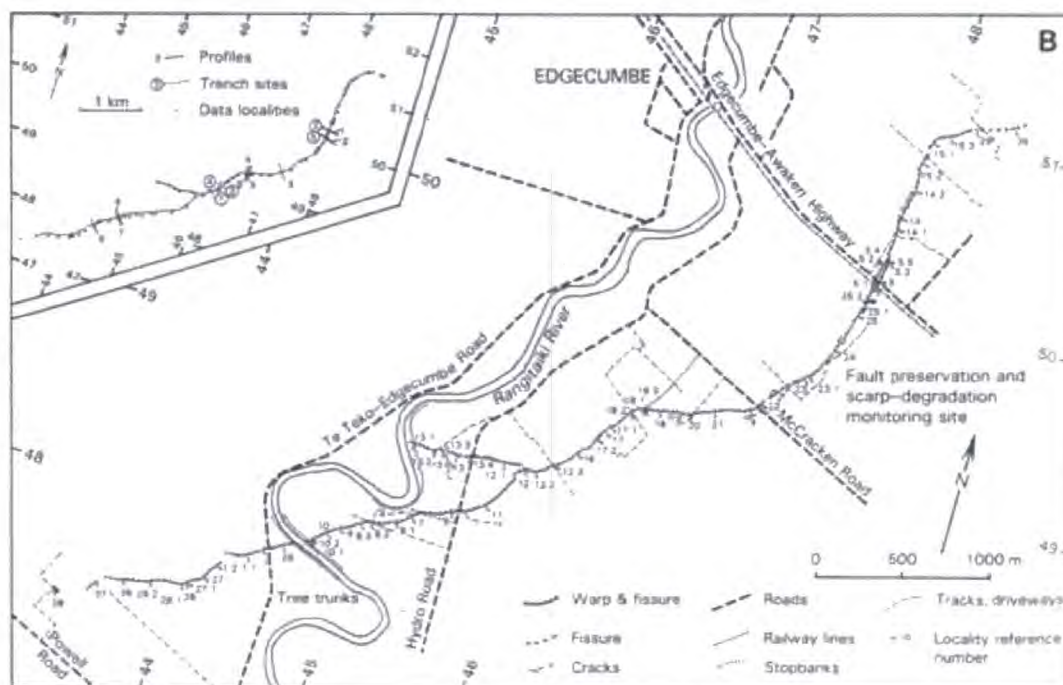
Figure 7: Edgecumbe Fault location (Beanland et al., 1989)

The earthquake caused reactivation of the Edgecumbe, Onepu and Rotoitipakau Faults and several new surface ruptures ranging in length from 0.5 to 7.0km (Reference 7). Typically the north-western side of the rupture dropped relative to the south-eastern. The largest displacement was near the centre of the Edgecumbe Fault rupture which is as close as 700m to the Sullivan's Breach site. This displacement was up to 2.5m vertically and 1.8m horizontally (Figure 7). The rupture crossed the Rangitaiki River about 3km upstream from the breach site.

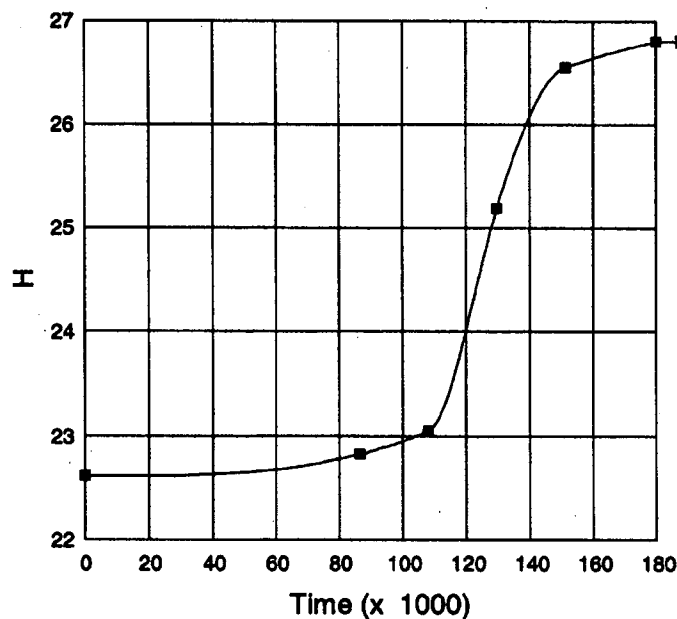
Figure 10: Flood Flow Hydrograph
(time in seconds from 8am 16 July 2004, stopbank crest 27.5m)

The flood flow hydrograph at Te Teko discussed in Section 2 above was used to model the flood up to the time of the breach. The hydrograph time was adjusted for the two hour time difference in river flow from Te Teko to Sullivan's Breach. The hydrograph levels were adjusted to allow for the 0.7m freeboard at the time of the breach. The resulting hydrograph is shown in Figure 10.

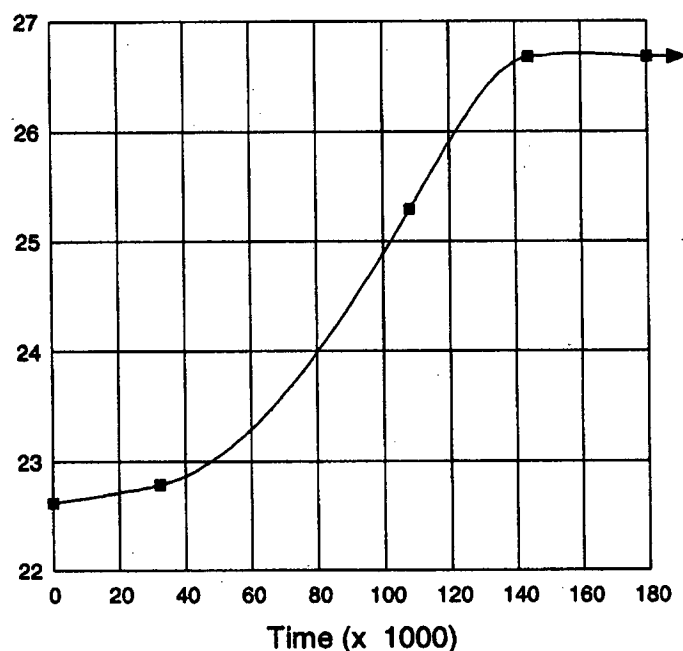
Figure 11: Trustpower modified flood flow hydrograph
(time in seconds from 8am 16 July 2004, stopbank crest 27.5m)

It can be seen by comparing the Trustpower modified hydrograph (Figure 11) to the recorded hydrograph (Figure 10) that modification would have resulted in higher river flows on 16 and 17 July. The seepage model was analysed using this hydrograph and it was found that the phreatic surface would have reached ground level in the paddock at 11.00pm on 17 July, compared to 6.00am on 18 July with the measured hydrograph. Heave of the top three soil layers in the paddock could have occurred at about 2.00am.

The comparison of the two hydrographs highlights the influence on seepage response of time at higher than normal river levels in contrast to the influence of actual river level.

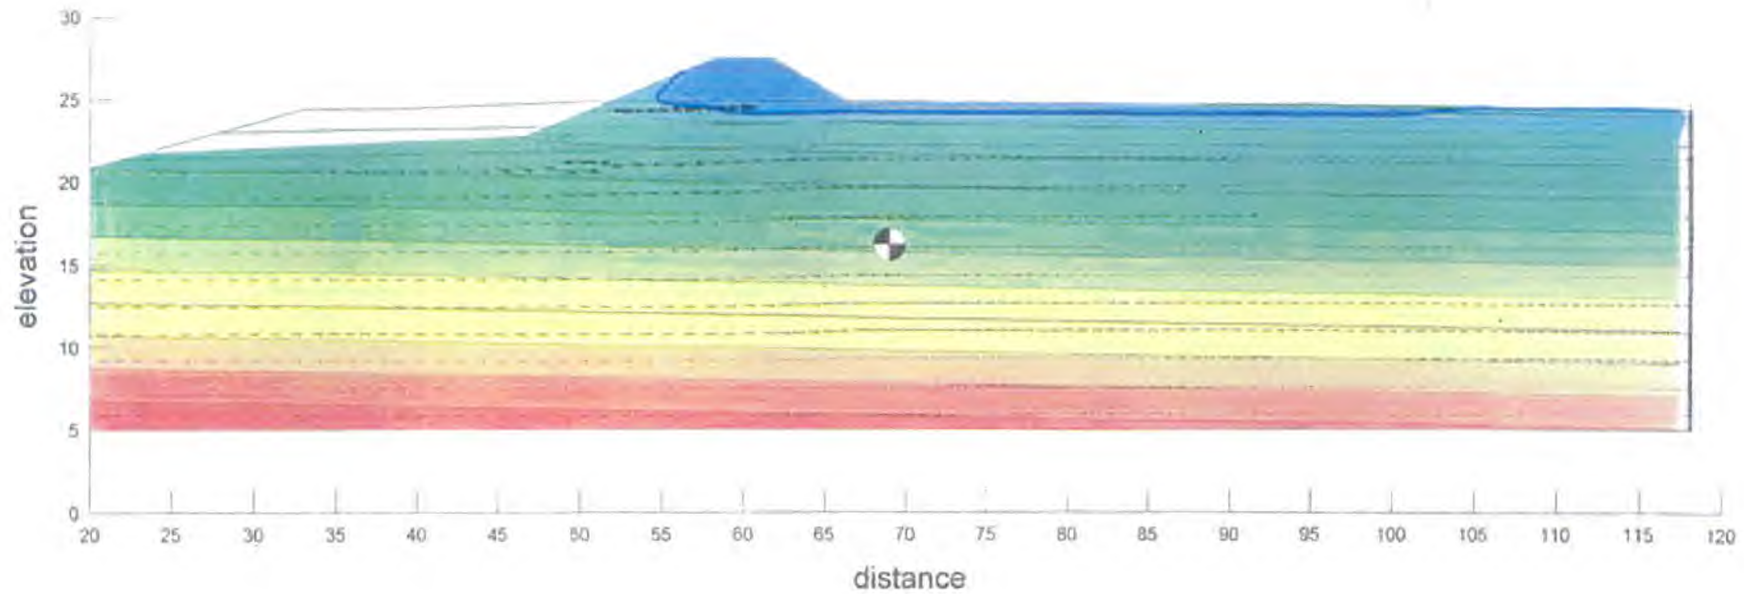
Description: Sullivan's Breach
Comments: prebreach stopbank profile
File Name: sullivan prebreach flood hydro730.sez
Last Saved Date: 19/08/2004
Last Saved Time: 3:20:57 p.m.
Analysis Type: Transient
conditions at 7.30am on 18 July 2004
no allowance for rainfall
pressure head contours at 1m intervals

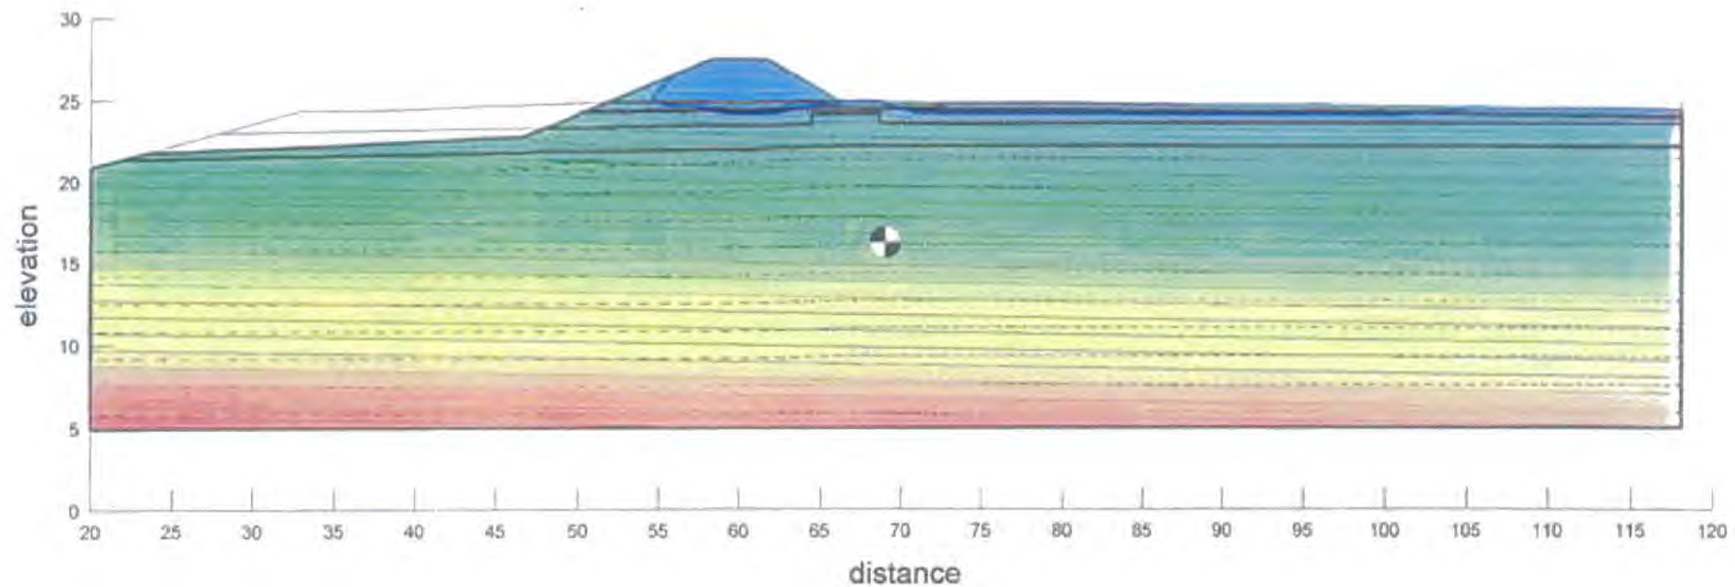
Description: Sullivan's Breach
Comments: prebreach stopbank profile
File Name: sullivan prebreach flood hydro7302.sez
Last Saved Date: 19/08/2004
Last Saved Time: 3:57:10 p.m.
Analysis Type: Transient

conditions at 7.30am on 18 July 2004

thin surface silty sand layer at landward toe (total thickness 0.7m)

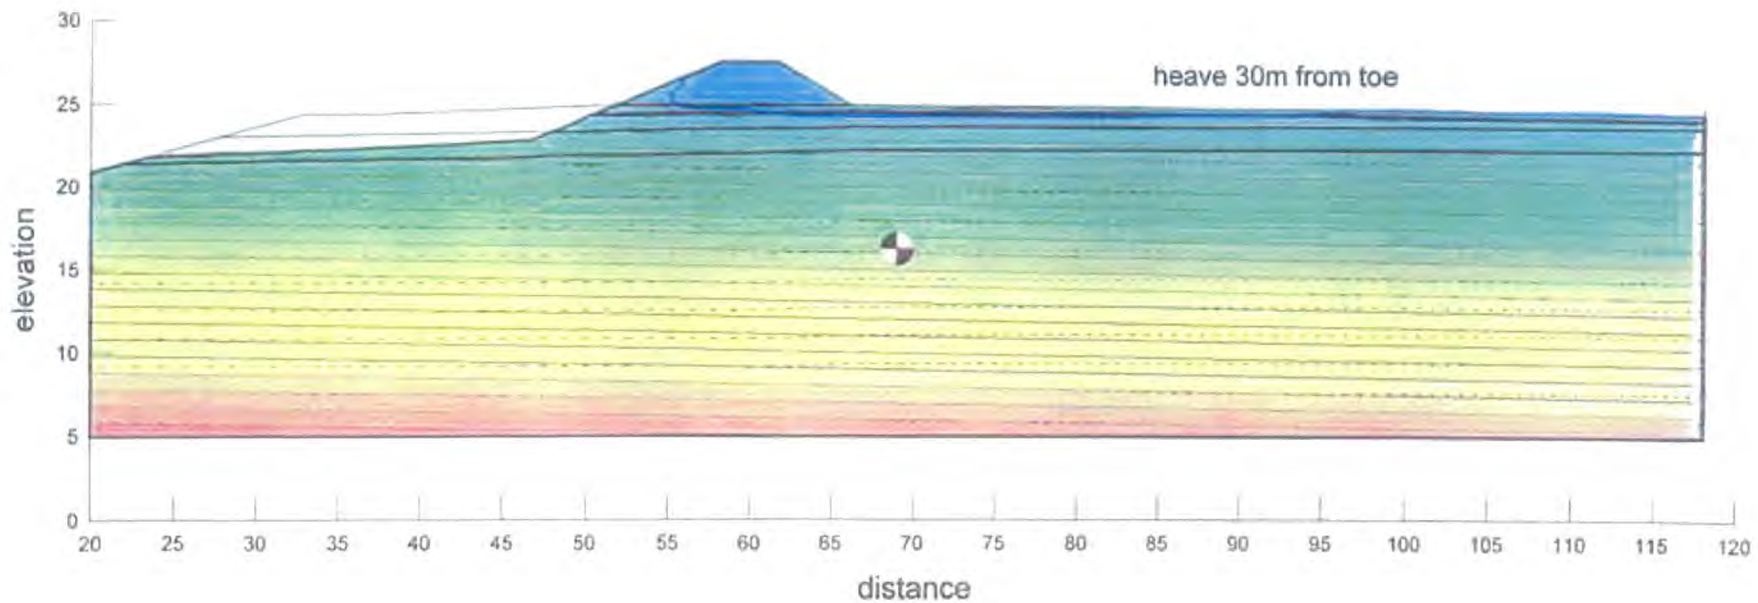
conditions at 10.0am on 18 July 2004
no allowance for rainfall

pressure head contours at 1m intervals

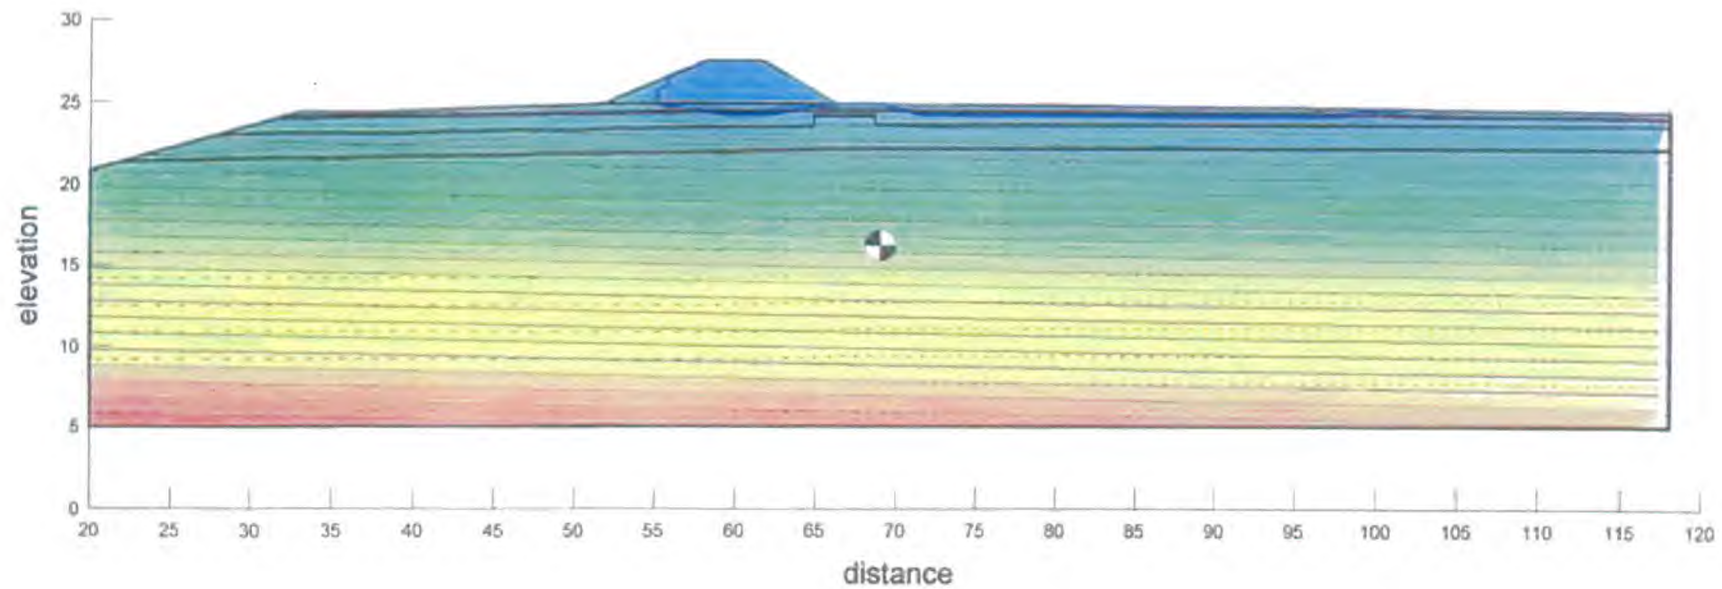
Description: Sullivan's Breach
Comments: original ground level - flood hydrograph
File Name: sullivan orig transient.sez
Last Saved Date: 18/08/2004
Last Saved Time: 10:55:24 p.m.
Analysis Type: Transient

conditions at 10am on 18 July 2004
assuming river berm intact

no allowance for rainfall
